CERTIFICATE OF APPROPRIATENESS PLACARD

425 N BLOODWORTH STREET

Tree Assessment Report

*Health assessment of the Osage Orange located at 425 N.
Bloodworth Street, Raleigh NC.*

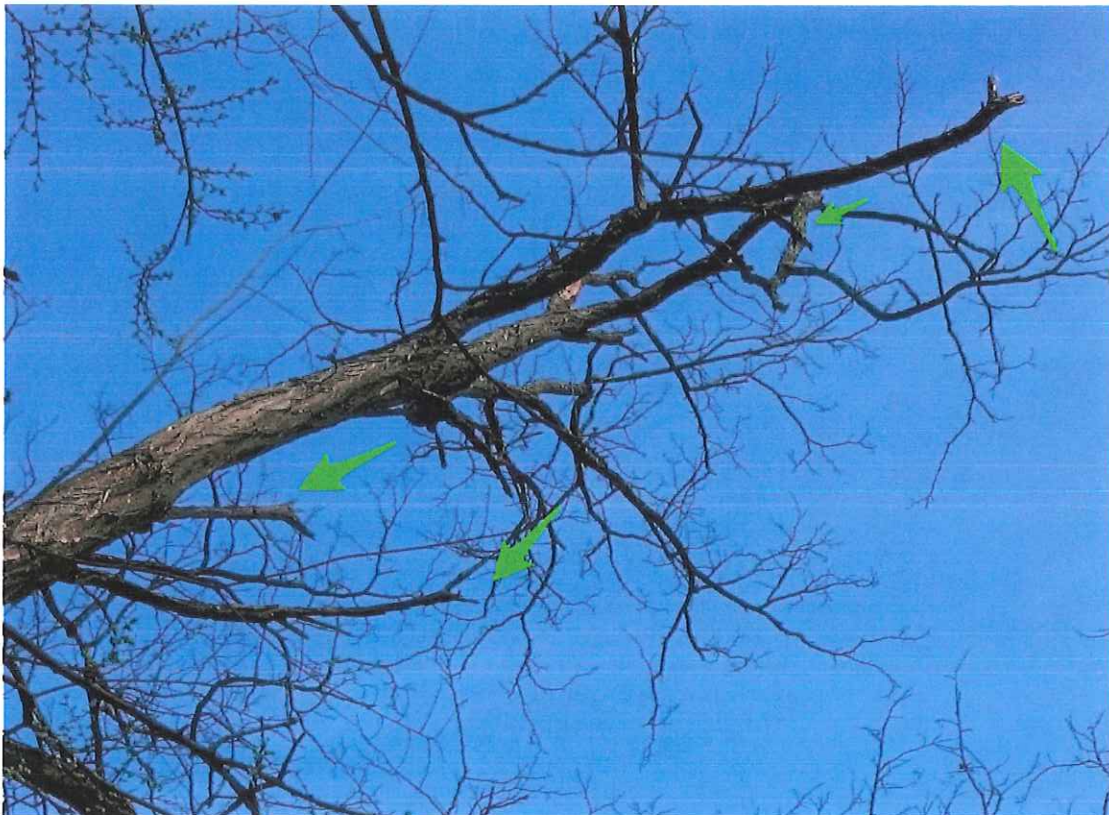
Though the tree did not have leaves at the time of the evaluation, there is observable and notable dieback in the canopy. Figure 4.1.1 is a close up view of the end of the leader that is growing over the house. The green arrows point to just a few areas of dieback. Canopy dieback is a symptom of declining vigor and health.

Based on the totality of the observable evidence, I recommend the tree for removal on the grounds that it presents a reasonable threat to both person and property and therefore qualifies as dangerous according to the City of Raleigh Historic Oakwood District's definition. The canopy dieback and tear-out wounds indicate the tree is of declining vigor and health. Further, branches falling on the roof and on the sidewalk show that the tree does indeed present a threat to property (branches on the roof) and person (branches dropping on the sidewalk). As the tree continues to decline the threat will increase. Removal is recommended.

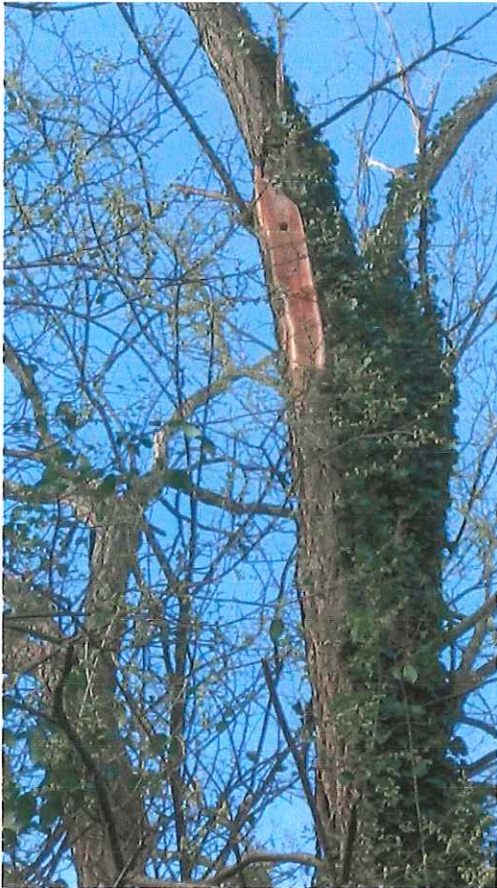
The tree exhibits evidence of multiple branch tear-out wounds. Excessive dropping of branches is another symptom of declining health. The client indicated that multiple branches fell on the roof and on the sidewalk. Figure 4.2.1 shows a large tear out wound from a branch that extended over the sidewalk. Figure 4.2.2 shows a smaller tear-out wound and a hanging limb from the stem that extends over the house.

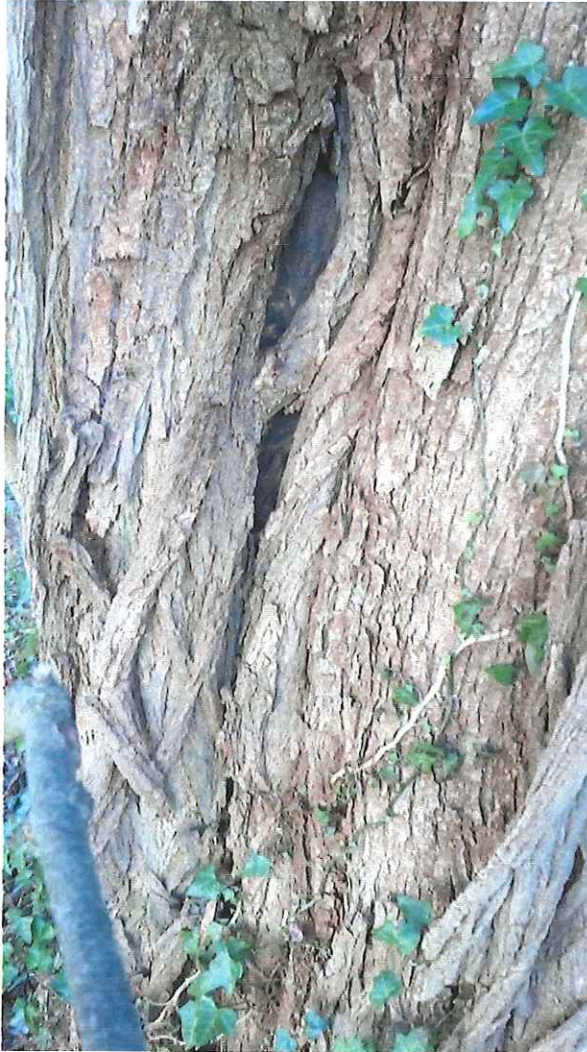
Figure 4.3.1

The trunk of the tree exhibits multiple sites where minor decay is present. The decay has yet to reach a point of endangering the structural integrity of the lower trunk. However, decay is an irreversible process that will only get worse over time. Figures 4.3.1 and 4.3.2 show two of these sites.

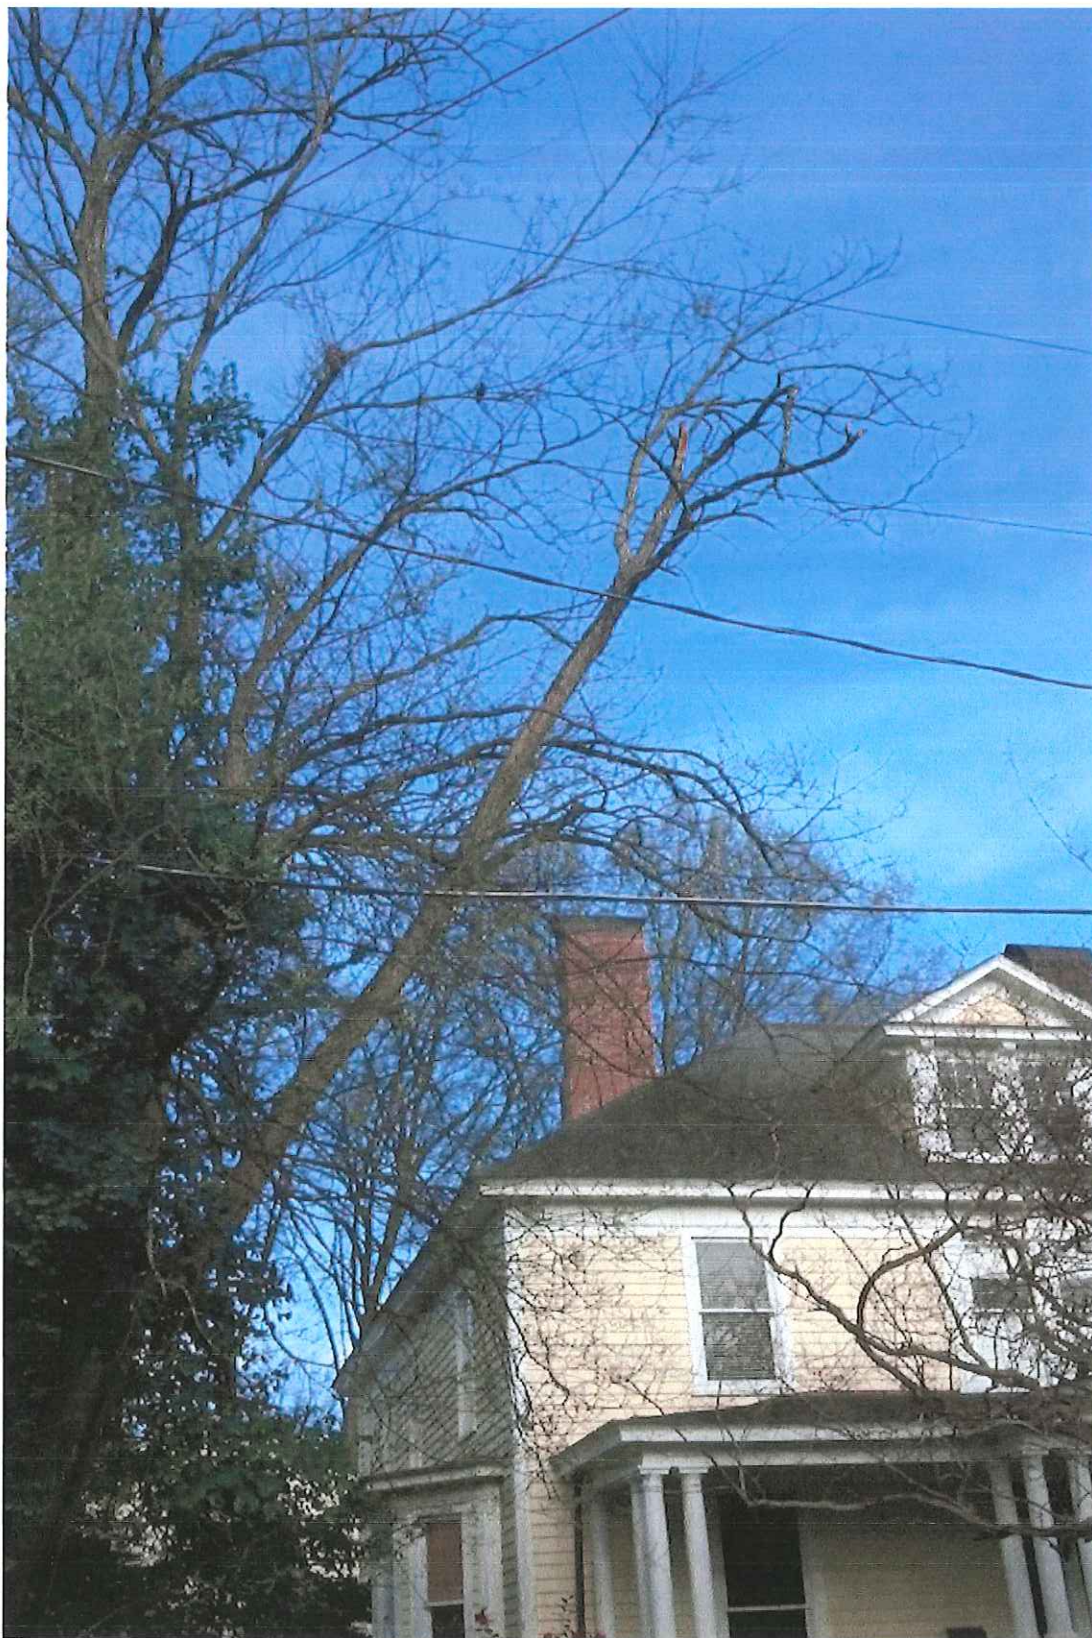
Figure 4.4.1

The tree has two main, co-dominant stems. While the union between the two stems is a U-shape (which is an inherently stronger stem union than one that is V-shaped), one stem extends at close to a forty-five degree angle over the roof (see Figure 4.4.1). This stem displays significant dieback and multiple branch tear-out wounds (see Figure 4.2.2). As such, it can be concluded that the stem is in decline. Due to the combination of poor health and the significant lean over the home, this stem can be considered a threat to the property.

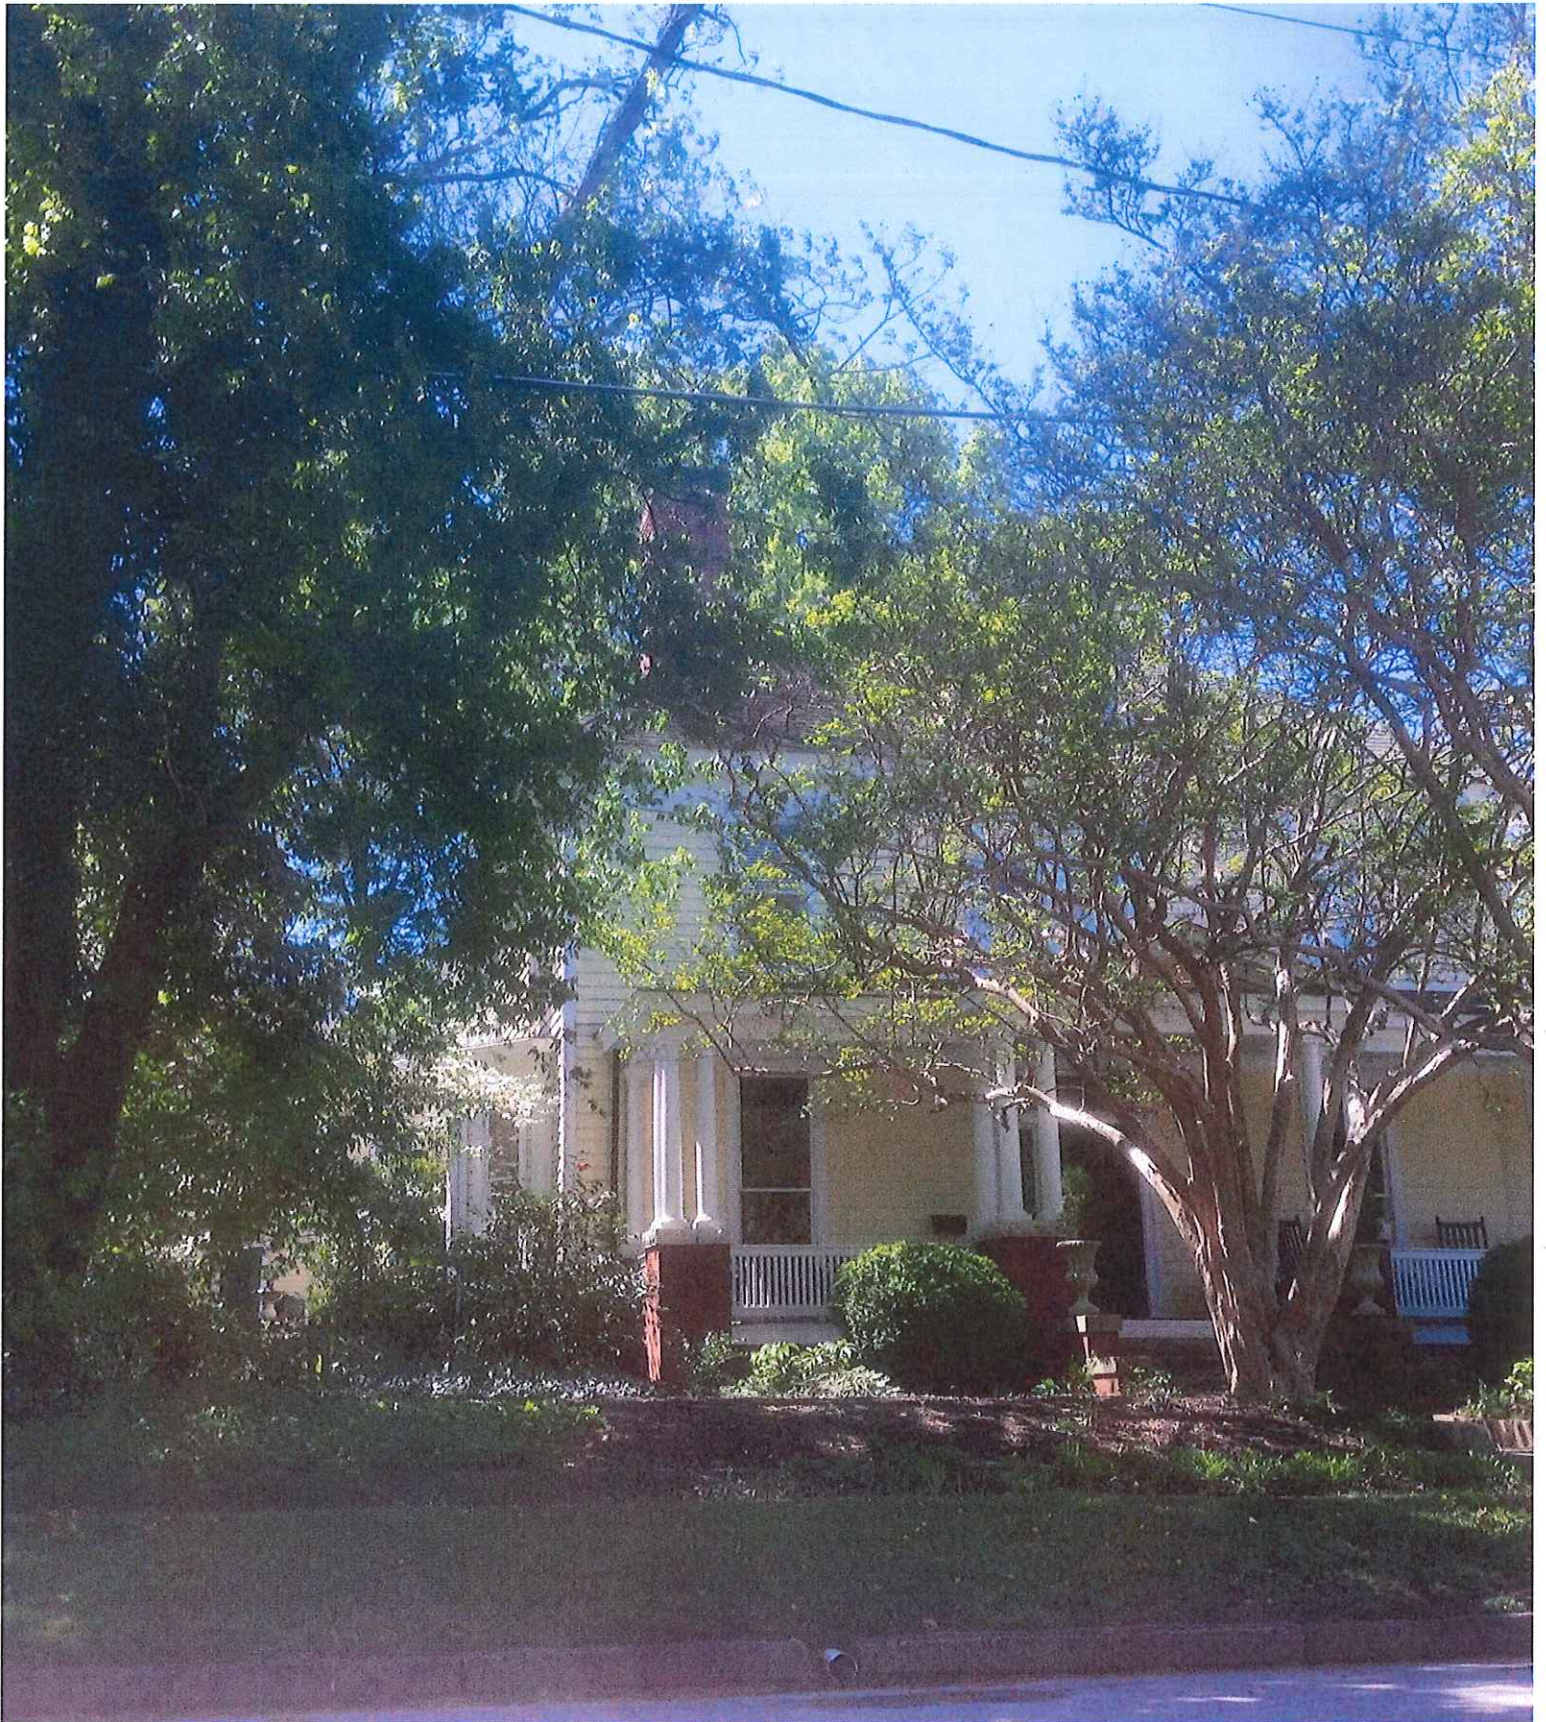
photo (4)

Hope you are doing well. Attached is a photo of the house and tree. The tree is the large double trunked one to the left of the house. I would like to plant a coral bark maple close to that spot but more into our yard and not so close to the lot line. There are power lines going to the next door neighbor's that need to be avoided as well so an understory tree would be more appropriate. Let me know if you need any more information from me. Thanks so much!
