Aging Stormwater Infrastructure

Pigeon House Branch Watershed Study

Condition Inspections

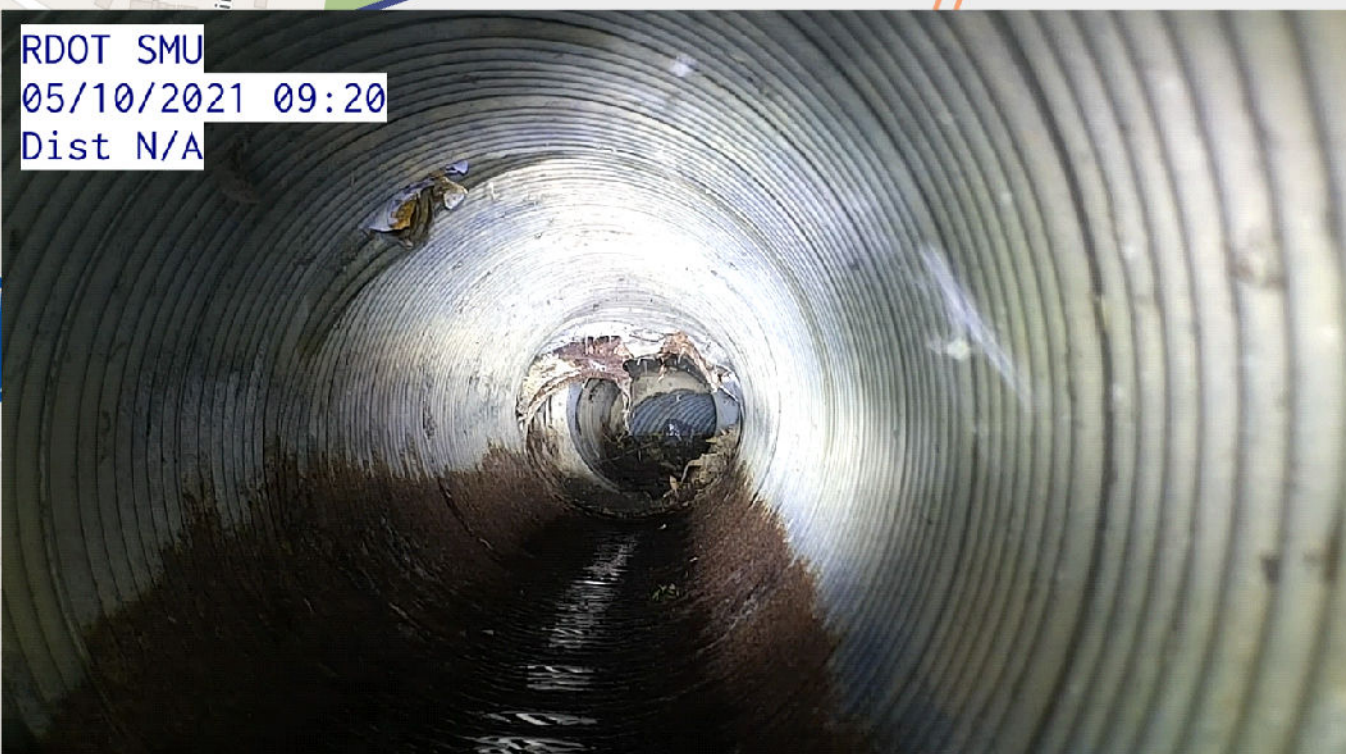
Corrugated Metal Pipe - Poor Condition

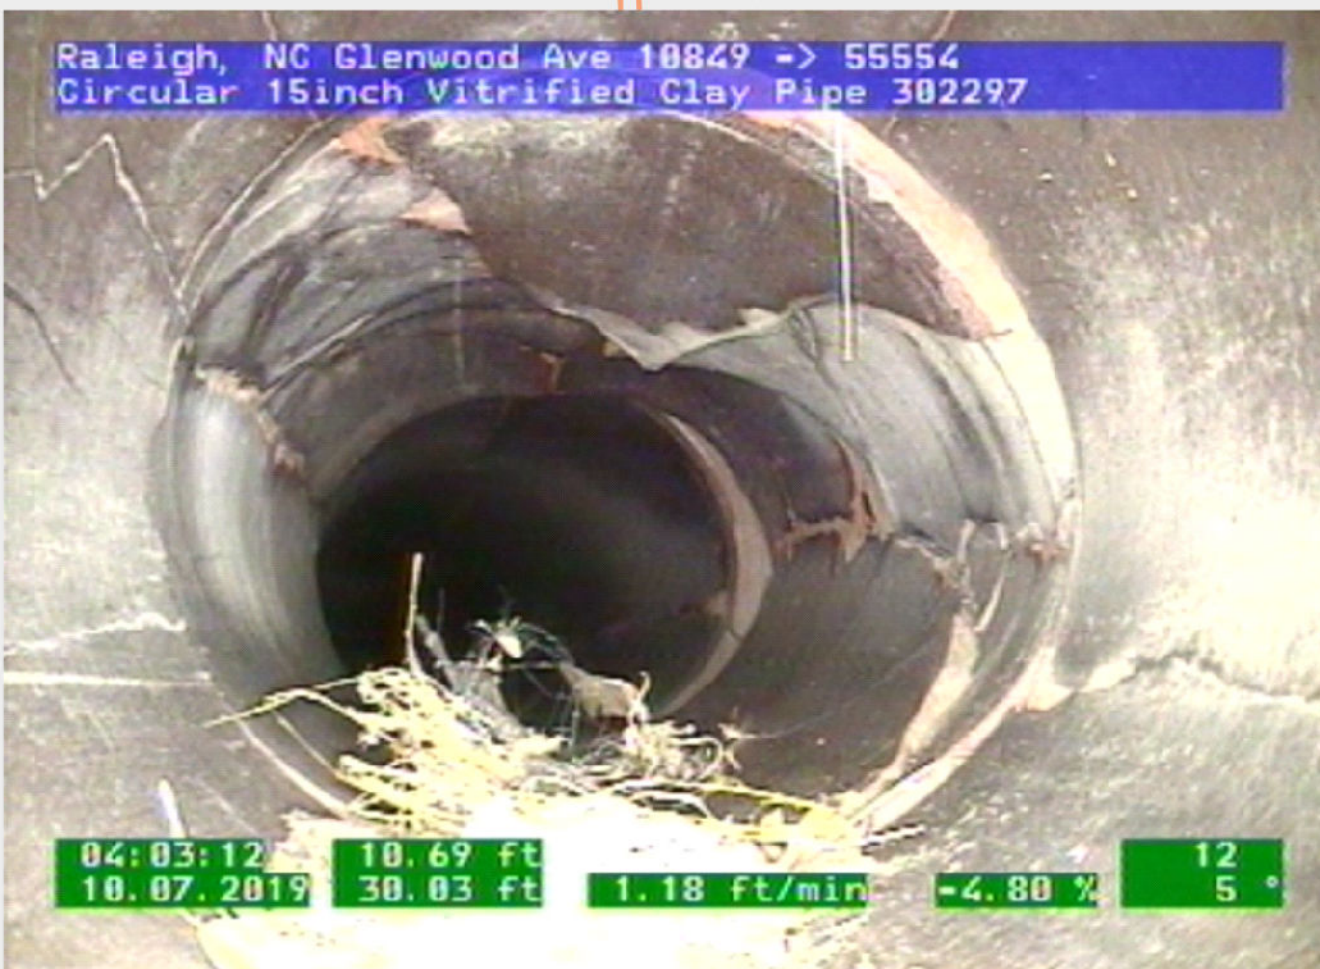
Vitrified Clay Pipe - Poor Condition

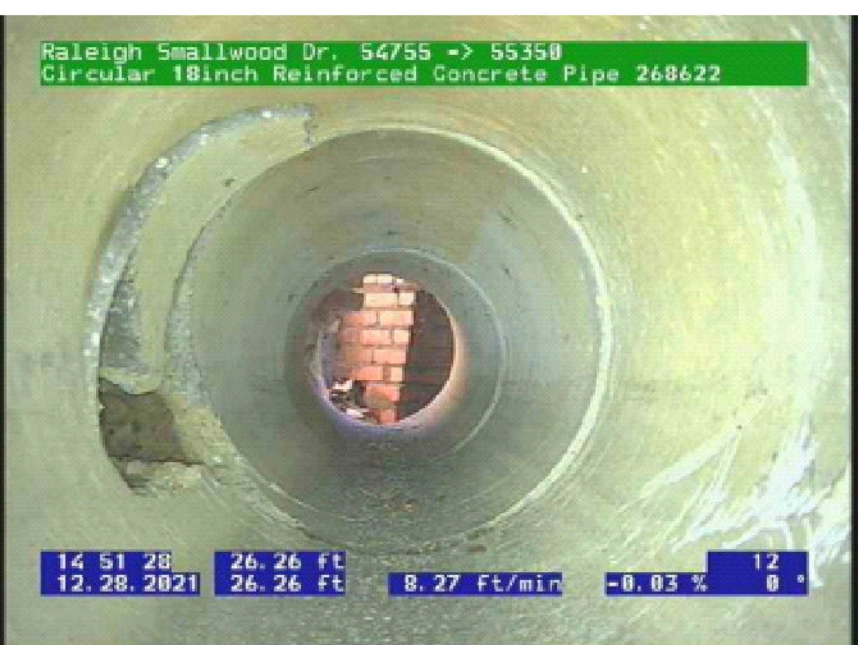
Before

A hole in this pipe was repaired with a Quick-Lock sleeve, which is inserted into the pipe using a crawler and expanded to permanently lock it in position.
