Eastgate Park Dam Preliminary Engineering Report

Final Report Hazen #32511-005 October 31, 2023

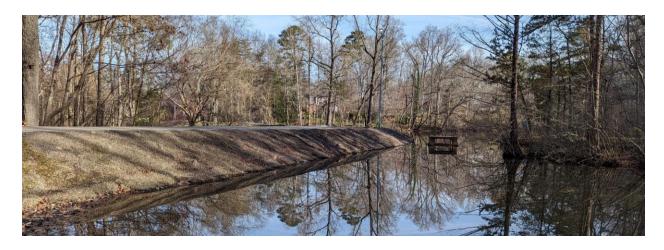
Picture 1: Upstream Face of Dam

Eastgate Park Dam is an earthen embankment with a grouted curtain wall, grouted riprap on the upstream face, and vegetation on the downstream face (**Picture 1** and **Picture 2**). The downstream slope is relatively steep at a grade of 2H:1V, while the upstream is around 3H:1V. The top of dam is lined with concrete slabs that have embedded area inlets and small-diameter drains that discharge into the Pond (**Picture 3**). Slabs on the top of dam exhibit signs of downward displacement, multiple fractures, and open joints. Overflow spillway sections, discussed later, are present on each end of the embankment. The spillways appear to be situated on or immediately adjacent to the abutment contacts, and thus may be at least partially located on embankment fill.

The downstream slope surface appears stable; however, multiple bare spots and large diameter trees are present. Additionally, vegetation on the slope consists various weeds, with a mix of ground covering and low-height species. There is also a substantial drop in elevation between the top of dam slabs and downstream face which is highly susceptible to erosion should the embankment overtop. The grout lining on the upstream slope is largely intact; however, numerous voids and fractures were observed in the vicinity of the drains and surrounding the large diameter trees growing through the lining. Large trees are also present within 15-feet³ of the downstream toe and both abutments. Lastly, embankment toe drains, presumably installed in accordance with the 1974 improvements (see Drawing #3), were unable to be located during site visits. As such, the presence and condition of the drains is unknown. A drain from the north is shown on the 1974 drawings as discharging into the riprap-lined portion of the outlet channel. A second drain, from the southern portion of the embankment, is shown discharging into a large, riprapped area downstream of the outlet structure; however, such an area does not appear to exist today.

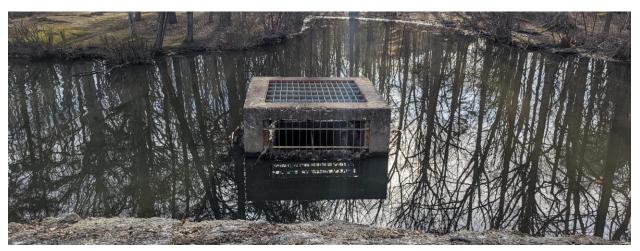
Picture 4: Principal Spillway Inlet Structure

The inlet and outlet structure are in fair condition with typical concrete weathering and deterioration. Only minor debris accumulation was observed on the trashracks. Vertical displacement of the concrete outlet apron / channel was observed, as well as open joints and fractures. A substantial amount of seepage was also seen emanating from below / behind the concrete slope protection on the left (southern) side of the concrete-lined channel where the concrete lining terminates (**Picture 8**). A large-diameter tree is present at this same location and may be contributing to uplifting of the concrete lining.

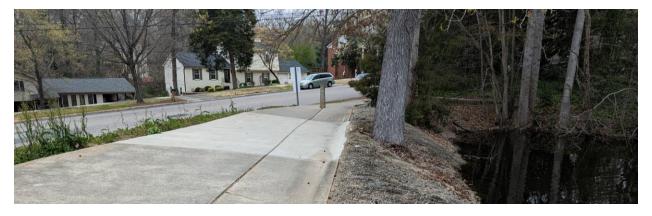
Picture 10: North Auxiliary Overflow Spillway

A second overflow section is located on the northern end of the Dam where the final 20-feet of the embankment is nearly 1.6-feet lower in elevation as compared to the dam. Should this section be activated, flows would travel down the steep embankment slope and downstream groin. While the downstream slope is lined with grass and weeds, the upstream slope and top of dam consist of concrete slabs. Similar to the southern auxiliary spillway, the shallow nature of this section provides little hydraulic capacity but presents erosion concerns if the spillway experiences flow.

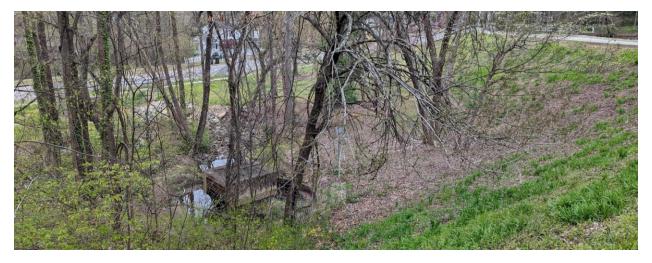
Picture 12: Area Downstream of Dam (At Principal Spillway Outlet)

Though not directly related to dam safety, the culvert and downstream channel were also inspected since these are located immediately downstream of the Dam and may impact inundation if not performing properly. The culvert appears to be in fair condition; however, during a March 2023 inspection, the amount of flow entering the pipe appeared to be less than the amount exiting, potentially indicating that water was running below the culvert. Additionally, the upstream endwall is in poor condition with both large vertical fractures and horizontal displacement (**Picture 16**). The channel reach downstream of the culvert is also in poor condition, with a downed tree across the waterway immediately downstream of the outlet and extreme erosion on both banks, including vertical slopes and undercuts (**Picture 17**).

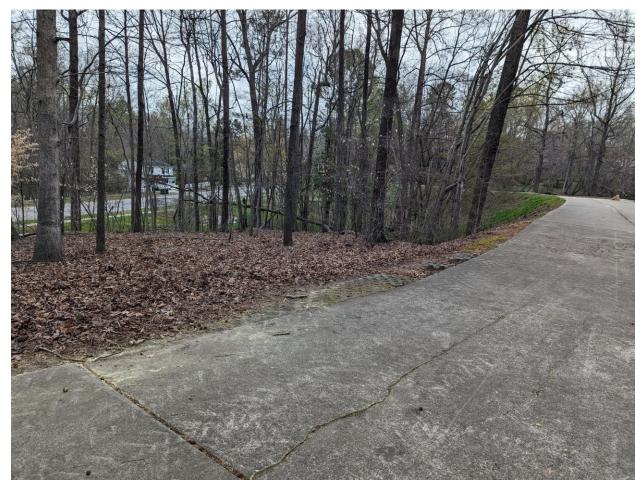
Location: South Auxiliary	Overflow Spillway (Crest / Top of Dam)	Direction: Northwest
Area(s) / Component(s):	Observation(s):	Concern(s):
Concrete Slab	Improper Joint	Slab Uplift / Failure
	Transverse Fracture	Slab Uplift / Failure
Downstream Groin	Large-Diameter Trees	Obstruction to Flow, Ground Stability
Downstream Area	Lack of Ground Cover	Erosion

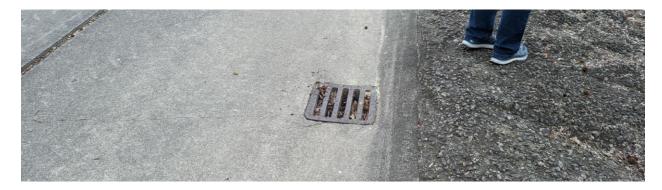
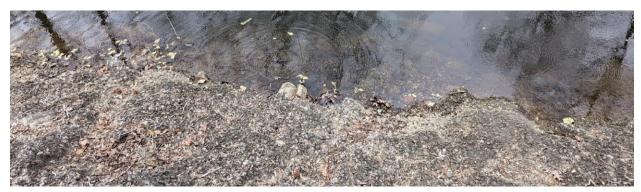
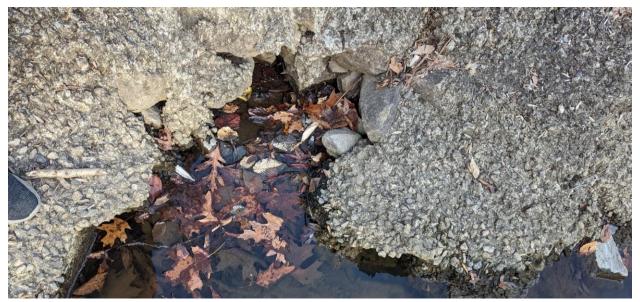
Location: Top of Dam near South Auxiliary Spillway Direction: North/West

Area(s) / Component(s): Concern(s):		Concern(s):
Area Drain (Typical of Multiple)	Drain in Dam Top	Slab Uplift / Failure
	Drain Outlet through Upstream Slope	Soil Piping / Stability
	Grouted Riprap Deterioration	Slope Stability, Material Mobilization

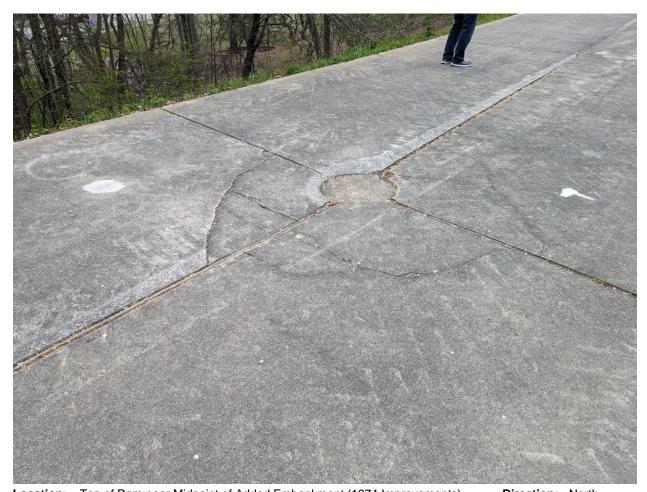
Location:	op of Dam nea	ar Midpoint of Added Embankment (197	4 Improvements)	Direction: North
Area(s) / Cor	nponent(s):	Observation(s):	Concern(s):	
Concrete Slab	Improper Joints	Slab Uplift / Failur	е	
	Transverse, Longitudinal, and Radial Fractures	Slab Uplift / Failur	e

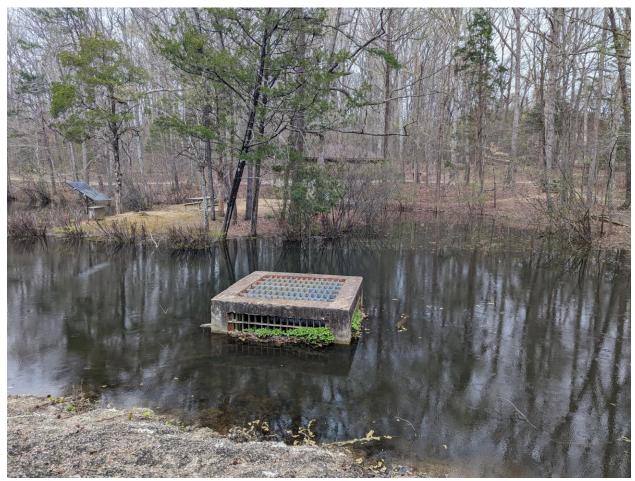
Location: Top of Dam near	Midpoint of Added Embankment (1974 In	nprovements) Direction: East
Area(s) / Component(s):	Observation(s):	Concern(s):
Primary Spillway Trash Rack	Minor Vegetation and Debris	Reduced Hydraulic Capacity
Gate	Operability, Type, and Condition Unknown	Emergency Drawdown Capability

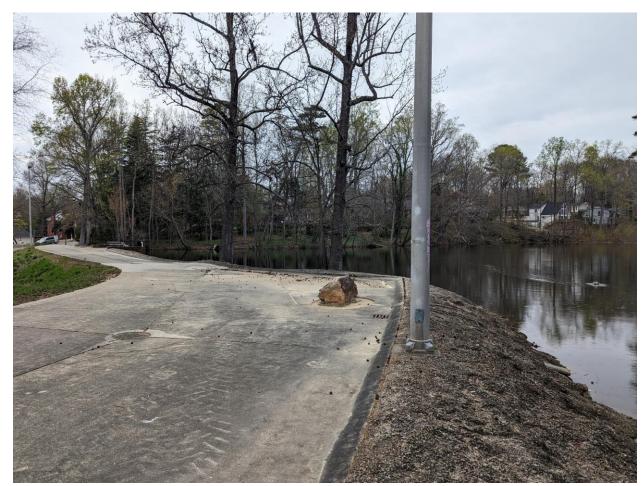
Location: Top of Dam nea	ar Midpoint of Embankment	Direction: North		
Area(s) / Component(s):	Observation(s):	Concern(s):		
	Improper Joints	Slab Uplift / Failure		
Concrete Slab	Transverse, Longitudinal, and Radial Fractures	Slab Uplift / Failure		
Upstream Face	Large-Diameter Trees	Slope Stability, Soil Piping		
	Light Pole	Slope Stability

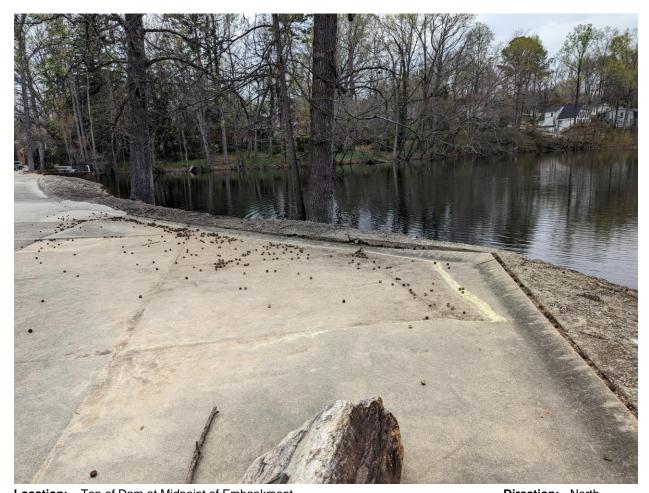
Location: Top of Dam at	Midpoint of Embankment	Direction: North
Area(s) / Component(s):	Observation(s):	Concern(s):
	Improper Joints	Slab Uplift / Failure
Concrete Slab	Transverse, Longitudinal, and Radial Fractures	Slab Uplift / Failure
	Settlement	Soil Stability / Mobilization
Upstream Face	Large-Diameter Trees	Slope Stability, Soil Piping

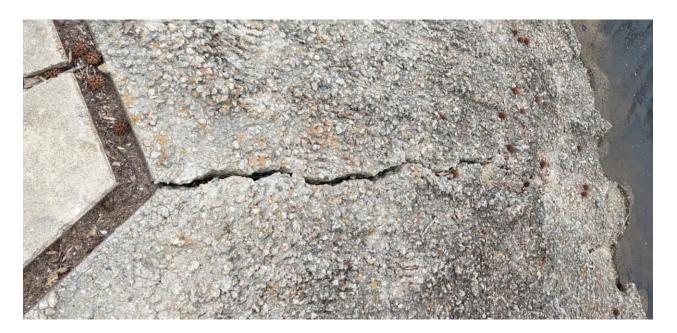
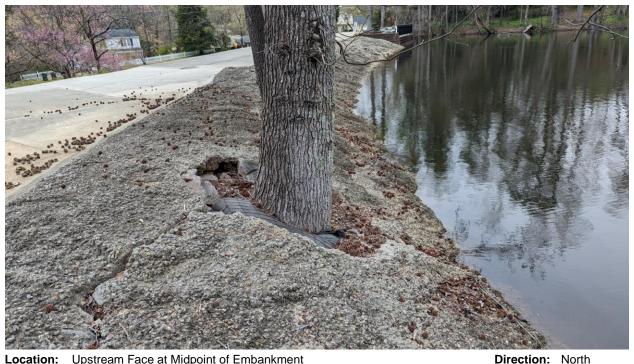
Ecoulori. Operican race at imapoint of Embandine		Direction: North
Area(s) / Component(s):	Observation(s):	Concern(s):
	Fractures	Uplift, Material Mobilization, Slope Stability
Grouted Riprap	Voids	Uplift, Material Mobilization, Slope Stability
	Large-Diameter Trees	Slope Stability, Soil Piping, Grout Damage

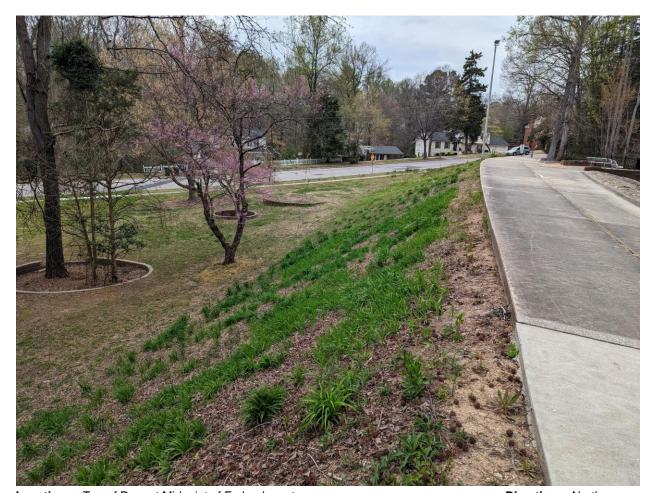
Location: Top of Dam at N	lidpoint of Embankment	Direction: North
Area(s) / Component(s):	Observation(s):	Concern(s):
	Bare Areas	Erosion
Downstream Face and Toe	Weedy Vegetation	Growth Competition, Erosion
	Large-Diameter Trees	Slope Stability, Soil Piping
Concrete Slab	Improper Trailing edge	Erosion

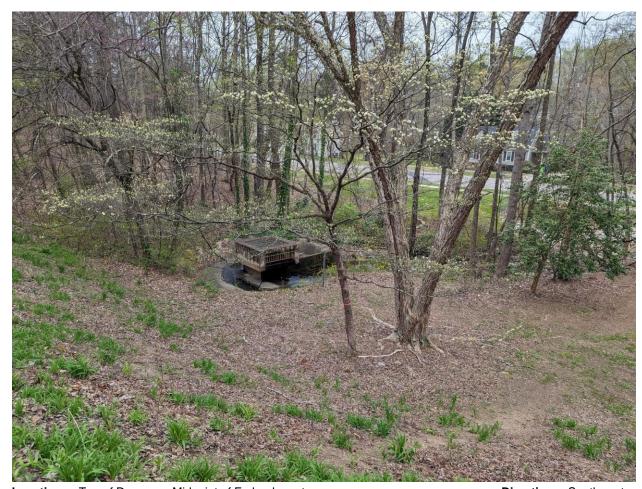
Location: Top of Dam near Midpoint of Embankment **Direction:** Southwest Area(s) / Component(s): Observation(s): Concern(s): Bare Areas Erosion Downstream Face and Toe, Weedy Vegetation Growth Competition, Erosion and Outlet Structure Large-Diameter Trees Slope Stability, Soil Piping

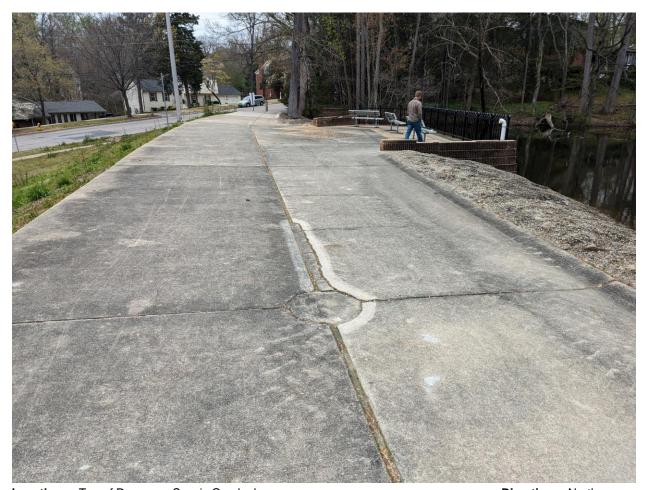
Location:
 Top of Dam near Scenic Overlook
 Direction:
 North

Concrete Slab
 Improper Joints
 Slab Uplift / Failure

Longitudinal Fractures
 Slab Uplift / Failure

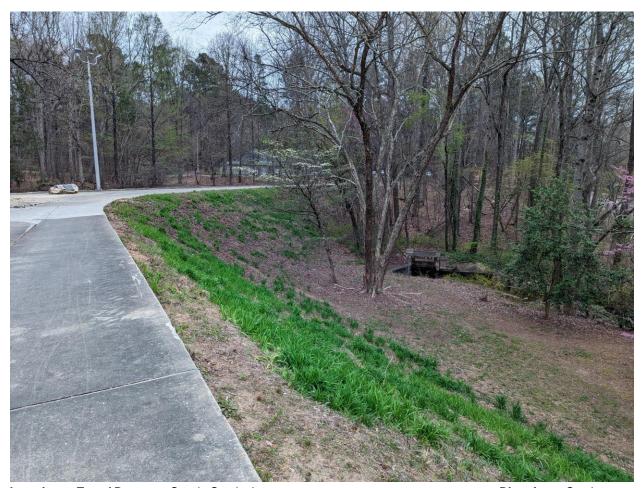
Location: Top of Dam near Scenic Overlook **Direction:** South Area(s) / Component(s): Observation(s): Concern(s): Erosion Bare Areas Downstream Face and Toe, Weedy Vegetation Growth Competition, Erosion and Outlet Structure

Slope Stability, Soil Piping

Large-Diameter Trees

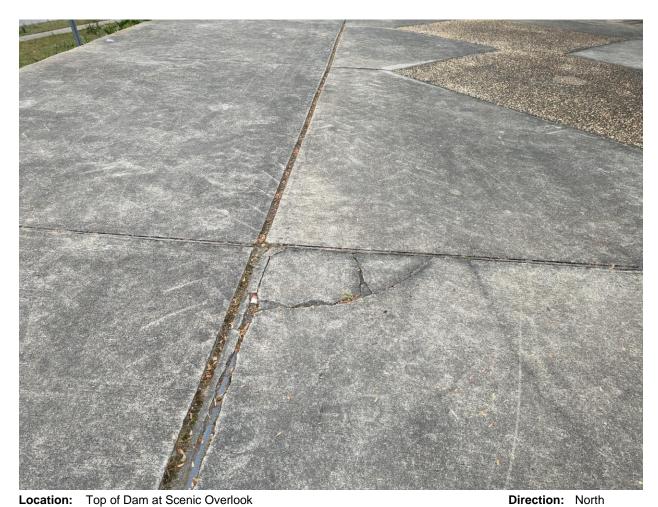
Area(s) / Component(s): Observation(s): Concern(s): Improper Joints Slab Uplift / Failure Concrete Slab Longitudinal and Radial Fractures Slab Uplift / Failure

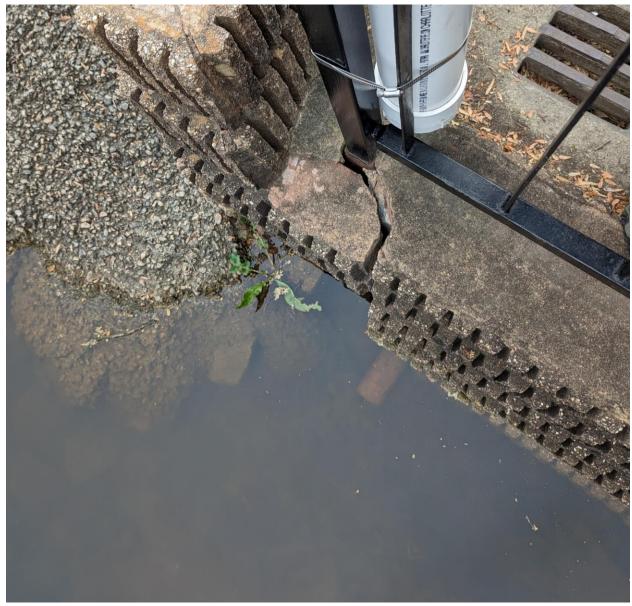
Location: Top of Dam at Scenic Overlook Direction: West

Block Wall Fracture Wall Failure, Material Loss

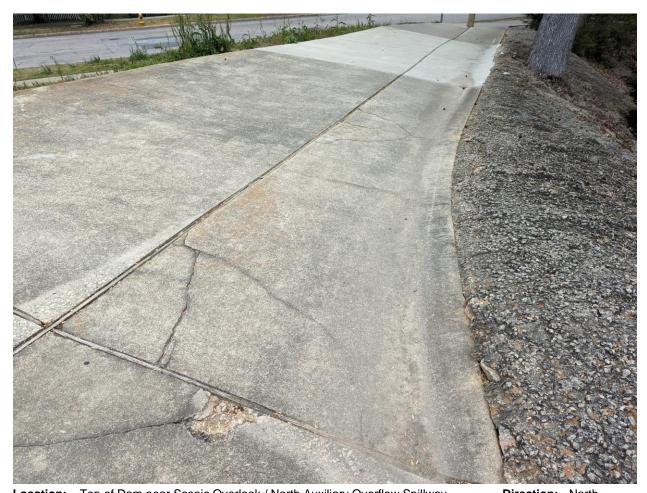
Location:	rop of Dam nea	r Scenic Overlook / North Auxiliary	Overliow Spillway	Direction: North
Area(s) / C	omponent(s):	Observation(s):	Concern(s):	
		Improper Joints	Slab Uplift / Failur	е
Concrete Slab	Longitudinal, Transverse, and Radial Fractures	Slab Uplift / Failur	e

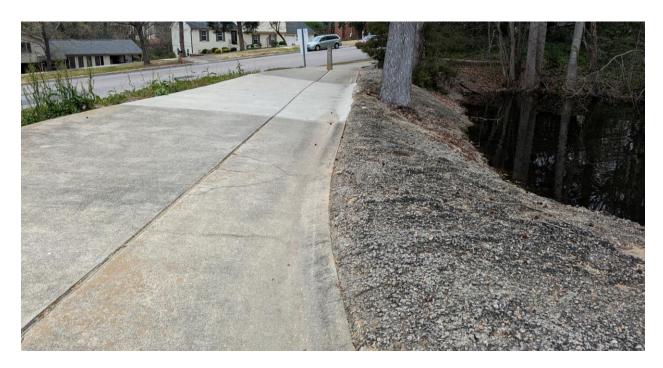
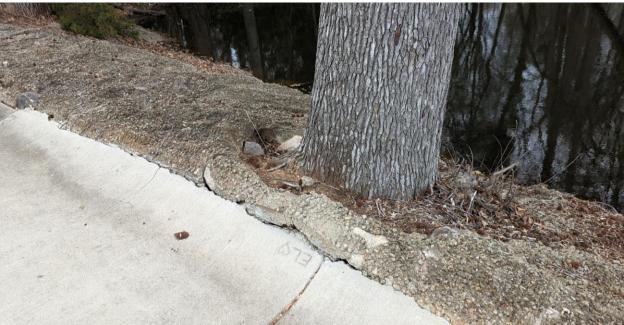
Location: Top of Dam nea	low Spillway Direction : North	
Area(s) / Component(s):	Observation(s):	Concern(s):
	Improper Joints	Slab Uplift / Failure
Concrete Slab	Longitudinal, Transverse, and Radial Fractures	Slab Uplift / Failure
Upstream Face	Large-Diameter Trees	Slope Stability, Soil Piping, Grout Damage

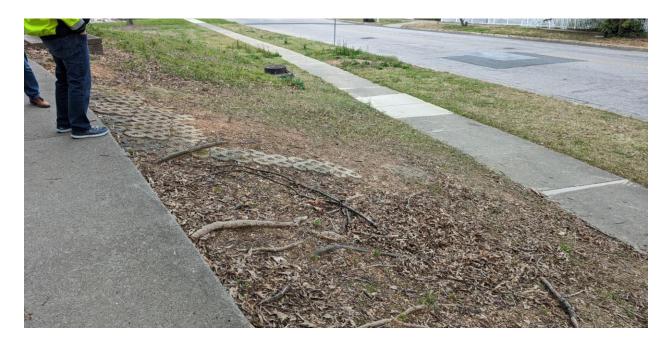
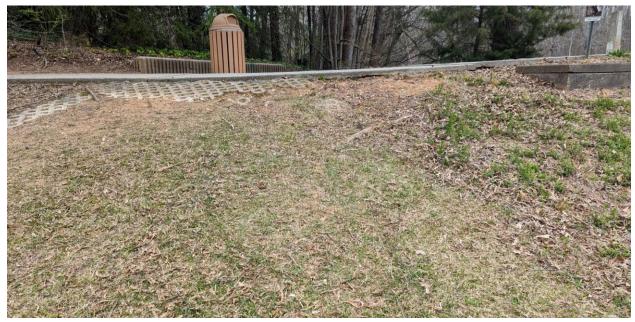
Location: North Auxiliary	Overflow Spillway / Downstream Face		Direction:	Southwest
Area(s) / Component(s):	Observation(s):	Concern(s):		
D	Bare Area, Sheet Erosion	Erosion		
Downstream Face	Improper Armoring	Erosion		
Concrete Slab	Improper Trailing Edge	Erosion

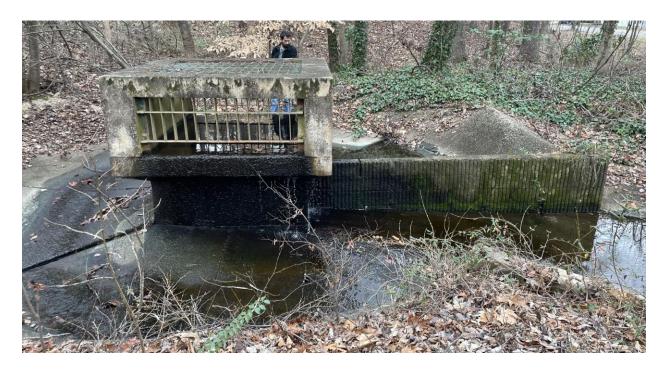
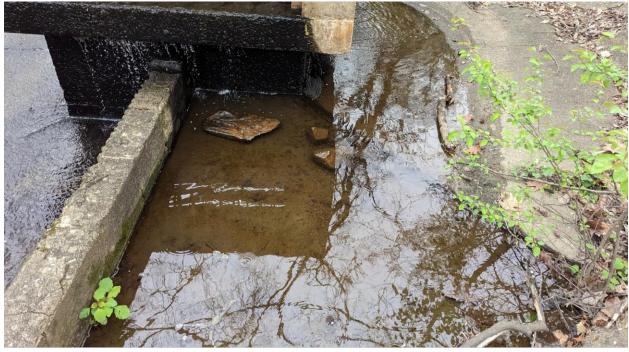
Location: Outlet Structure	9	Direction: South
Area(s) / Component(s):	Observation(s):	Concern(s):
Concrete Slab	Slab Displacement	Slab Uplift /Failure
	Fractures	Slab Uplift / Failure
Adjacent Area	Trees	Ground Stability, Soil

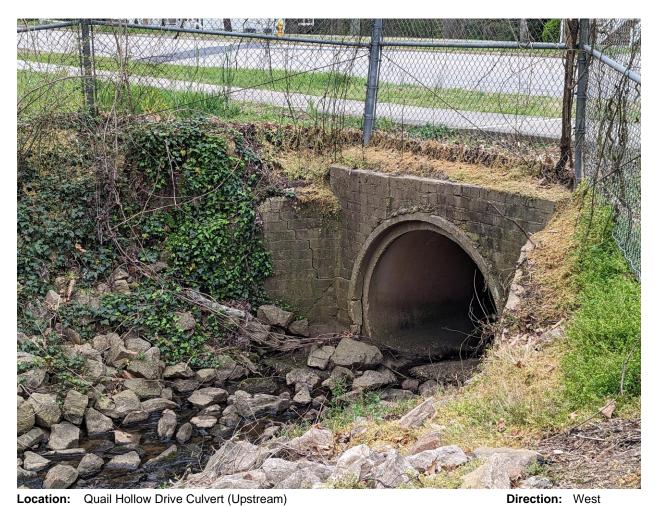
Observation(s): Concern(s): Area(s) / Component(s): Fractures Wall Failure Endwall Horizontal Displacement Wall Failure

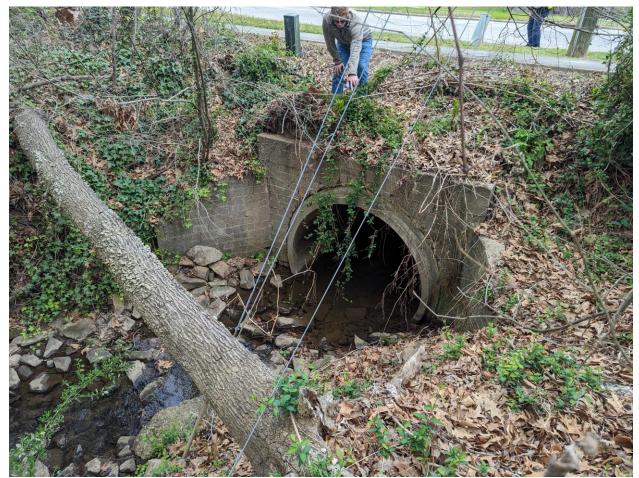
Location: Quail Hollow D	Direction: Northeast	
Area(s) / Component(s):	Observation(s):	Concern(s):
Faduall	Fractures	Wall Failure
Endwall	Horizontal Displacement	Wall Failure
	Lack of Ground Cover	Erosion
Adjacent Area	Trees / Woody Vegetation	Ground and Wall Stability, Root Intrusion
	Downed Tree	Reduced Hydraulic Capacity

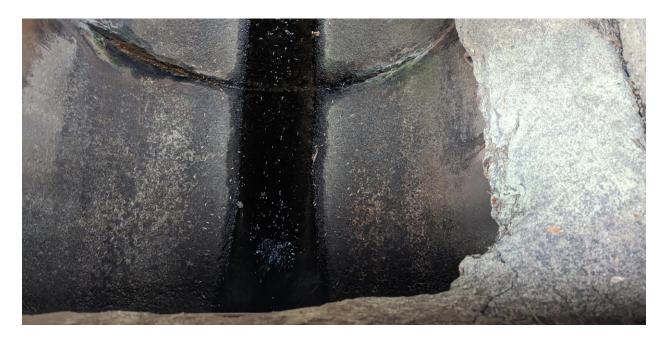
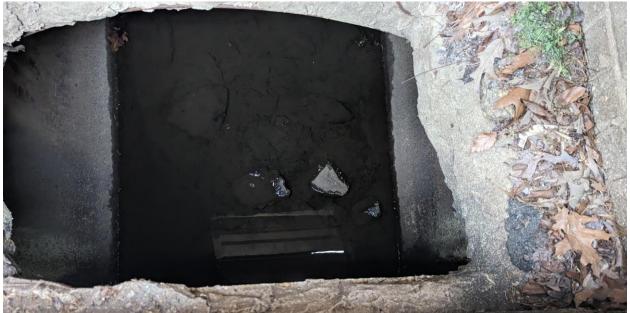
Location: Quail Hollow Drive Culvert Direction: West / East

Area(s) / Component(s):	Observation(s):	Concern(s):
	Outflow Appears to Exceed Inflow	Inspectors noted that culvert outflow
Culvert	Visible Change in Flow inside Pipe	appeared to exceed outflow, possibly indicating flow may be occurring below the pipe. Additionally, there is a substantial change in culvert flow velocity and depth between the inlet and outlet (however, this may be due to a change in slope or debris obstructing flow)

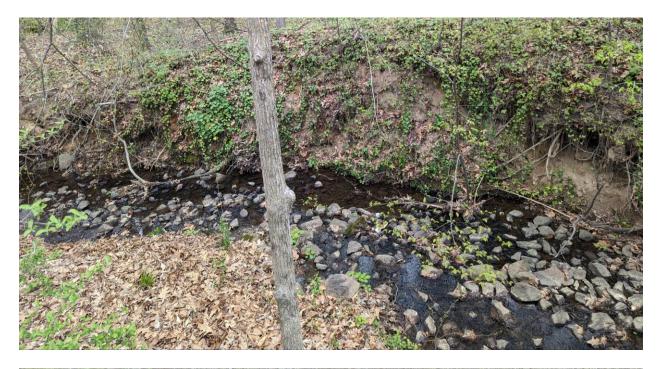
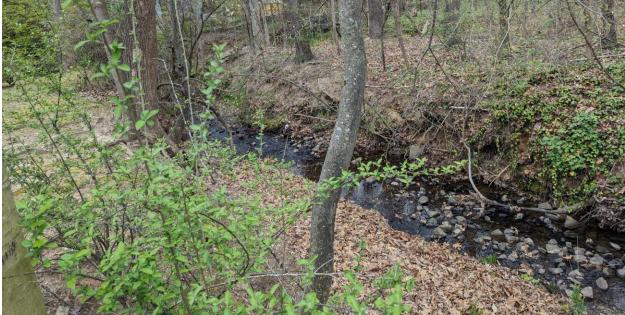
Location: Downstream of Quail Hollow Drive Culvert **Direction:** Northwest

Channel Bank Erosion Erosion, Property Damage
