REPORT
AUGUST 2024

Marsh Creek Stream Assessment

Prepared for:
City of Raleigh

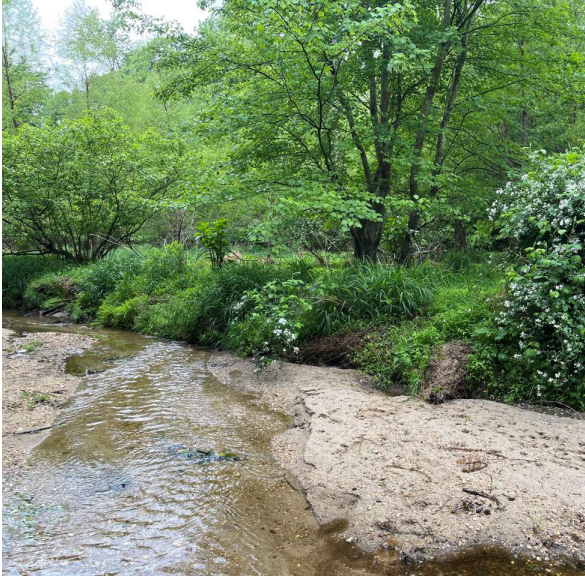
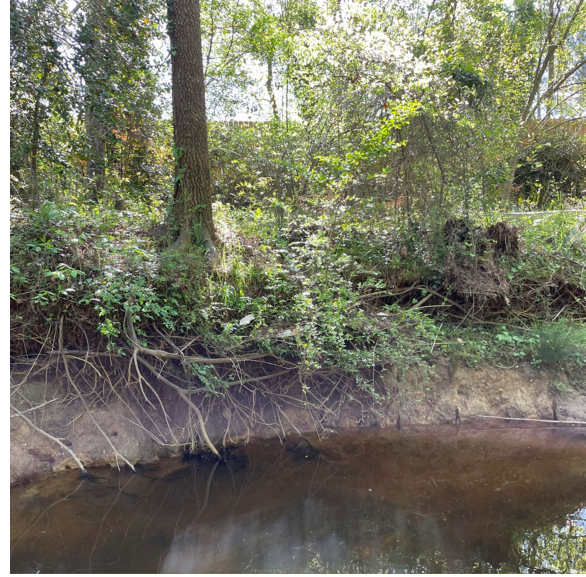
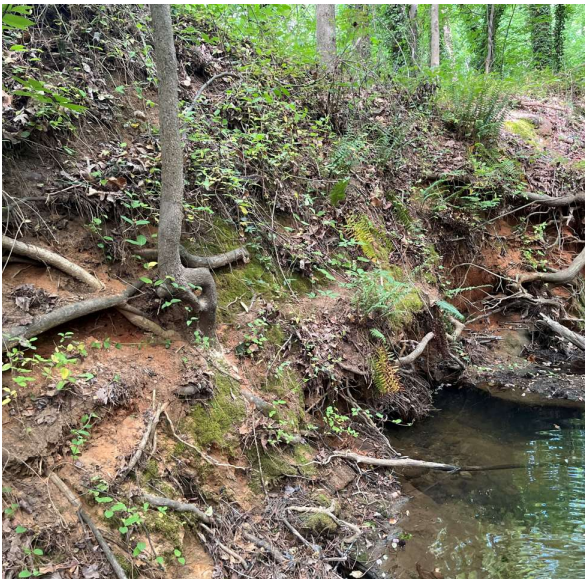
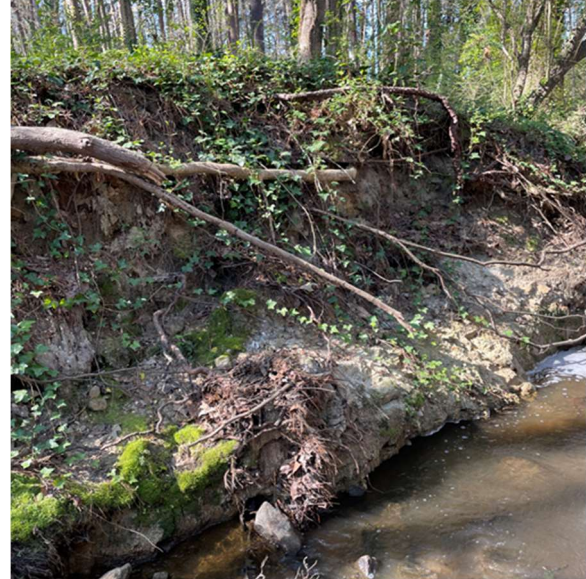
Photo 1-1 Stream bank erosion from 0-25 percent at the end of Leafcrest Court (upper left), 25-50 percent near Huntleigh Drive (upper right), 50-75 percent near Volant Drive (lower left), and 75- 100% near Oates Drive (lower right).

In general, streams in the Marsh Creek watershed are eroding in response to recent and historic land use changes. Deforestation and mill pond construction in the late 18th century by European settlers, straightening of many streams by farmers in the early 20th century, and more recent urban development have led to sedimentation and erosion in most of the stream segments within the Marsh Creek watershed. Most are historically incised and detached from their floodplains and are still cutting down through drainages that were filled with sediments from deforestation and damming. The streams are currently receiving higher and more pulsed rates of inflow from stormwater runoff associated with increased development and density, leading to further erosion in the confined channels. Hot spots for erosion exist throughout the watershed as the streams try to gain equilibrium, but areas near the headwaters where development is denser and more recent, and lower reaches where they are more

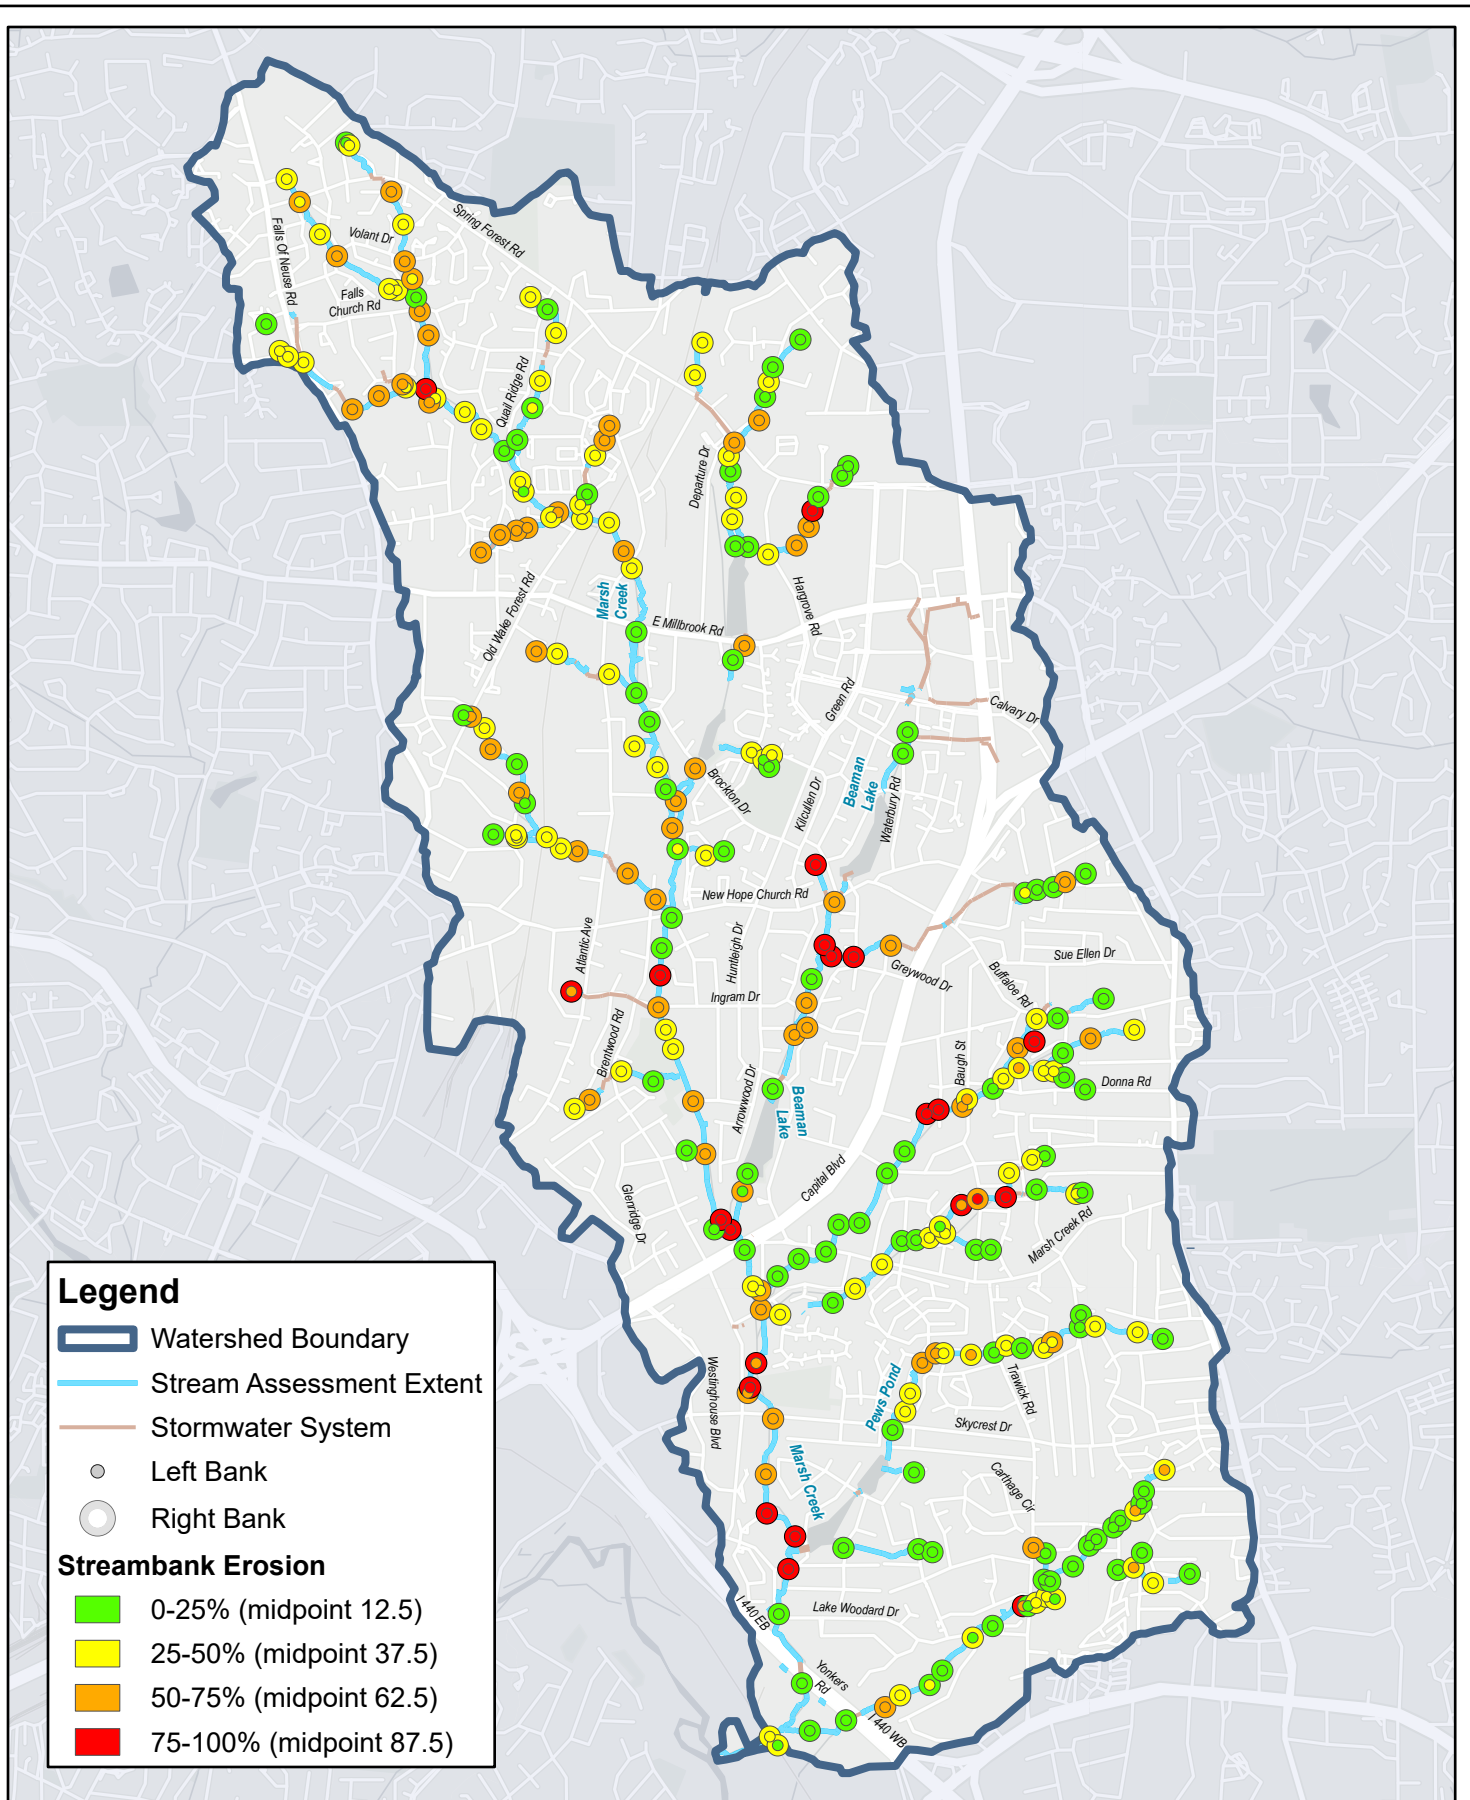
Figure 1-2 Streambank Erosion
Marsh Creek Watershed Study
City of Raleigh, North Carolina

detached from the floodplain have higher bed and bank erosion (**Figure 1-2**). Erosion was observed within more than 25 percent of most stream segments, indicating they are subject to active erosion.

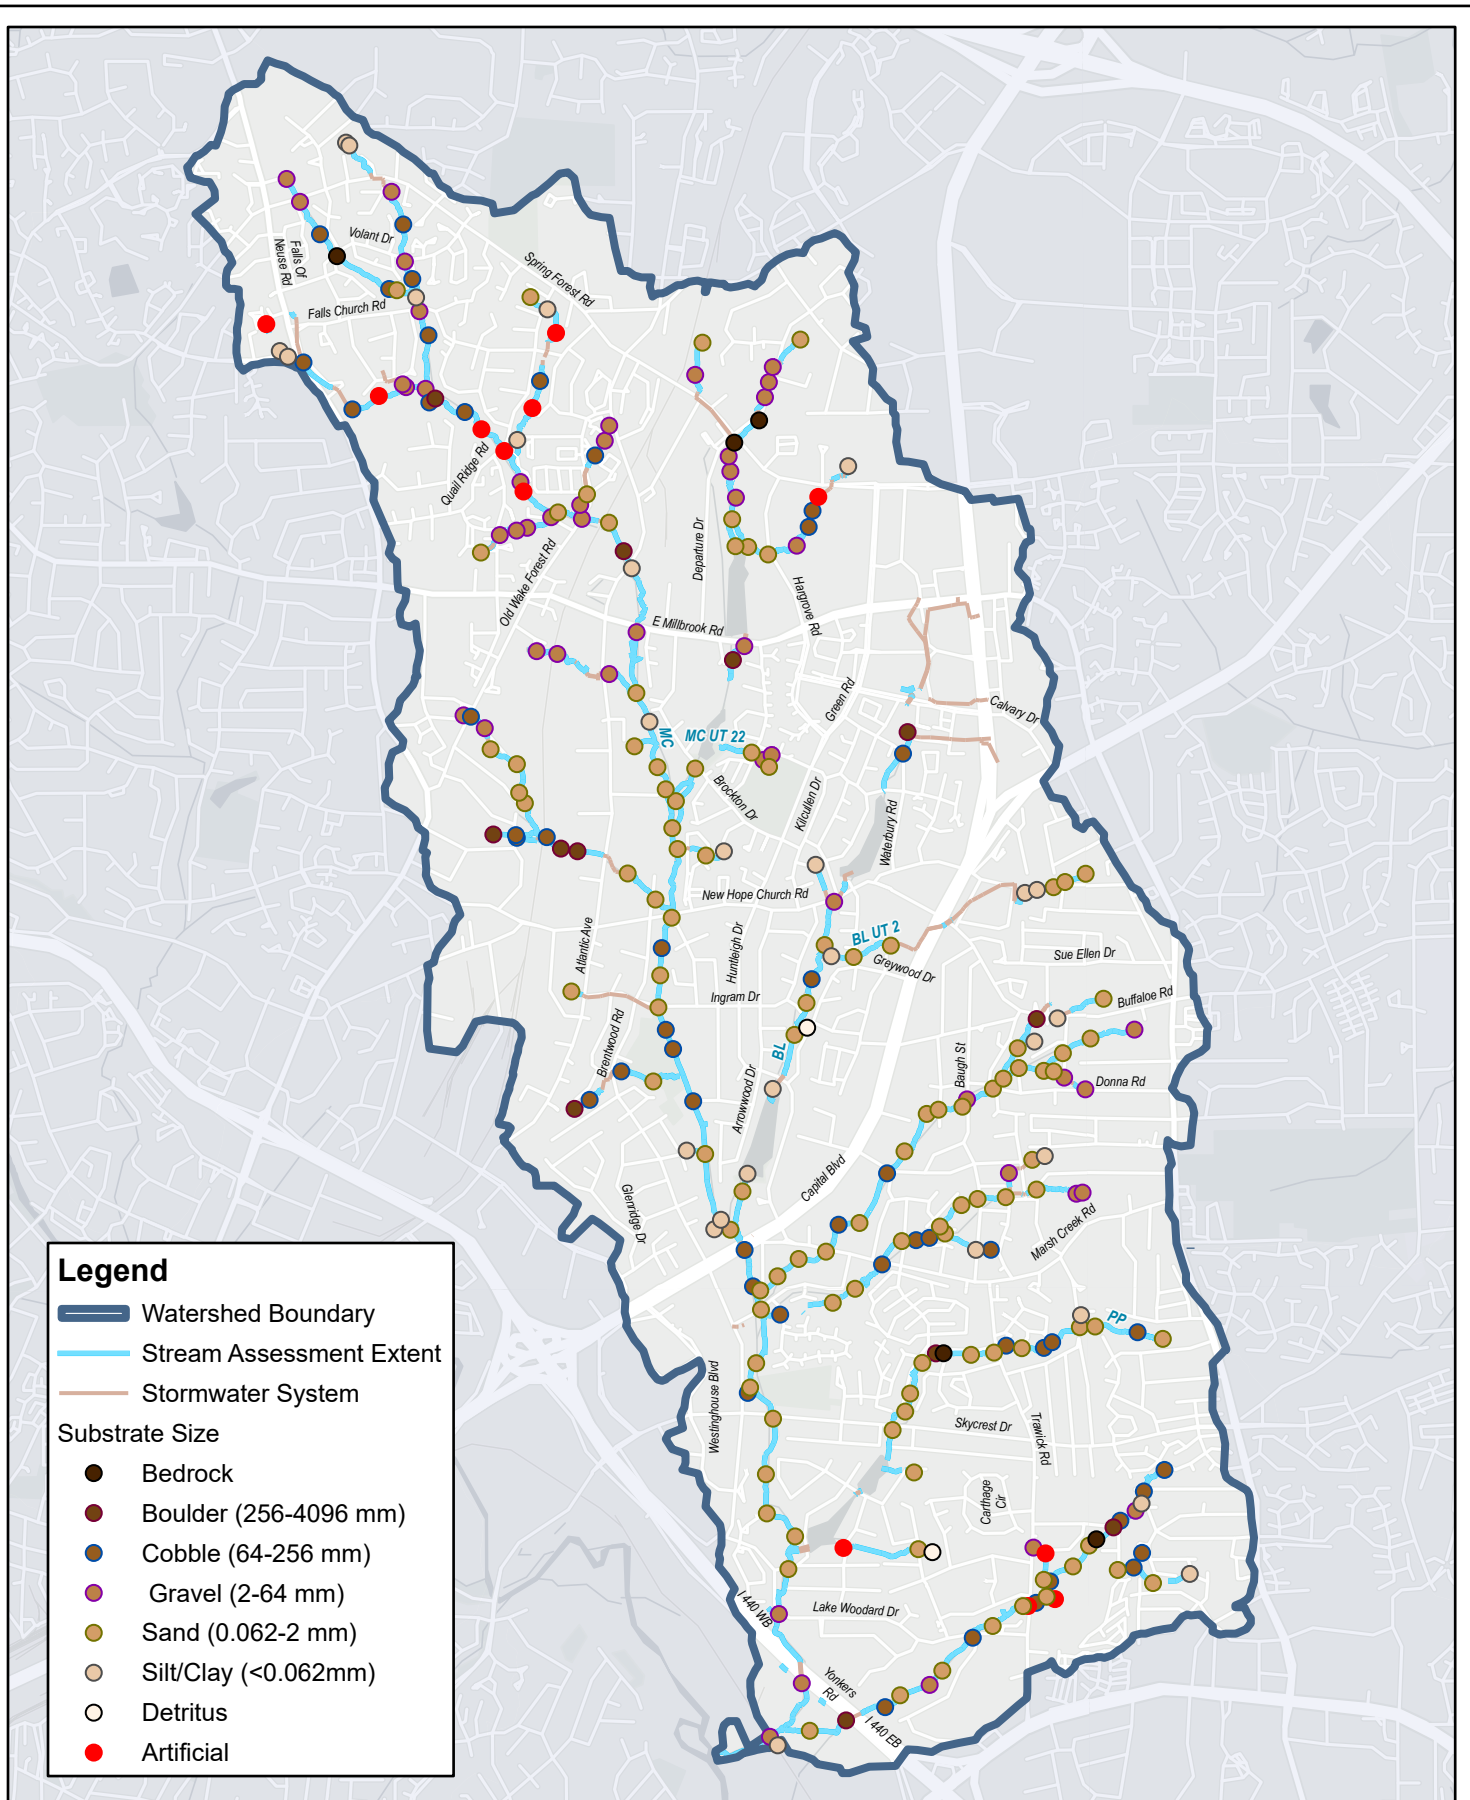
Figure 1-3 Substrate
Marsh Creek Watershed Study
City of Raleigh, North Carolina

The dominant streambed material observed within each stream condition assessment reach was classified into one of eight classifications based on the size and type of bed material (**Table 1-4**). The predominate bed material observed was sand (44 percent), which when in excess can cover riffle pool complexes and native bedforms providing poor quality habitat for aquatic life.

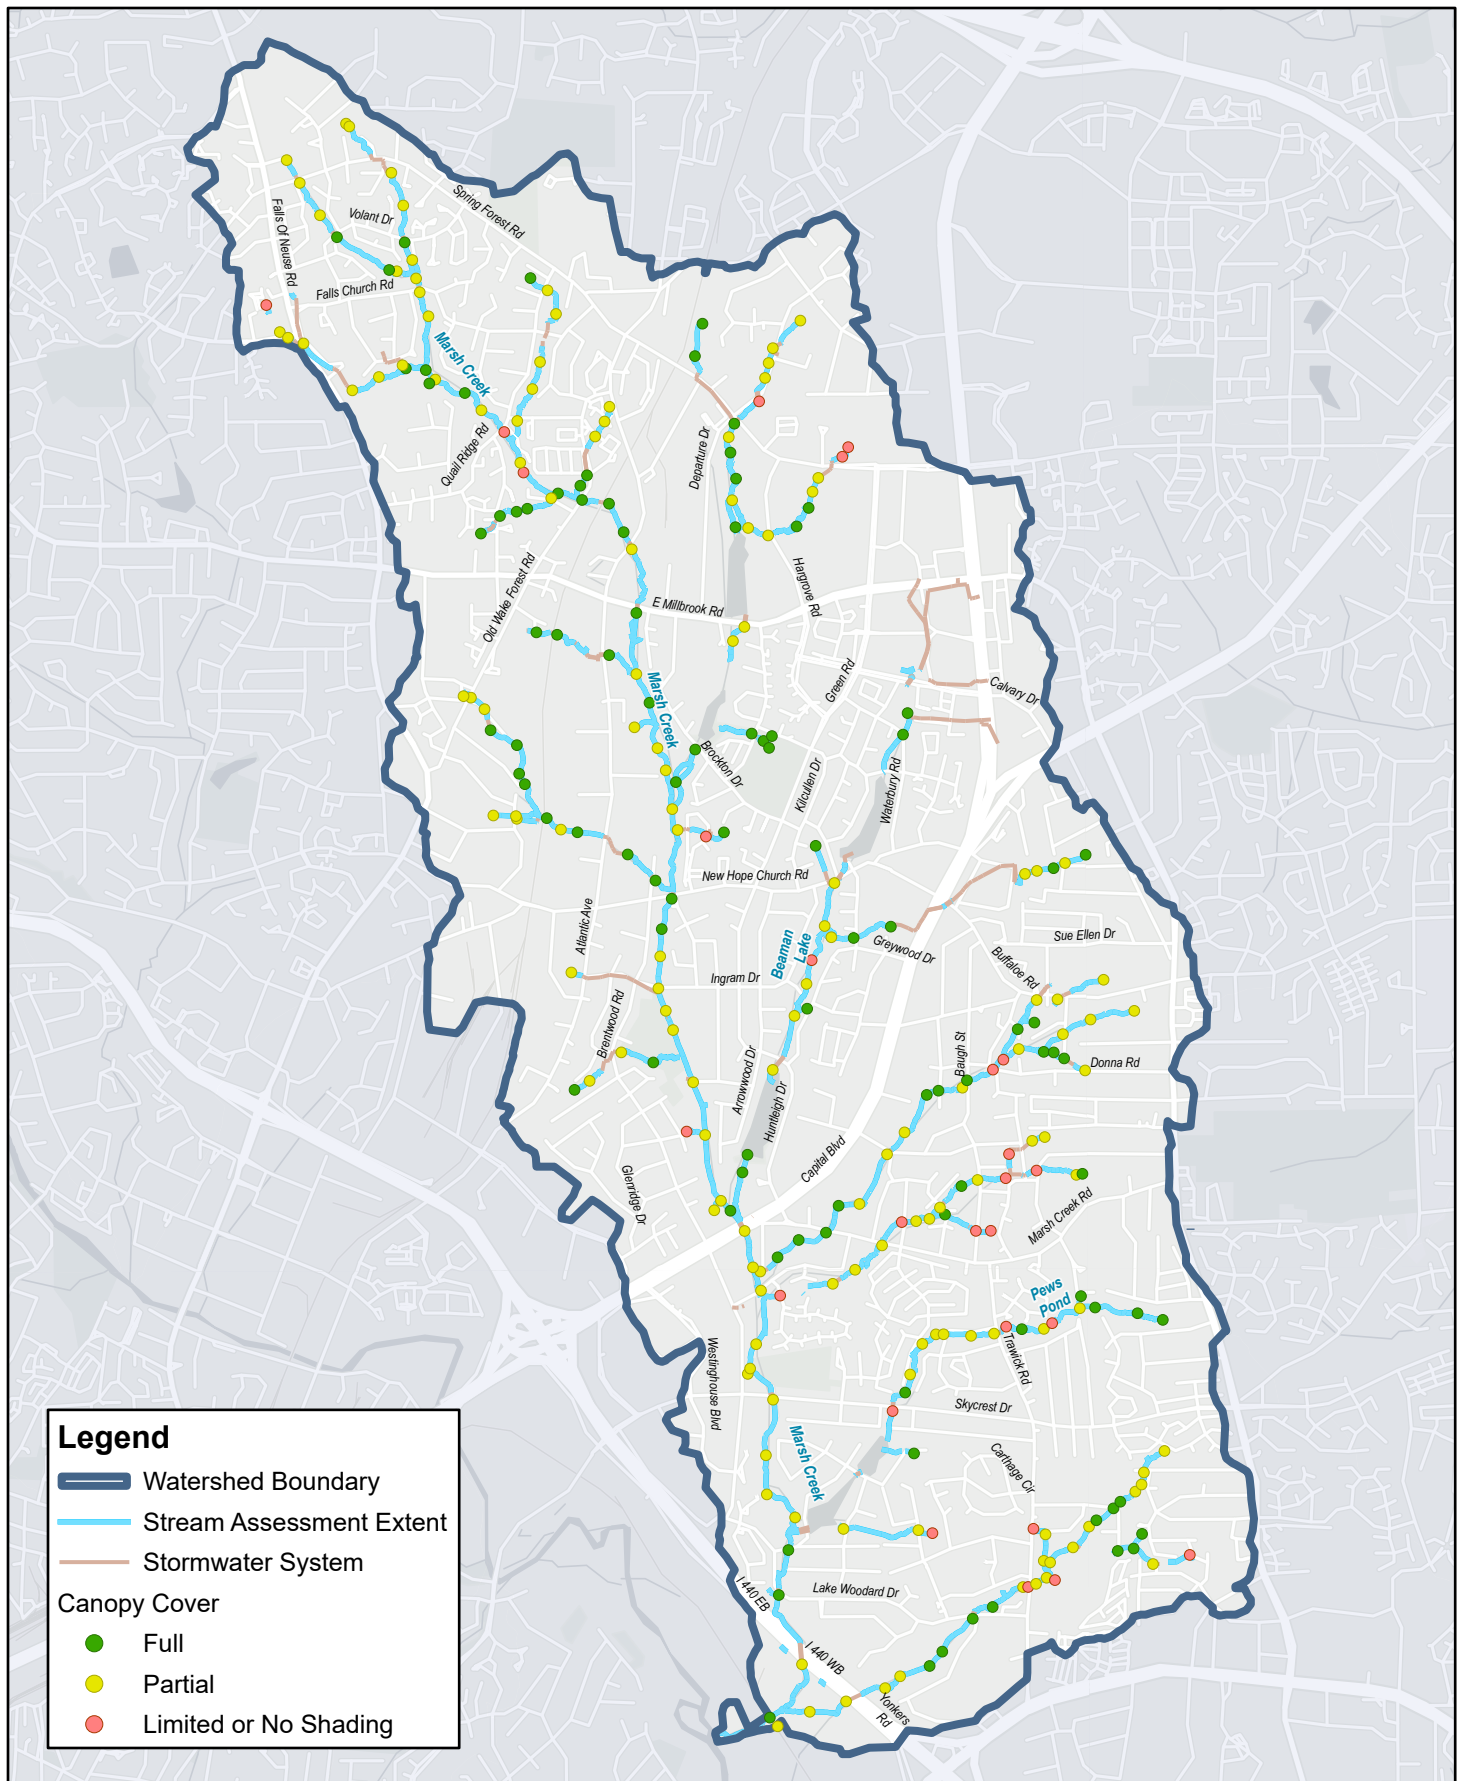
Figure 1-4 Stream Canopy Cover
 Marsh Creek Watershed Study
 City of Raleigh, North Carolina

The tree canopy and vegetation in the riparian buffer provide shade for streams that helps regulate water temperature, which if elevated can affect water quality and aquatic life. Overall decent canopy coverage was observed throughout the Marsh Creek watershed (**Figure 1-4**). Stream canopy cover within each stream condition assessment reach was classified into three categories based on the amount of shading provided to the stream channel, full shade, partial shade, or limited to no shading (**Table 1-5**). Most reaches had at least partial or full canopies. Canopy coverage was lower in denser residential and commercial areas, and higher in floodplain areas and larger undeveloped parcels.

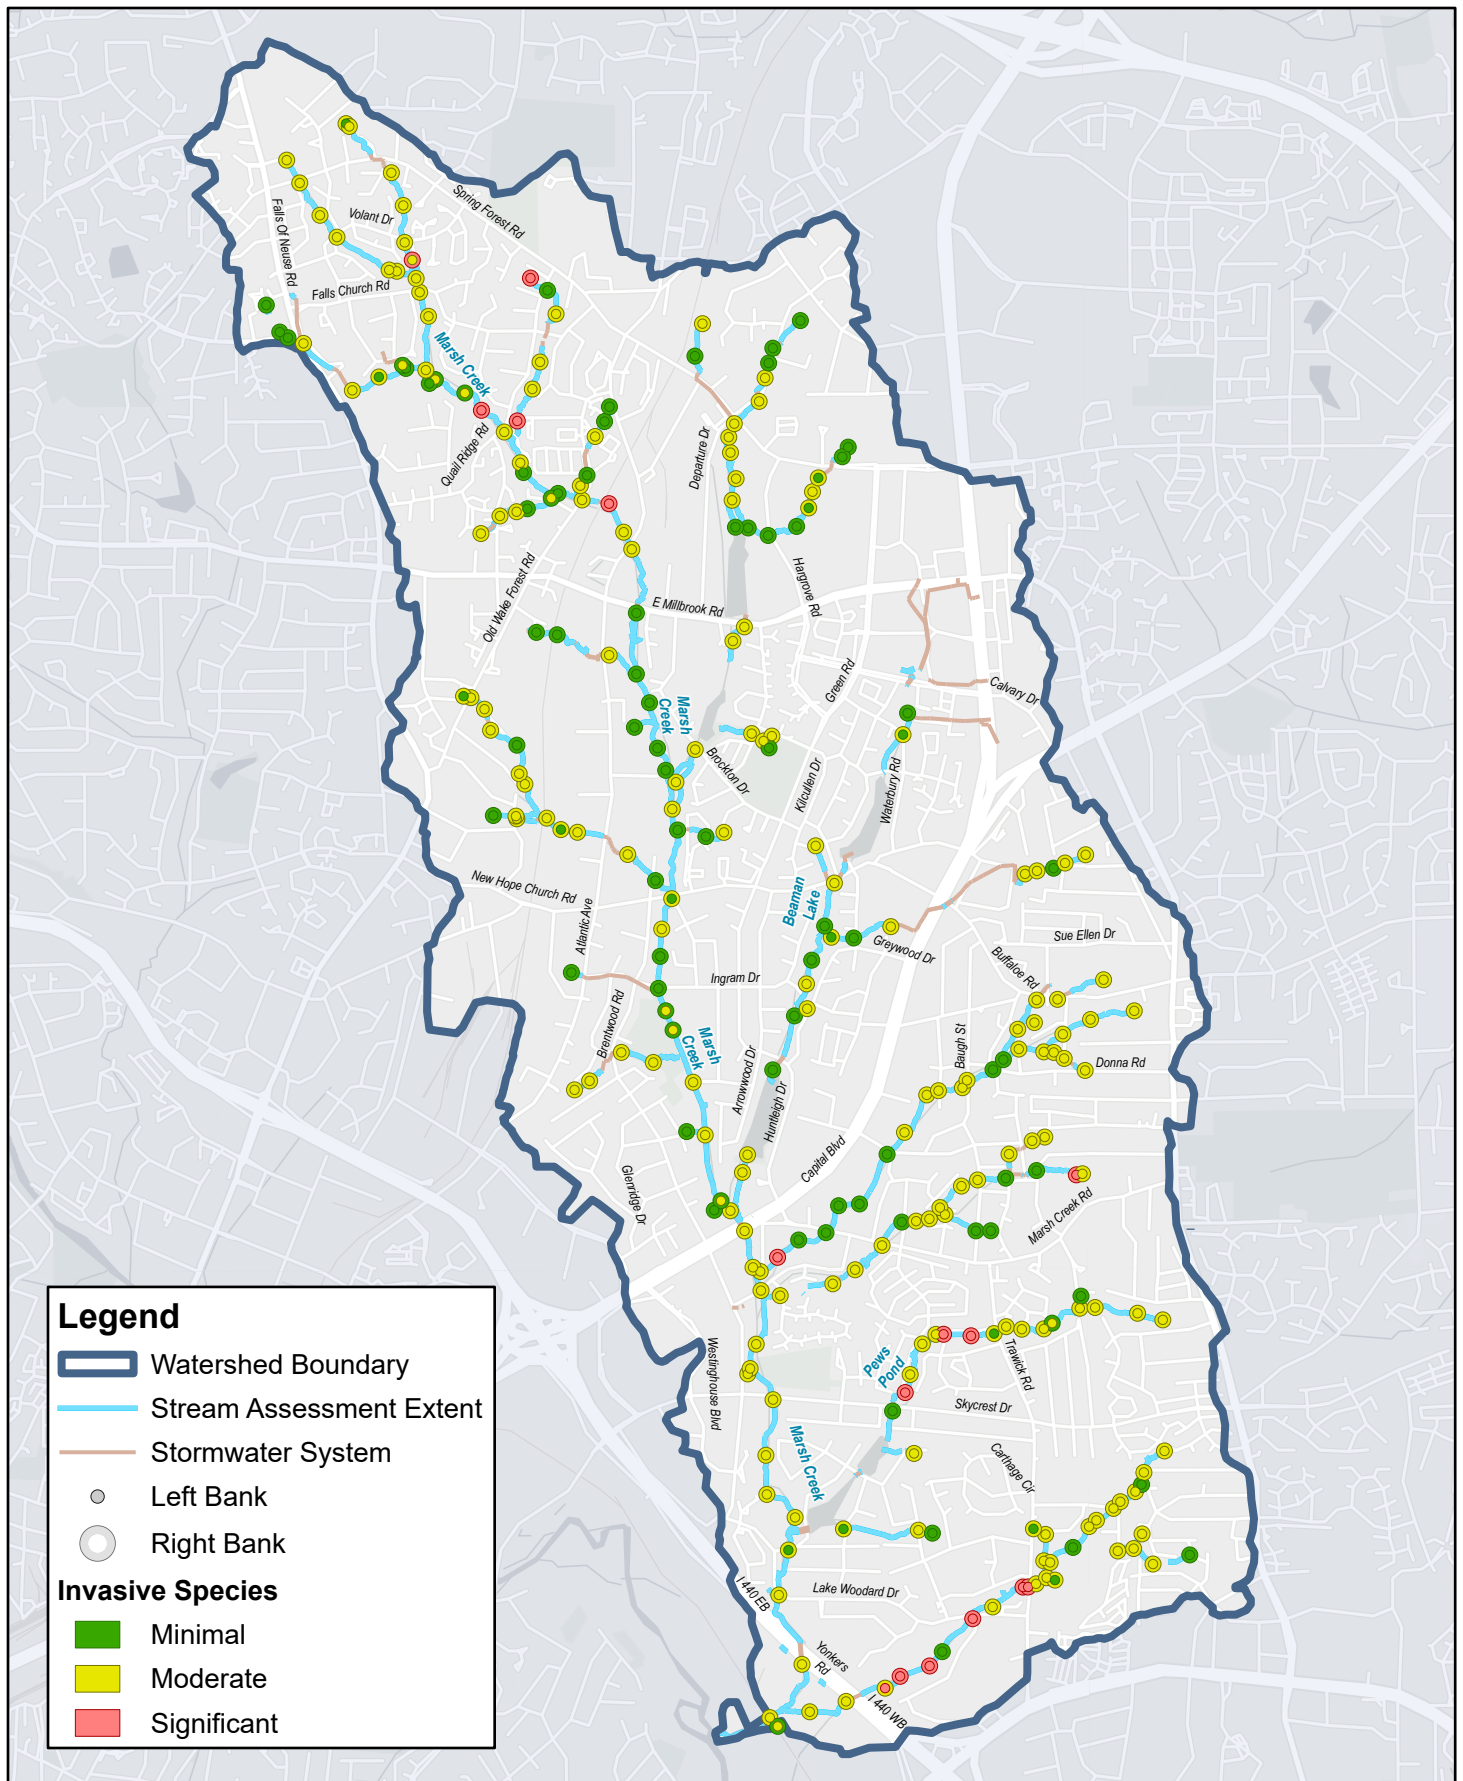
Figure 1-7 Invasive Species
Marsh Creek Watershed Study
City of Raleigh, North Carolina

watershed with 73 percent of the assessed stream reaches classified as having moderate to significant amounts of invasive species. Table 1-7 shows that more than half (53 percent) of the fully intact buffers are impacted by invasives species. A similar compilation of data for the partial buffers indicates that 78 percent have moderate (71 percent) or significant (8 percent) amounts of invasive species present. Invasive species outcompete native plant species often by limiting or killing beneficial native canopy and understory species. Invasive climbing vines like English ivy or wisteria can also increase the risk of trees falling due to their weight. Once established they provide a homogeneous plant species composition that is poor habitat for natural communities and less effective at filtering sediment and nutrients from runoff.

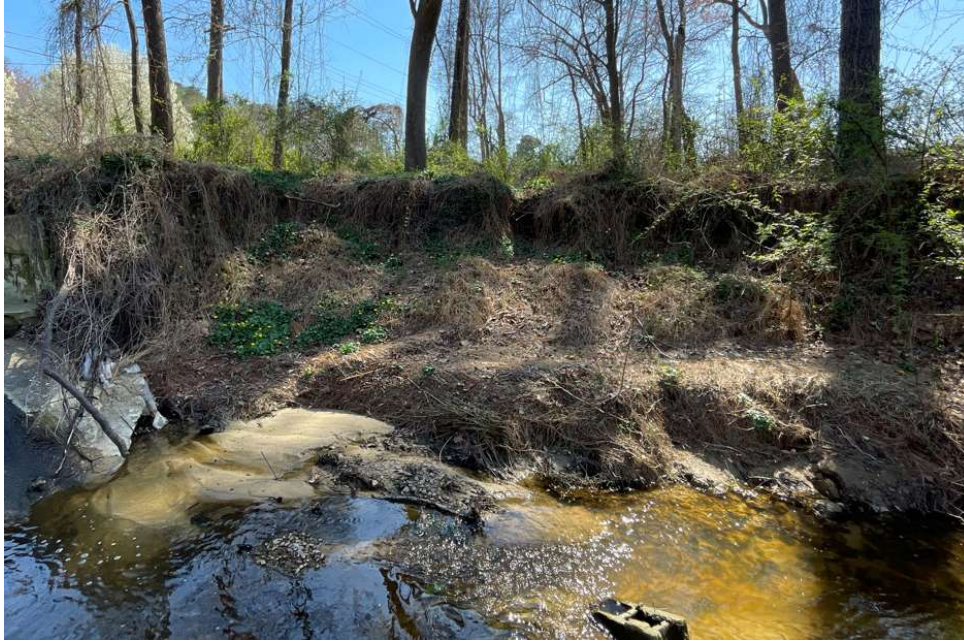
Photo 1-2 Significant invasive species downstream of Trawick Road near Bond Street (Wisteria, Kudzu, Privet, Multiflora Rose, and Japanese Honeysuckle)

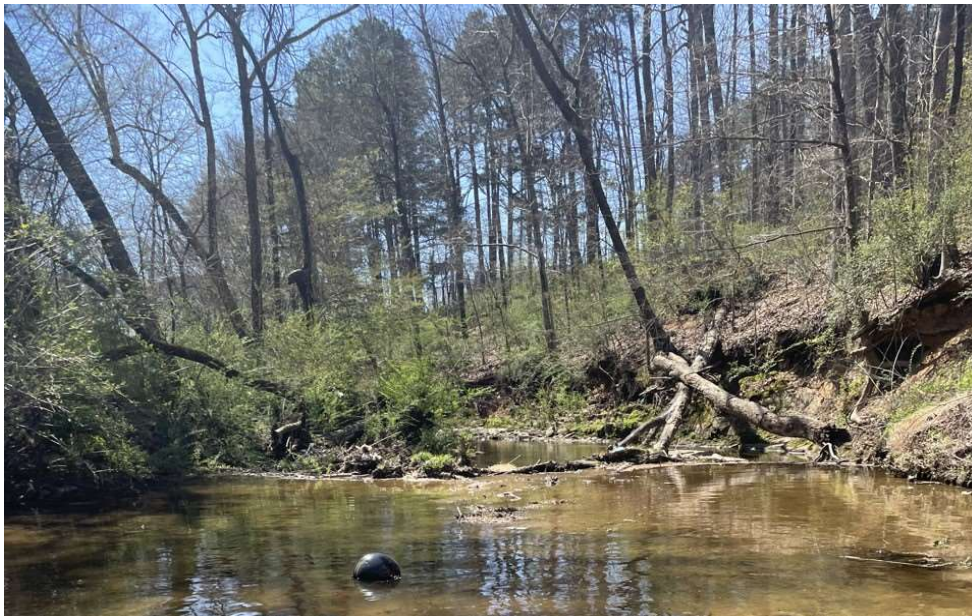
Photo 1-3 Moderate invasive species in buffer understory upstream of Skycrest Drive near Brentwood Road (Privet)

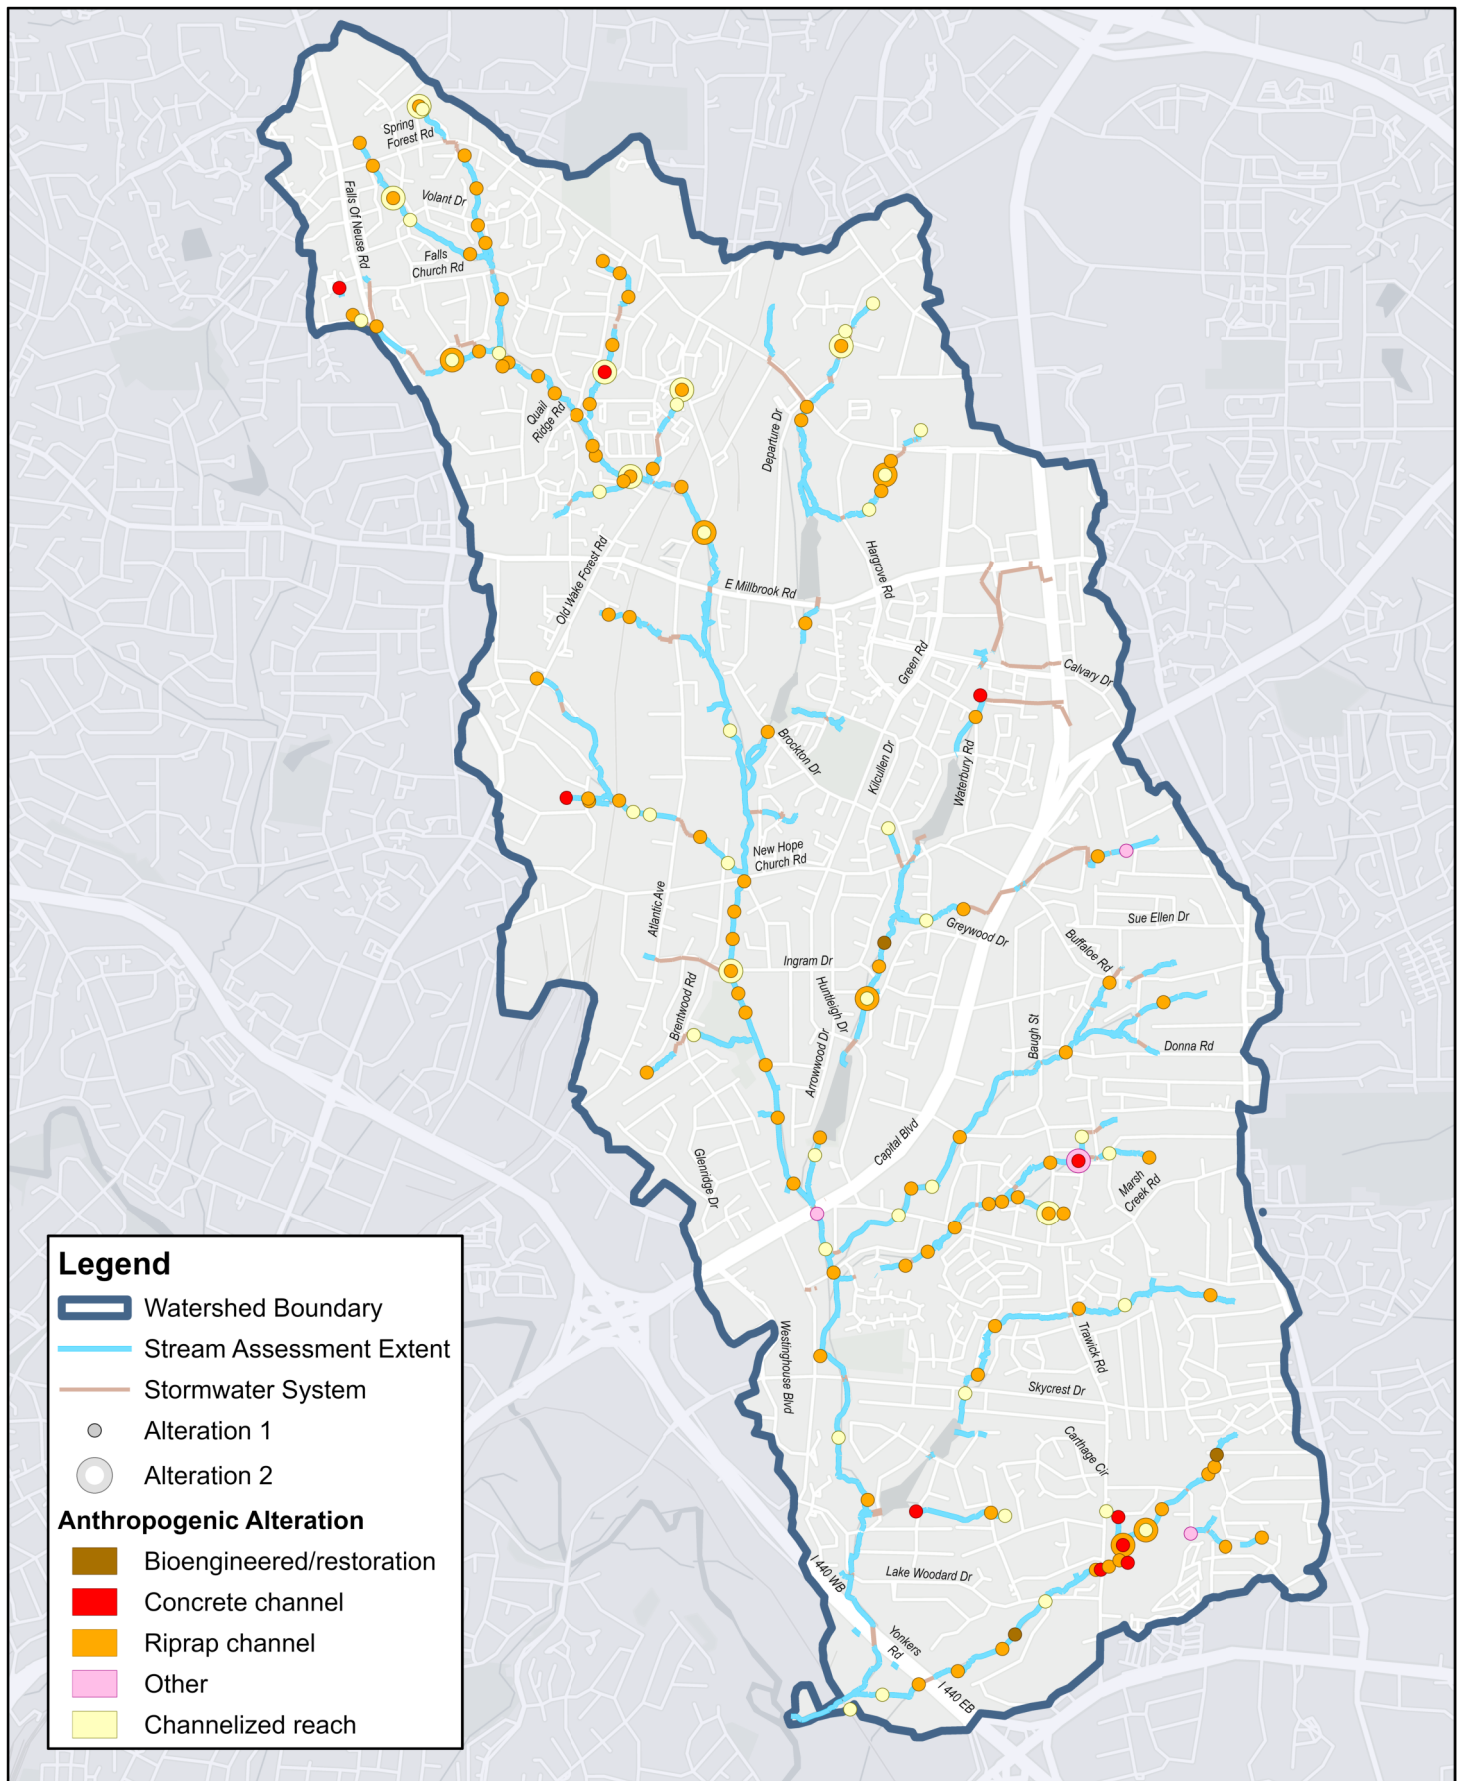
Figure 1-8 Anthropogenic Alterations
Marsh Creek Watershed Study
City of Raleigh, North Carolina

Channelized reaches where the stream has been straightened were observed along 20 percent of all the assessed stream lengths. Approximately 6 percent of the total streambed length has been both hardened and channelized, resulting in a total streambed length column total of 106 percent. This data collection category does not currently specify the location of channelized, hardened reaches, so this estimate of overlap could be a little low. Regardless, the amount of channel hardening and straightening in the Marsh Creek watershed is significant. Around 30 percent of the total streambed length assessed has been hardened or channelized or both. Areas with concentrated anthropogenic alterations are located in the headwater tributaries and along the central mainstem of Marsh Creek. Reaches with multiple alterations are shown as dual points/circles in **Figure 1-8**. These areas correspond well with areas of high streambank erosion. Riprap channel lengths were primarily associated with culverts and utility crossings.

Stormwater systems or piped reaches, shown as light brown lines on Figure 1-8, are not included in the total assessed stream lengths. However, they also account for a significant amount of adverse anthropogenic alteration within the Marsh Creek watershed. These reaches have the greatest loss of stream function and value and produce the highest and most concentrated flow velocities, adding to watershed wide increases in erosion associated with anthropogenic alterations.

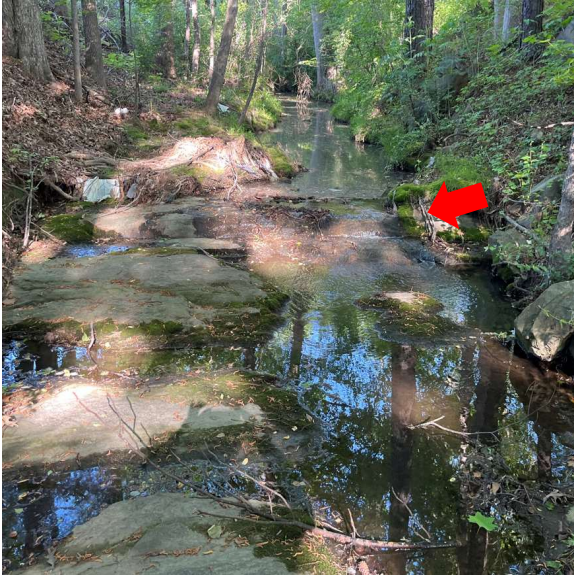
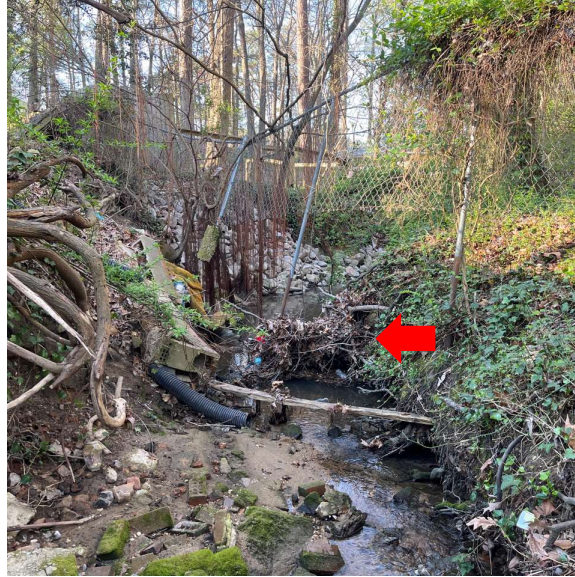
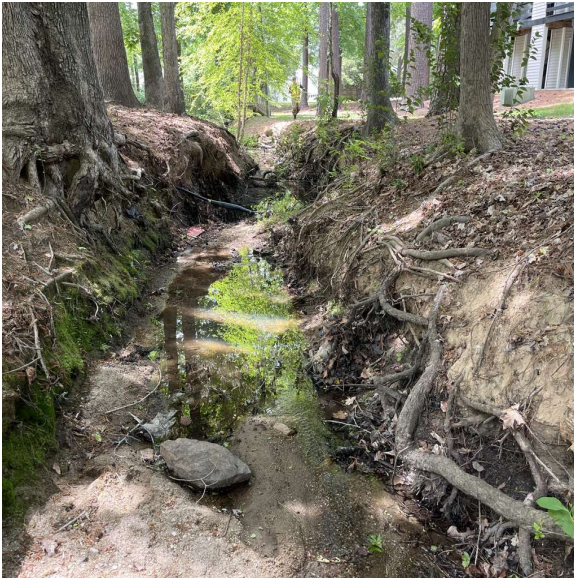
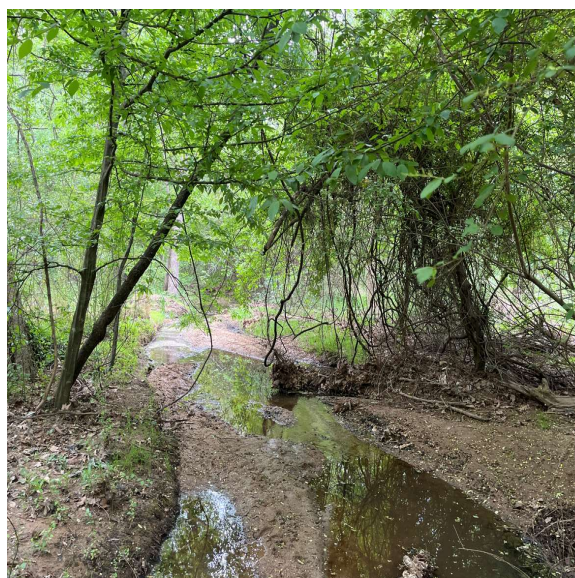
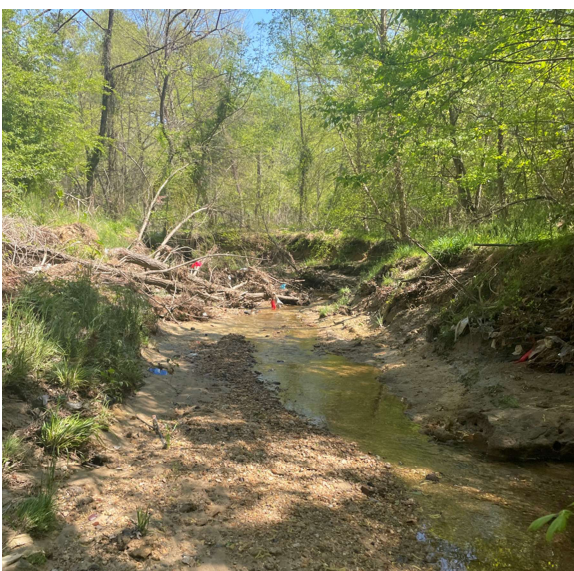
Photo 1-4
Upper Left - Knickpoint (labeled as 2-4 feet in height) near Atlantic Avenue

Upper Right – Headcut near Willow Oak Road

Middle Right – Widened Channel near Julian Drive

Lower Left – Incised and Widened channel near Old Creek Court

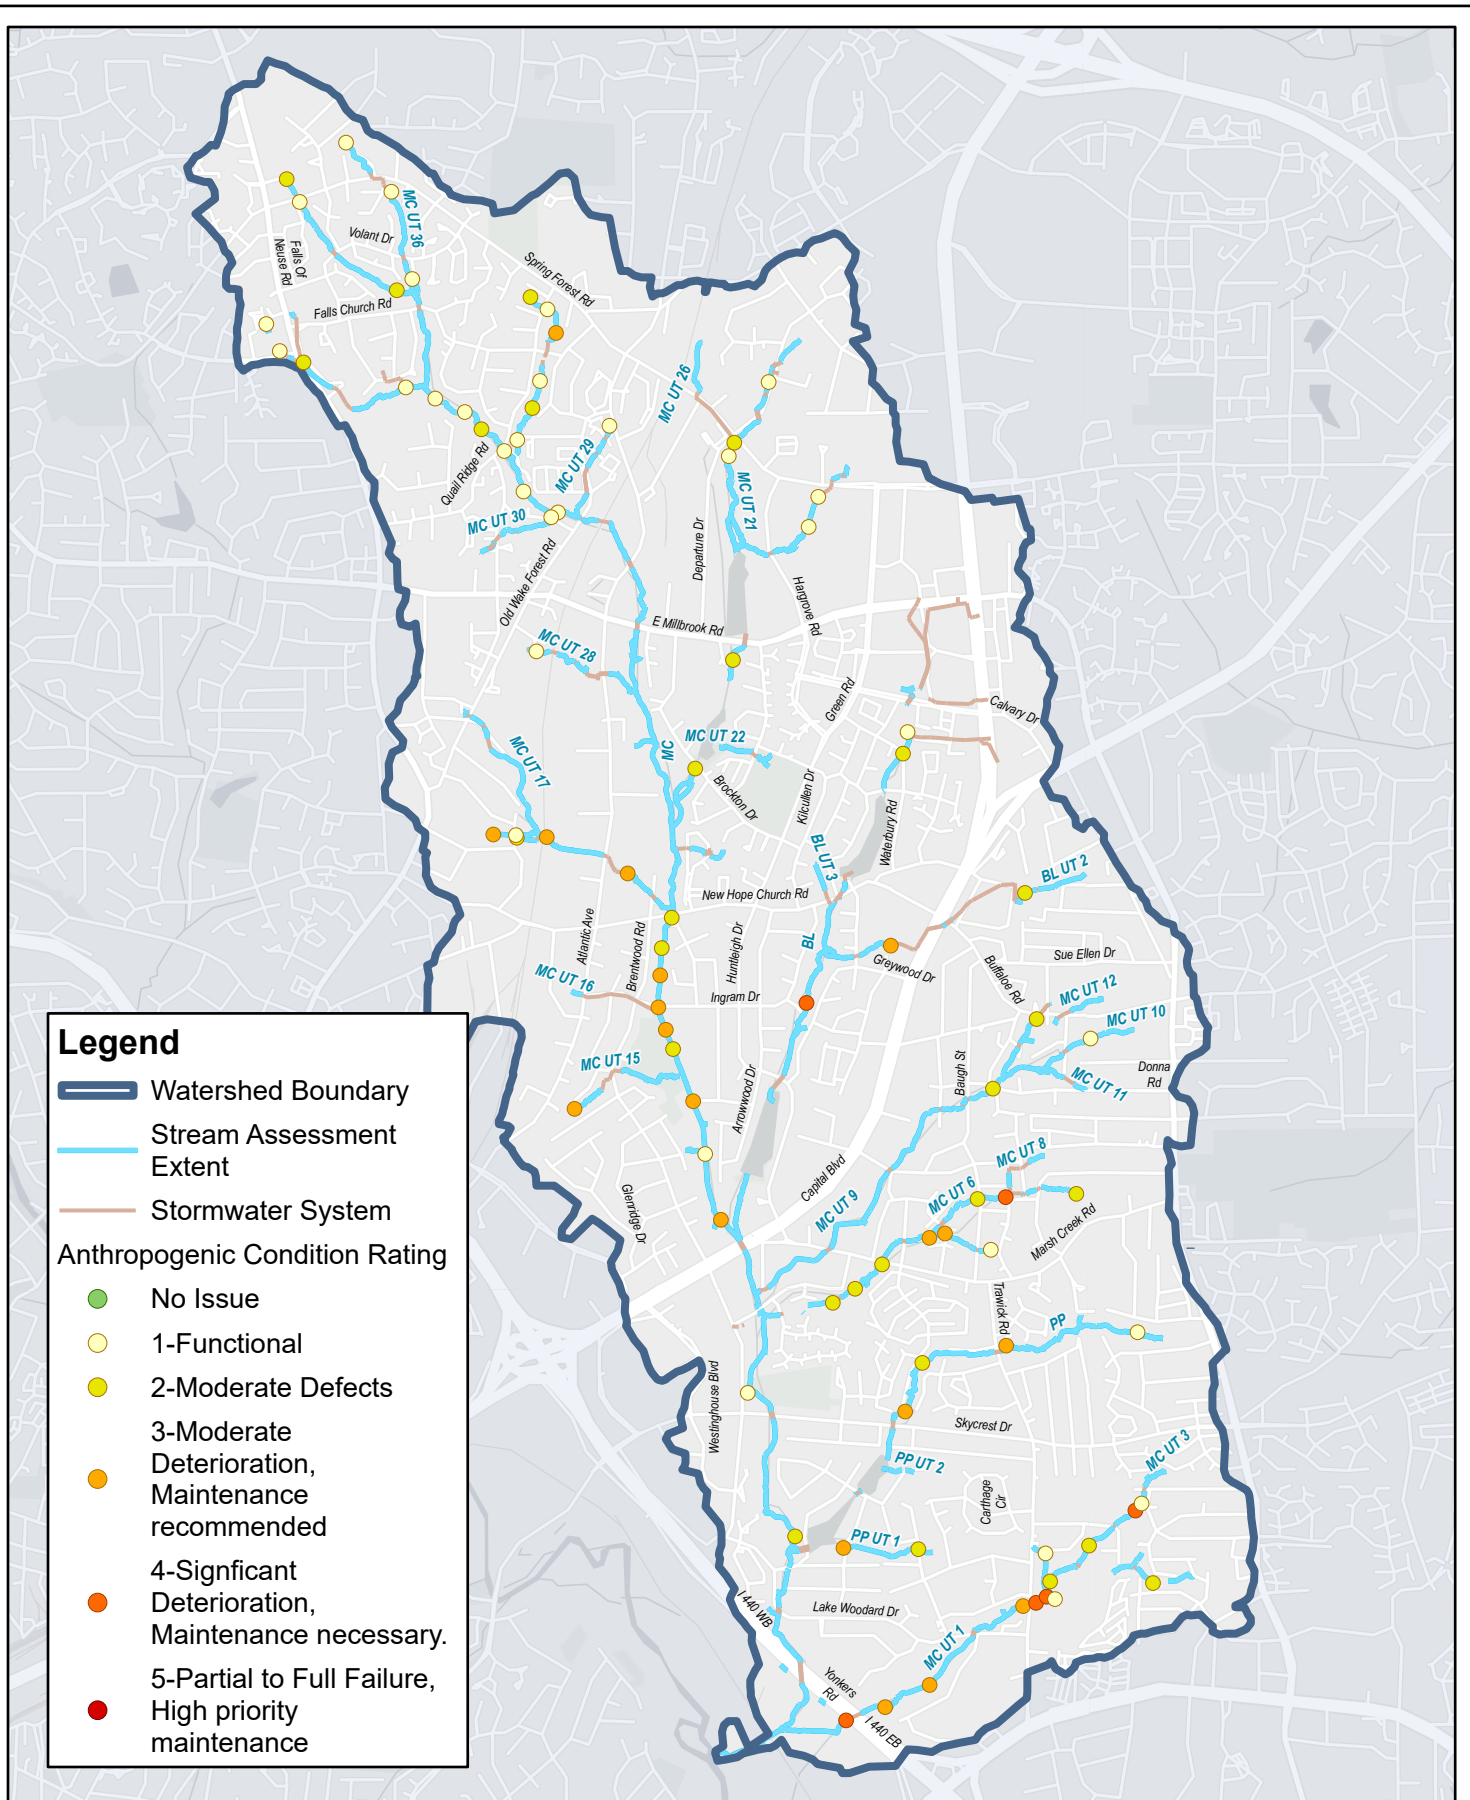
Figure 1-9 Structural Condition Rating for Hardened Anthropogenic Alterations
Marsh Creek Watershed Study
City of Raleigh, North Carolina

For all hardened channels, a condition rating was assigned to assess structural integrity and functionality. The rating ranges from zero to five, with zero being 'No Issues' and five being 'partial to full failure'. Most hardened structures showed some deterioration, with concentrations of structures having more deterioration being observed along the central mainstem of Marsh Creek and the central portion of the lower tributary (MC UT 1) to Marsh Creek (**Figure 1-9**). Hardened channels with high scores most often correspond to riprap channels that have been heavily eroded.
