REPORT
AUGUST 2024

Marsh Creek Stream Assessment

Prepared for:
City of Raleigh

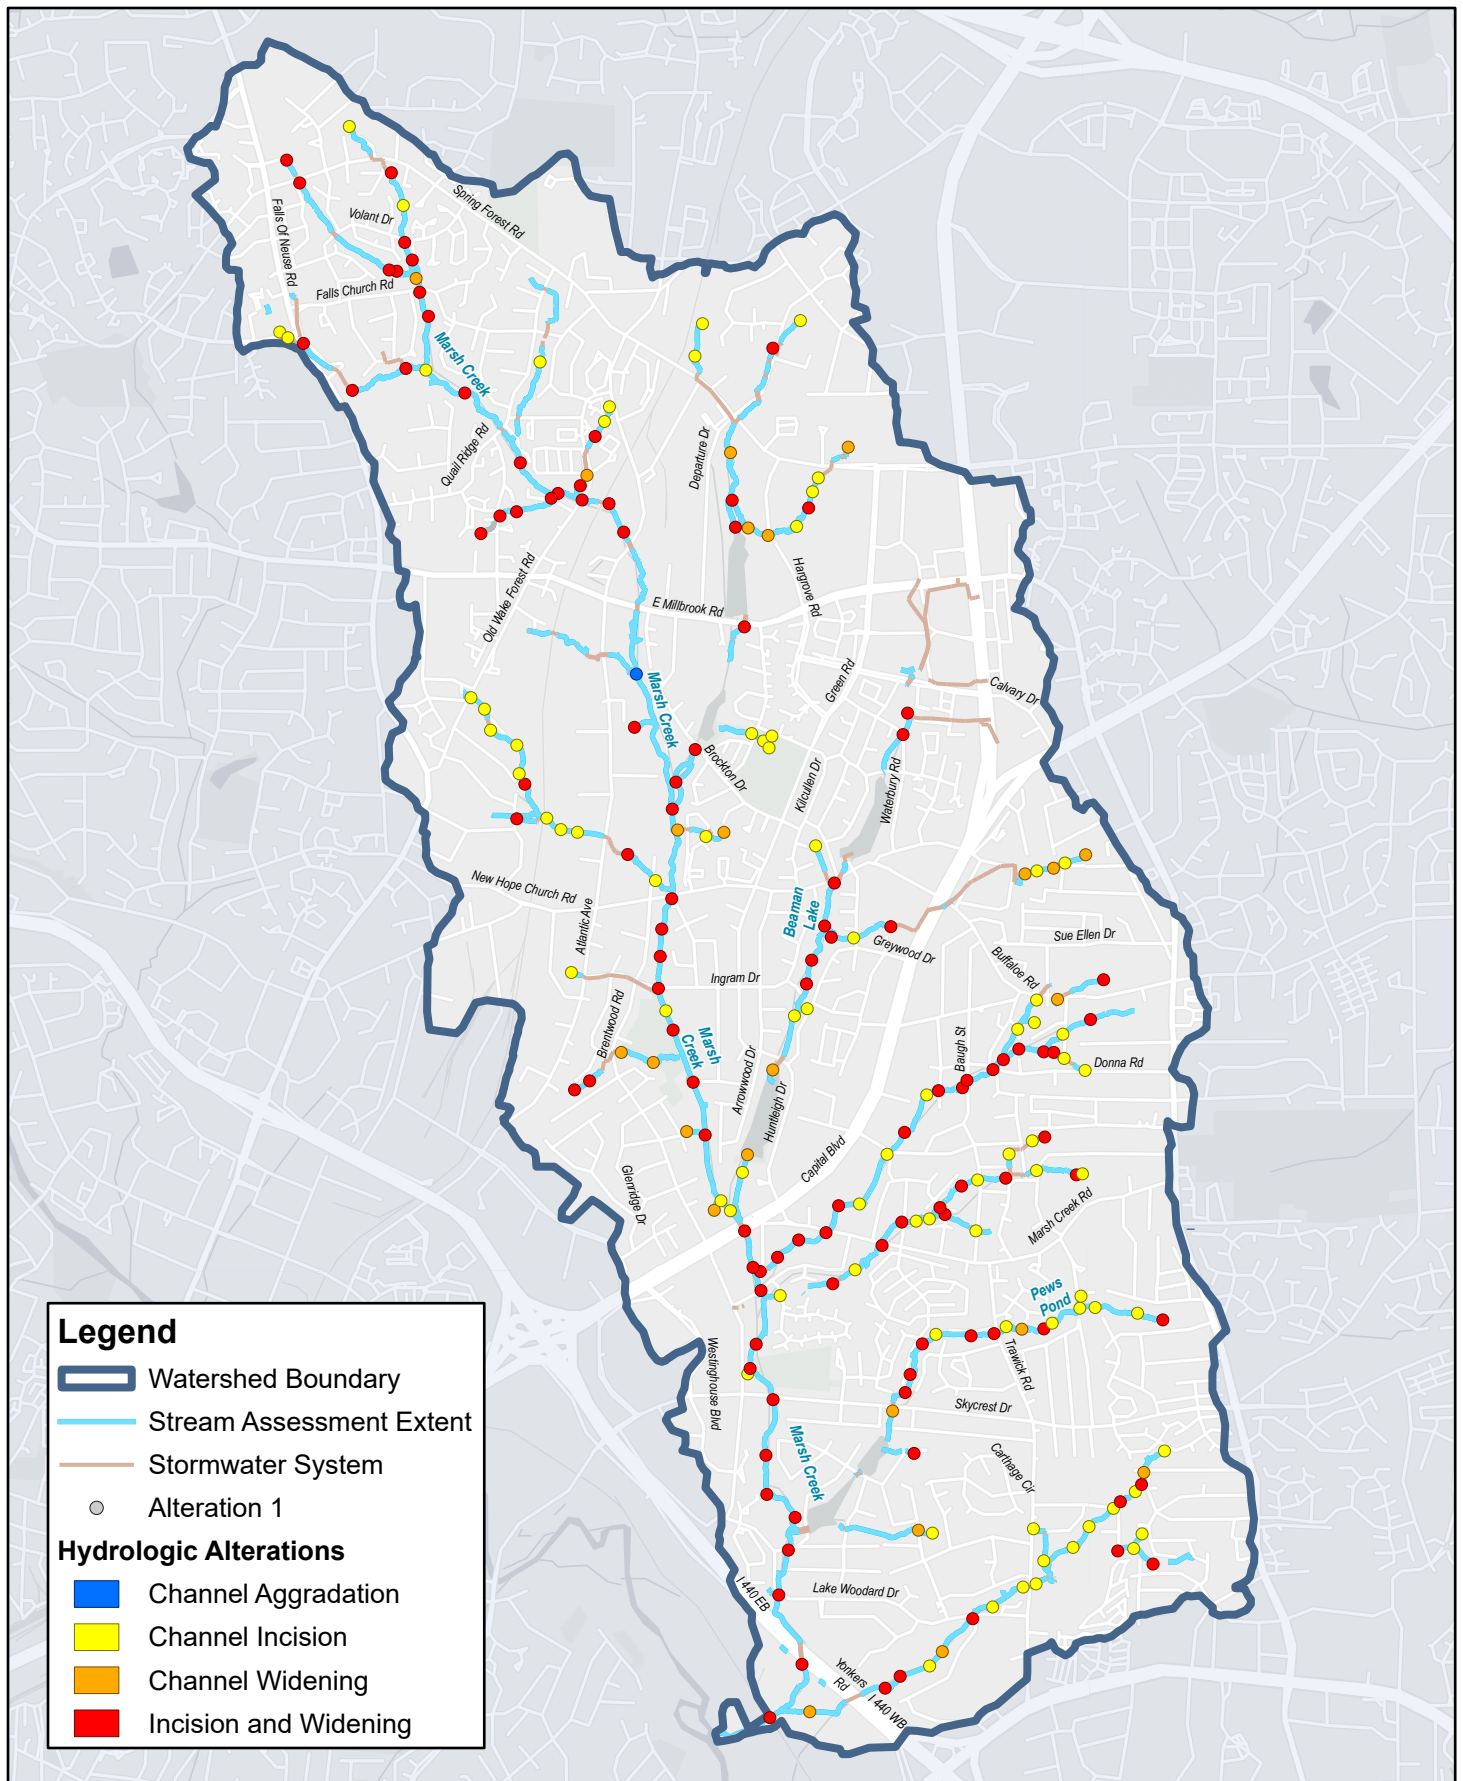
Figure 1-10 Hydrologic Alterations
Marsh Creek Watershed Study
City of Raleigh, North Carolina

Figure 1-10 and **Table 1-10** show that approximately 89 percent of stream channel lengths assessed within the Marsh Creek watershed are either incising, widening, or both incising and widening. Hydrologic alterations are prevalent throughout the watershed, with concentrations of reaches showing both incision and widening near the headwaters of tributaries and along the mainstem of Marsh Creek. Bedrock and culvert knickpoints maintain channel grades at locations along the mainstem and tributaries. Temporary channel aggradation is occurring above knickpoints that are holding sediment moving downstream, but those areas are small and fluctuate with flow events. No full stream assessment reaches showed channel aggradation. In many locations, stream incision and streambank erosion has exposed and/or is threatening existing infrastructure (e.g., culverts, roads, utilities, structures). Because of widescale hydraulic alterations within the stream, protection of existing infrastructure and installation of future infrastructure should be planned to anticipate further channel erosion.

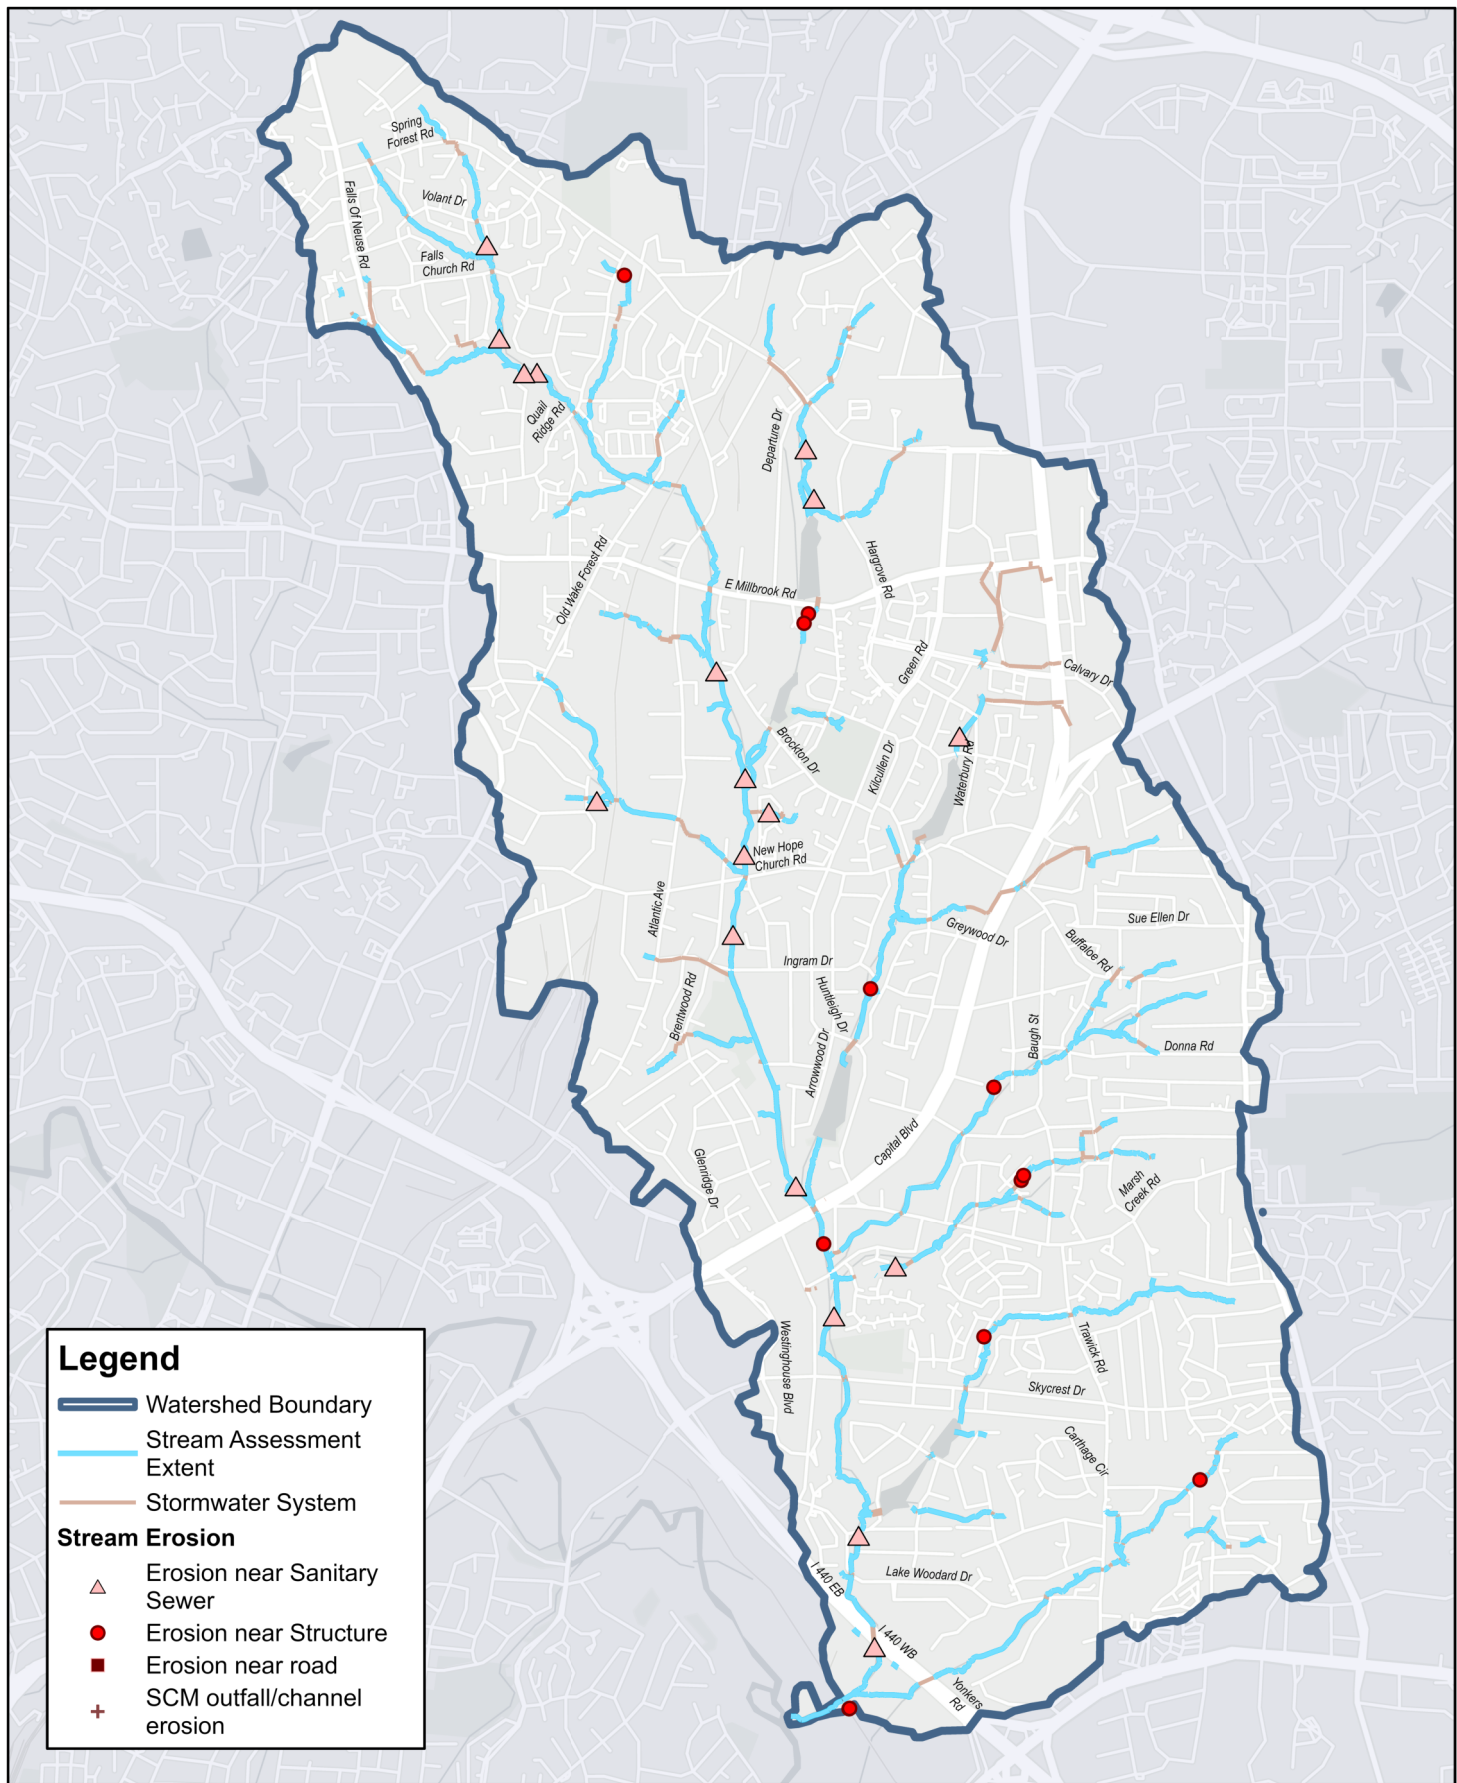
Figure 1-11 Stream Erosion Impacts
Marsh Creek Watershed Study
City of Raleigh, North Carolina

Figure 1-11 and **Table 1-11** catalog a total of 30 stream erosion impacts. Erosion near a structure was the most prevalent observed impact followed by erosion near a sewer line. There were several areas where the streambank has exposed or eroded to within 10 feet of a structure or sewer line.

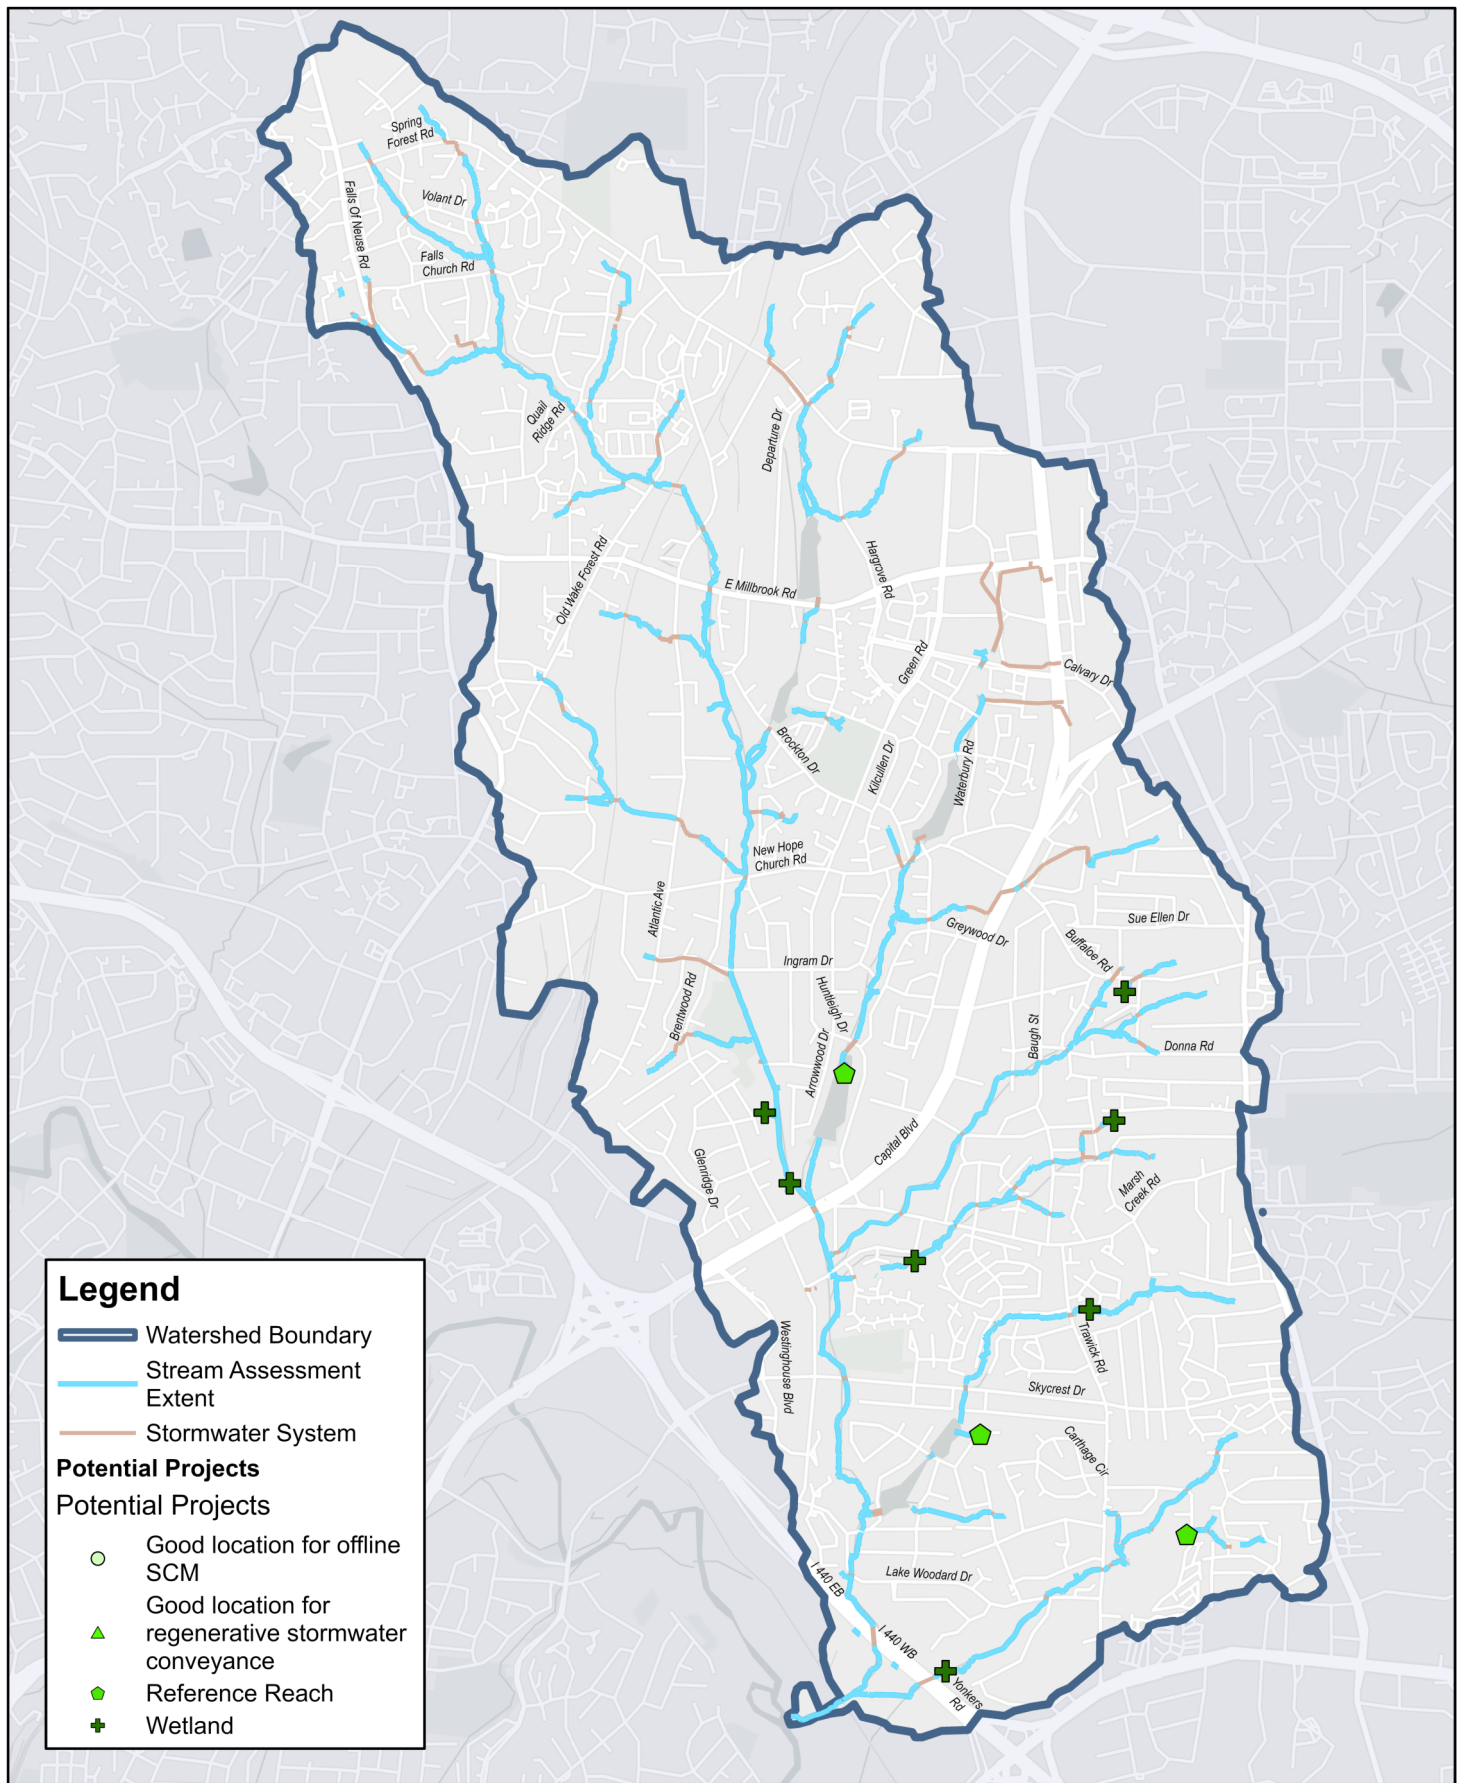
Figure 1-12 Potential Projects
Marsh Creek Watershed Study
City of Raleigh, North Carolina

Project related information is listed in **Table 1-12** and illustrated on **Figure 1-12**. Three suitable reference reaches were observed in the watershed and seven wetland areas were visible from within the stream. These were all found at the headwaters of ponds or former ponds. No potential SCM and Regenerative Stormwater Conveyance (RSC) locations were identified during stream assessment. However, opportunities for these types of projects will be evaluated in subsequent phases of the project.

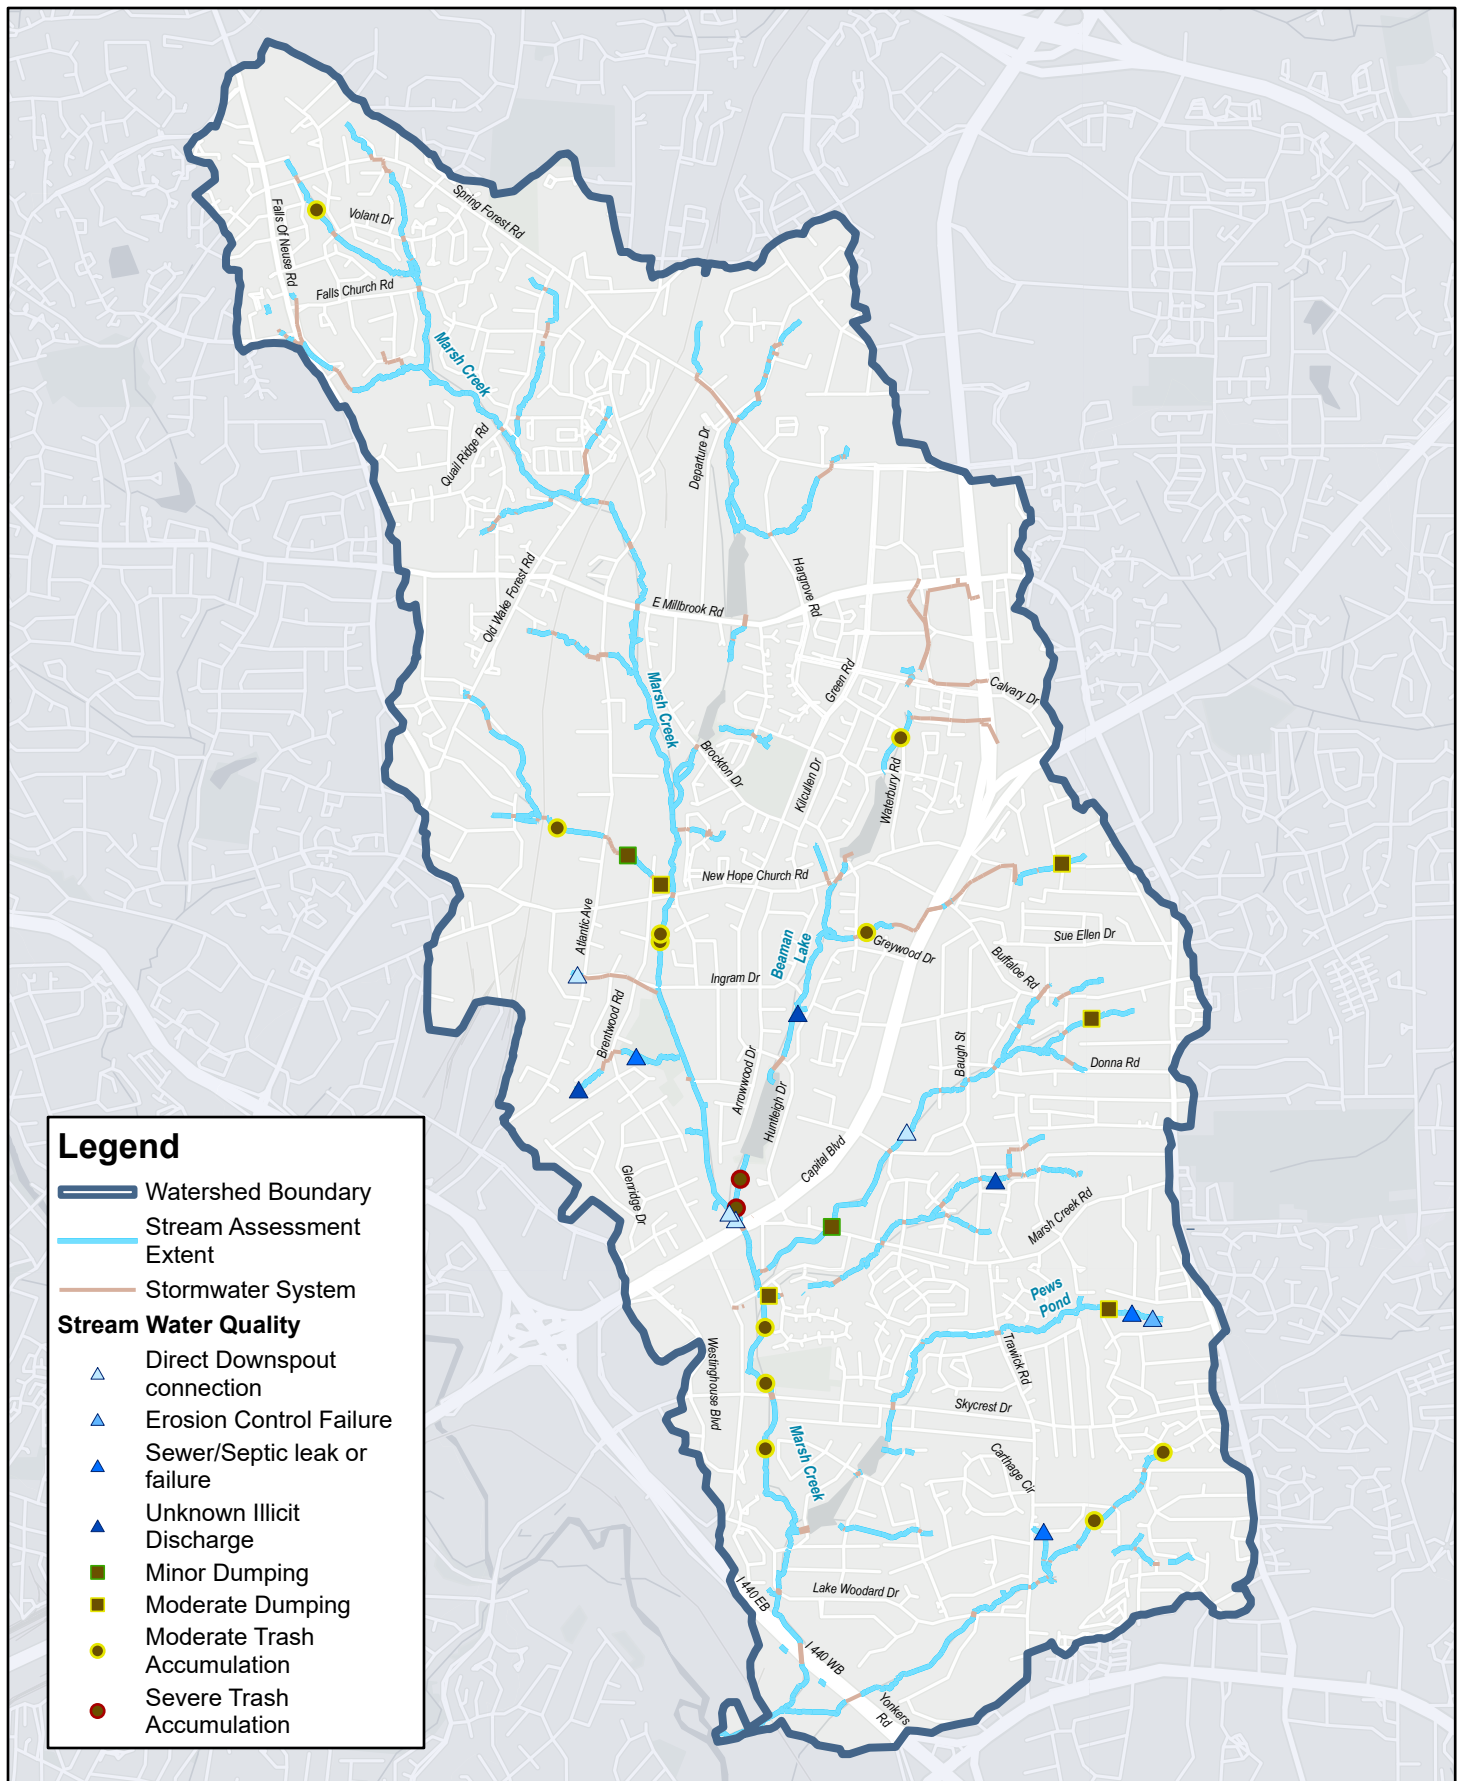
Figure 1-13 Stream Water Quality
Marsh Creek Watershed Study
City of Raleigh, North Carolina

Water quality impacts were also denoted during field condition assessment (**Table 1-13** and **Figure 1-13**). Five cases of potential illicit discharge or sewer/septic leak were immediately reported to Raleigh Stormwater upon discovery. The City's illicit discharge team responded to the locations reported by the stream assessment team and provided follow-up with the appropriate parties to address the discharge. In addition to these five cases, there were two sites that demonstrated characteristics that were unnatural in appearance, but not field-confirmed as an illicit discharge. As a result, these sites were recommended for follow-up investigation by the City. The City's illicit discharge team has conducted follow-up at these sites.

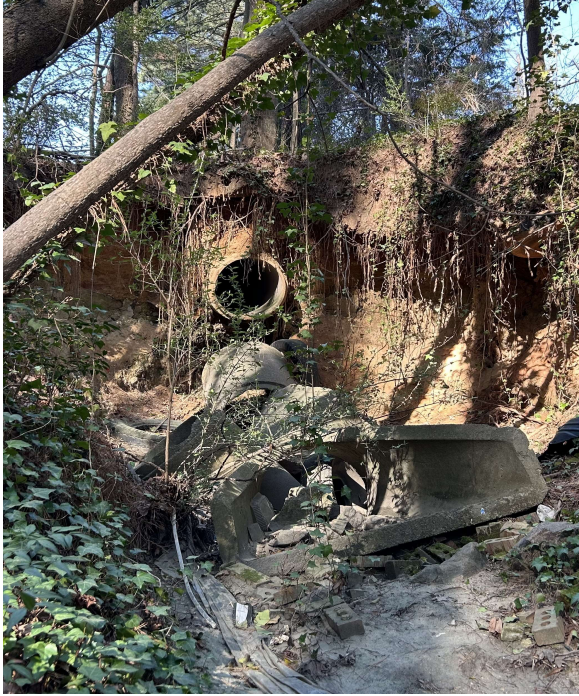
Photo 1-5 Example of Stormwater Infrastructure with a High Condition Assessment Score

Eight locations along the stream assessment extents were identified where infrastructure is in a critical state of deterioration. These are given a rating of 5 in Table 1-16. One example is near 3316 Hobby Court, a headwall and pipe section collapsed due to erosion (**Photo 1-5**). A photograph was taken of each documented issue and may be accessed via the online GIS data (StreamAssessment_PipeIO). It should be noted that all assets visible from the stream were assessed regardless of ownership. Ownership information is included in the GIS data. Maintenance and repair of infrastructure located on private property is the owner's responsibility.

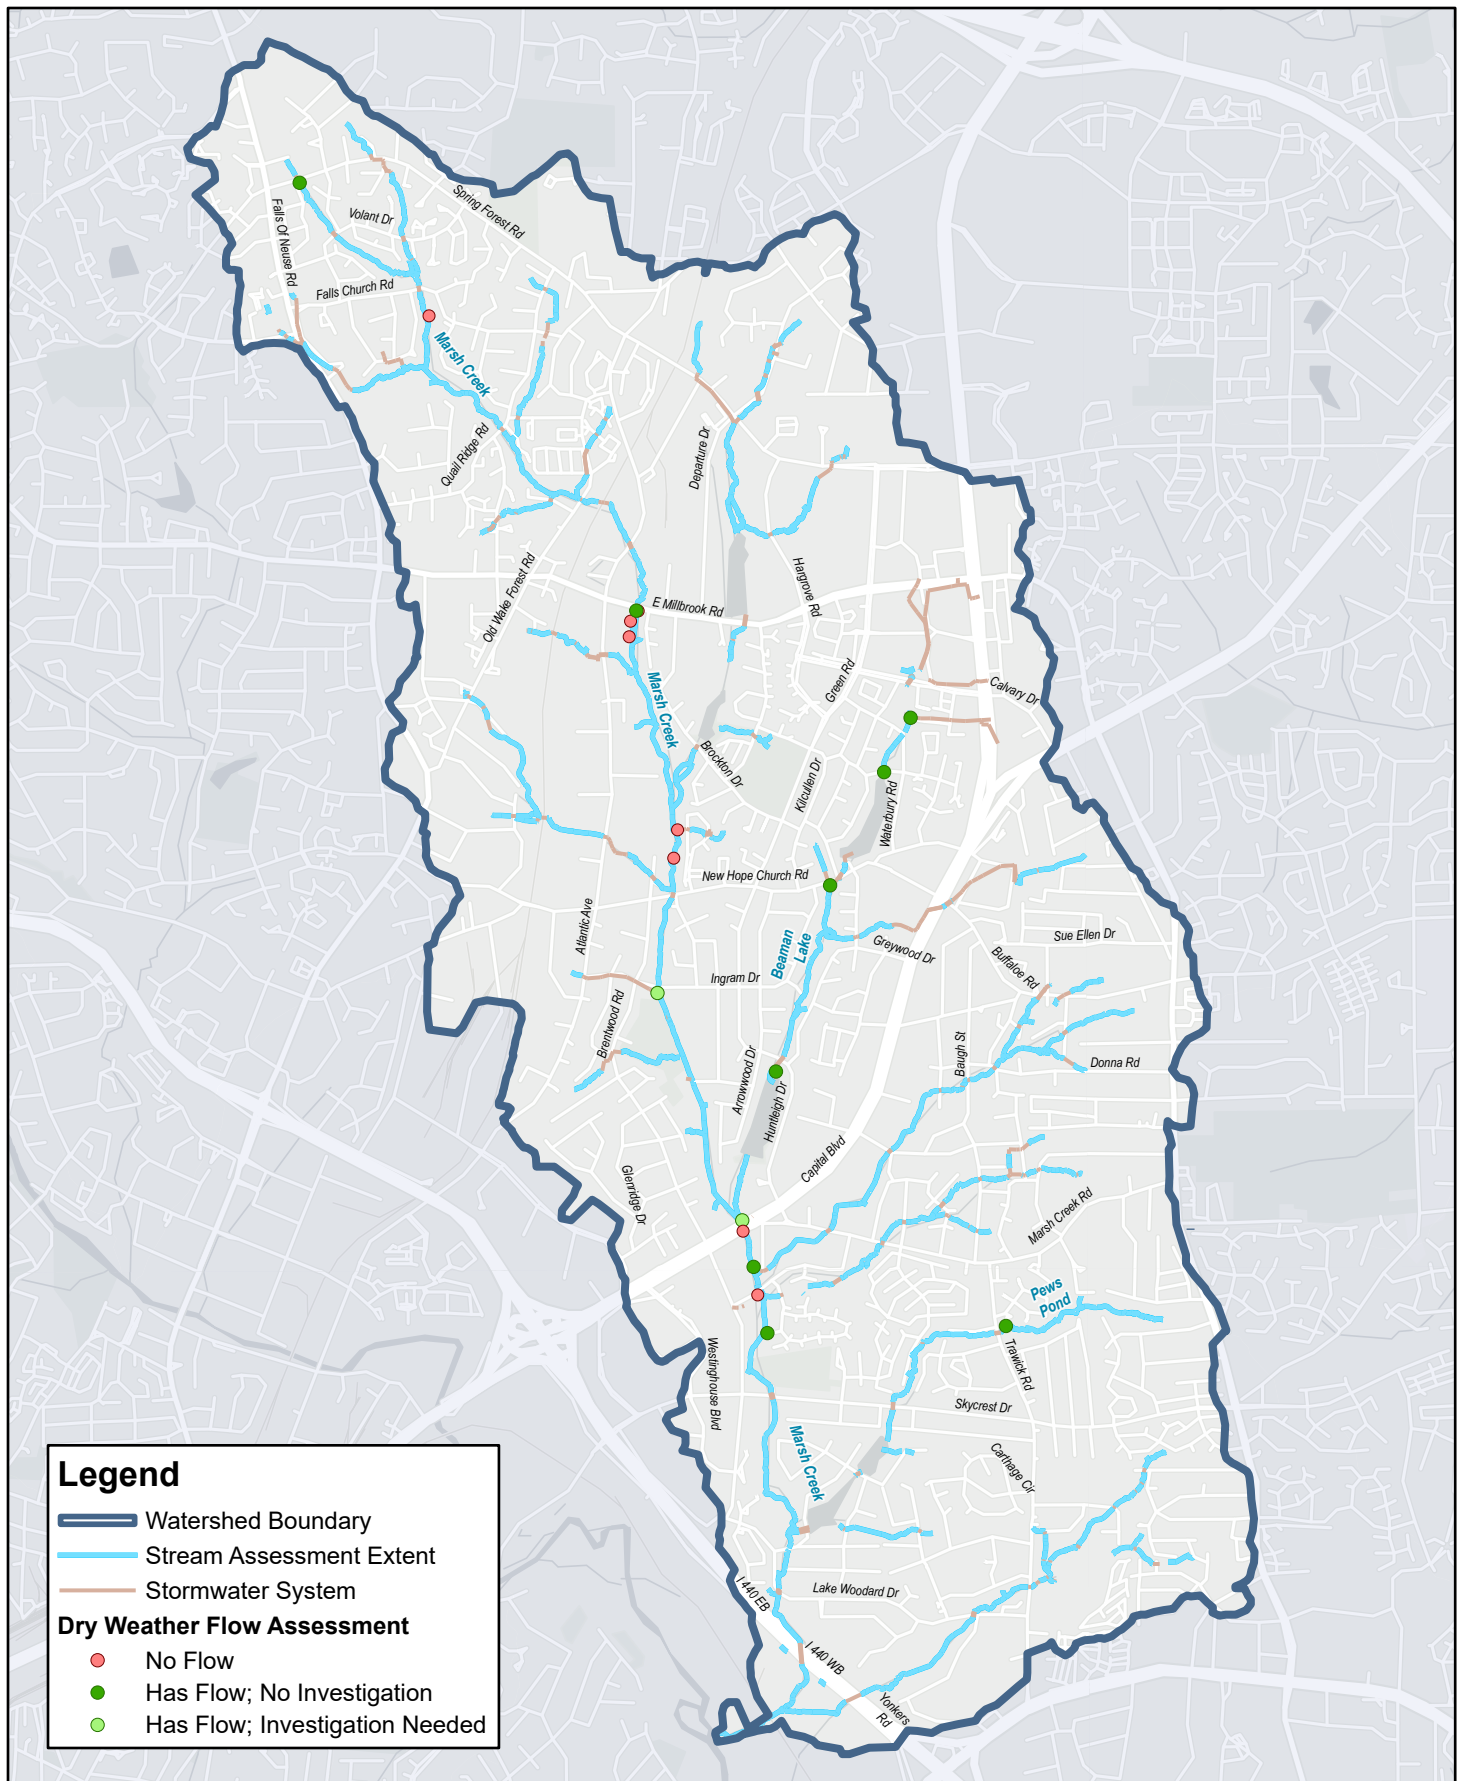
Figure 1-16 Dry Weather Flow Assessment
Marsh Creek Watershed Study
City of Raleigh, North Carolina

Eight of the assessed outfalls did not have flow. If an outfall was found to have flow, but the infrastructure was downstream of a flowing stream, and there were no signs of an illicit discharge then no further investigation was required. This was the case for nine of the assessed outfalls. However, two outfalls are recommended for further investigation.

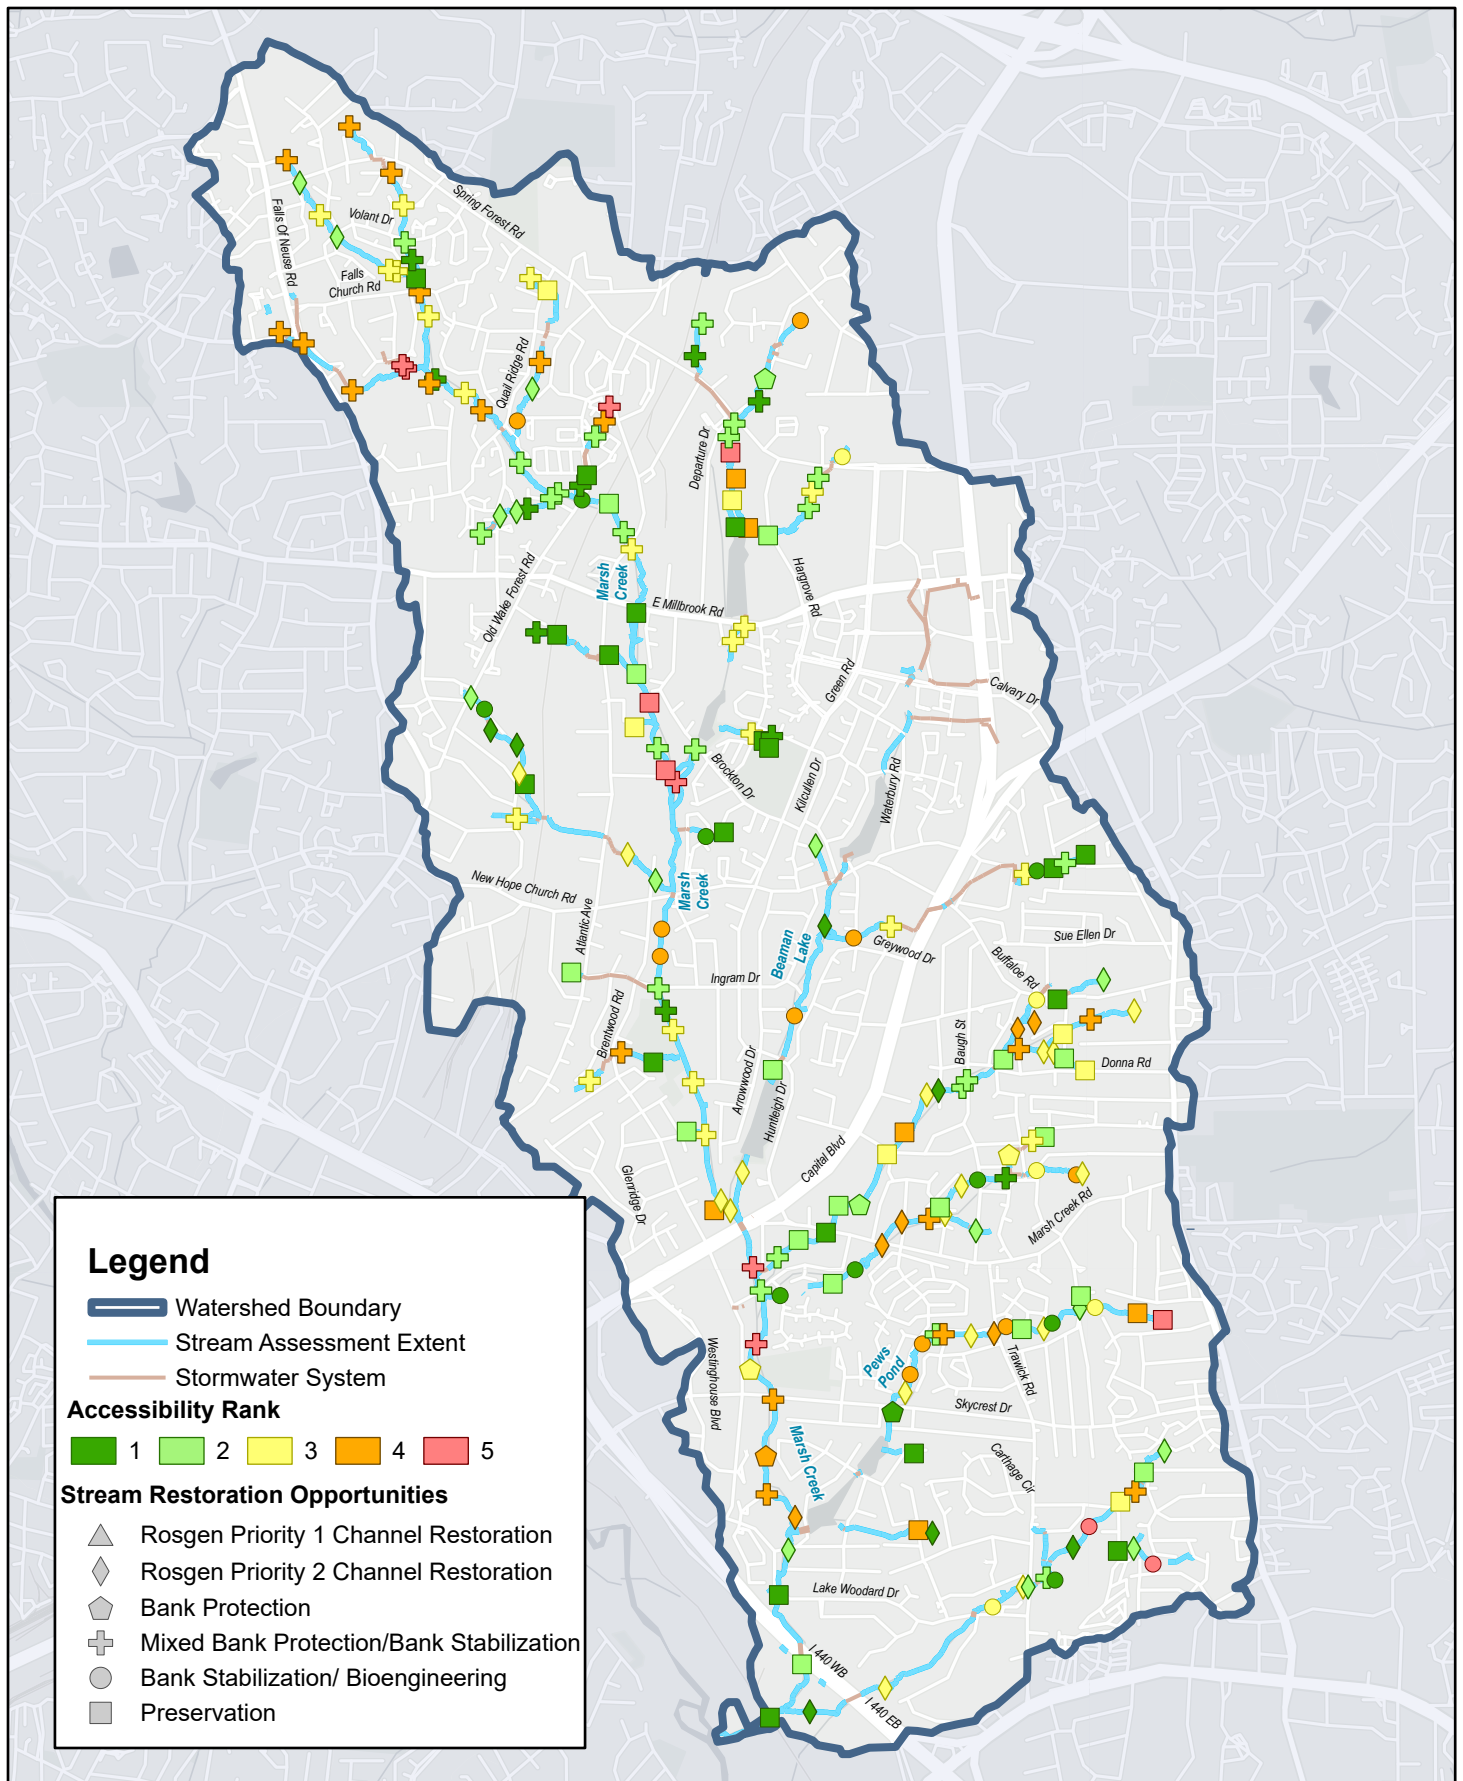
Figure 1-17 Stream Restoration Opportunities
Marsh Creek Watershed Study
City of Raleigh, North Carolina

In Marsh Creek, potential sites for a Priority 1 restoration lie in the upper mainstem and tributaries to the lower mainstem. This restoration option would likely require a larger channel than the historic channel to accommodate increased peak flows, a slightly steeper channel slope than the historic channel to better connect channel grades, and some lowering of the current floodplain elevation. These modifications are more characteristic of other Rosgen Priority restoration options. Though an ideal Rosgen Priority 1 restoration site is difficult to find there are a couple locations within the Marsh Creek watershed that could closely approach one. More Rosgen Priority 2 stream restoration options exist in urban watersheds than Priority 1 options because the challenges of matching back to existing grade are less. However, they are still limited by available room to relocate the channel and excavate the floodplain. All potential stream restoration opportunities identified during stream assessment are shown on **Figure 1-17**.
