MOORE SQUARE COMPREHENSIVE TREE STRATEGY

Raleigh Parks and Recreation Department
April 2013

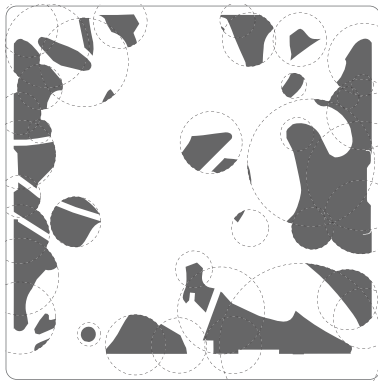
EXCESSIVE MULCH

The existing thick mats of mulch in the tree protection area is creating moisture competition and fosters vertical root growth affecting the health of the existing trees.

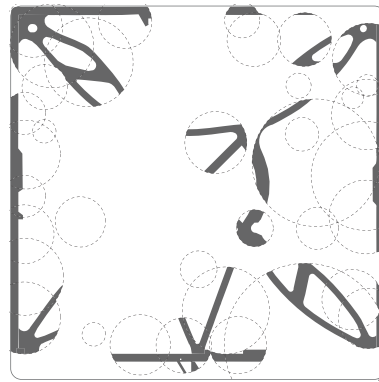
TREE / PATH CONFLICTS

Currently there are many existing paths within the tree protection areas. These traditionally built paths were created by cutting into the root zones.

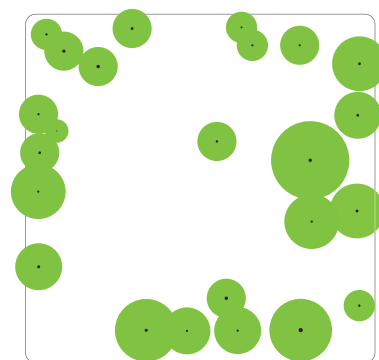
TREES FOR HAZARDOUS TREE REVIEW

This report has found 24 existing canopy trees that should be reviewed per potential impacts on the public safety.

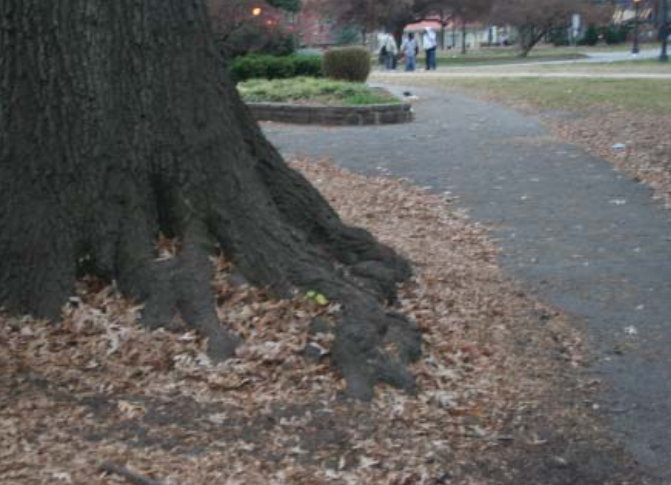
PATH CONFLICTS WITHIN THE TRUNK PROTECTION AREA SHOULD BE IMPROVED

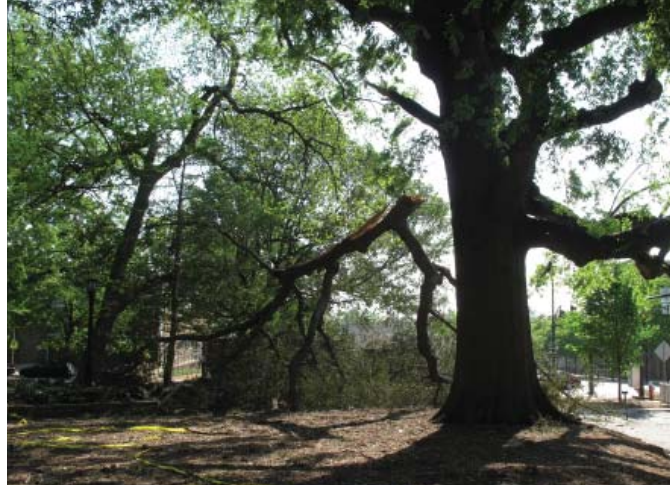
STORM DAMAGE HAS AFFECTED THE SAFETY OF CERTAIN TREES WITHIN THE SITE

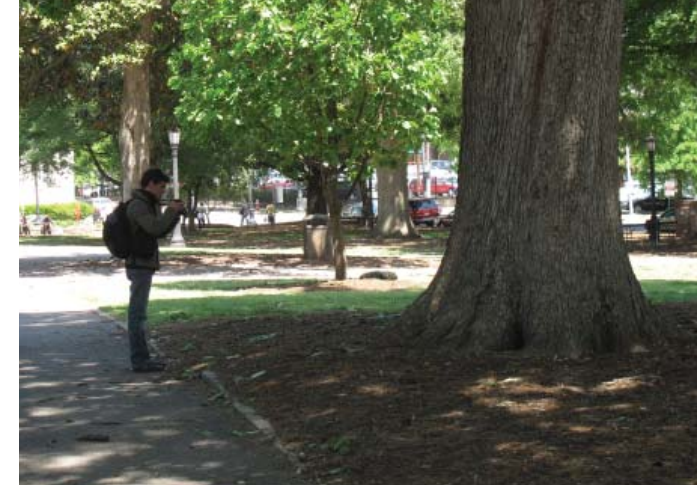
PATH CONFLICTS WITHIN THE TRUNK PROTECTION AREA SHOULD BE IMPROVED

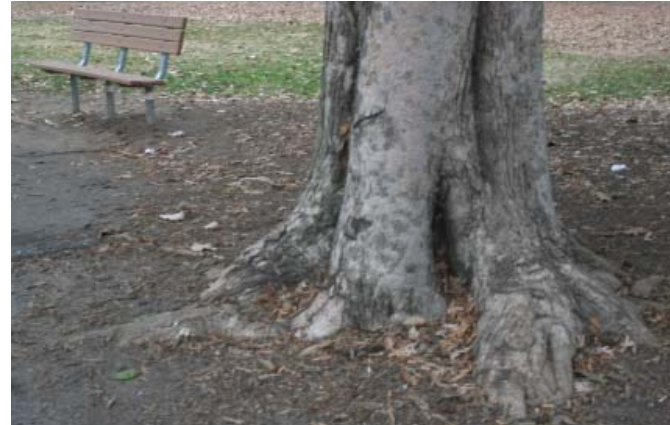
STORM DAMAGE HAS AFFECTED THE SAFETY OF CERTAIN TREES WITHIN THE SITE

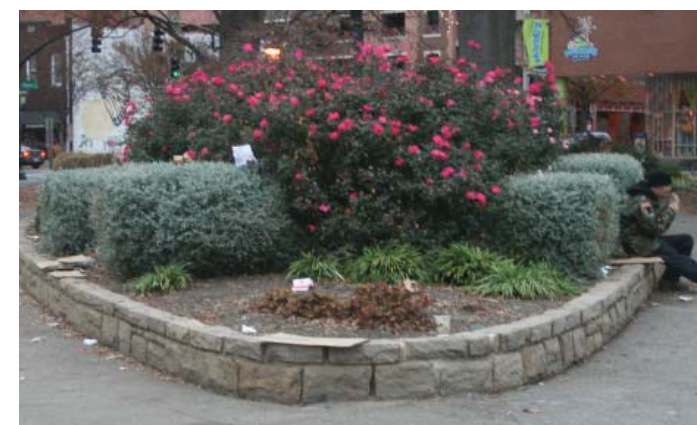
WALLS AND PLANTERS WITHIN TREE AND TRUNK PROTECTION AREAS SHOULD BE REMOVED

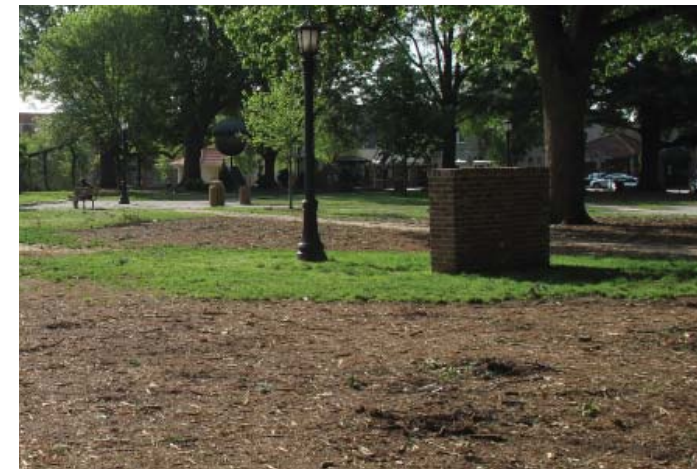
OVER MULCHING AND UTILITY STRUCTURES WITHIN TREE PROTECTION AREAS CAN DAMAGE TREES

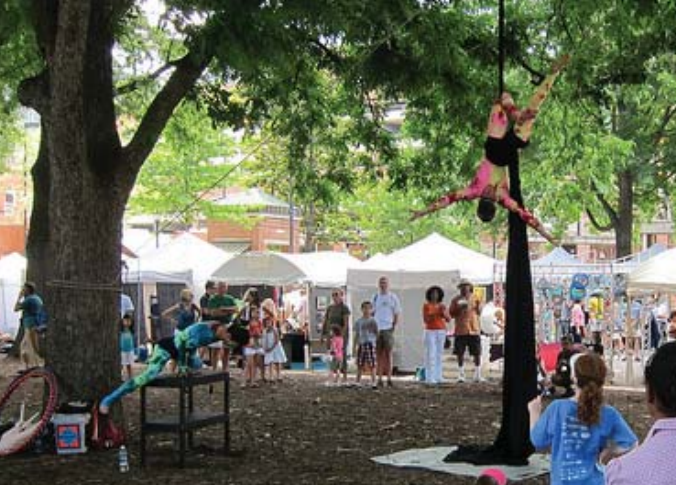
EVENTS WITHIN TREE PROTECTION AREAS CAN DAMAGE EXISTING TREES

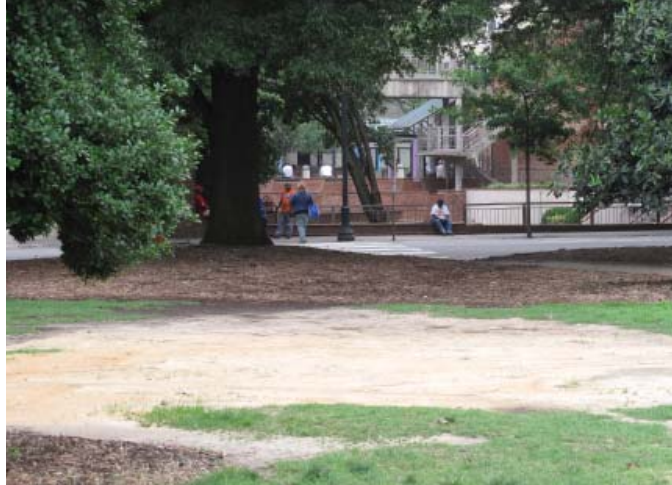
EXISTING LAWN CANNOT SUPPORT URBAN USE

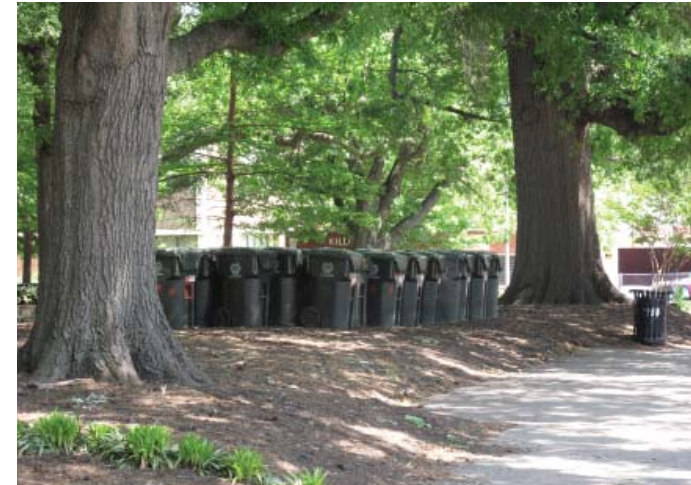
OPEN PERIMETER ALLOWS FOR USES THAT CAN DAMAGE ROOT ZONES OF EXISTING TREES

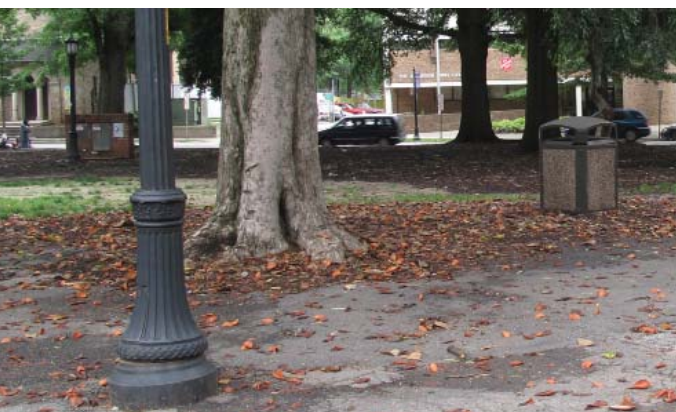
EXISTING PATHS AND UTILITY LINES VIOLATE TREE AND TRUNK PROTECTION AREAS

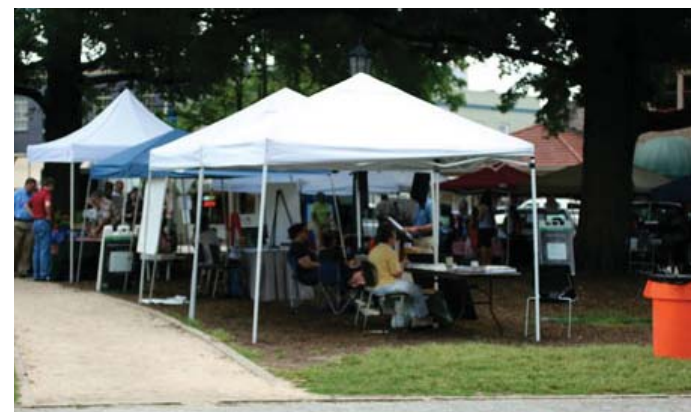
EVENTS WITHIN TREE PROTECTION AREAS CAN DAMAGE EXISTING TREES

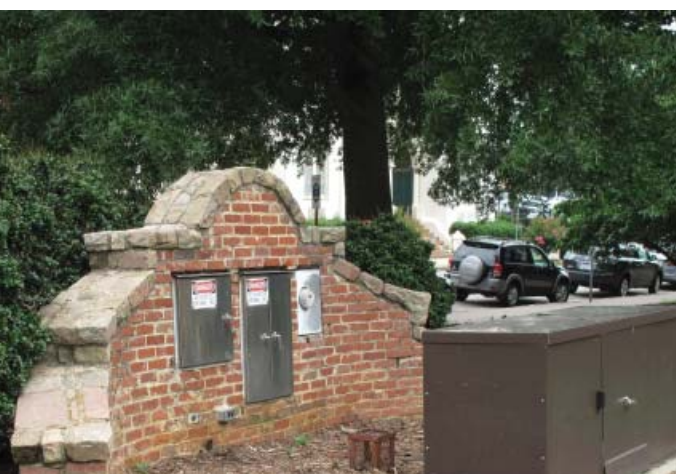
UTILITY STRUCTURES WITH TRADITIONAL FOUNDATIONS WITHIN TREE PROTECTION AREAS

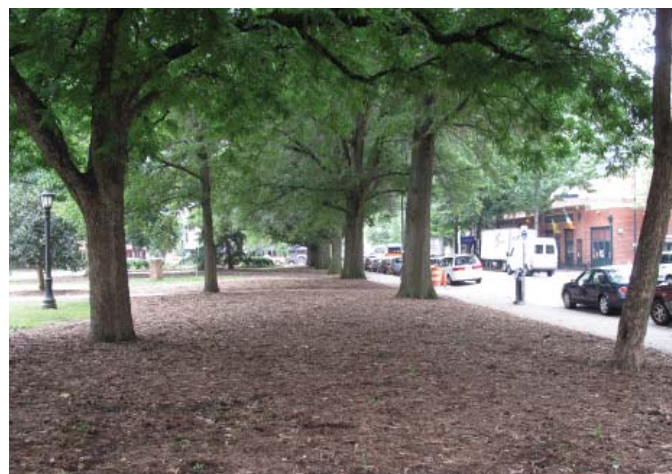
OVER MULCHING AND UNRESTRICTED ACCESS TO SENSITIVE TREE PROTECTION AREAS

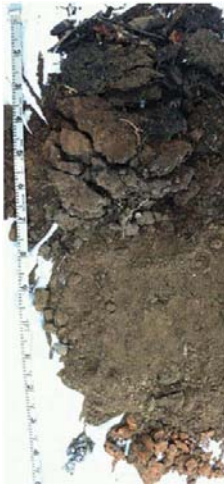
Surface cover: Wood chip mulch
	0-0.2'	Wood chip mulch
	0.2'-0.3'	Very organic loam, dark brown/black; moist; loose; roots observed
	0.3'-0.4'	Interface; sandy loam fill; brown; dry; firm; roots observed
	0.4'-0.6'	Interface; loam fill; dark brown; dry; firm; roots observed
	0.6'-1.2'	Interface; fine sandy/gravel loam; grey/brow; dry; hard to V hard; roots observed
	1.2'	Coal ash fragments Trace of sandy clay, orange; dry; auger refusal

Remarks: Fill soils over subgrade soils. Disturbed soil profile.

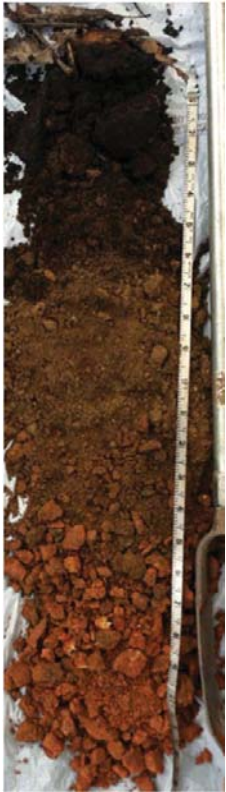
Surface cover: Wood chip mulch
	0-0.3'	Decomposing wood chips, dark brown/black; moist; soft; roots observed
	0.3-0.7'	Interface; sandy loam; dark brown; moist; soft; roots observed
	0.7-1.4'	Interface; fine sandy loam; light brown; damp, firm; roots observed
	1.4'-2.4'	Interface; gravel and fine sandy clay; orange; moist, firm
	2.4'	Stopped digging

Remarks: Highly disturbed soil near walk

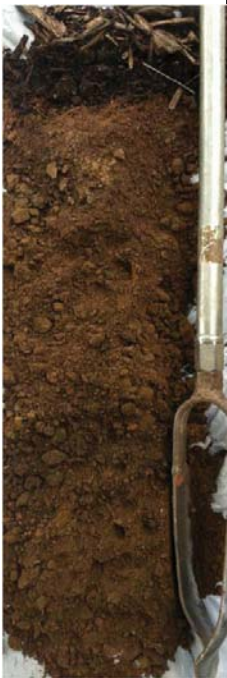
Surface cover:
	0-0.2'	Decomposing wood chips; dark brown/black; moist; soft; roots observed
	0.2'-0.7'	Fine sandy loam; brown; dry; firm; roots observed
	0.7'-1.2'	Interface; fine sandy silt loam; light brown; dry; firm; roots observed
	1.2'-1.3'	Interface; silty sandy loam; dark brown; moist; firm; roots observed, glass fragment, likely buried fill soil
	1.3'-1.9'	Interface; fine sandy silt loam; light brown; dry; hard; roots observed
	1.9'	Auger refusal; bits of hard orange subsoil observed

Remarks: Disturbed fill soils

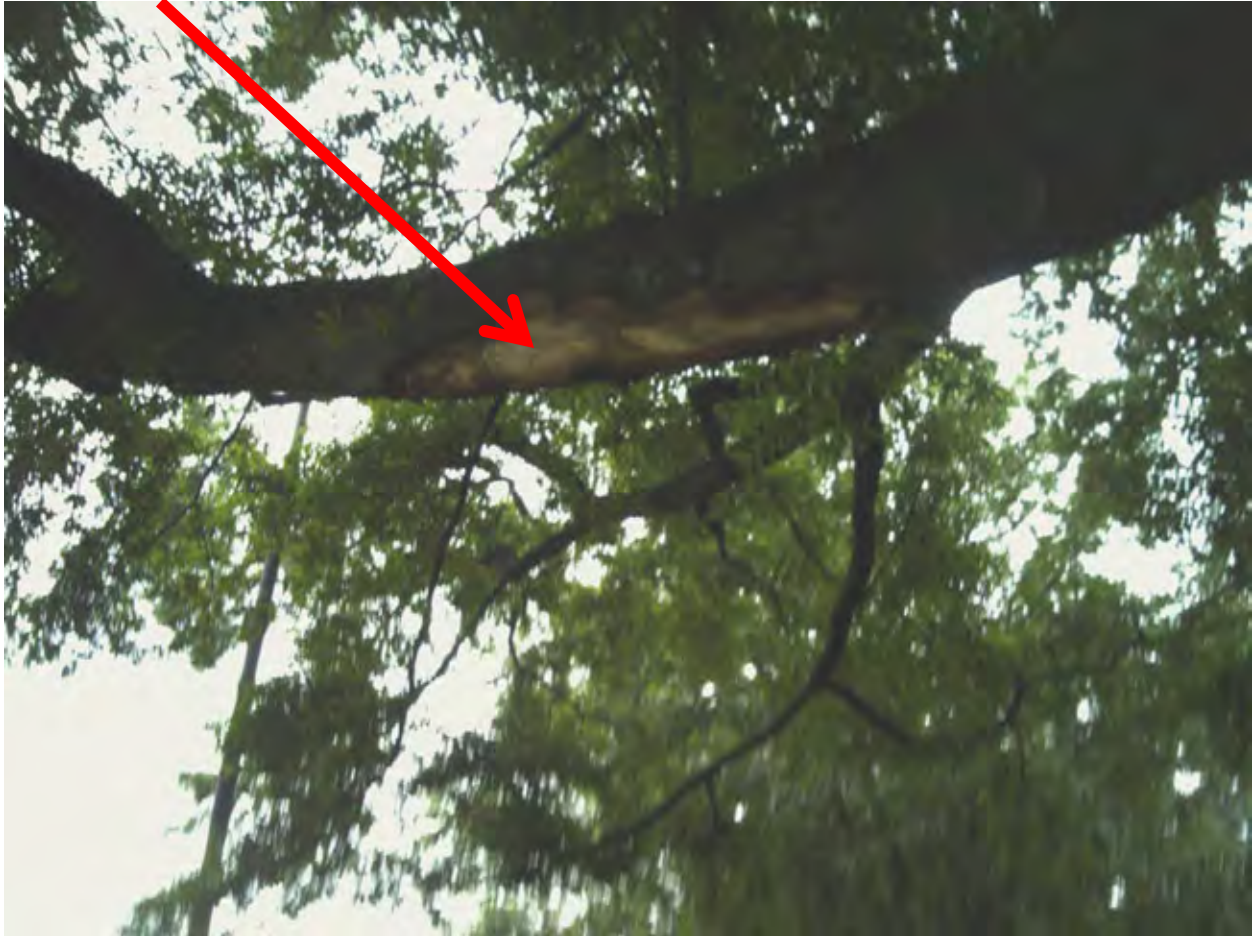
Figure 1: Tree #32 with a branch wound present.

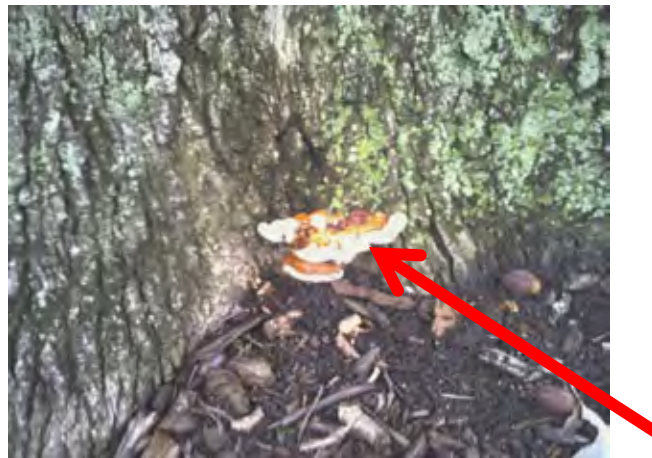
Figure 2: The presence of fungal conks on Tree #29 necessitates an advanced tree risk assessment to more thoroughly assess internal decay and risk of failure.

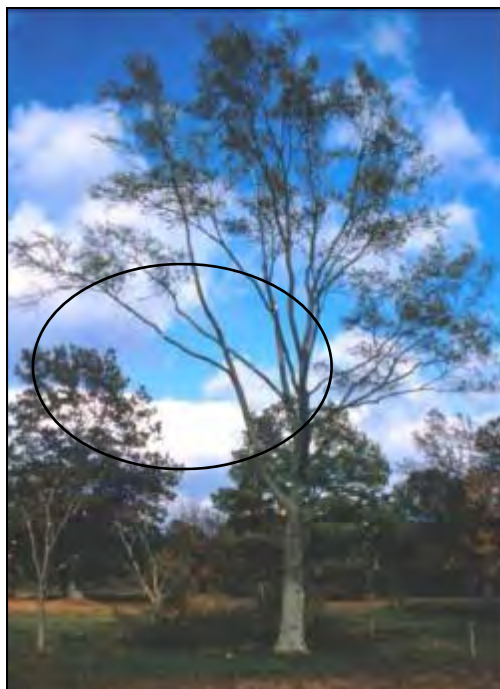
Figure 3: Black oval indicates general area of excessive foliage removal.

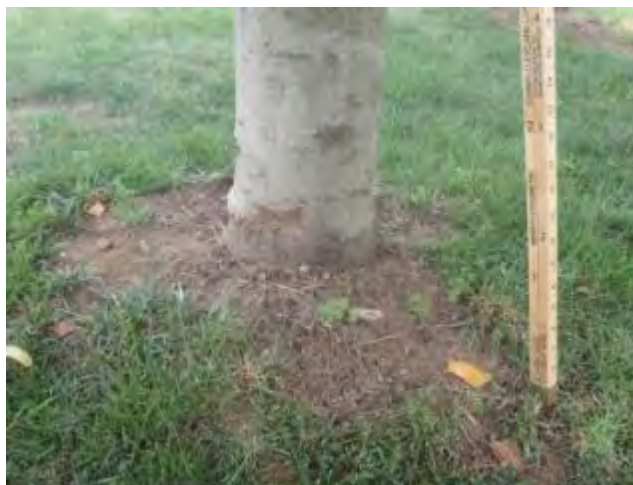
Figure 12: No root flare is visible at this tree's base. The root collar is buried.

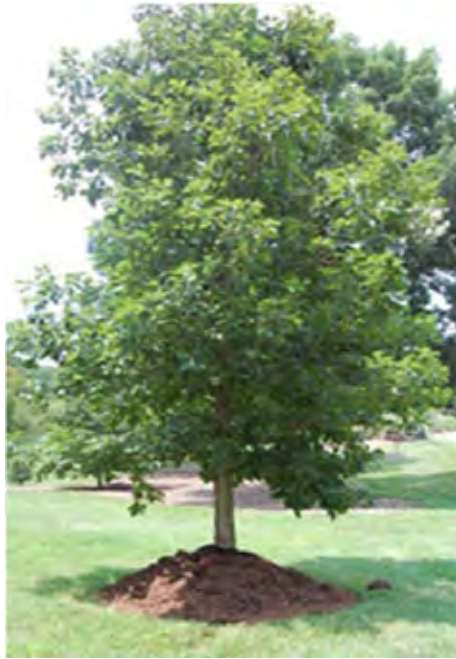
Figure 14: Example of improper mulch application, known as “volcano mulch.”
