**Inventory and Assessment of Sidewalk  
and Pedestrian Facilities  
-Summary of Findings-  
*October 2025***

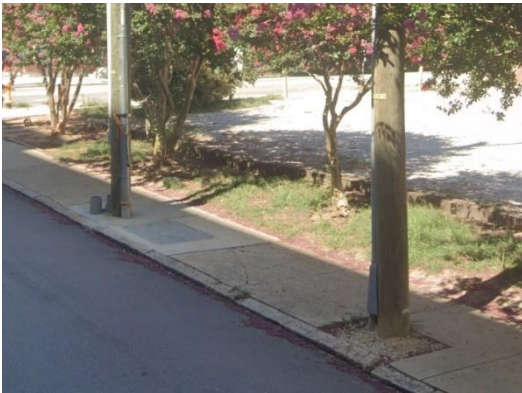
**Sidewalk Obstruction – Utility Obstruction**

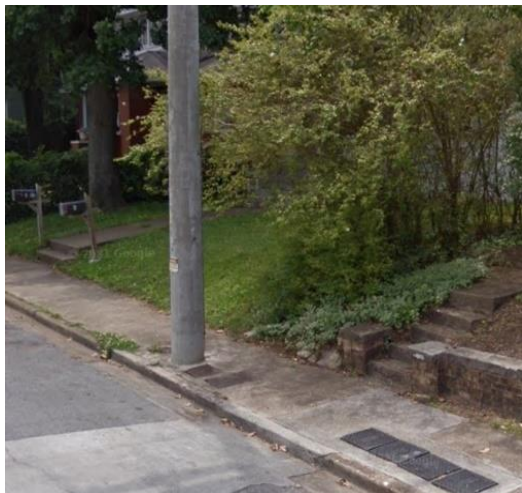
**Sidewalk Obstruction – Overhead Vegetation Protrusion**

- Vegetation growing overhead or alongside the sidewalk represent the two highest factors in barriers to the sidewalk.
- Utilities and Power Poles represent 329 locations combined. These types of obstructions are costly to relocate and/or require challenging design solutions. In some cases, obstruction removal may be the responsibility of other agencies (such as NCDOT, a utility company, etc.) and require more coordination and time to correct.

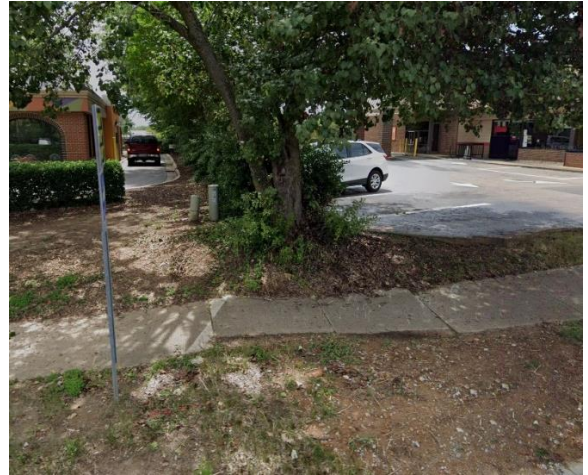
**Sidewalk Heave**

- Changes in level, or heaves, are common issues found in sidewalks for every community.
- Heaves are caused by many factors, including but not limited to tree root growth and changing soil conditions over time.
- Uneven heaving in the sidewalk concrete is a common occurrence of obstruction counts, as previously reported.
- Heaves of a certain dimension can often be addressed by cutting or grinding sidewalks.
- Only 2% of heaves are 1" or higher.
- Over 72.3% of the heaves measured fall between  $\frac{1}{4}''$  and  $\frac{1}{2}''$ , which often represent an opportunity for remediation without replacing an entire sidewalk segment. While not compliant, these are also found to be far less severe.

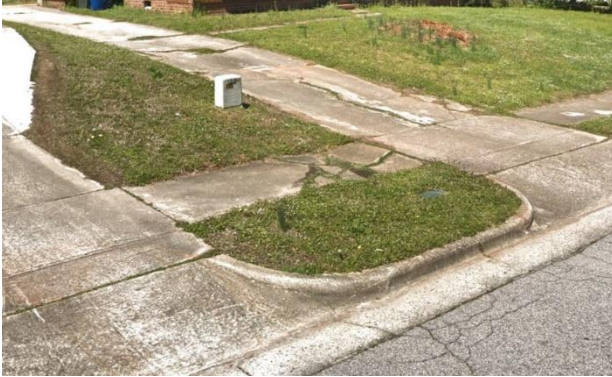
**Poor Surface Condition**

- Poor Surface Condition is multiple measurements of vertical displacement in close proximity, consistent with broken/cracked panels, spalling, or other surface roughness.
- Heaving clusters are distinguished from panel joint heaves, where remediation can be grinding.
- Remediation of this type of accessibility issue is typically sidewalk replacement.
- Locations with other issues requiring sidewalk replacement are not counted in this total.

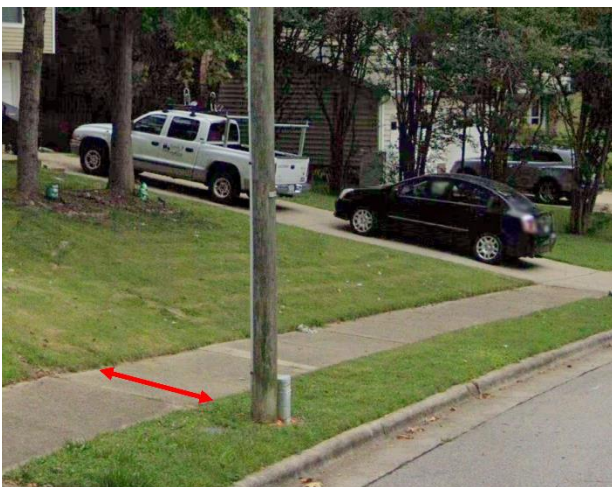
**Sidewalk Cross Slope, as depicted by arrow**

- 46.4% of the cross slope issues fall in the 2-3% range and many of these fall to just above the 2% maximum allowable standard. This is considered a less severe violation unless additional compliance issues are present.
- 24.2% of cross slope issues fall in the 3-4% range, and 15% of the remaining violations are above 4% cross slope, where the slope may become very visible.
- Sidewalk cross-slope violations are a common issue at driveway crossings.
- Run slope issues were less common compared to cross slope.
- Only .3 miles fell above 8.33% run slope grade, which is considered more severe than the 1.32 miles at 5.01-8.3% grade.

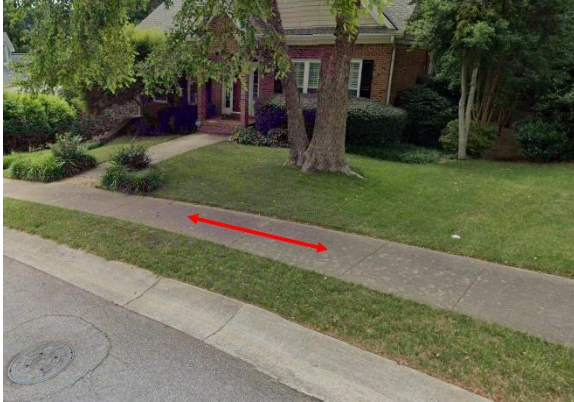
Sidewalk Run Slope, as depicted by arrow

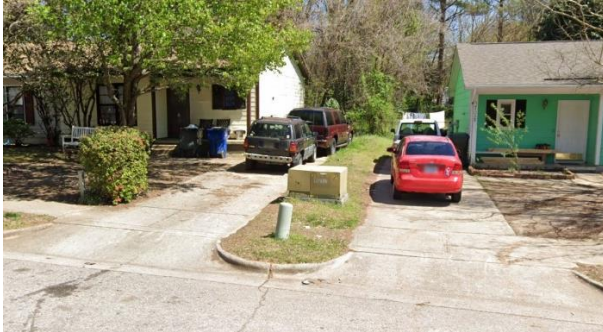
**Sidewalk Connectivity**

- Sidewalk Connectivity represents a gap in service (missing sidewalk between two unconnected sections / buried sidewalks, bus stops) or inadequate service (buried, narrow). It is important to note that these gaps in service have possible solutions for remediation outside of installing new sidewalk.
- Driveway Crossings: Cross slopes of driveway crossings often exceed the 2% maximum allowable per the standards for cross slope; this can present a challenge if sidewalk connectivity utilized the driveway to continue the sidewalk path.

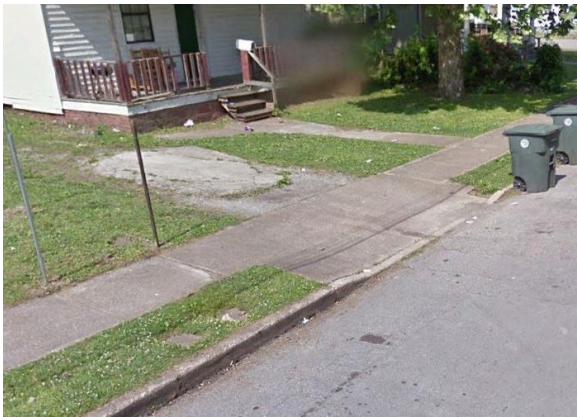
**Sidewalk built through a driveway**

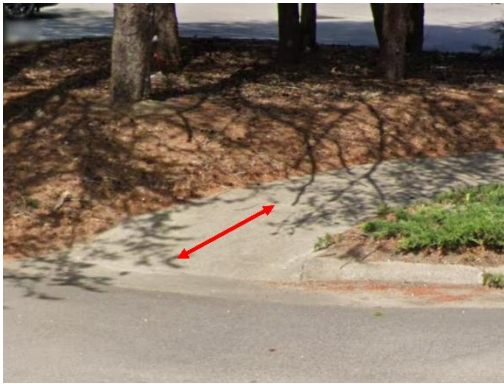
Run Slope, as depicted by arrow

- The quantity of run slopes collected does not correlate directly to the number of ramp locations collected, as ramp systems can be comprised of multiple ramp runs.
- 20.2% of the run slope issues fall in the 8.34-10% range and many of these falls to just above the 8.3% maximum allowable standard. This is considered a less severe violation unless additional compliance issues are present.
- 45.5% of all curb ramps had run slope issues

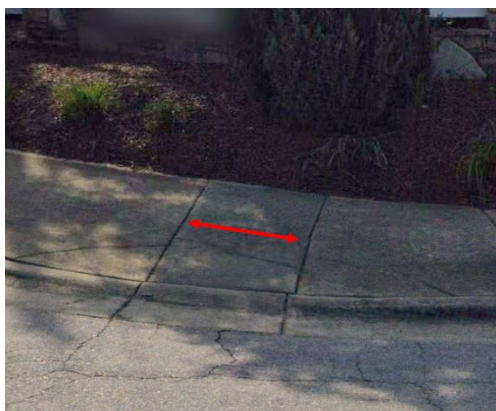
Cross Slope, as depicted by arrow

- The quantity of cross slopes collected does not correlate directly to the number of ramp locations collected, as ramp systems can be comprised of multiple ramp runs.
- 17.4% of Curb Ramps met cross slope requirements.
- 15,767 of Curb Ramps had cross slope issues. Of these, 20.4% fell into a 2-3% cross slope range, generally considered less severe than higher ranges.

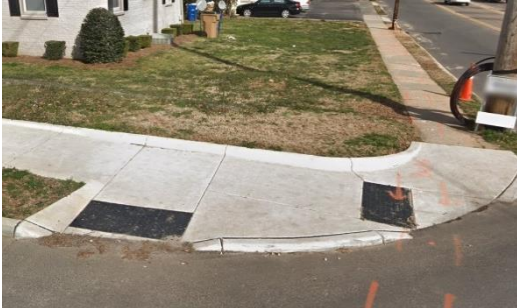
**Curb Ramp Detectable Warning**

- DWS falling in the non-compliant count were most often due to the DWS not extending for the full width of the ramp

\*Of the 18,028 which failed at the Early Validation Approach, the ramps failed due to other non-compliant ramp components, and there is most often some degree of reconstruction necessary. For these ramps, any DWS concern will be addressed when the ramp is corrected for compliance.

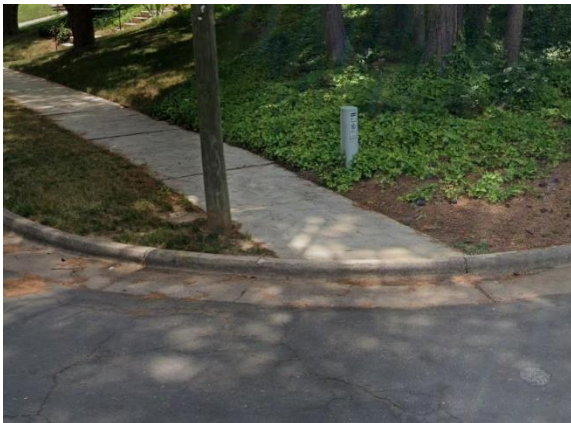
**Missing Curb Ramp**

- Missing Curb Ramps are ramps that are not present in locations where they are required.
- T-Intersections can sometimes be the cause of a report of missing curb ramps. These locations most often must be reviewed closely by the City to determine if an alternate approach can be taken to rectify the concern.

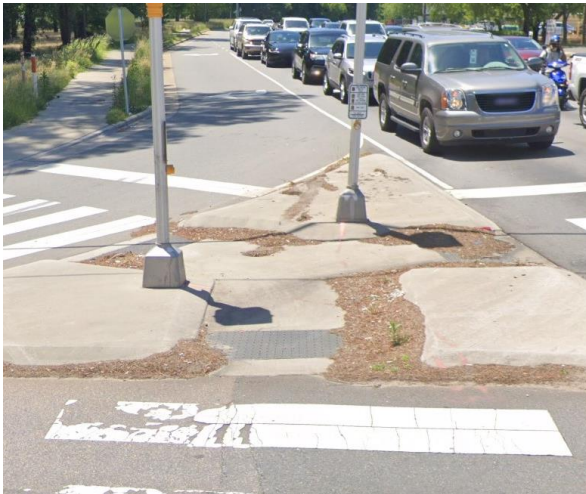
**Refuge Island Ramps with Non-Compliant  
Run Slopes**

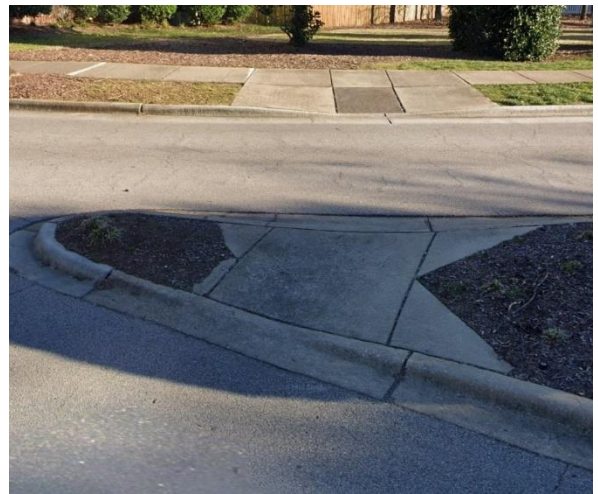
**Refuge Island Ramps with Non-Compliant  
Width**
