## 105-18-CA

### 536 E JONES STREET

Nature of Project:  
Replace two front doors,  
one second floor balcony  
door (after-the-fact); alter  
second floor balcony railing

## APPLICATION FOR A CERTIFICATE OF APPROPRIATENESS – STAFF REPORT

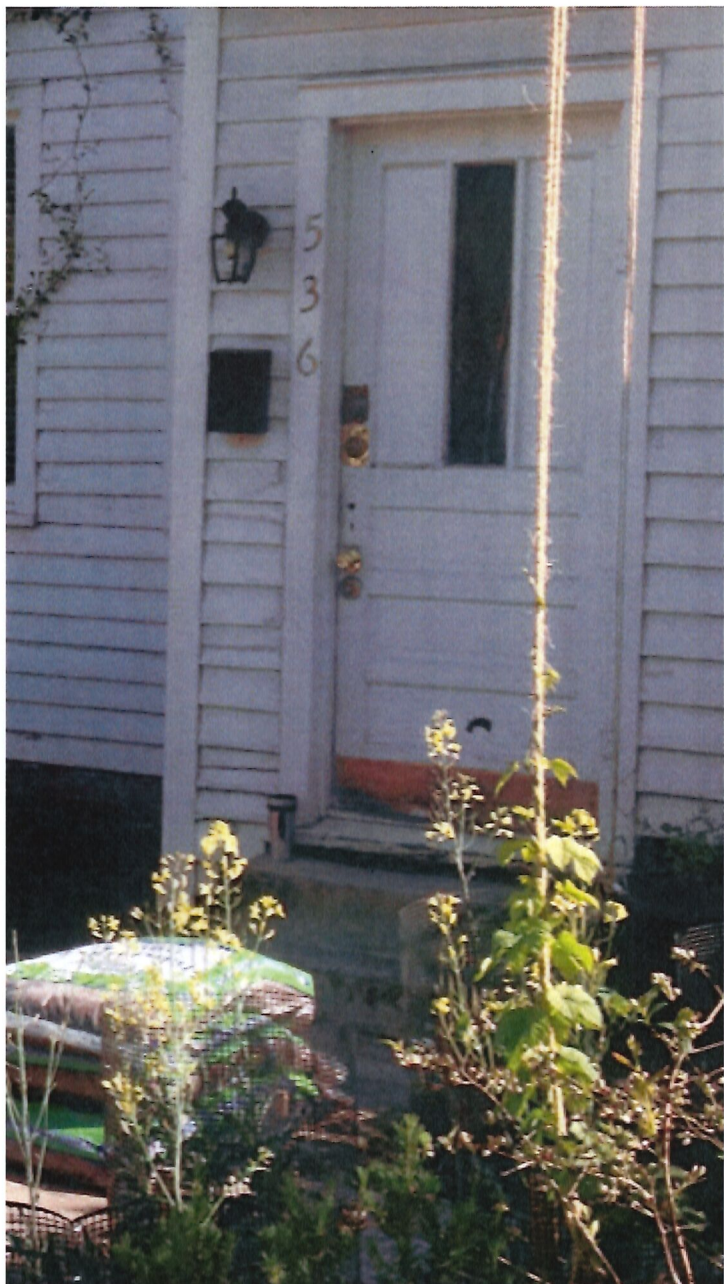
The right front door, in addition to missing all 3 panes of glass, 2 filled in with plywood and a 3<sup>rd</sup> with chicken wire and plexiglass, has had 5 holes for doorknobs and deadbolts drilled into it. It had also been kicked in several times it appears and was missing large chunks from the center edge of the door where the original doorknob had been and also the bottom hinge side of the door. A fracture ran the over half the length of the door just to the center side of the (5) doorknobs/ locks. The bottom, which has cracks on both the doorknob and hinge side, was held together with the support of an additional piece of wood bracing attached at some point.

Original condition front right door (evidence of original blue is visible at bottom)

The replacement front bottom doors, both left and right, have 9 short panes, filling the same space, as the 3 long panes of the originals. The reason for the slight difference is that identical doors were not technically feasible. After a search of numerous vendors in the area, the design is not available. An exact replication would have to be specially designed and built, at a cost several thousand dollars more than the very similar replacements that were commercially available.

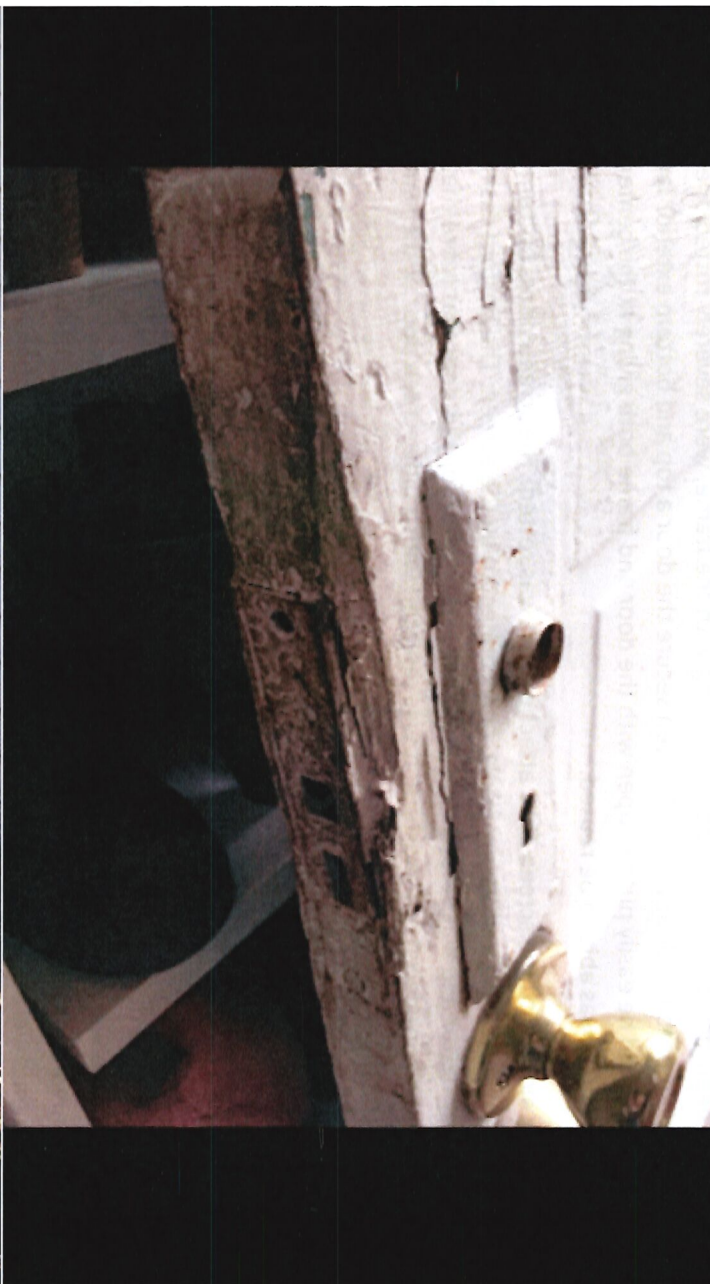
Detail of right front door (outside)

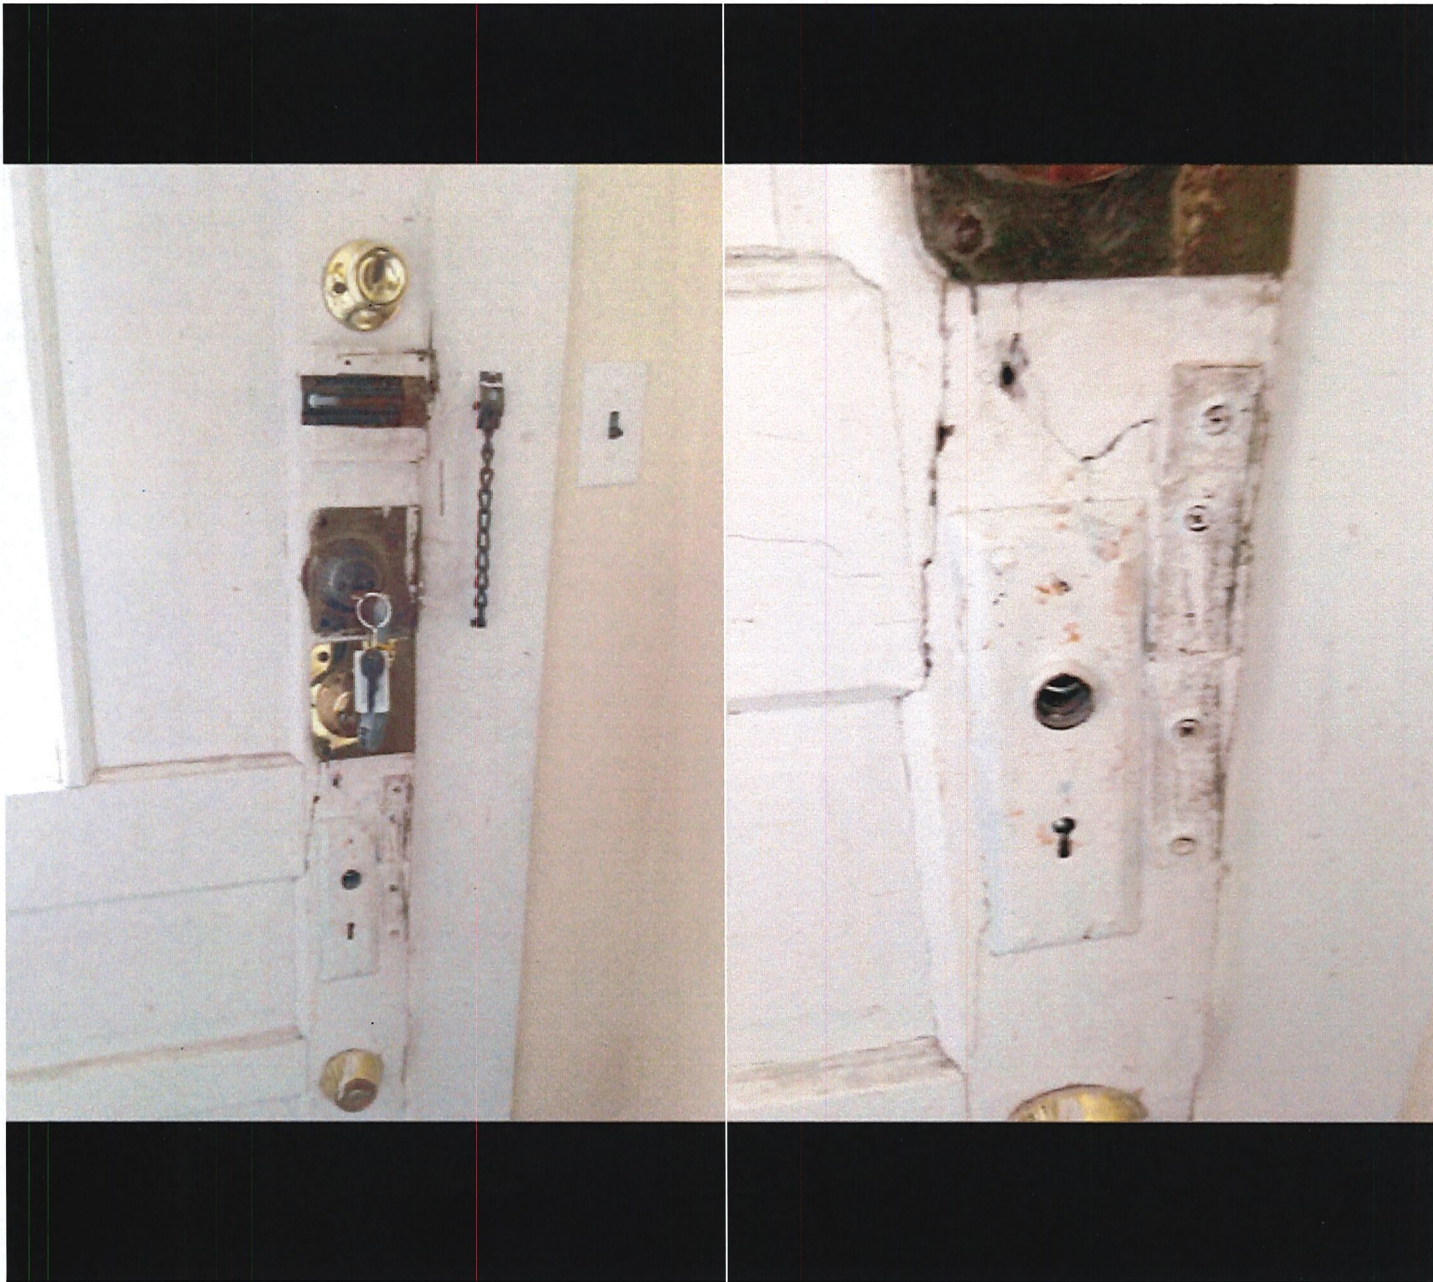
Interior right front door (shows full length split, metal bracing, and 5 separate holes for locks and knobs)

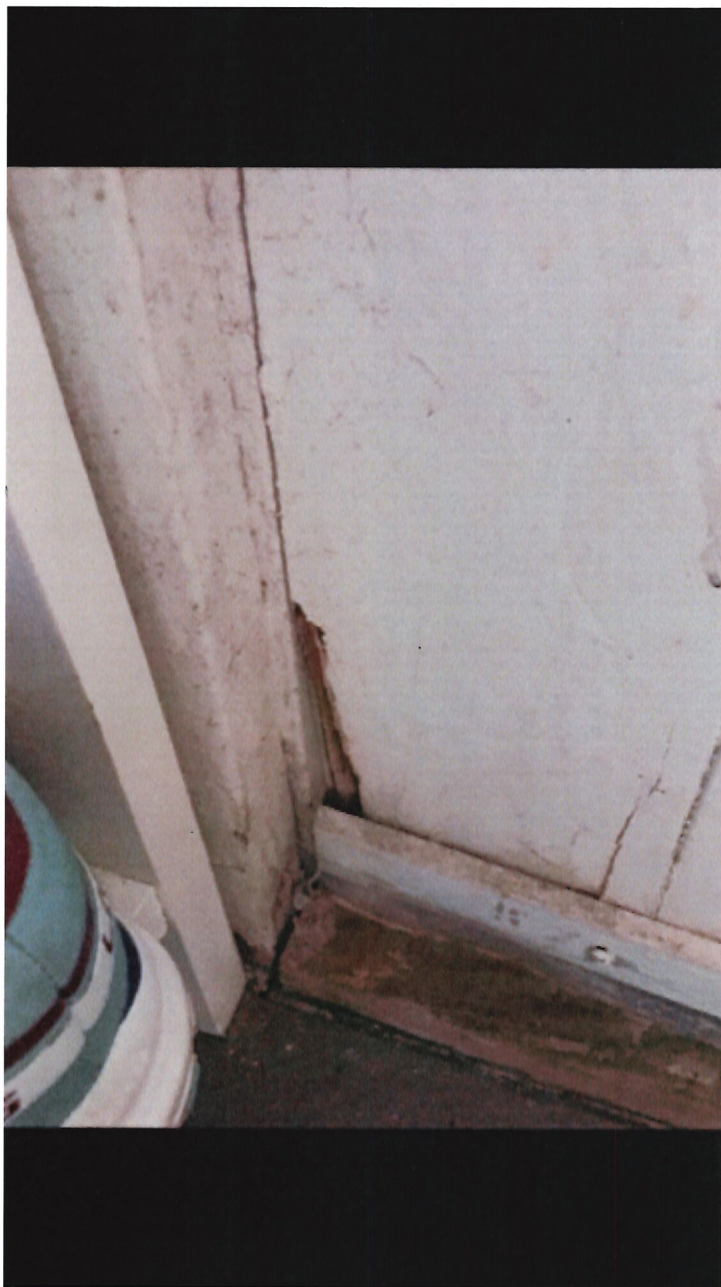
**Large chunk missing from inside front right door. Also shows more cracking and extra wooden bracing applied to help keep the door together.**

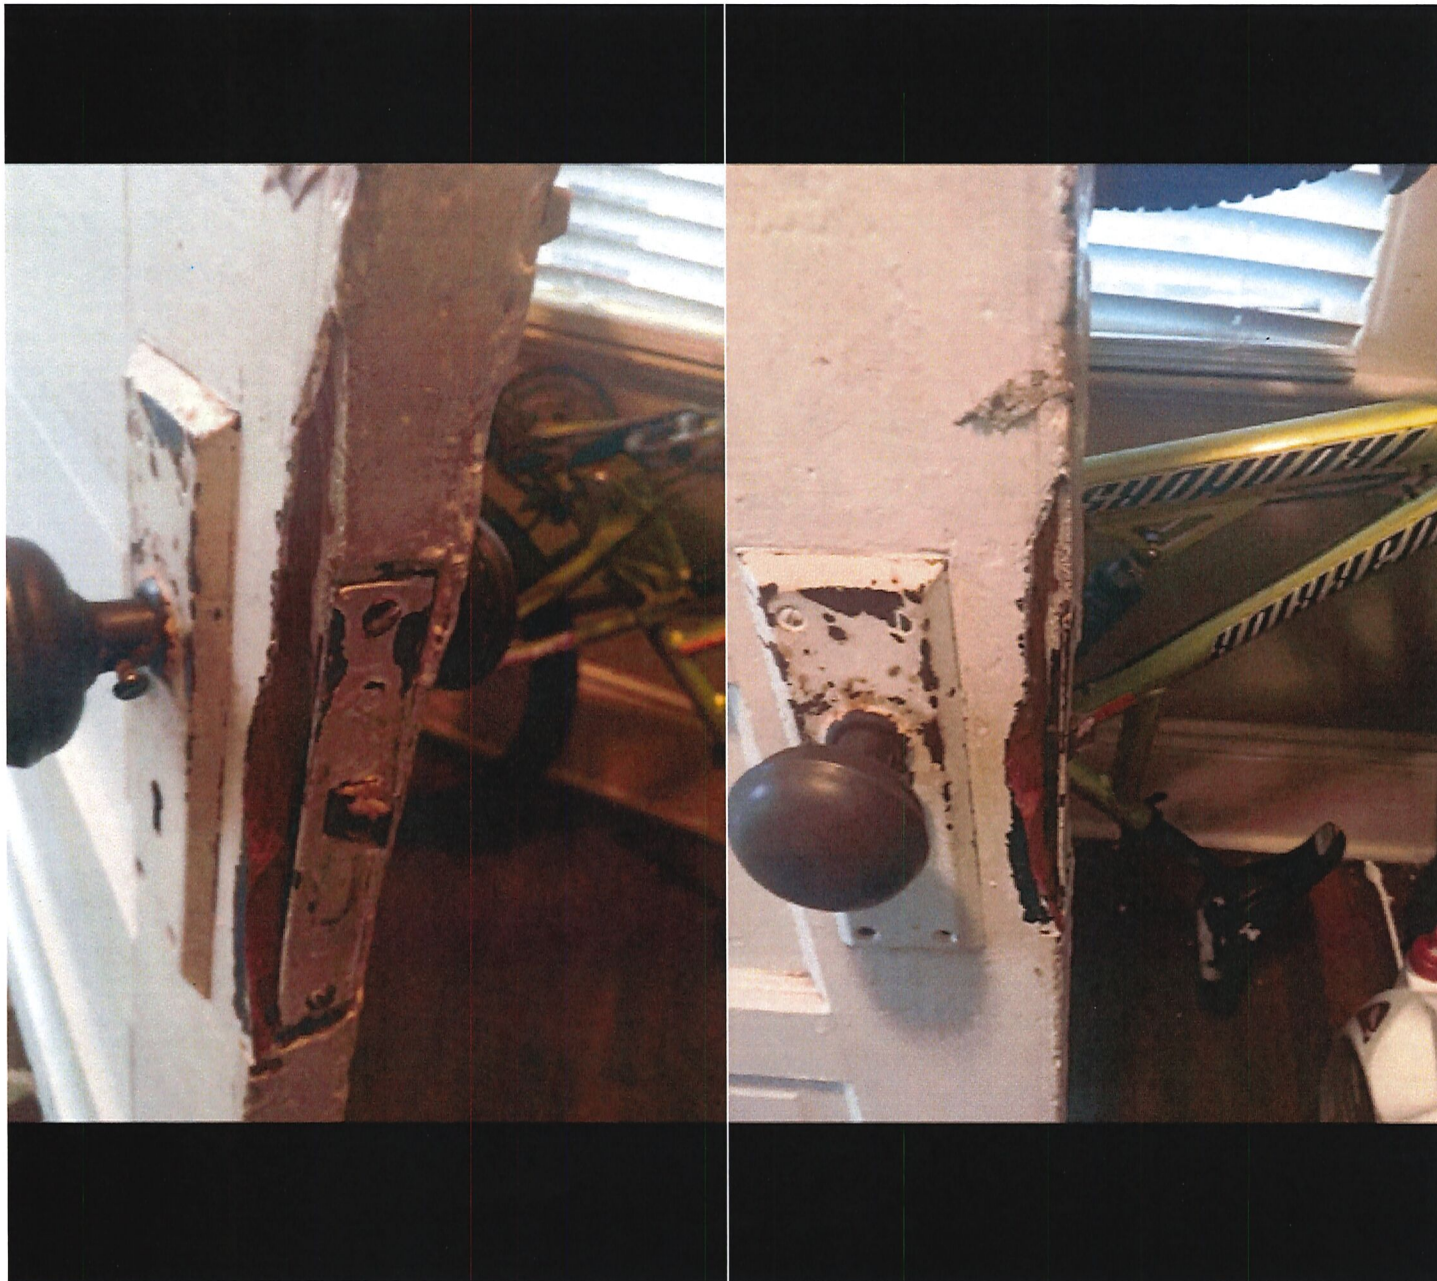
The left front door had similarly been kicked in at some point, and required metal bracing to allow the door to properly secure the building. Large chunks were missing (as evidenced in the photos) at critical points along the center doorknob edge. Repair was not feasible. The screen door associated with this entryway was able to be reused. It was only given a new coat of white paint (same as before)

Front left door detail. Shows significant pieces missing from (what appears to be) forced open at some point.

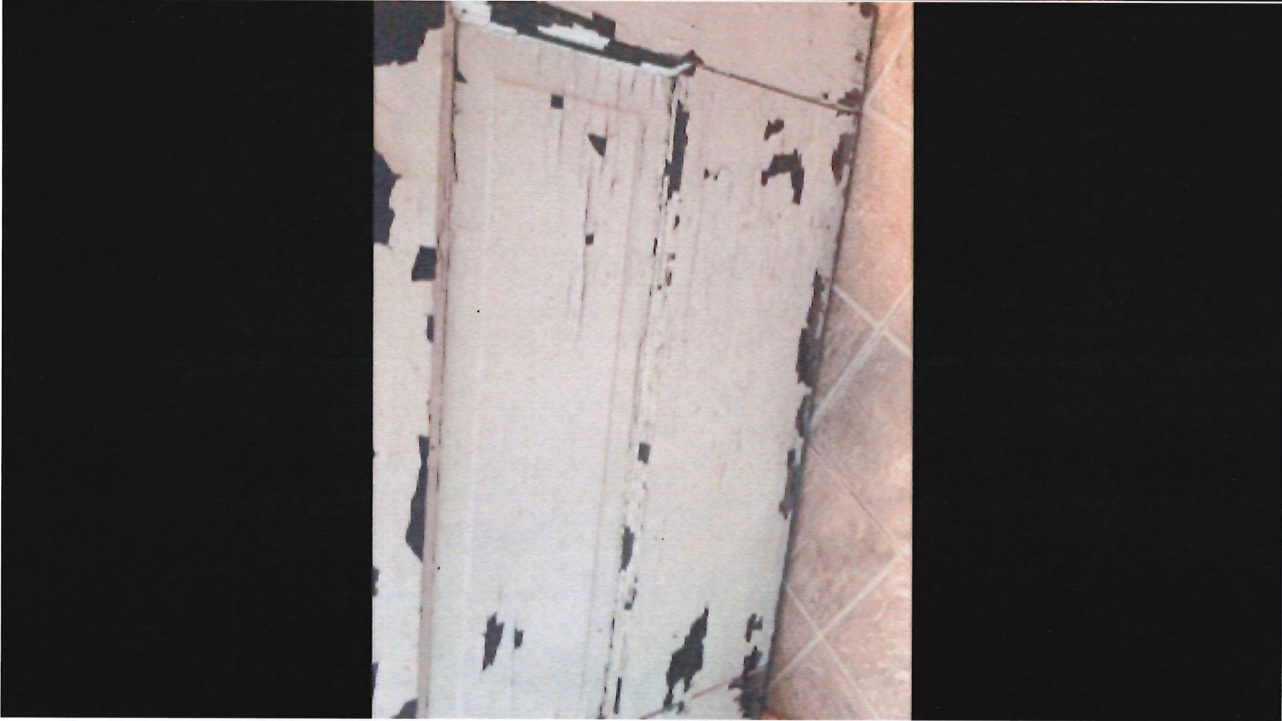
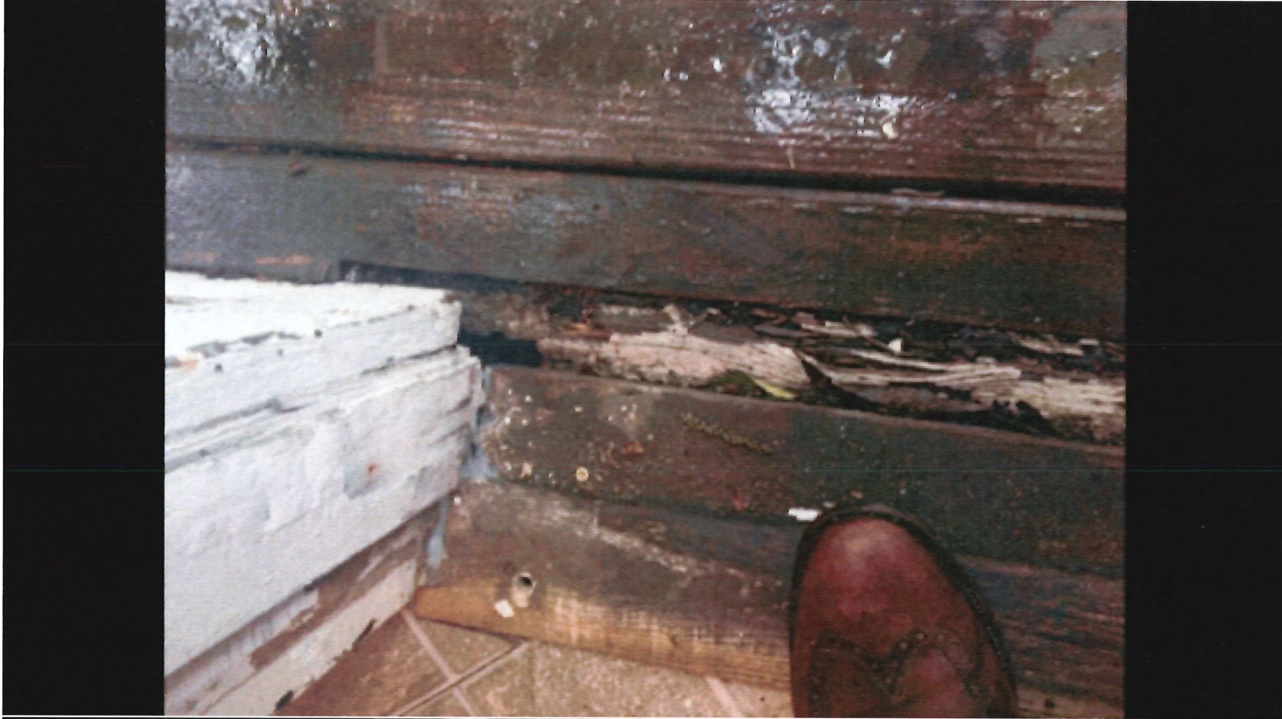
The rear door had also been kicked in at some point. It, along with the frame, were severely rotted due to a 2<sup>nd</sup> story AC that had historically leaked onto the door below. To even secure the door a top and bottom exterior latch was required. Without these, the door could be easily pushed open with the door and frame both giving at the center. The screen door associated with this entryway was able to be reused.

Rear door, and framing. Framing is representative of the deterioration of the bottom of the door. Both were soft to the touch

The balcony door and rear door have 15 panes (F). This difference was decided based on two factors.

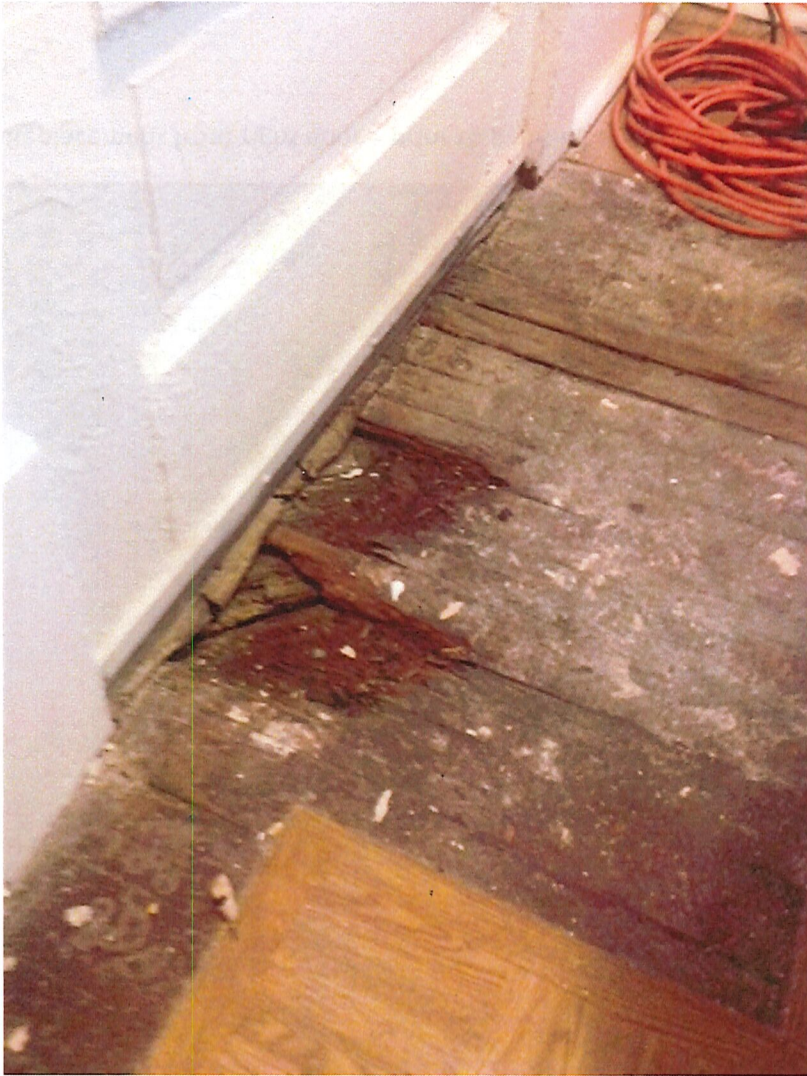
The front balcony door, along with the screen door attached to it was rotted. The screen doors bottom casing had detached from the rest of the casing and swung freely, only connected by the screen. The bottom casing of the primary door was only marginally better and was soft to the touch. The screen door for this door was more than beyond repair and really could have been considered non-existent. It was replaced with a pine screen door of the same design. It was also painted white, as was the original.

I'd previously repainted the balcony door, and did my best to hide the damage, but the flooring is a good indicator of the damage to the door.

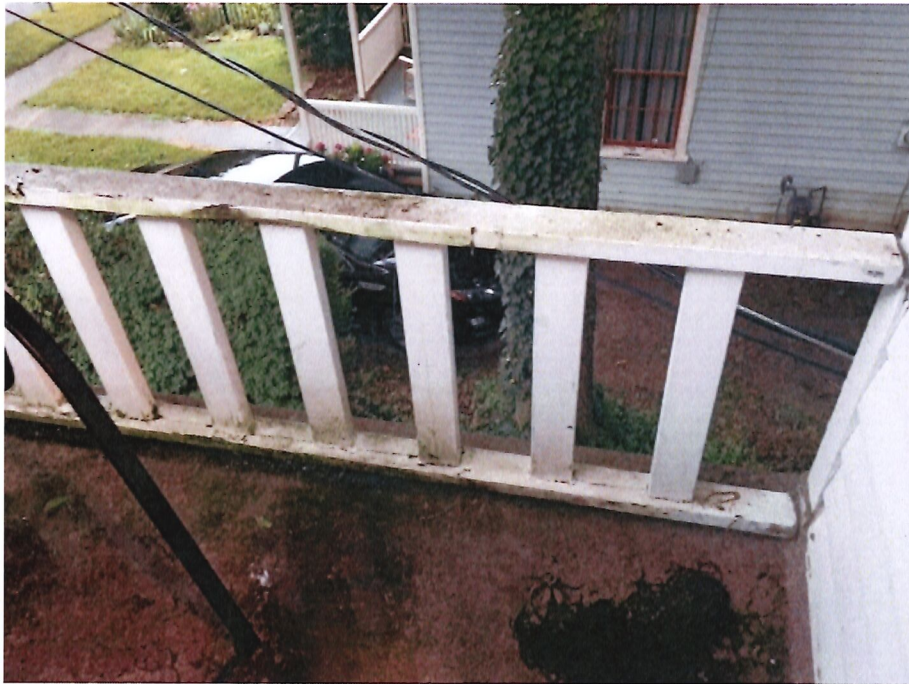
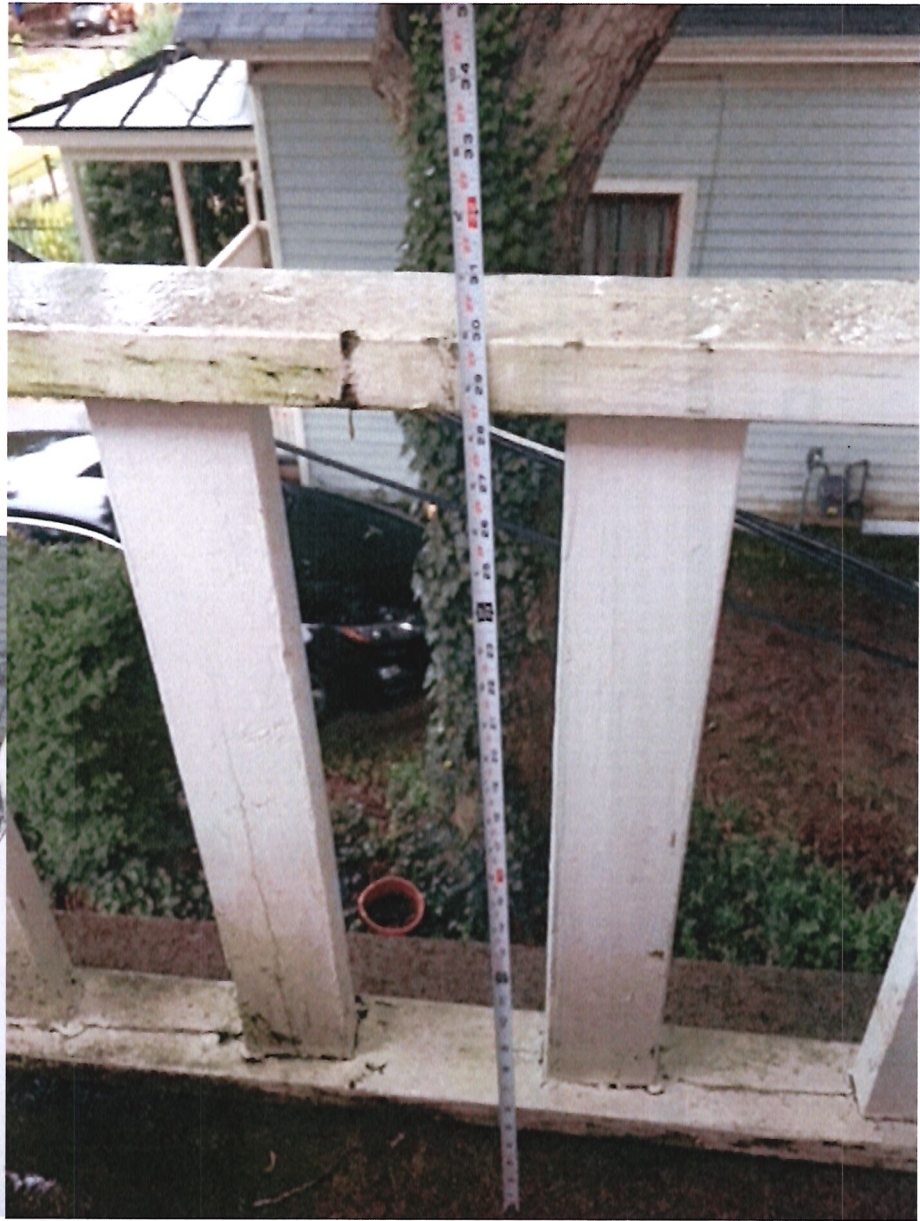
**Project 2 - Replace balcony railing.** Current balcony is attached via two nails at each of the two corners (A), is unable to support any load, and does not meet the International Building Code ('IBC'). As shown below, the railing measures 30" high, and has spaces greater than 6" between the balusters. IRC requires 36" high railings and spaces no greater than 4". In addition to not meeting code, the railing simply feels unsafe. I'm also getting a small dog shortly and the current railing would preclude allowing the dog onto the balcony. The eventual plan is to rent the house, the balcony as it is currently is a liability. Finally, the proposed plan is identical to numerous homes in Oakwood, including the next door neighbors and across the street (both pictured below).

Height of balcony railing. 6" below IRC requirements

My proposal is to replace the current railing with a 36" tall railing made of 2x2's spaced 3" apart, and a 2x4 along the top edge, and a 1x2 running below the 2x4 along the top edge. This will meet code, match the lower porch railing, and be identical to countless railings found throughout Oakwood. The replacement would be painted white, matching the current color scheme.

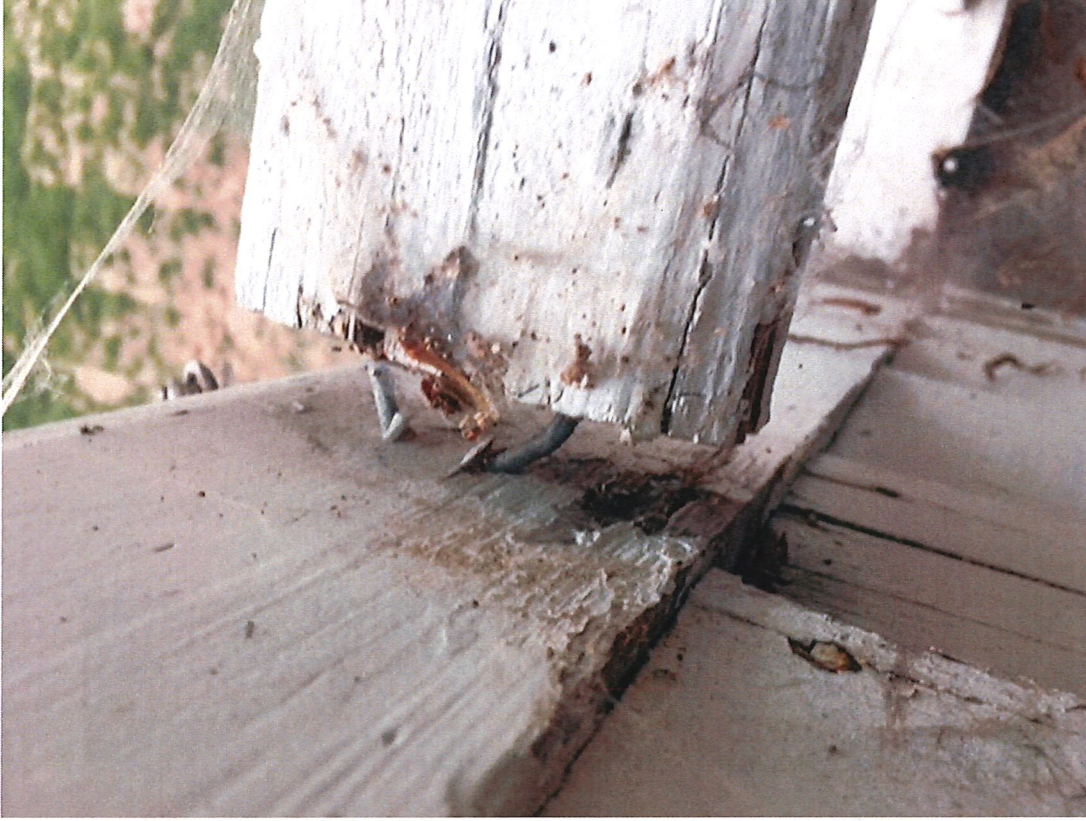
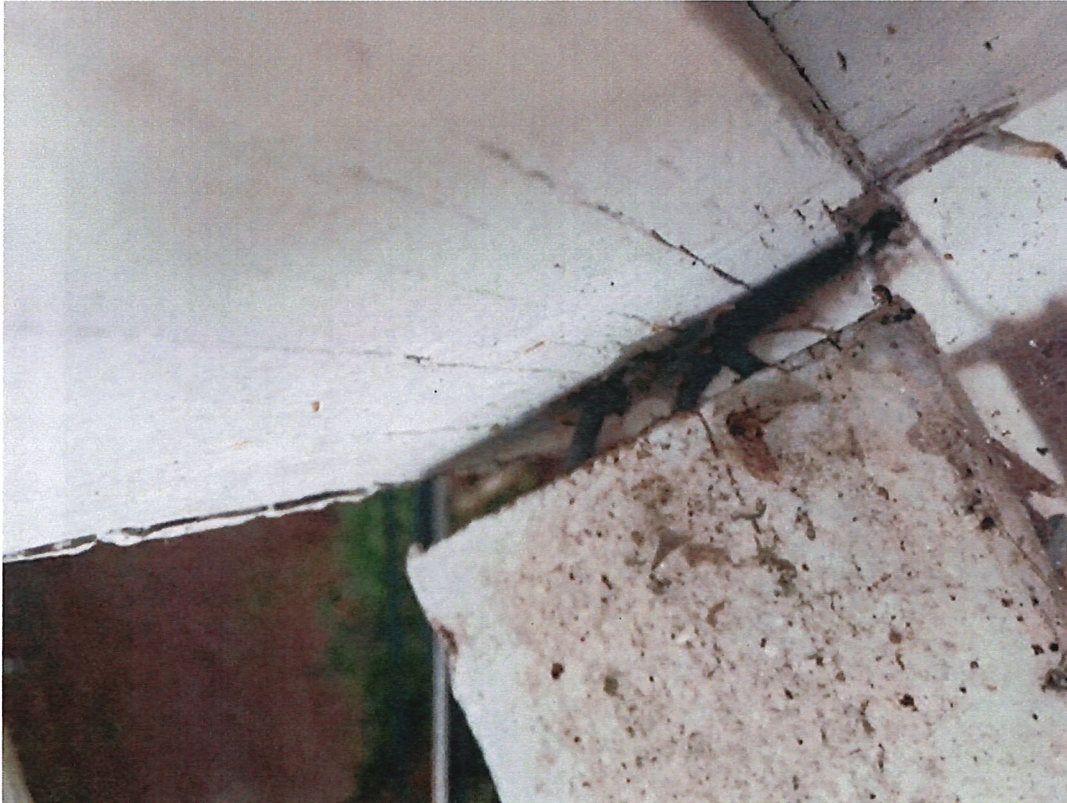
4 nails holding the balcony in place

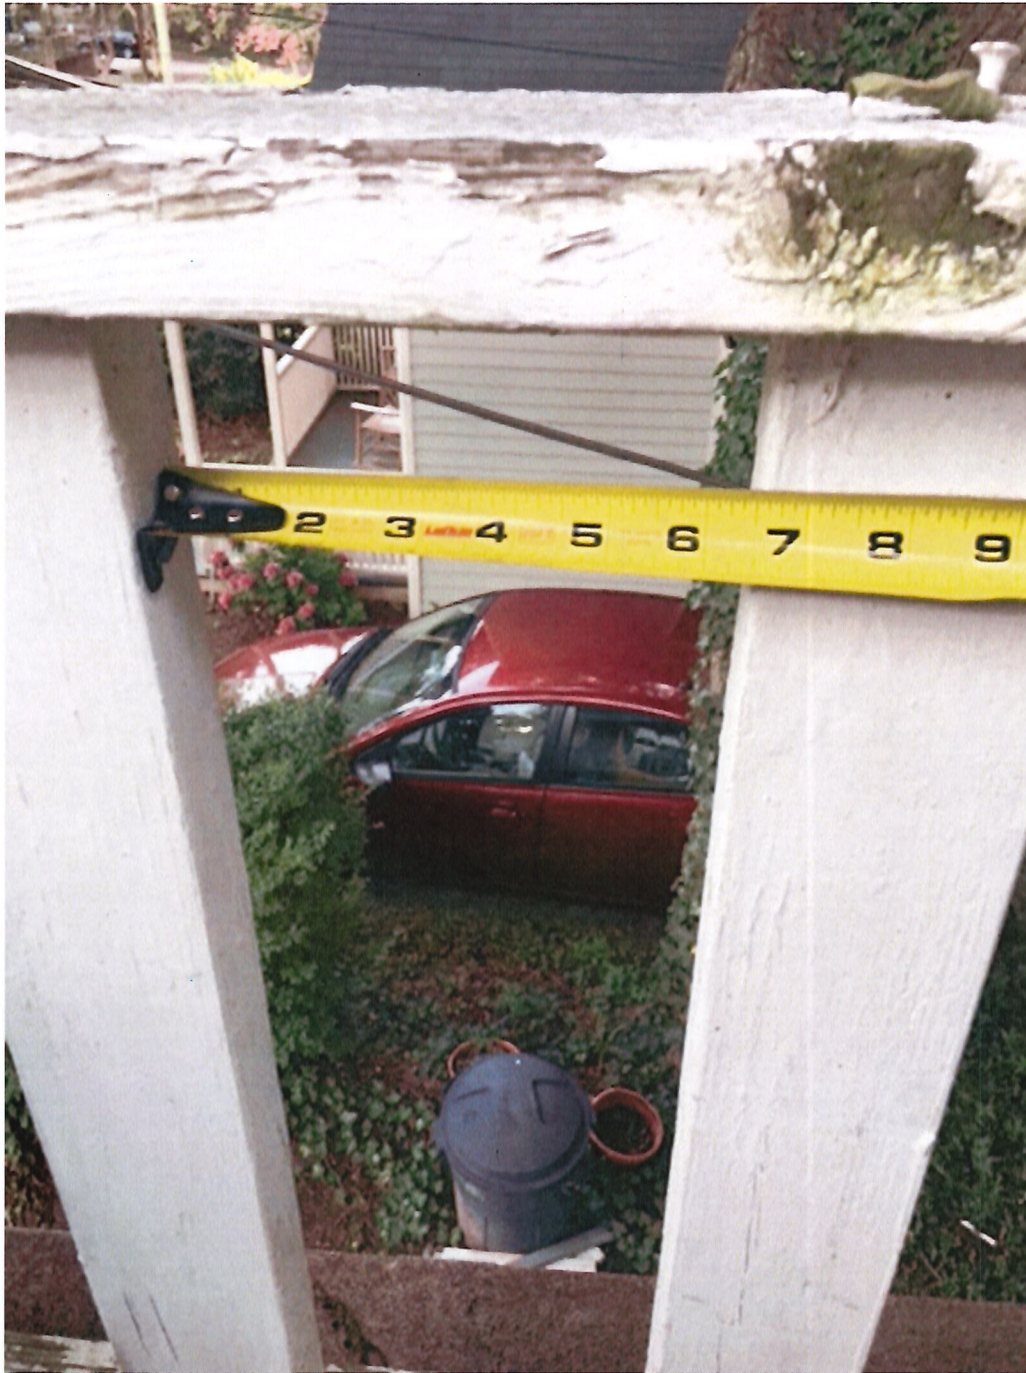
- 2\* The baluster size and spacing on existing balcony railing is atypical in Oakwood and appears to have been added after the mid-1930s.
- 3\* The height of the current balcony is 6" shorter than current safety code requires and, per the applicant, is structurally unsound. Historic architectural details are typically grandfathered and not required to meet code. Historically, railing height ranged between 24-30".

Width of space between balcony balusters.

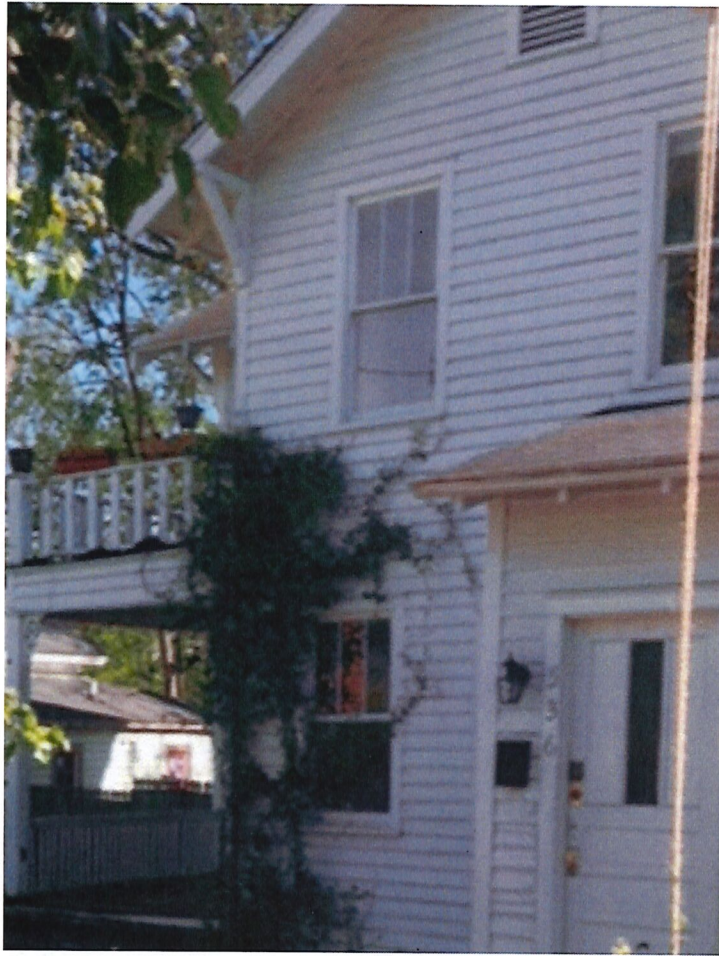
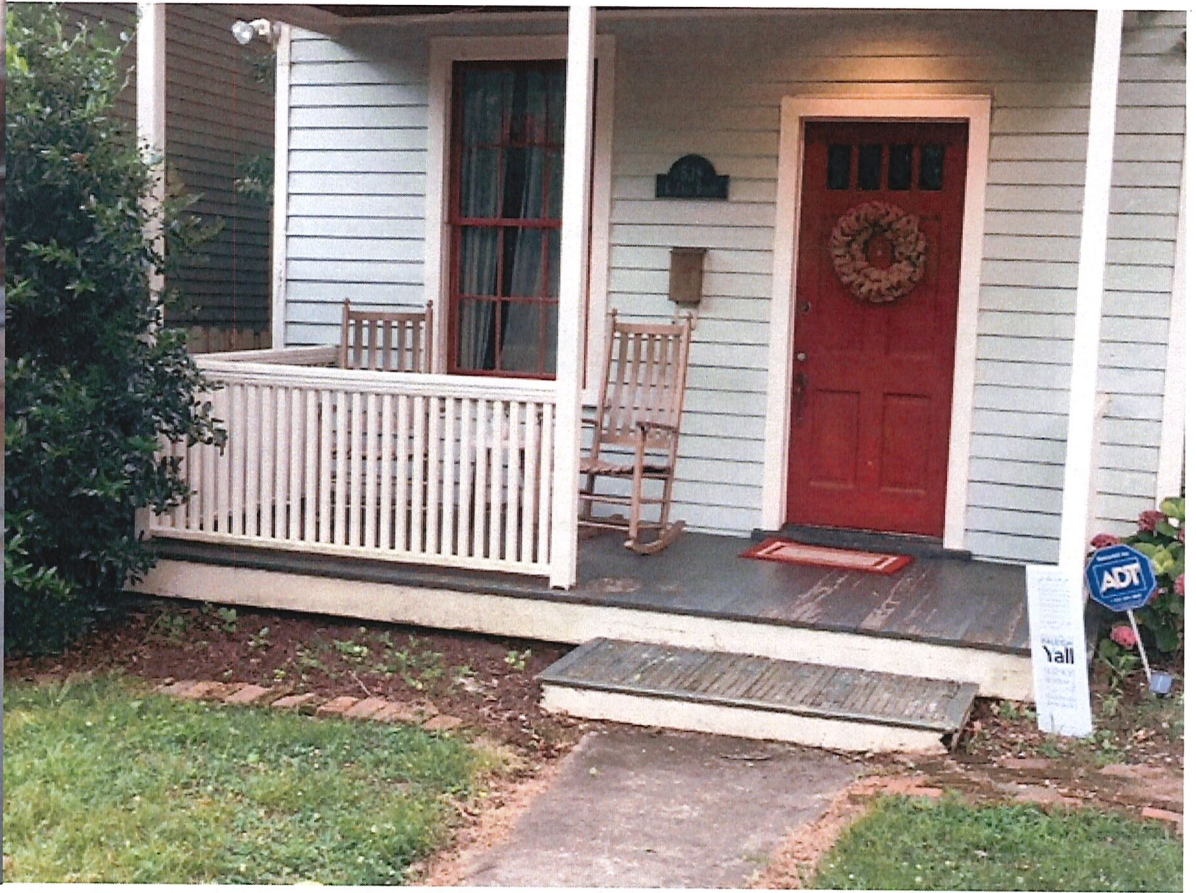
Upper and lower railings do not match. Lower matches many others in neighborhood. Next door neighbor and across the street match lower railing/ proposed upper redesign.
