129-18-CA

412 KINSEY STREET  
BOYLAN HEIGHTS  
HISTORIC DISTRICT (HOD-G)

## APPLICATION FOR A CERTIFICATE OF APPROPRIATENESS – STAFF REPORT

Nature of Project: Implement master landscape plan; install fence; alter driveway; remove trees

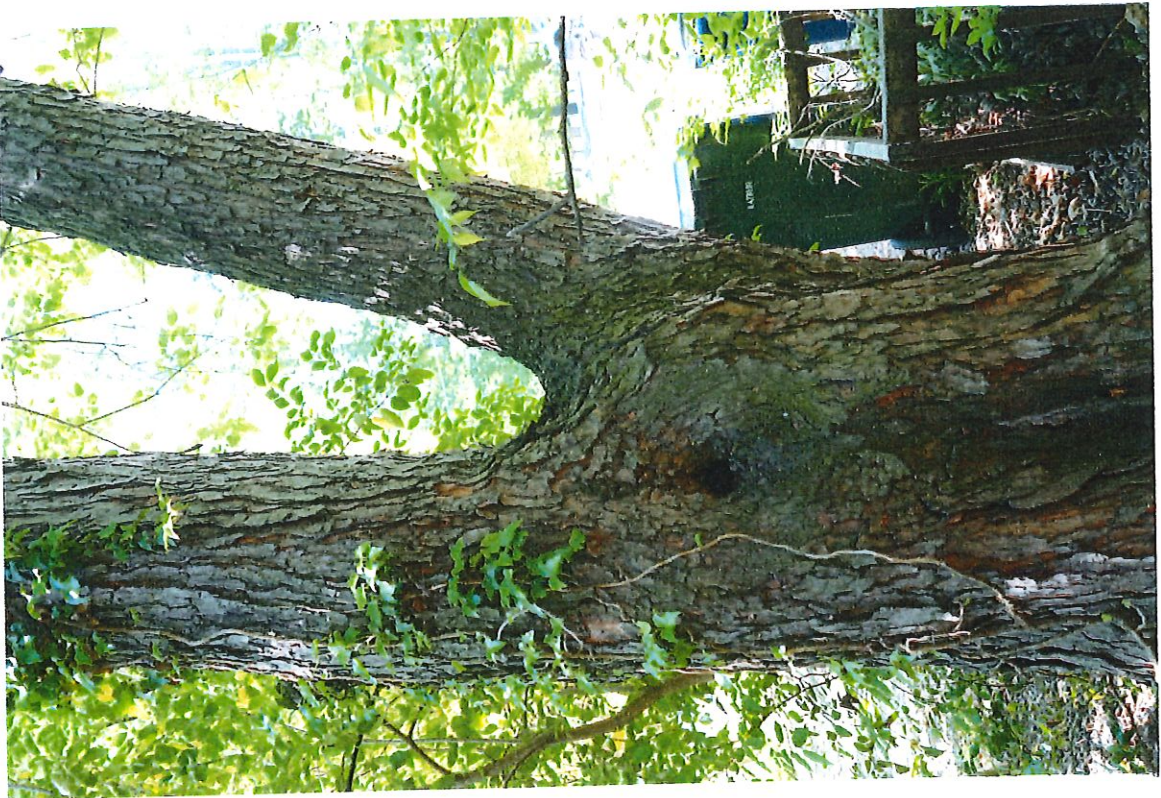
THIS OVERHANG FROM TREES #1 & (2)

Canopy shows evidence of how far under the foundation roots are growing, as upper canopy lower roots

have comparable width & footprint

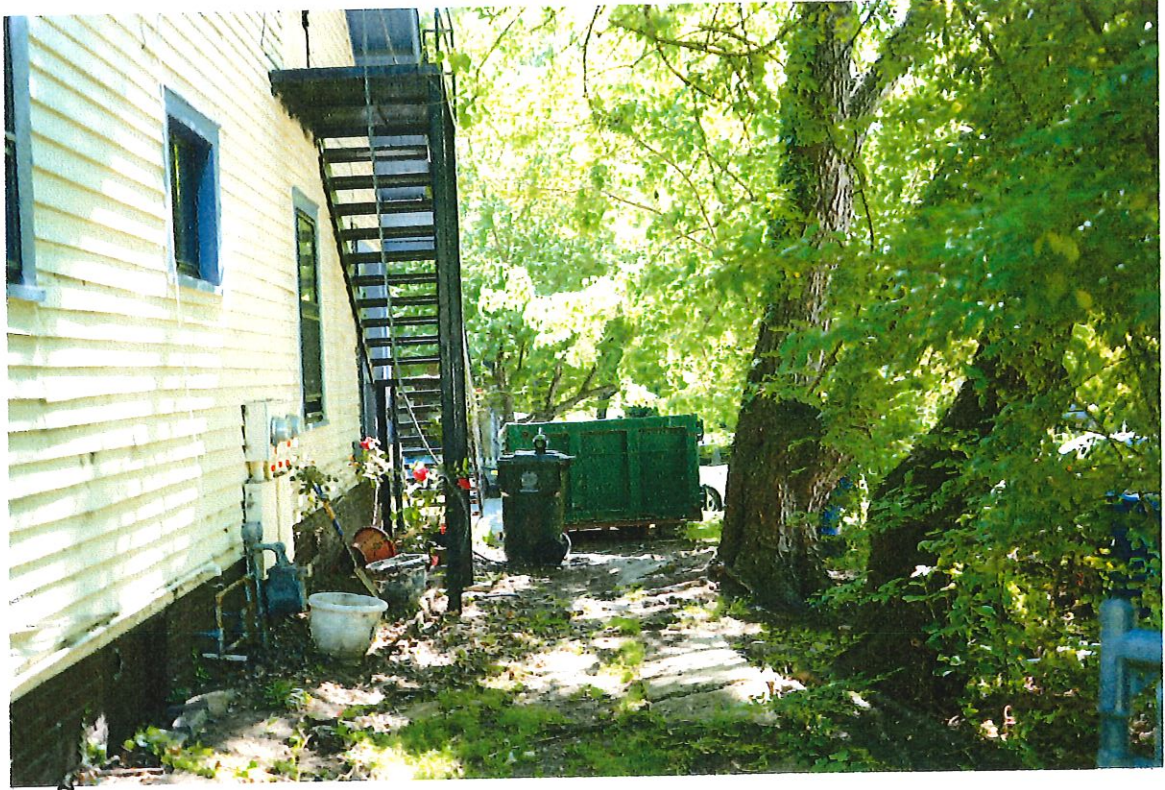
③ Smaller tree leaning toward shed w/ roots  
 damaging shed slab

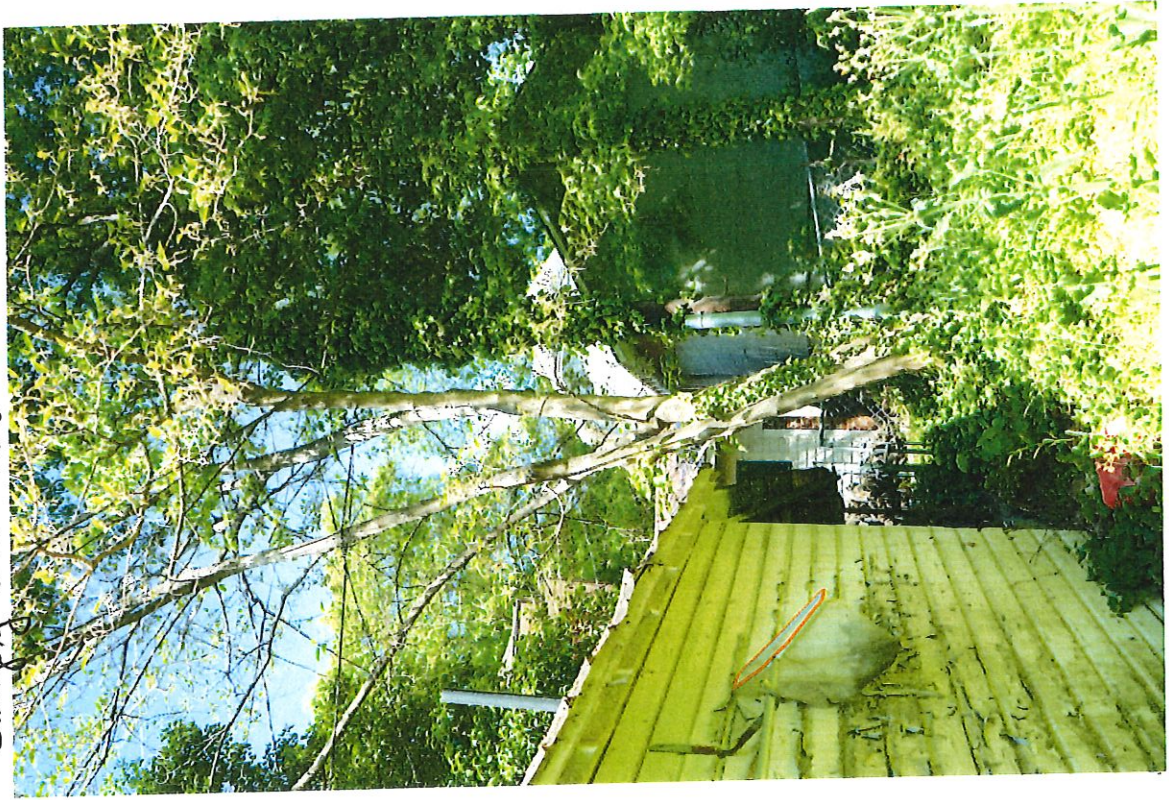
✖ This photo shows the severity of  
 the trunk of #② leaning toward neighboring  
 apt. parking  
 lot. Slighter  
 leaning  
 of tree #①

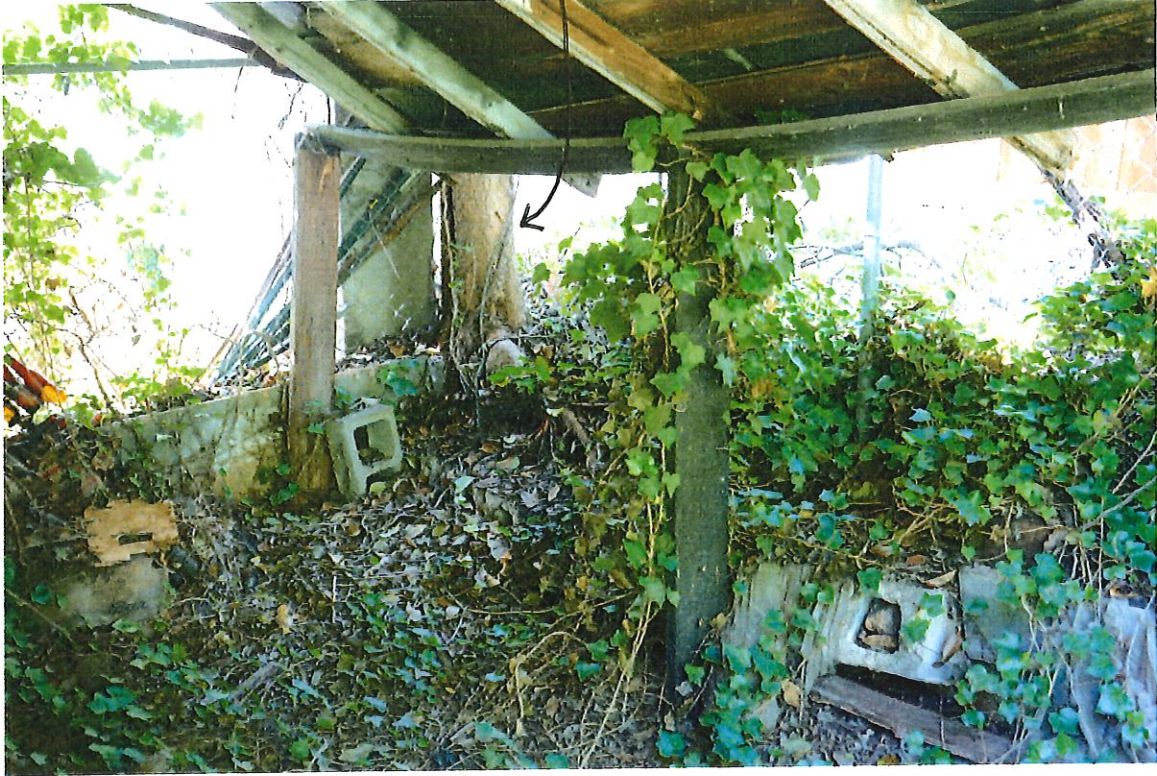
③ tree leaning toward shed & roots interfering with shed slab and foundation

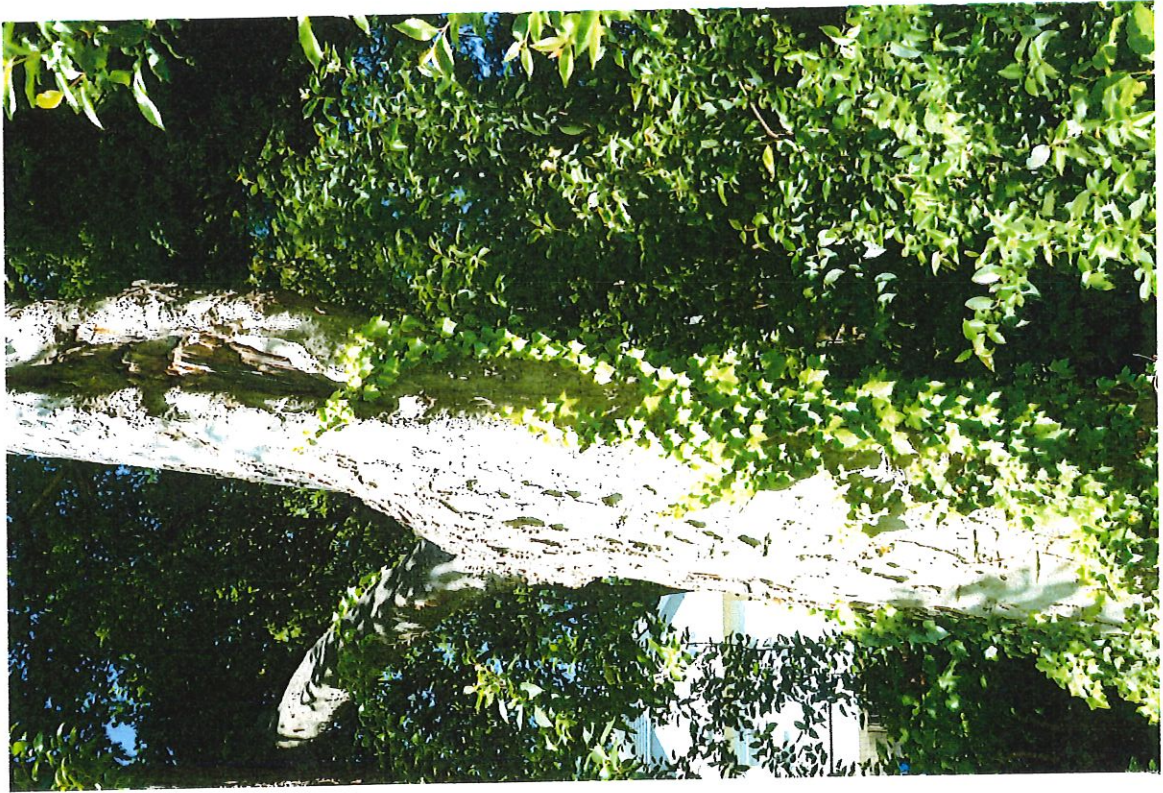
5

area of  
severe damage  
to main trunk

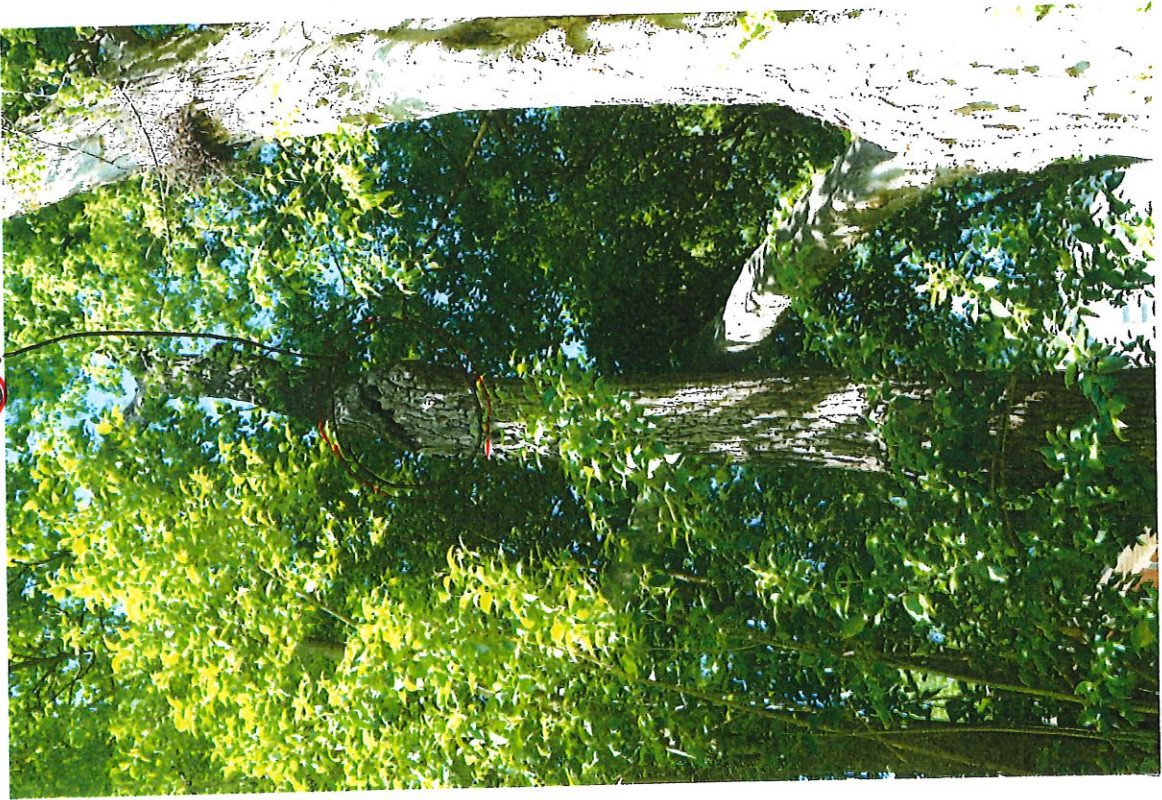
④

severe damage  
to main  
trunk

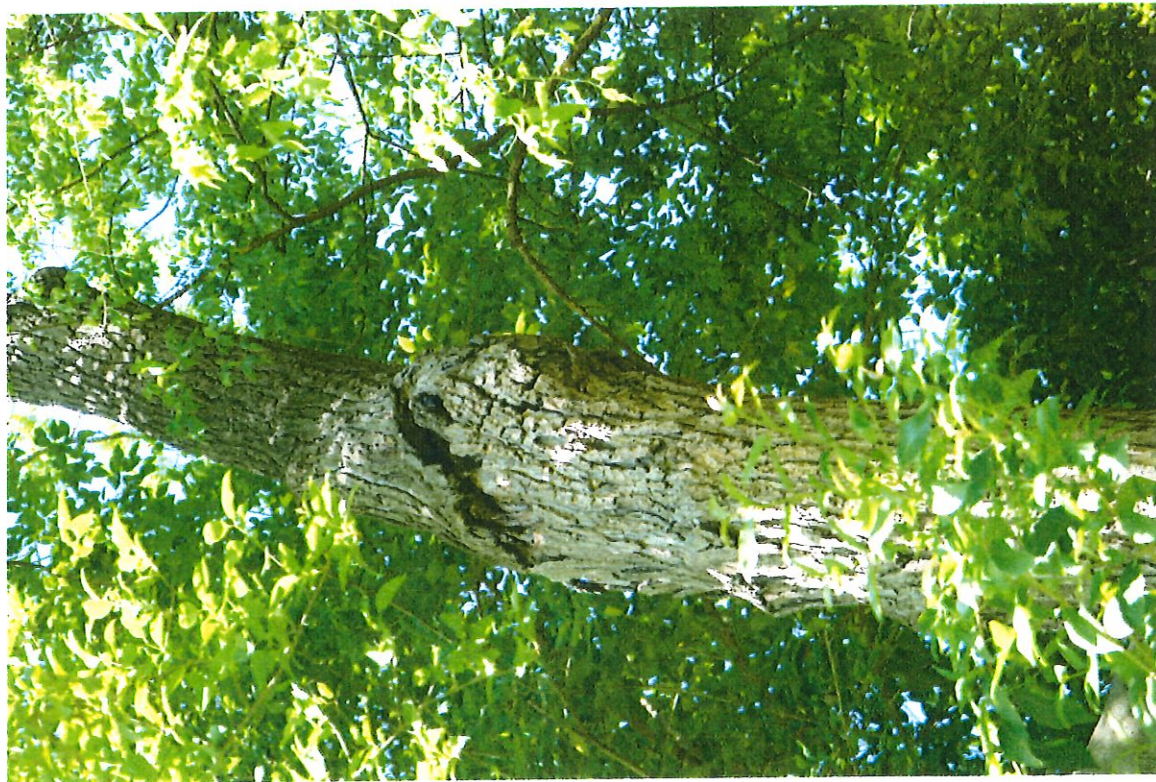
close up to damage  
of main trunk  
(4)

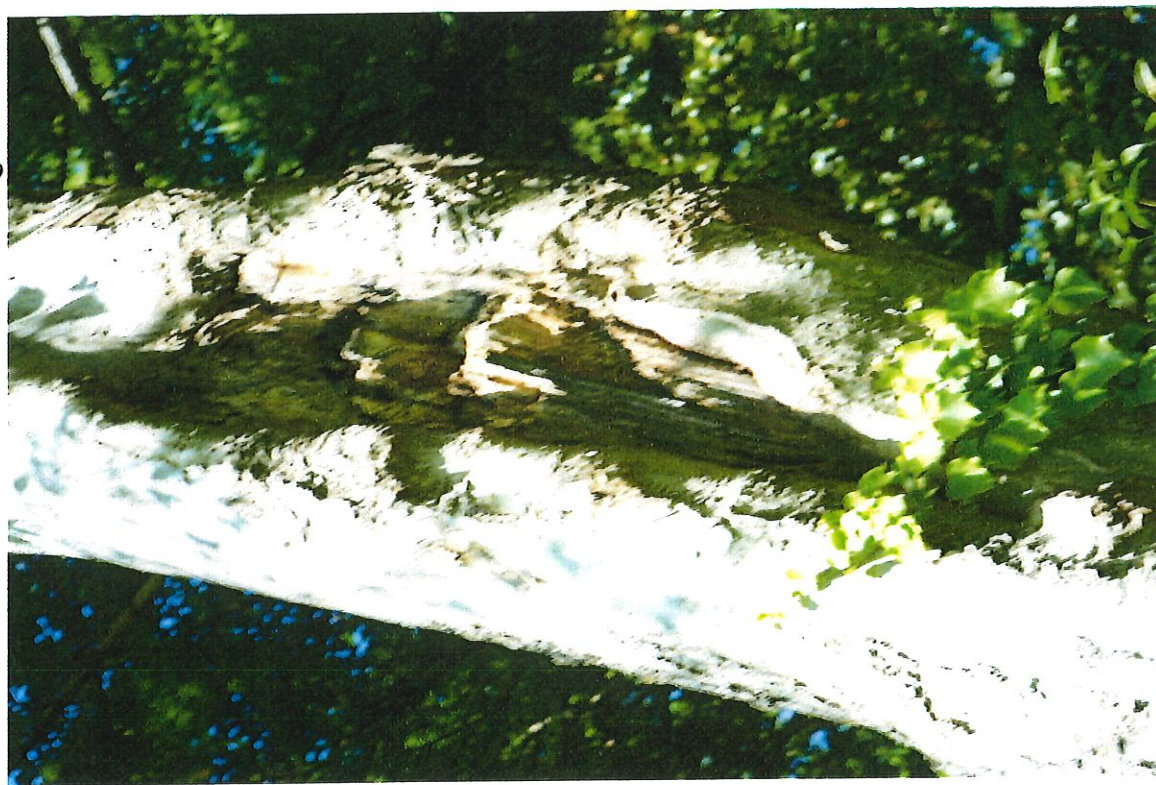
close-up of  
damage to main trunk  
(5)

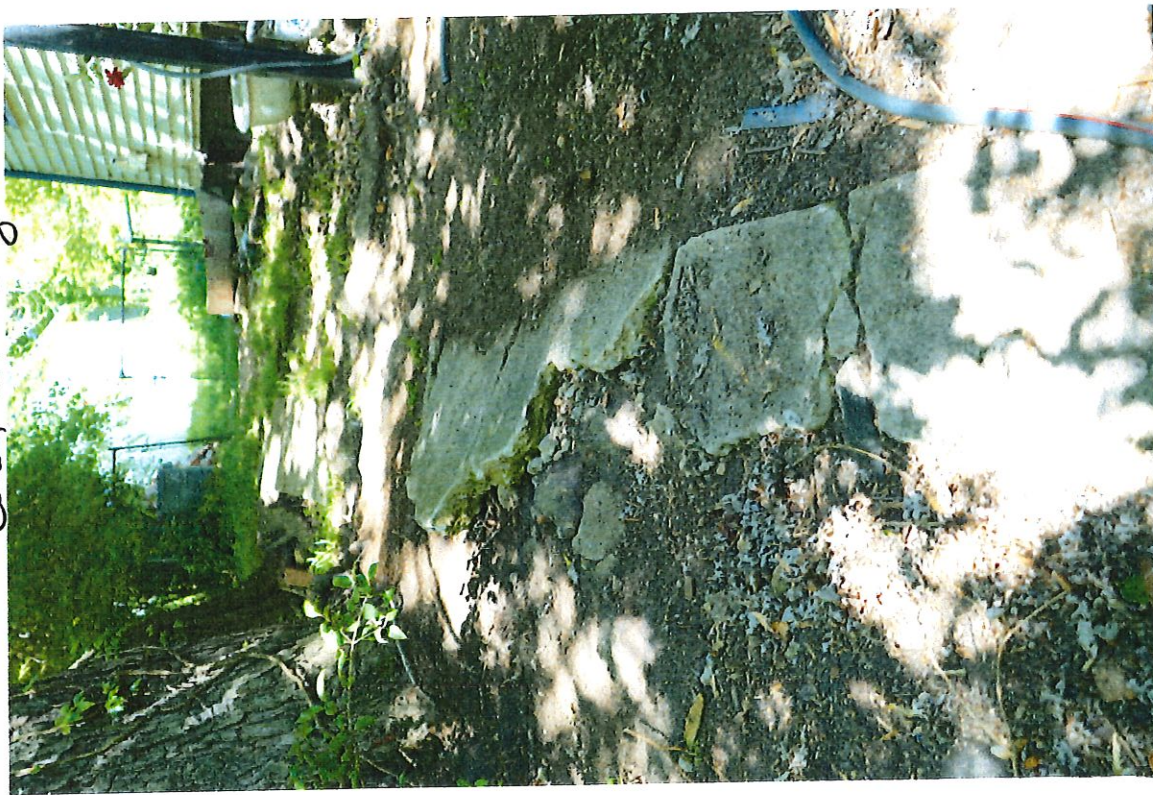
① & ② damage to previous  
concrete driveway ribbon
