APPLICATION FOR A CERTIFICATE OF APPROPRIATENESS – CERTIFIED RECORD

COA-0093-2019 330 E DAVIE STREET

Nature of Project: Remove tree

Attachment to Major Work COA Application: Tree Removal at 330 E. Davie Street

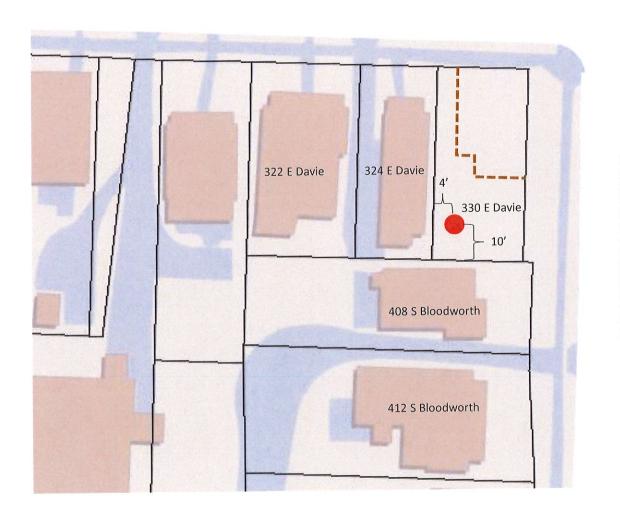
SITE PLAN

White Mulberry (Morus Alba) (approximate location)

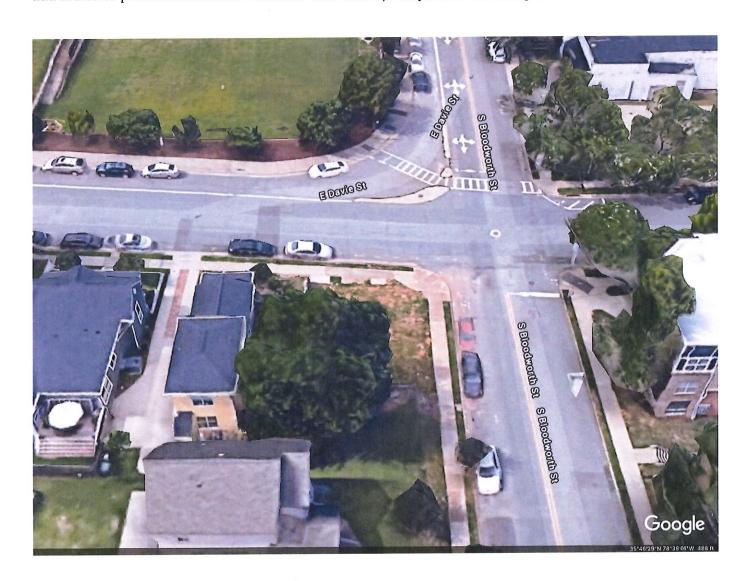
I am presented with a mature, 44" DBH (diameter at breast height) White Mulberry tree growing on the elevated portion of this property close to the fence shared with a neighboring home.

My initial view is of a vigorous tree with a full crown with some large diameter dead wood.

The tree's crown is mainly comprised of advanced re-sprouts from visible large diameter topping cuts to the main scaffold limbs.

This has resulted in an uneven crown distribution of severely crossing, rubbing and conflicting limbs. Several low scaffold limbs facing the street corner are strongly cantilevered and weeping low over the mowed area.

The full integrity of the stem is difficult to assess at this time due to the heavy growth of English Ivy all around.

There is abundant adventitious sprouting low on the stem just above where decay is evident from an old lost, large diameter stem near ground level.

Some buttress root upheaval seems probable on the tension side of the lean closest to the neighboring home.

There are enough factors here to warrant removal even with incomplete information about the condition of the stem of this tree.

remove the Ivy and evaluate for any possible stem flaws/decay, prune the crown to eliminate dead wood, crossing/conflicting limbs, prune cantilevered limbs for weight reduction, eliminate low sprouts and all surrounding weed, tree, bramble growth, add mulch to protect the critical root zone from traffic/compaction and competition.
