# CERTIFICATE OF APPROPRIATENESS PLACARD

Remove dead/diseased/dangerous tree; plant replacement tree

417 Watauga St

# Tree Evaluation Report

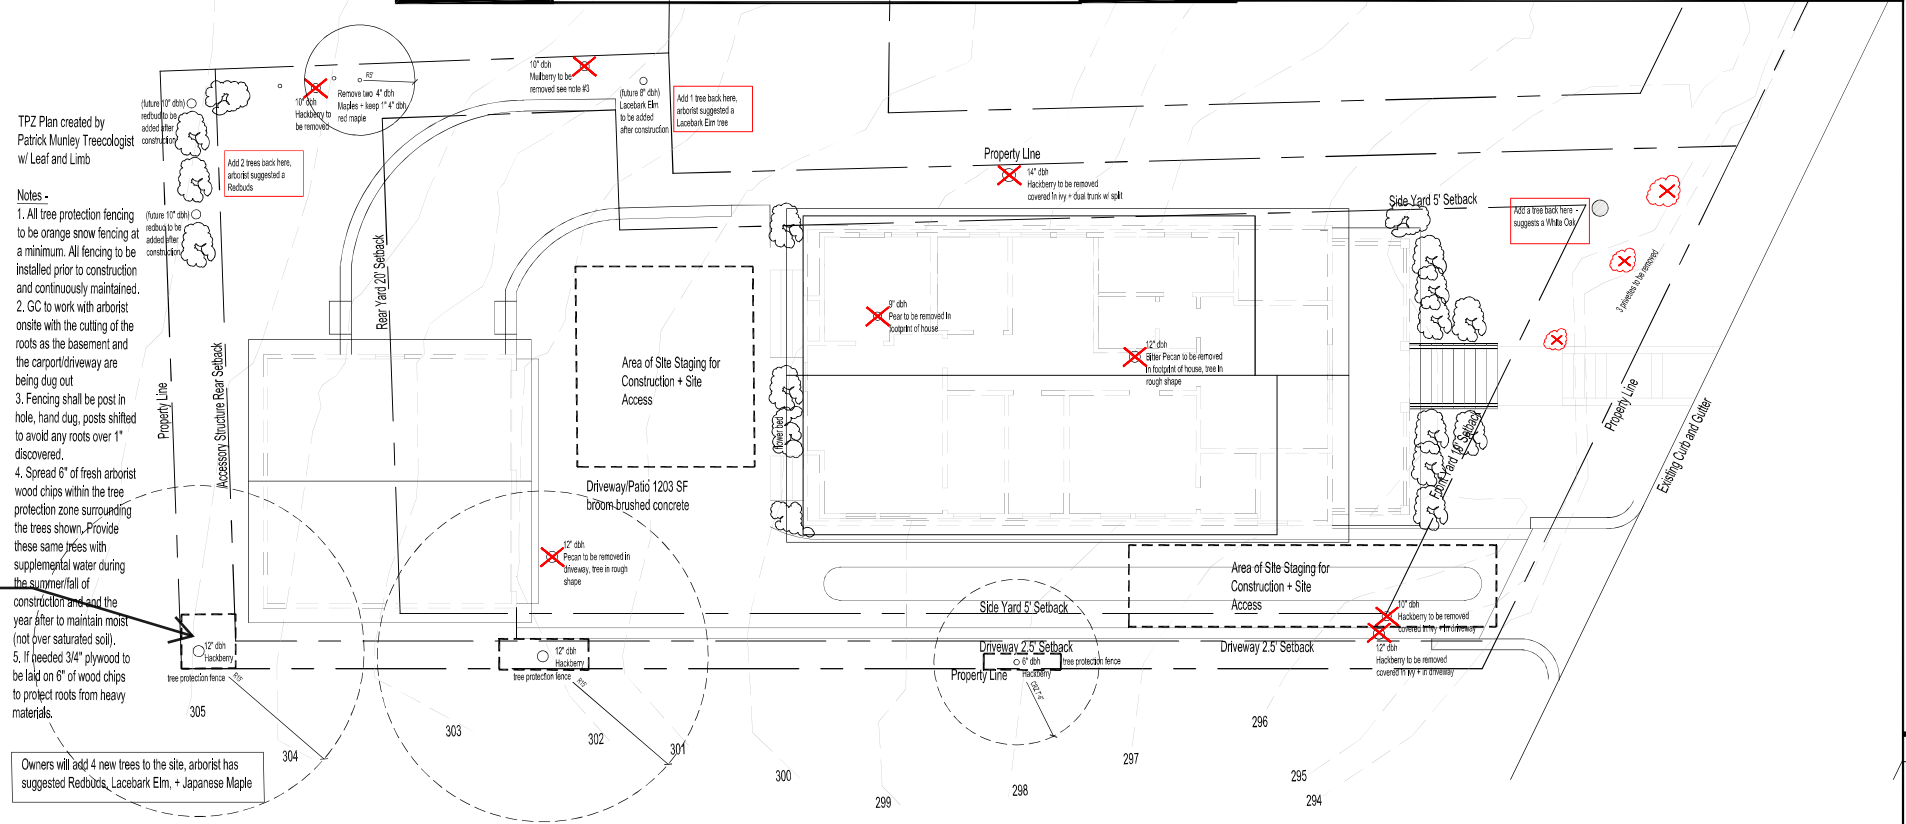
A1.02	1	TREE PROTECTION PLAN SCALE : 1/8" = 1'-0"
-------	---	--

Tree to be removed & replaced with similar mature size tree

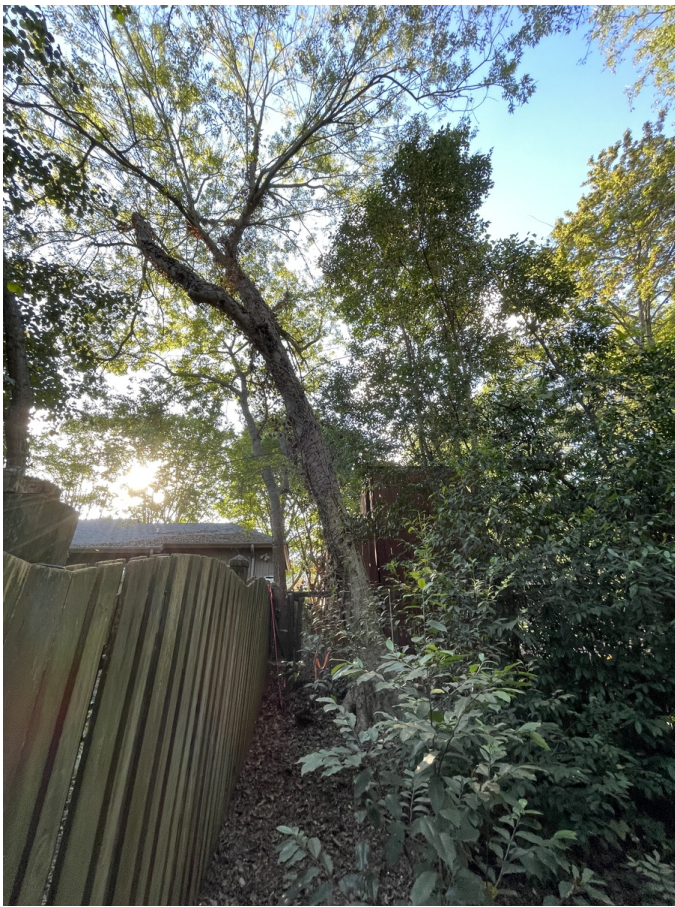
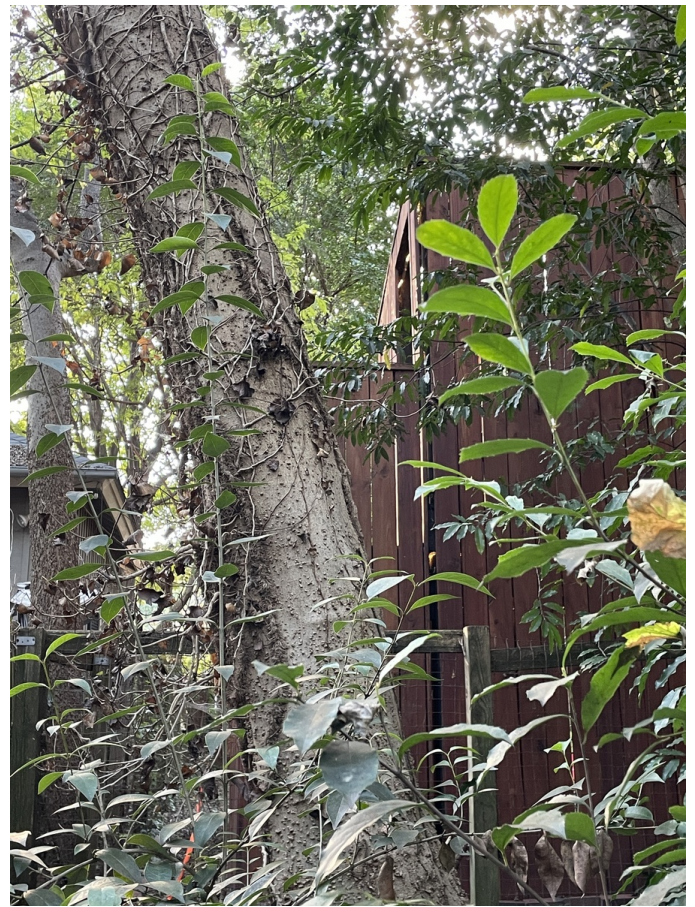
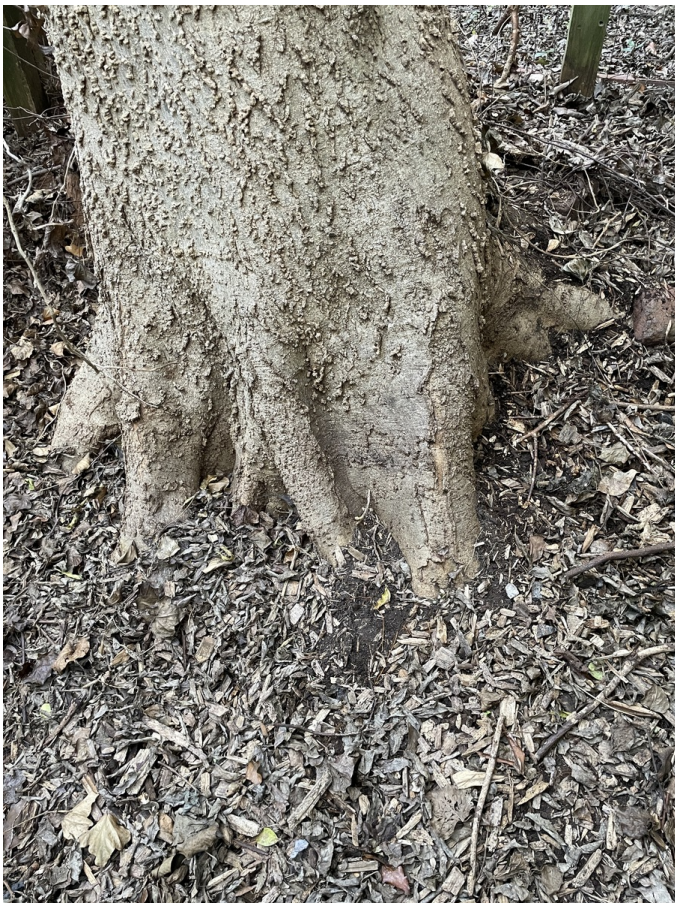
The 19-inch Hackberry live crown is about 50%. There are 2 major scaffold branches left on the tree. The larger major scaffold branch end is gone causing secondary growth along the largest major scaffold branch. Secondary growth is not as beneficial to the tree's health as the original true branch. The other major scaffold branch further divides into 3 branches, 1 is gone and 2 true branches are present.

The foliage is chlorotic (yellowing), sparse, the twig growth is average, the callus wood development when branches are removed is poor and the tree vigor is fair (the tree's ability to form callus wood when branches fall off or when removed).

The base of the tree trunk has a natural 20 degree lean to the southwest. Further up the stem the top of the larger scaffold branch leans a further 10 degrees to the southwest. The prevailing wind direction in the Raleigh area is from the South in the Summer and from the North in the Winter. Due to the natural lean, the crown of the tree is over the backyards of two of the neighboring properties. One neighbor has a constructed outdoor play area for their children and the other neighbor has outdoor furniture arranged partially under the tree. There is no decay in the buttress roots or lower trunk or upper stem that I detected from a ground inspection. The buttress roots are growing around bricks. There is an old wire fence along the property line growing into the buttress roots and lower trunk.

The site was previously a residence, the buildings have been removed. The 19-inch Hackberry tree is being evaluated because the site is proposed to be developed with a garage. The garage top left corner is proposed to be located approximately 5 ft. east of the tree and 3 ft. north of the tree. The area for grading, excavation, and ground preparation for the garage will remove 25% of the critical root zone (23.75 ft. for 19-inch dbh tree) of the tree. (The critical root zone used by the City of Raleigh for development purposes is 1.25 ft./inch diameter). There are 12 visible buttress roots/root flairs, 4 of those will most likely be affected by the garage. These 4 roots are on the backside of the lean.

Due to the 20 degree natural trunk lean to the SW toward the neighboring property, the roots affected opposite the lean, the unhealthy large scaffold branch, chlorotic foliage and the poor vigor of the tree, and the 25% root disturbance my recommendation is to remove the 19-inch dbh Hackberry tree.
