504 E JONES STREET
OAKWOOD HISTORIC
DISTRICT (R-10)

Nature of Project:
Demolish garage

APPLICATION FOR A CERTIFICATE OF APPROPRIATENESS – STAFF REPORT

107-18-CA 504 E JONES STREET

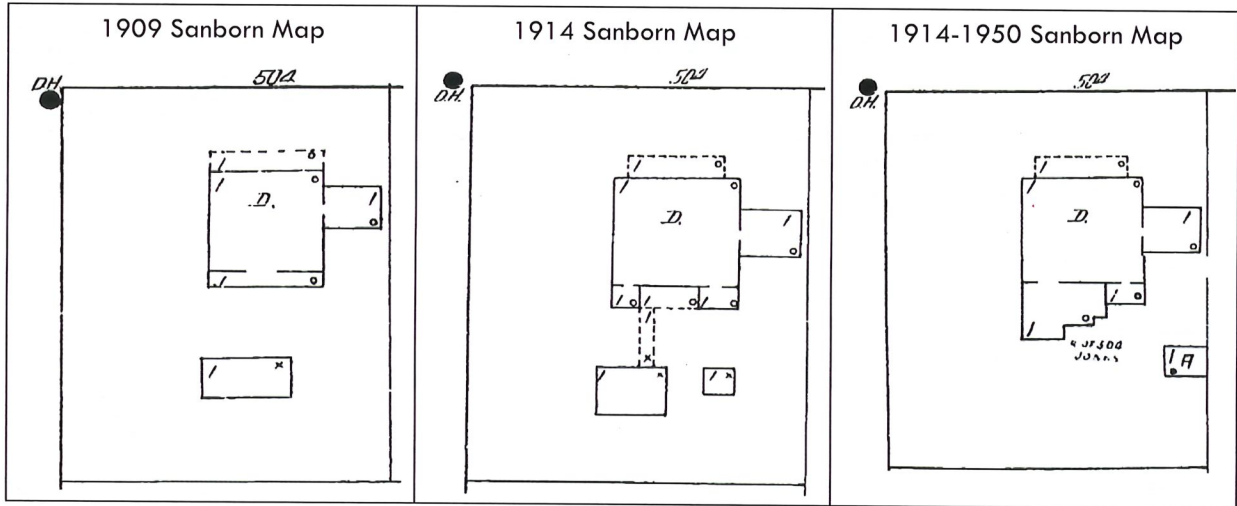
Below are the Sanborn Maps available for the house. The 1909 map depicts a detached kitchen; the 1914 map depicts the detached kitchen and likely an outhouse. In 1920, running water was installed in the house, the detached kitchen was moved and attached to the main house, and a bathroom was added to the south side of the house.² The 1914-1950 map depicts the garage.

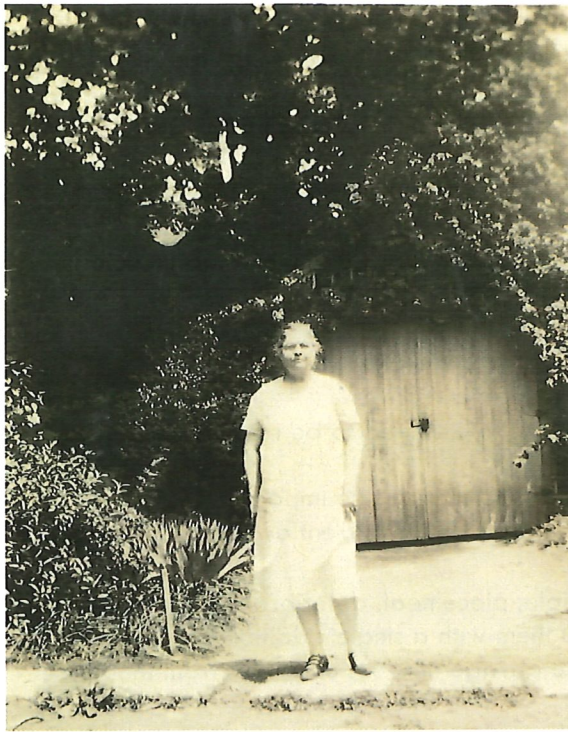
Albertine Maynard standing on the stepping stones to the original detached kitchen in the backyard, with the garage in the background (c. 1920s or 30s, photo provided by Hutchins).

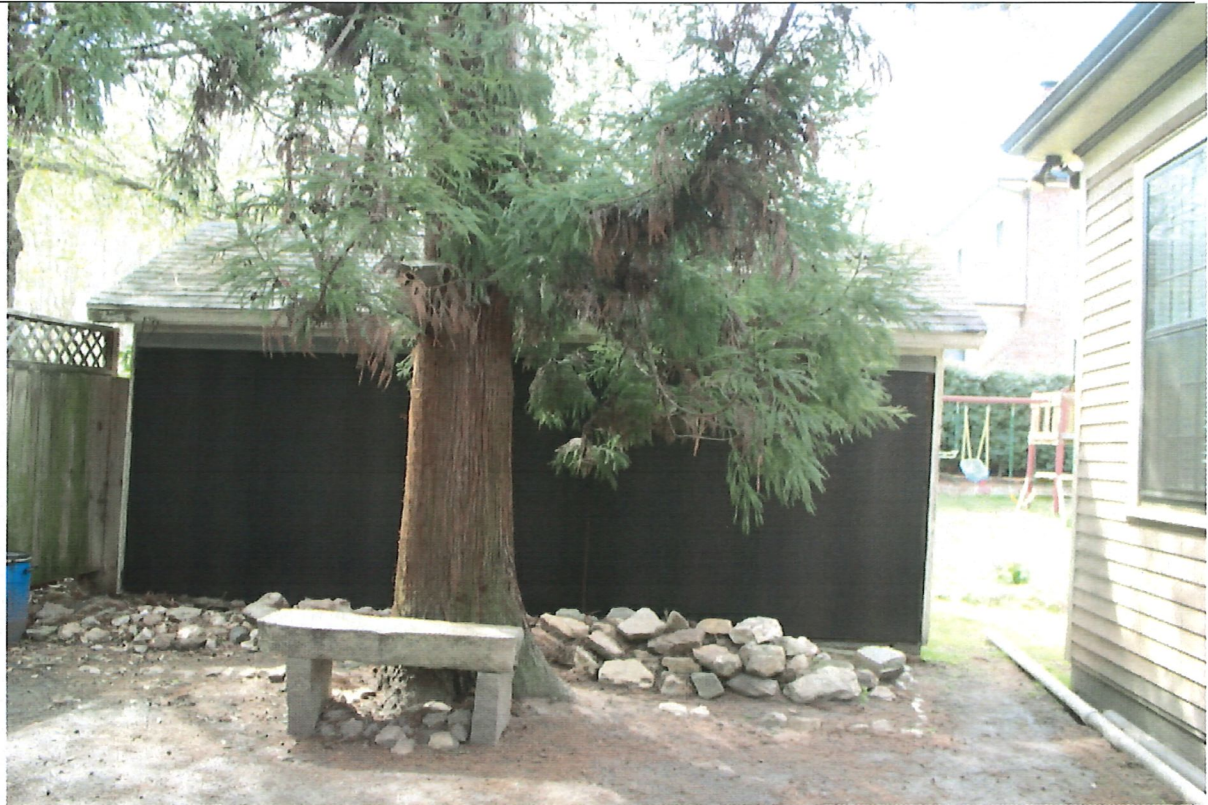
North side of garage

- 6* The weatherboard on the north and south faces of the garage was removed during a previous project to repair deteriorated siding on the house. No COA was acquired for this alteration.

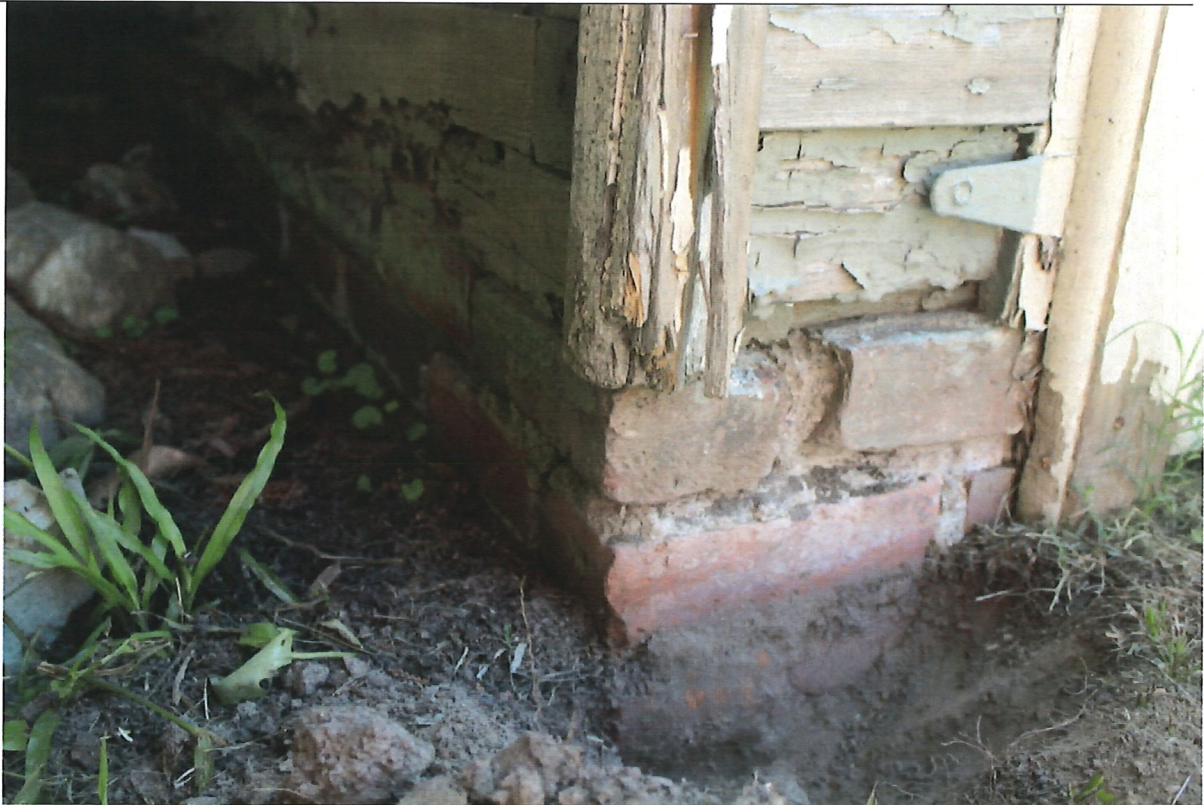
- The foundation extends only 2-4" below grade and is not situated on a footing. A new foundation would be required to ensure a stable and durable structure.
- The sill plate has significant termite damage and rot due to its close proximity to grade. It would have to be replaced on all sides.
- At the suggestion of Mike Turner (a well-known painter of Raleigh historic houses), the owners removed a significant amount of wood siding from the garage to patch up many deteriorated boards on the main house because the old wood is thought to be superior to new wood available for purchase. Therefore, new siding would be necessary for the garage.
- The asphalt shingle roof is failing in places and would need to be replaced.

Shallow foundation

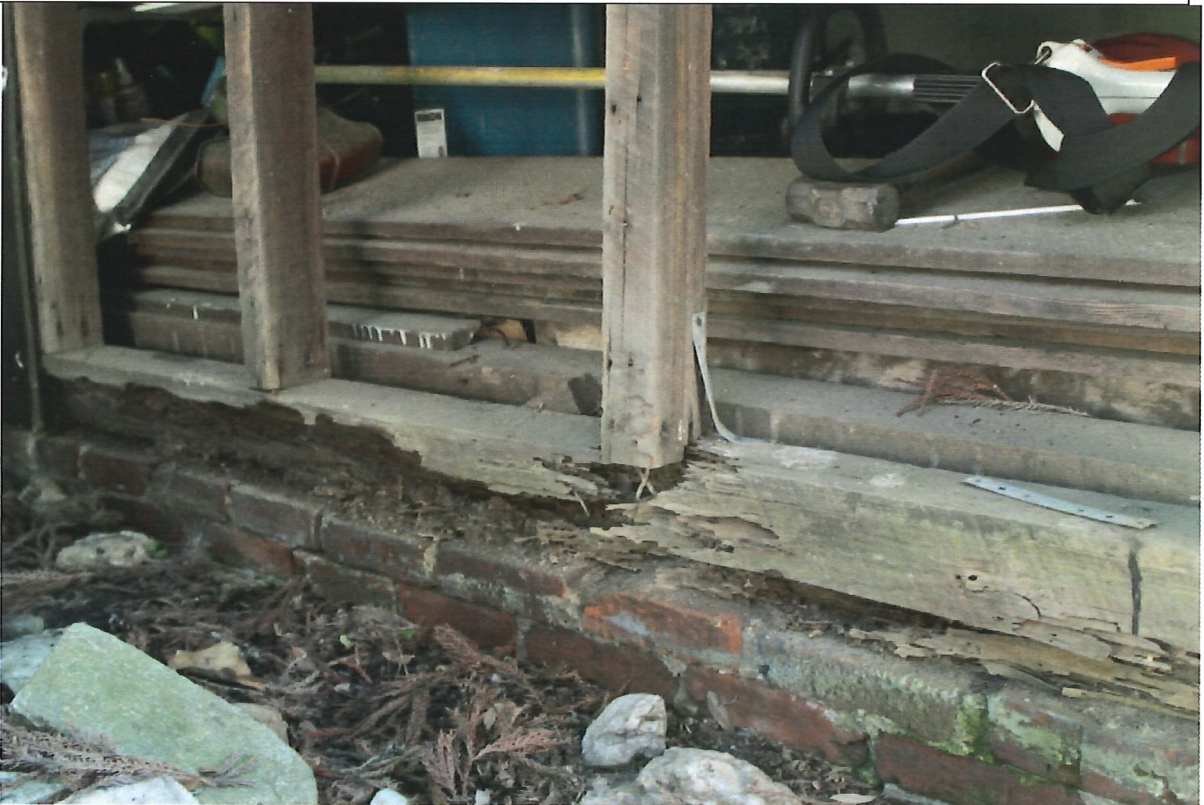
- 5* The applicant provided several photographs that show the current condition of the garage. The application describes foundation and rot issues and presents one photograph showing a deteriorated sill plate. A professional assessment of the structural integrity of the garage was not provided. Detailed drawings of the existing garage were not provided.

Deteriorated sill plate

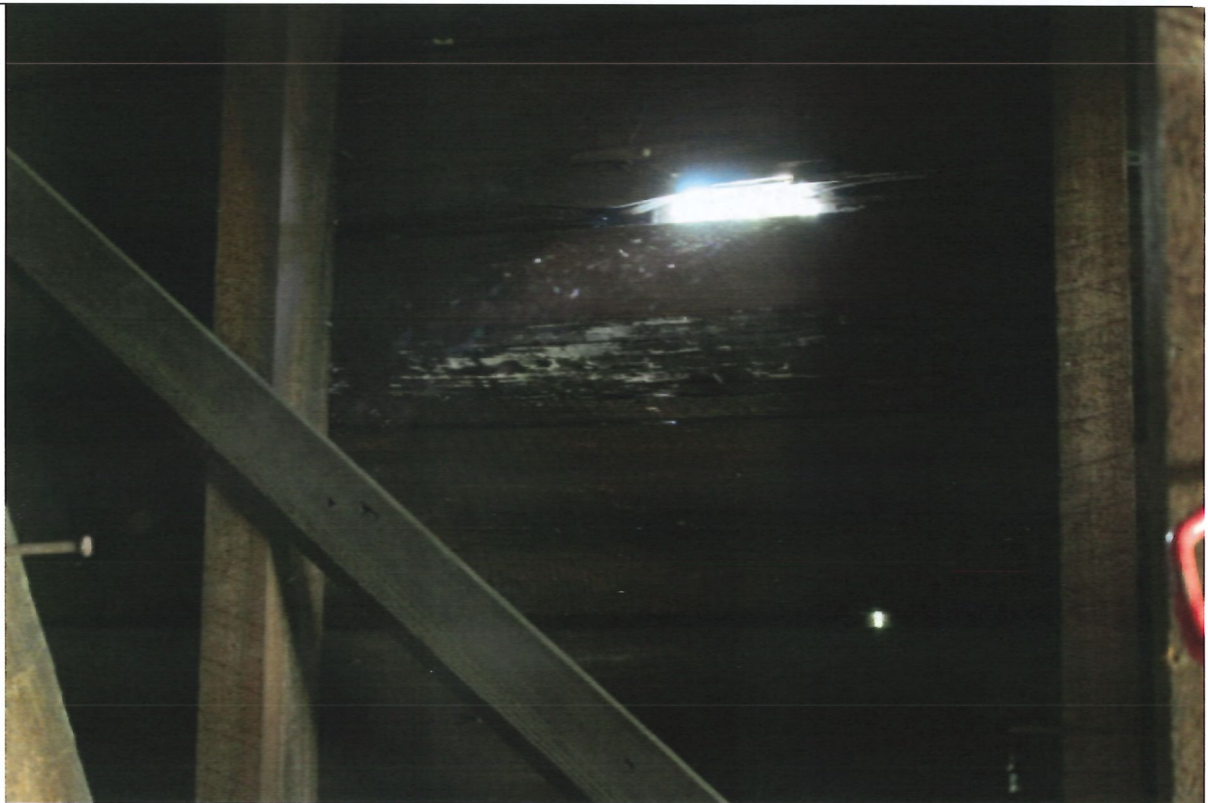
Holes in roof

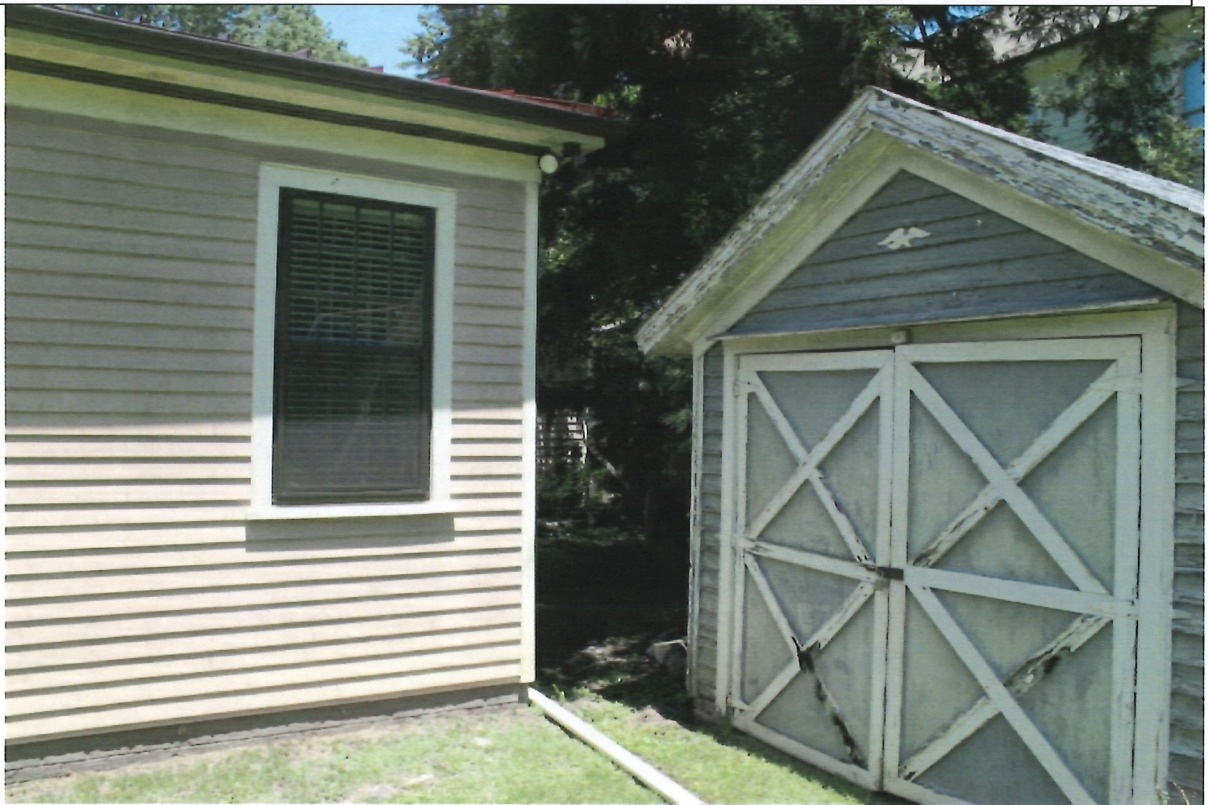
- Because the current owners tore down multiple, piecemeal, deteriorated additions to the southeast corner of the house and replaced them with a single addition that squared off the house (COA submitted in July 2013), the garage now sits only 3'1" from the house (1'11" if you measure to the garage eave).
- In addition, the garage is situated very close to one of only three mature trees on the .36 acre lot.

Proximity to main house is 3'1" (1'11" from garage eave)
