CERTIFICATE OF APPROPRIATENESS PLACARD

Joel Lane House

COA-0002-2020

Optical Microscopy Exterior Paint Analysis

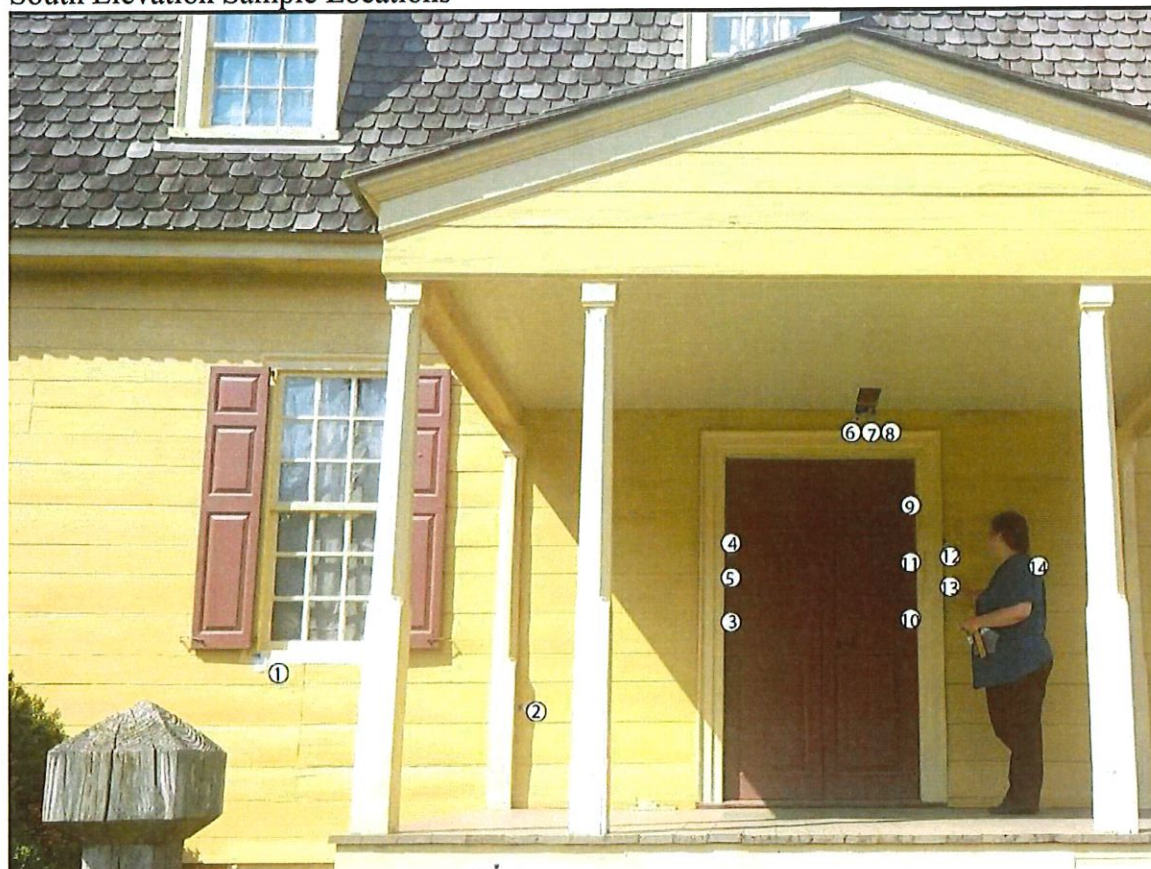
South Elevation Sample Locations

Sample Locations

Sample 1. Window trim, bottom left corner, window left of door.

Sample 2. Siding right of left pilaster.

Sample 3. Door trim, left side.

Sample 4. Door left side.

Sample 5. Door left side.

Sample 6. Siding above door.

Sample 7. Siding above door.

Sample 8. Siding above door, at join with ceiling.

Sample 9. Door right side.

Sample 10. Door right side.

Sample 11. Door trim right side.

Sample 12. Siding right of door.

Sample 13. Siding right of door.

Sample 14. Siding right of door.

Sample 15. Window trim, bottom left corner, window right of door.

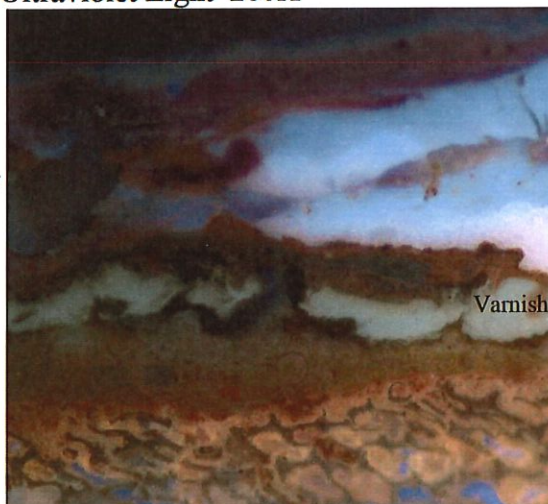
Sample 5. Door left side.

Door. There are approximately 16 generations of paint in samples 5 and 9 from the door. The earliest paints are fragmentary, especially in sample 5 where there are only remnants of a dark reddish paint layer trapped in the wood. In sample 5 the second generation appears to be decorative grain-painting to replicate figured wood. The paints used to create this graining pattern consist of deep yellow base coat, a brown glaze and a layer of plant resin varnish (identified based on its characteristic whitish autofluorescence in reflected ultraviolet light).

Visible Light 100X

Visible Light 200X

Ultraviolet Light 200X

So, while the earliest door paints are more disturbed than the original paints found on the trim and siding, the presence of two early generations of grain-painting suggests that it is appropriate to decoratively paint the front door with graining to replicate figured wood as it may have been re-grained in the second period of the house (1790-95). The most appropriate graining for a late 18th-door in this region would be mahogany. Similar early graining has been found on the main door of Mount Vernon, the main door of the Hammond-Harwood House in Annapolis, and the main door of the Coke-Garrett House in Williamsburg, Virginia (the graining here may be post-Revolutionary). Grain-painting evidence does not often survive on exterior doors because of the damage caused by weathering and repainting.

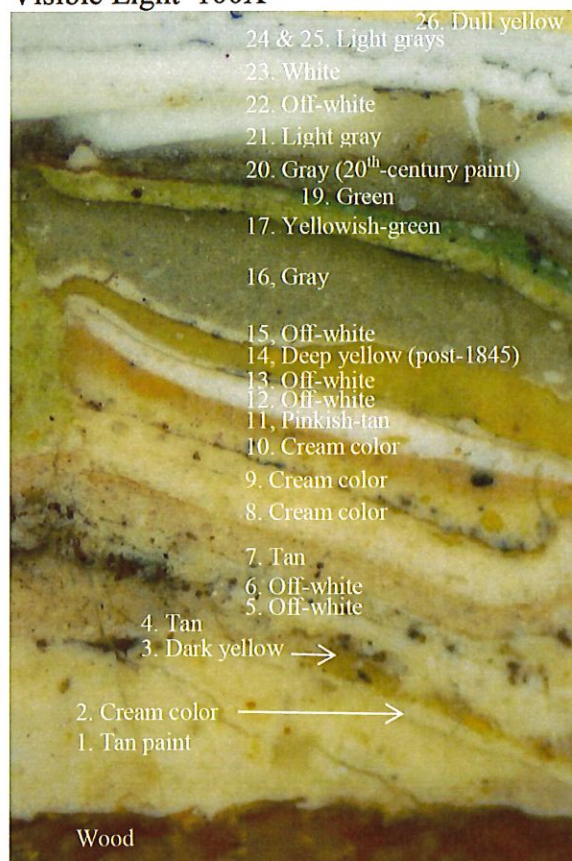
Sample 11. Door trim right side.

Window and Door Trim. The window and door trim elements are currently painted with a cream color which matches the trim on the porch. The two samples from the windows (1 and 15) do not retain early paints, probably because these elements are so exposed. Door trim sample 3 is also compromised from weathering and partial paint removal. Fortunately, door trim sample 11 appears to retain a full chronology of 27 generations of paint. Window and door trim elements were traditionally painted the same color, so the paints in sample 11 probably represent the chronology of window trim paints as well.

The original paint is a thickly applied, oil-bound, tan-colored paint. The trim was repainted with a white lead-based dark cream color in generation 2, followed by a dark yellow paint in generation 3. The second-generation dark cream color is may have been applied before the end of the eighteenth century. The 40X image of cross-section sample 11 shows that there were distinct color changes over time, including pinkish-tan paint in generation 11, deep yellow in generation 14, and greens in generations 17 and 18. The deep yellow paint in generation 14 contains the pigment zinc white (based on its characteristic sparkly autofluorescence in reflected ultraviolet light), which means this paint must post-date about 1845 when zinc white was available for paint-making. The finely ground, evenly mixed, nonfluorescent paints that start at generation 20 likely date to the twentieth century.

Binding media analysis with biological fluorochromes shows that all the paints are oil-based (with the fluorochrome Rhodamine B). Polarized light microscopy (PLM) analysis shows that the original tan paint contains white lead, calcium carbonate, and widely dispersed yellow ochre and red ochre pigments.

Visible Light 40X

Visible Light 100X

Ultraviolet Light 100X

Ultraviolet Light 200X

UV Light & RHOB for the presence of oils
Positive for oils in all paint layers

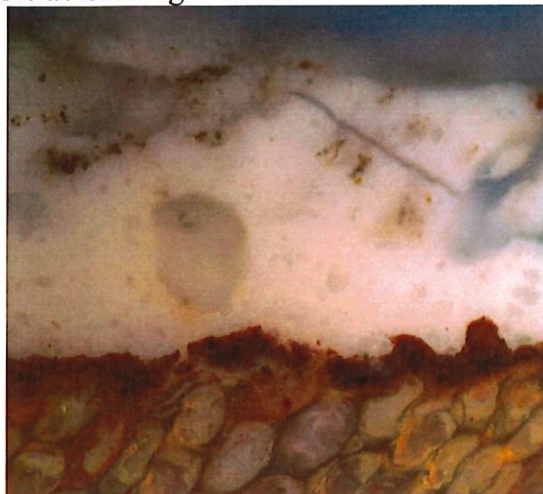
Sample 7. Siding above door.

In samples 6 and 7 from siding above the door, there is a light green paint above the fourth generation of off-white paint. This is likely an overlap of later porch ceiling paint as it does not appear in the other two cross-sections from the siding to the right of the door.

Visible Light 200X

Ultraviolet Light 200X

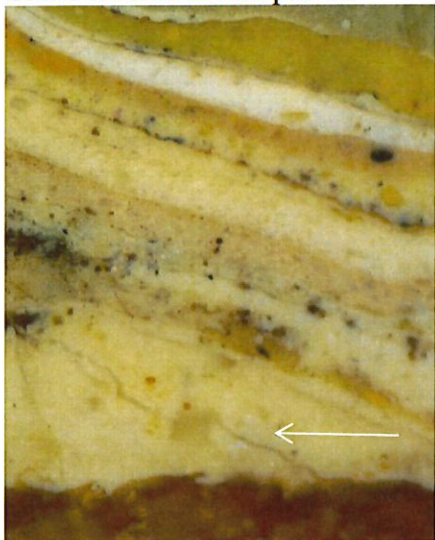
Cross-section of sample 11

Joel Lane Museum House Original Tan Trim Paint

Color System*		Coordinates	
Munsell	Hue	Value	Chroma
	6.5Y	7.0	3.2
CIE L*a*b*	Black to White	Green to Red	Blue to Yellow
	L70.96	a-3.58	b+22.67

The Benjamin Moore match #HC-25 is an excellent visual match to the best preserved areas of the original tan-colored trim paint when examined in full spectrum light both at 30X magnification and unmagnified. The evidence suggests that that this layer was somewhat glossy and could be replicated in a satin gloss level.

Benjamin Moore #HC-25 “Quincy tan”
