CERTIFICATE OF APPROPRIATENESS PLACARD

Replace roof covering; install standing seam roof on porch; remove utility chimneys

530 E Jones St

530 E Jones St. – COA Roof and Chimneys

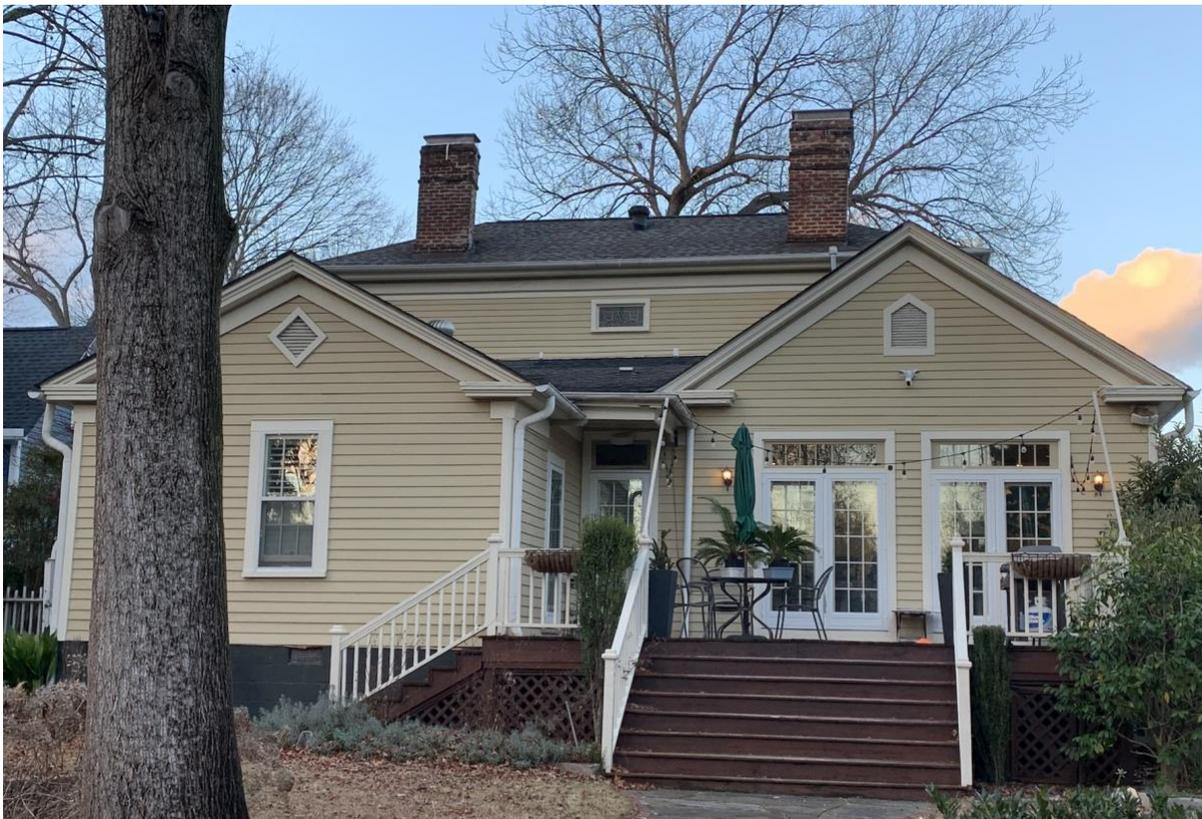
530 E Jones Rear

The Chimneys are barely visible from the street, just the tops of the aluminum caps which are not original to the home are visible. From a certain vantage point in the backyard the chimneys are visible. There is nothing particularly unusual about the look of the chimneys, in fact they were probably built too narrow for their width and height, contributing to the leaning. Not only is it completely unaffordable to replace the chimneys, but it is also a pointless exercise as they could not be used, therefore we request approval to remove the chimneys.

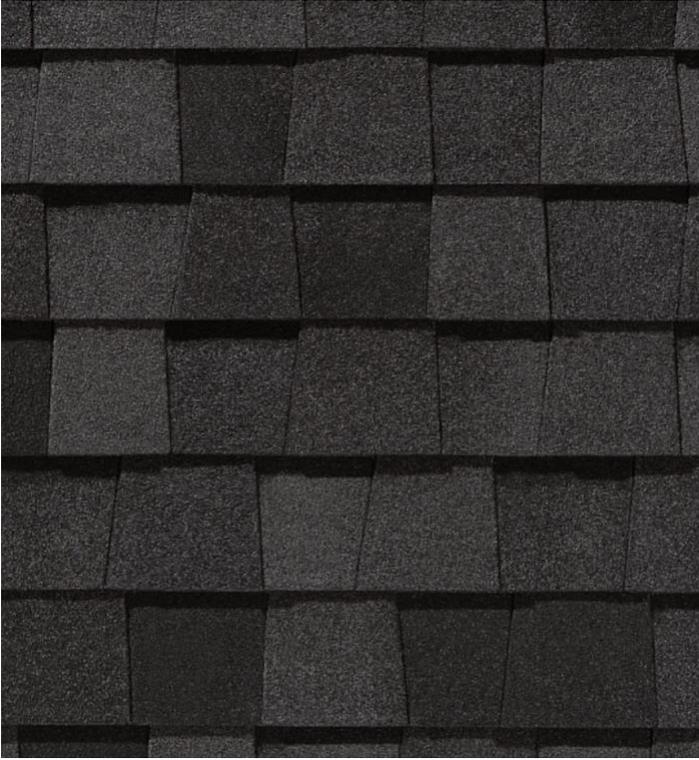
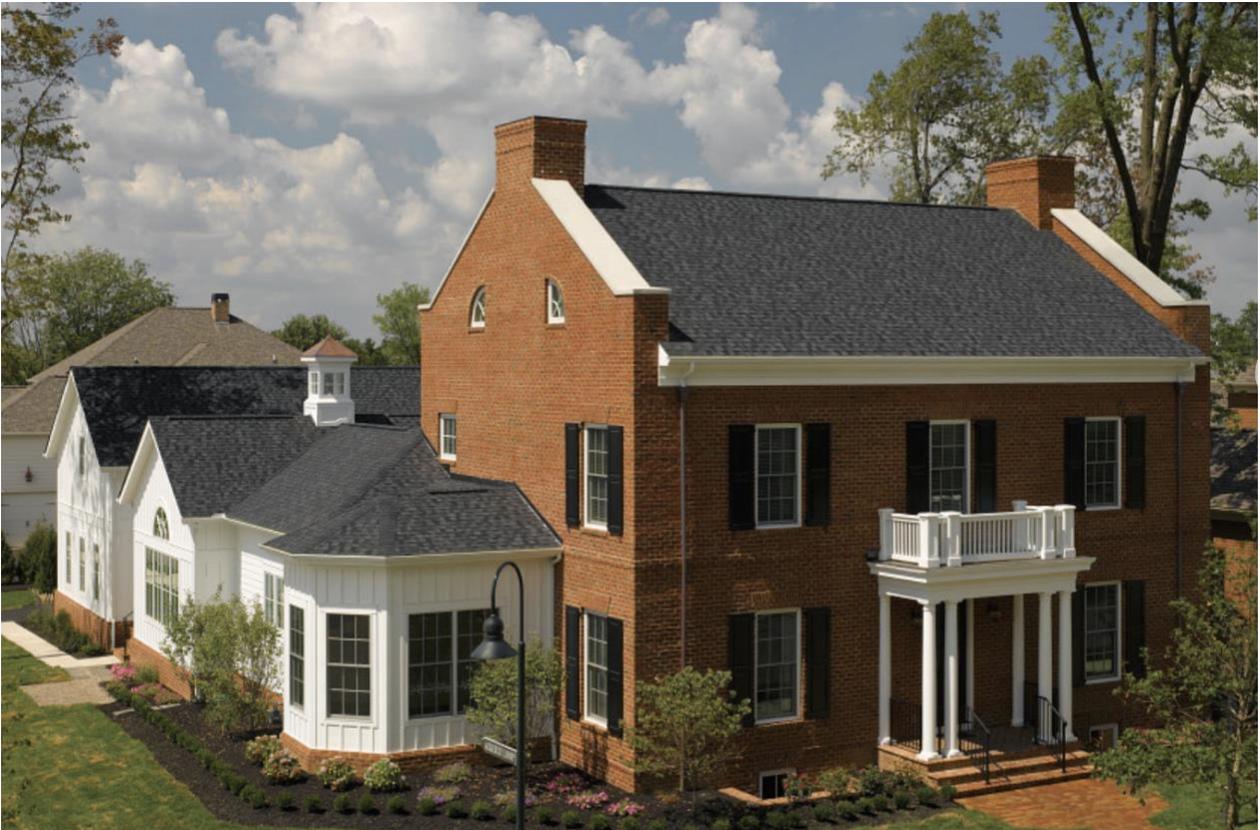
The existing asphalt shingle will be replaced with a similar style and color shingle.
Shingle Manufacturer: CertainTeed's Landmark® PRO (higher quality than existing)
Shingle Color: Moire Black (close match to current color)

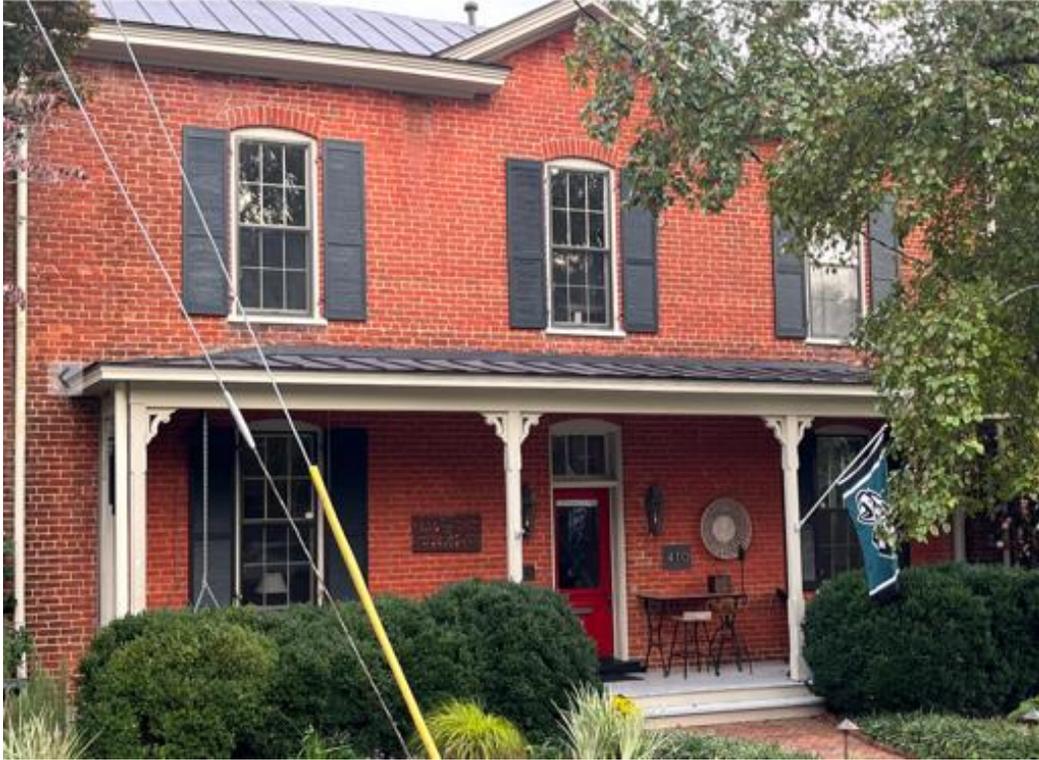
410 Elm St.

Current asphalt shingle over the front porch will be replaced with a black, 24-gauge, 1.5 inch standing seam, snap-lock / concealed fasteners, flat (without striations), standing seam metal roof, with seams 16 inches apart. This is very typical of other metal roof porches within Historic Oakwood, several examples are pictured below:

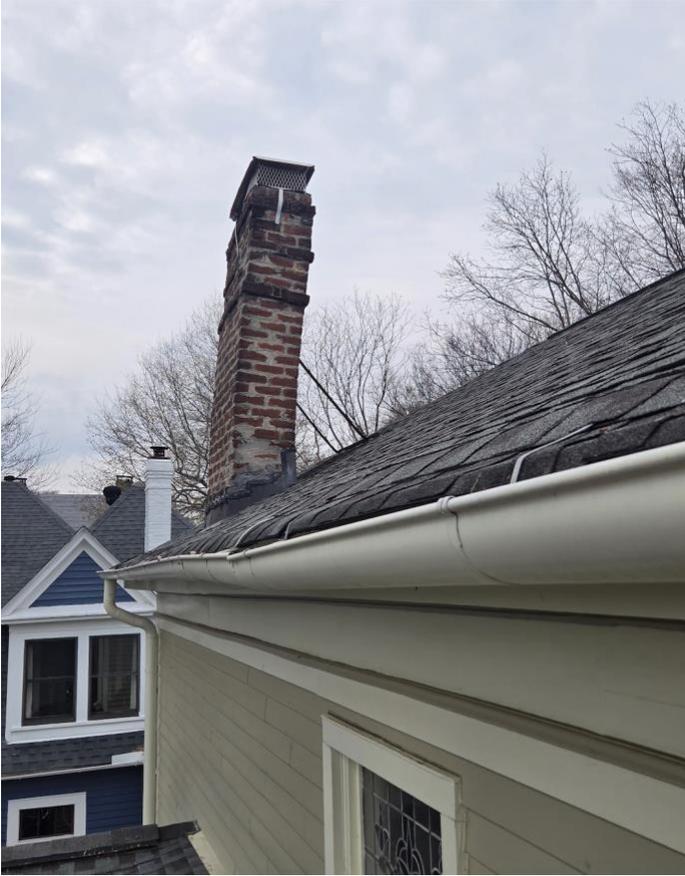
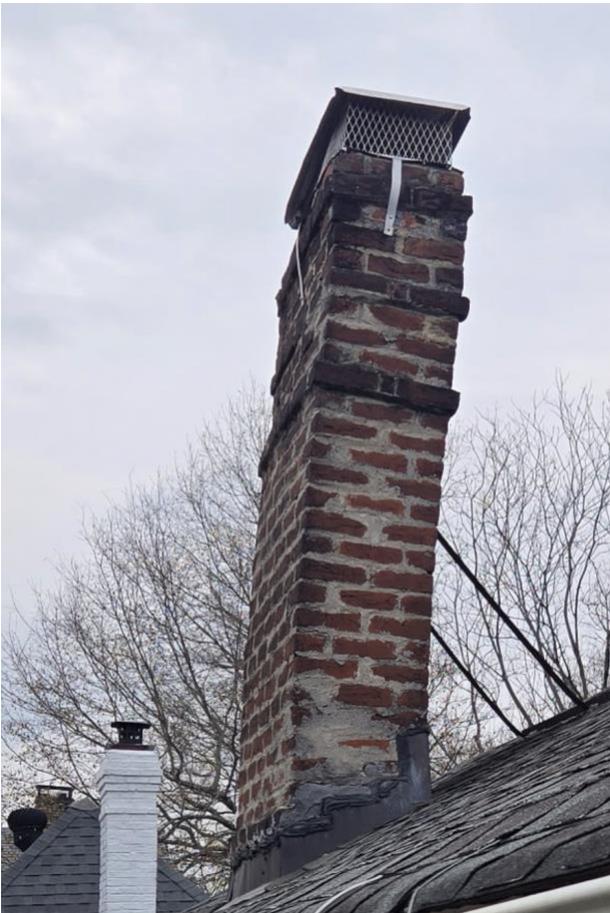
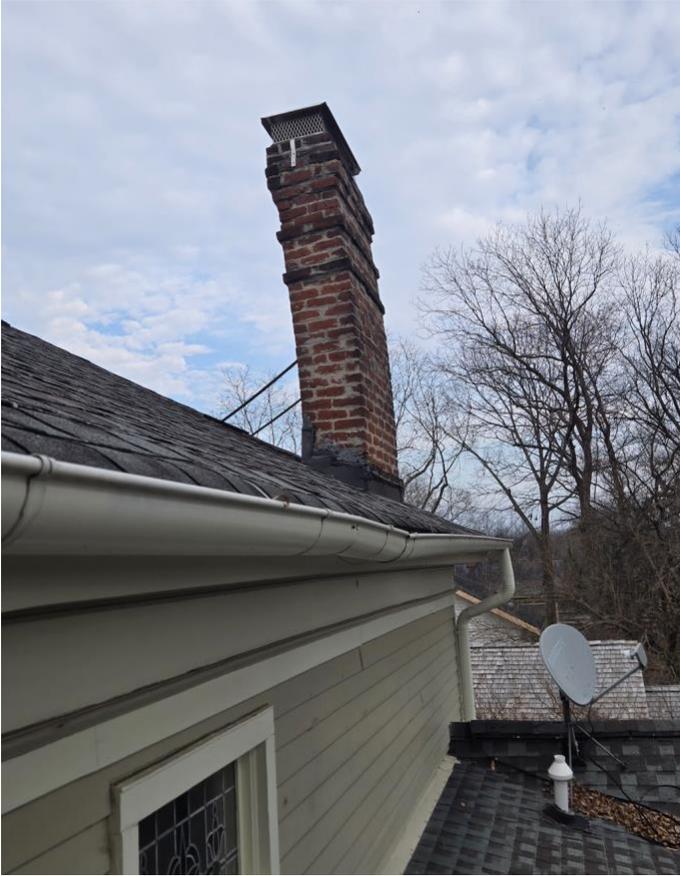
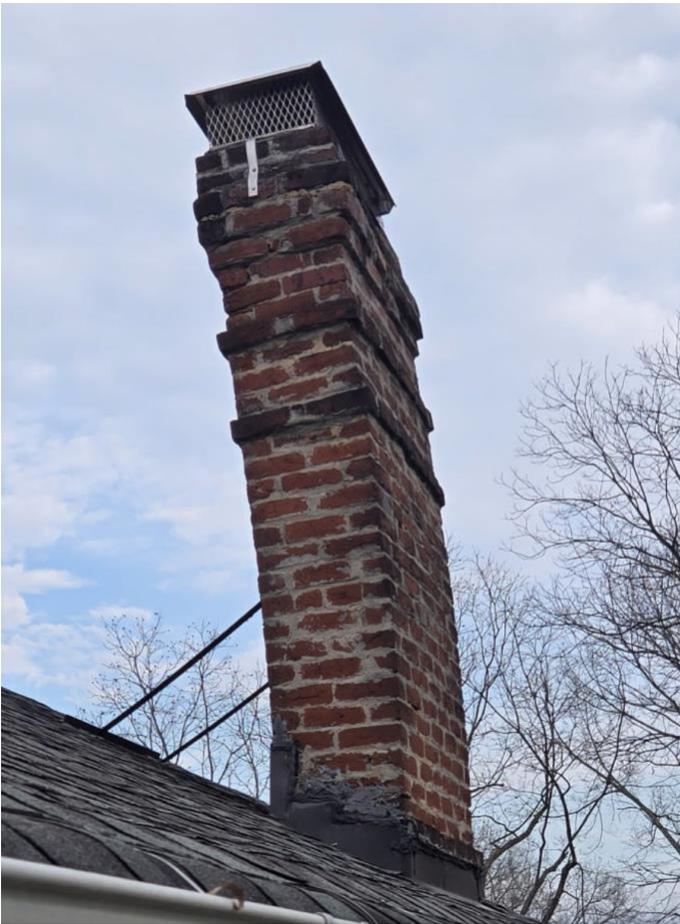
While gathering quotes to replace the asphalt shingle on the house, roofing companies brought to our attention the extent of the leaning and dangerous condition of the chimneys. They expressed concern about working in the vicinity of the chimneys and showed us pictures and video of their poor condition and the pointlessness of the braces that were installed by a previous owner.

Based upon my visual observations of the chimneys, and the extreme leaning toward the front of the house, it is my professional opinion that these chimneys are a hazard and must be removed. The leaning has also reached a stage that renders the bracing totally ineffective.

We immediately hired a structural engineer to evaluate the condition of the chimneys. The conclusion of Lysaght & Associates Structural Engineers was the “chimneys are a hazard and must be removed” (see attached).

Both chimneys are non-functioning. The remaining fireplaces were coal burning and are unusable. Mr. Smokestack also recommended removal, noting the chimneys are also unlined and a ~\$40,000 rebuild would be purely cosmetic and a waste of money.
