CERTIFICATE OF APPROPRIATENESS PLACARD

Replace asphalt shingle roof; rebuild front porch railing and concrete front steps; alter exterior paint colors

704 Florence St

COA-0018-2023

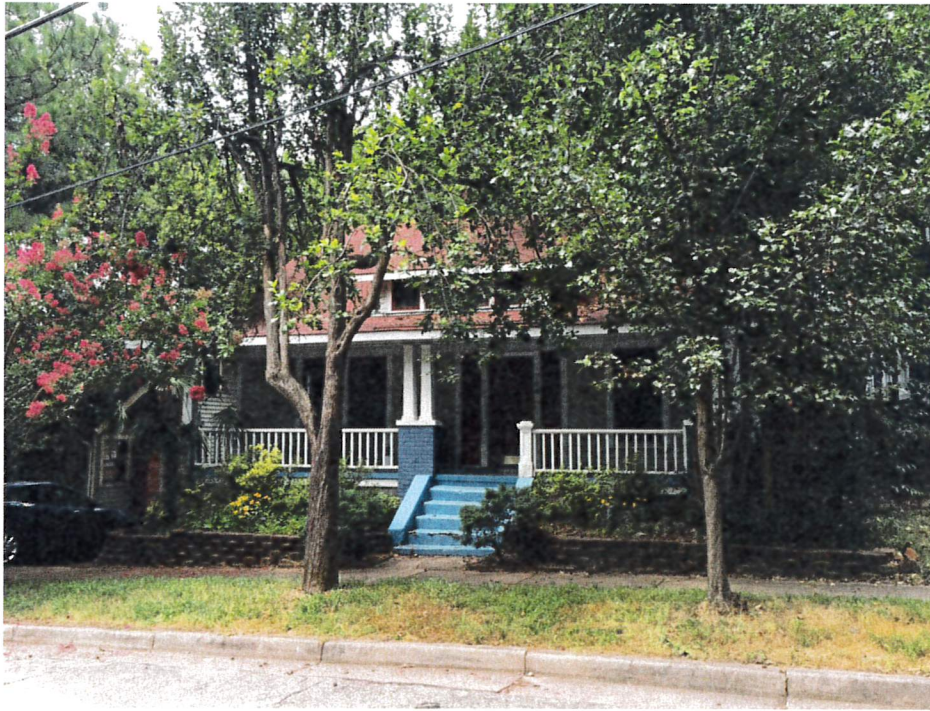
Old roof pictures (old color appeared terra cotta):

The previous roof of 704 Florence Street was in state of significant disrepair with known leaks in 6 areas, despite multiple repairs (some leaks requiring buckets inside the house during large storms). A full new roof was required to maintain the integrity of the house. The owners chose new roof shingles in a more neutral gray color versus the non-original terra cotta, thinking ahead to a planned exterior paint color change.

Scope of May 2019 new roof and related external carpentry work by TEW Contractors, Tyson Warren (local contractor who has worked on multiple properties across Boylan Heights):

- Remove existing shingles from roof
- Inspect decking for bad wood
- Sweep debris off roof
- Install felt paper underlayment
- Install CertainTeed Landmark dimensional shingle (30 year) in Colonial Slate
- Flash chimney with new back aluminum flashing
- Apply NP-1 black polyurethane caulking where needed
- Install new pipe flashing
- Install all new drip edge

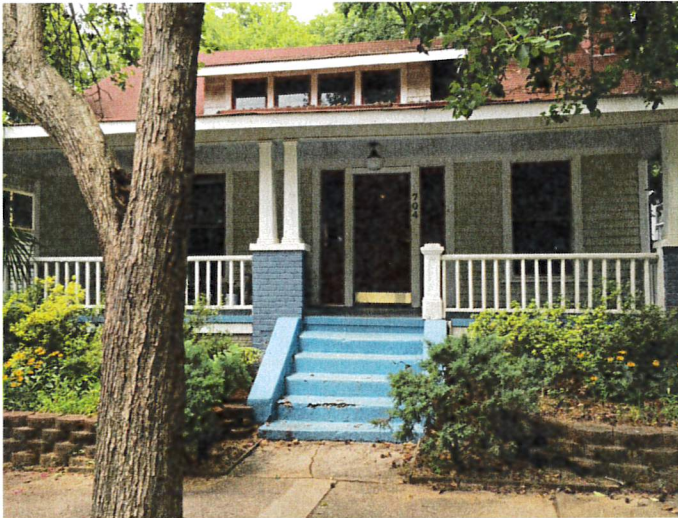
Old steps picture:

The front porch steps of the house were in a state of disrepair with chunks of concrete missing and broken, as well as a dangerously sloped top step which was a significant liability and fall risk. The steps were replaced in the exact same style as the original, with the same concrete material, but left natural in color versus the bright blue paint the previous rental tenants had applied to the steps and porch.

Porch steps - demo and rebuild

- Demolition - remove existing front steps
- Masonry - build new front stairs to match existing
- Clean up and trash removal

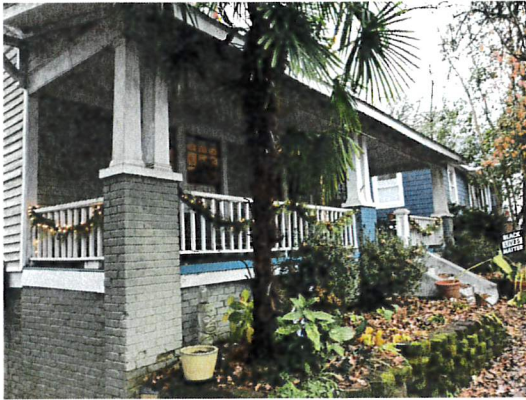
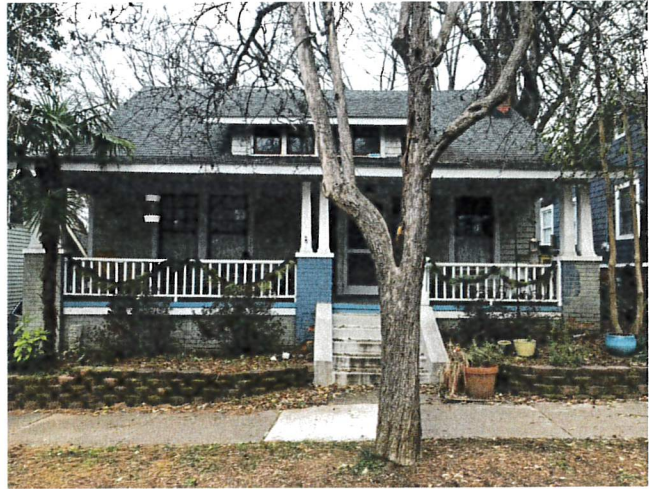
Old paint scheme:

Paint was in extreme disrepair across the entire exterior of the house, creating a siding/wood integrity issue. The paint was peeling off of nearly every surface, exposing sections of wood to the elements as well as shedding lead-based paint chips. Further, porch paint was improperly applied by past tenants with different colors across columns (multi-colored, non-matching, uncoordinated) and steps/porch floor (non-durable paint quality). The current home owners enlisted Socaz Painting, an EPA lead-certified company, to scrape the house in order to remove all peeling sections of paint and properly dispose of paint scrapings. The house was then properly primed and painted with durable PPG Permanizer paint. In addition to bringing the siding and paint into good standing, the brick foundation was repointed to address the many holes, gaps, and cracks in the mortar around the house's foundation. The previously-painted foundation was then primed with Loxon XP moisture barrier/seal and painted.

- siding - 1 heavy coat of Lead Block Encapsulating primer and 1 heavy coat of paint to siding
- soffit, rafter tails/corbels, fascia, cornerboards/decorative trim, porch ceiling, attic vents - 1 coat of paint
- columns*- 1 coat primer and 2 coats of paint after stripping
- windows & casings* - removed and reglazed loose or missing portions of glazing
- doors & casings - 1 coat of paint to white door casing & 3 coats of paint to window sashes, red door faces, and sidelights
- porch floor - 1 coat of paint to porch and floor enamel
- foundation - Loxon XP used as primer on newly repointed foundation and porch curtain rebuild as a moisture barrier and seal.

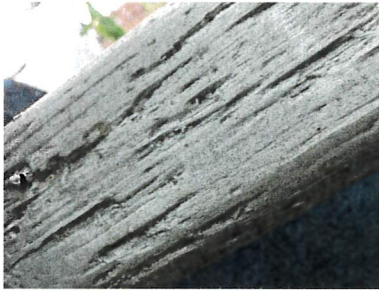
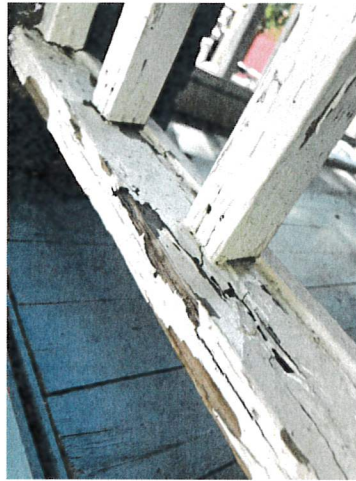
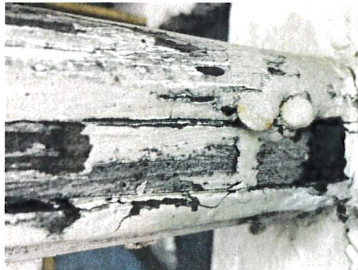
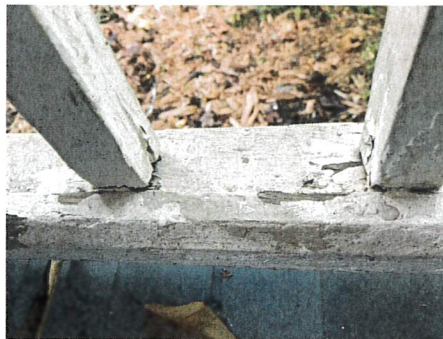
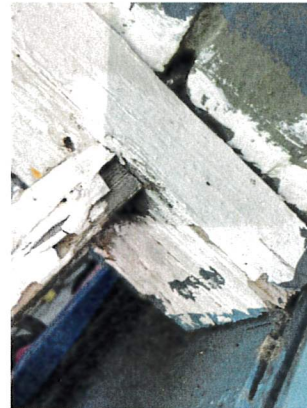
The front porch banister was in extreme disrepair with deteriorating wood causing stability issues across the entire porch. The wood/paint had not been properly maintained before the current owners purchased the house. As such, the banister was weak and broken down. The banister was fully rebuilt in the exact same style, dimension, and material. It was painted with the same shade of white as the old banister and coordinating house trim. See pictures for examples of deterioration.
