APPLICATION FOR A CERTIFICATE OF APPROPRIATENESS – STAFF REPORT

COA-0035-2019 410 CUTLER STREET

Nature of Project: Replace slate roof with architectural shingles; replace terne roof with membrane; install gutters and downspouts

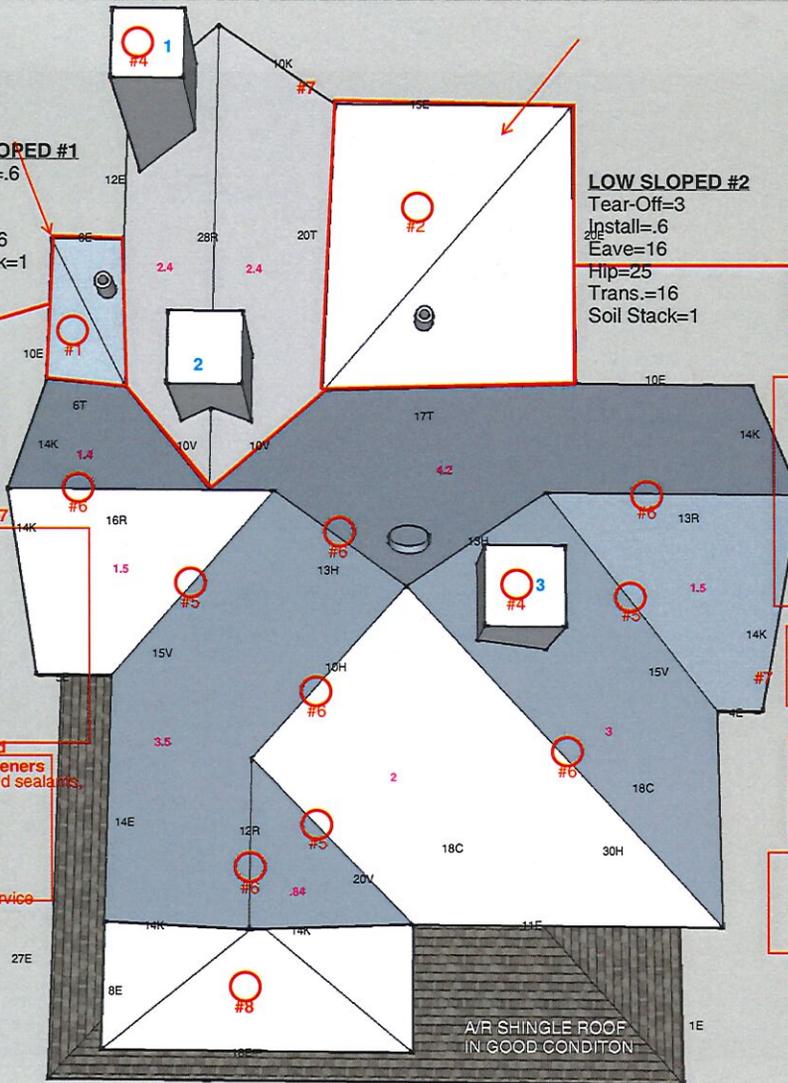
**#2 FLAT SEAM ROOF**

Flat seam roof #2  
This is a term flat seam roof that has reached the end of its service life. There is wind uplift and a tear at the Western edge  
**REPLACE**

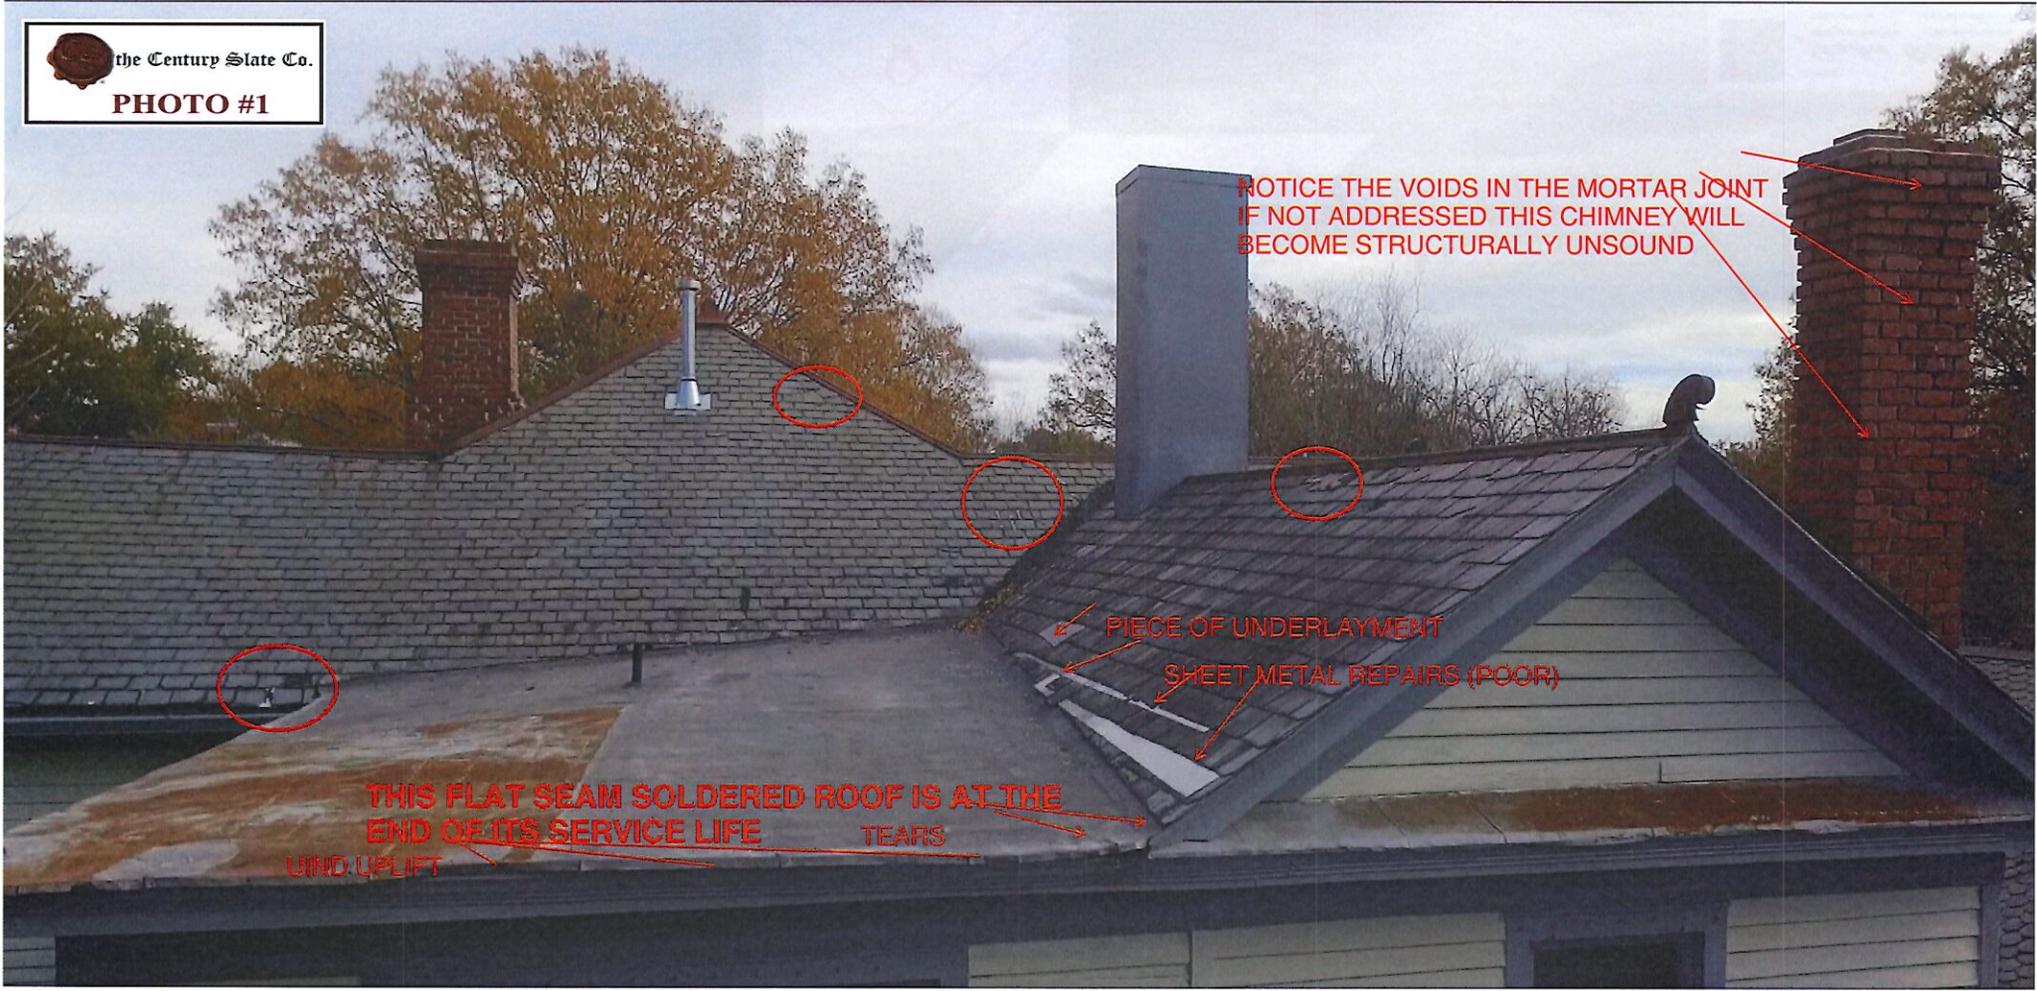
NOTICE THE VOIDS IN THE MORTAR JOINT  
IF NOT ADDRESSED THIS CHIMNEY WILL  
BECOME STRUCTURALLY UNSOUND

THIS FLAT SEAM SOLDERED ROOF IS AT THE  
END OF ITS SERVICE LIFE

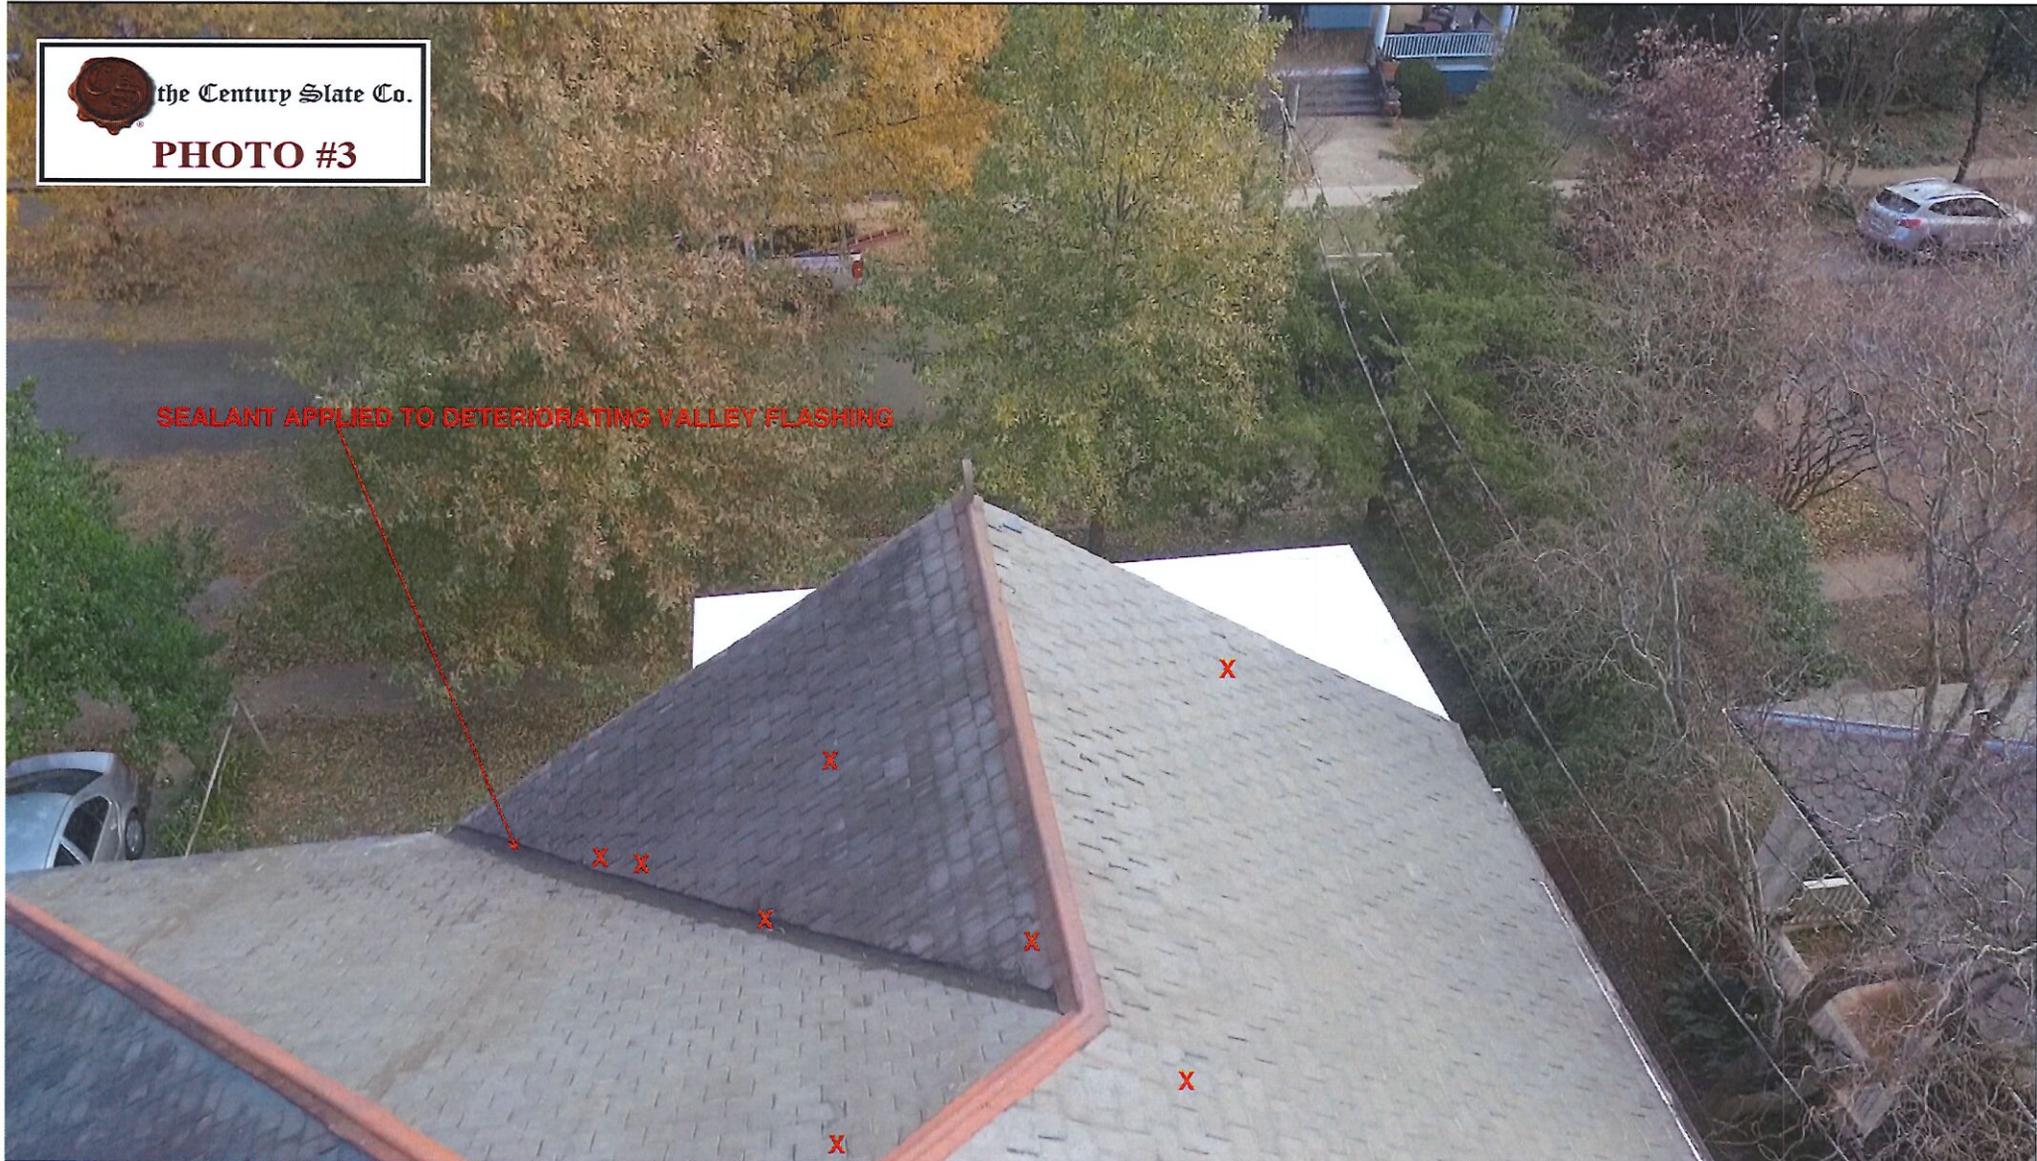
**THE WIDESPREAD USE OF SEALANTS ALL OVER THIS ROOF IS ALARMING. SLATE ROOFS SHOULD FUNCTION WITHOUT REQUIRING SEALANTS. THIS INDICATES A LACK OF UNDERSTANDING AND EXPERIENCE ON PROPERLY REPAIRING A SLATE ROOF**

**VOIDS IN MORTAR JOINTS FILLED WITH SEALANT**

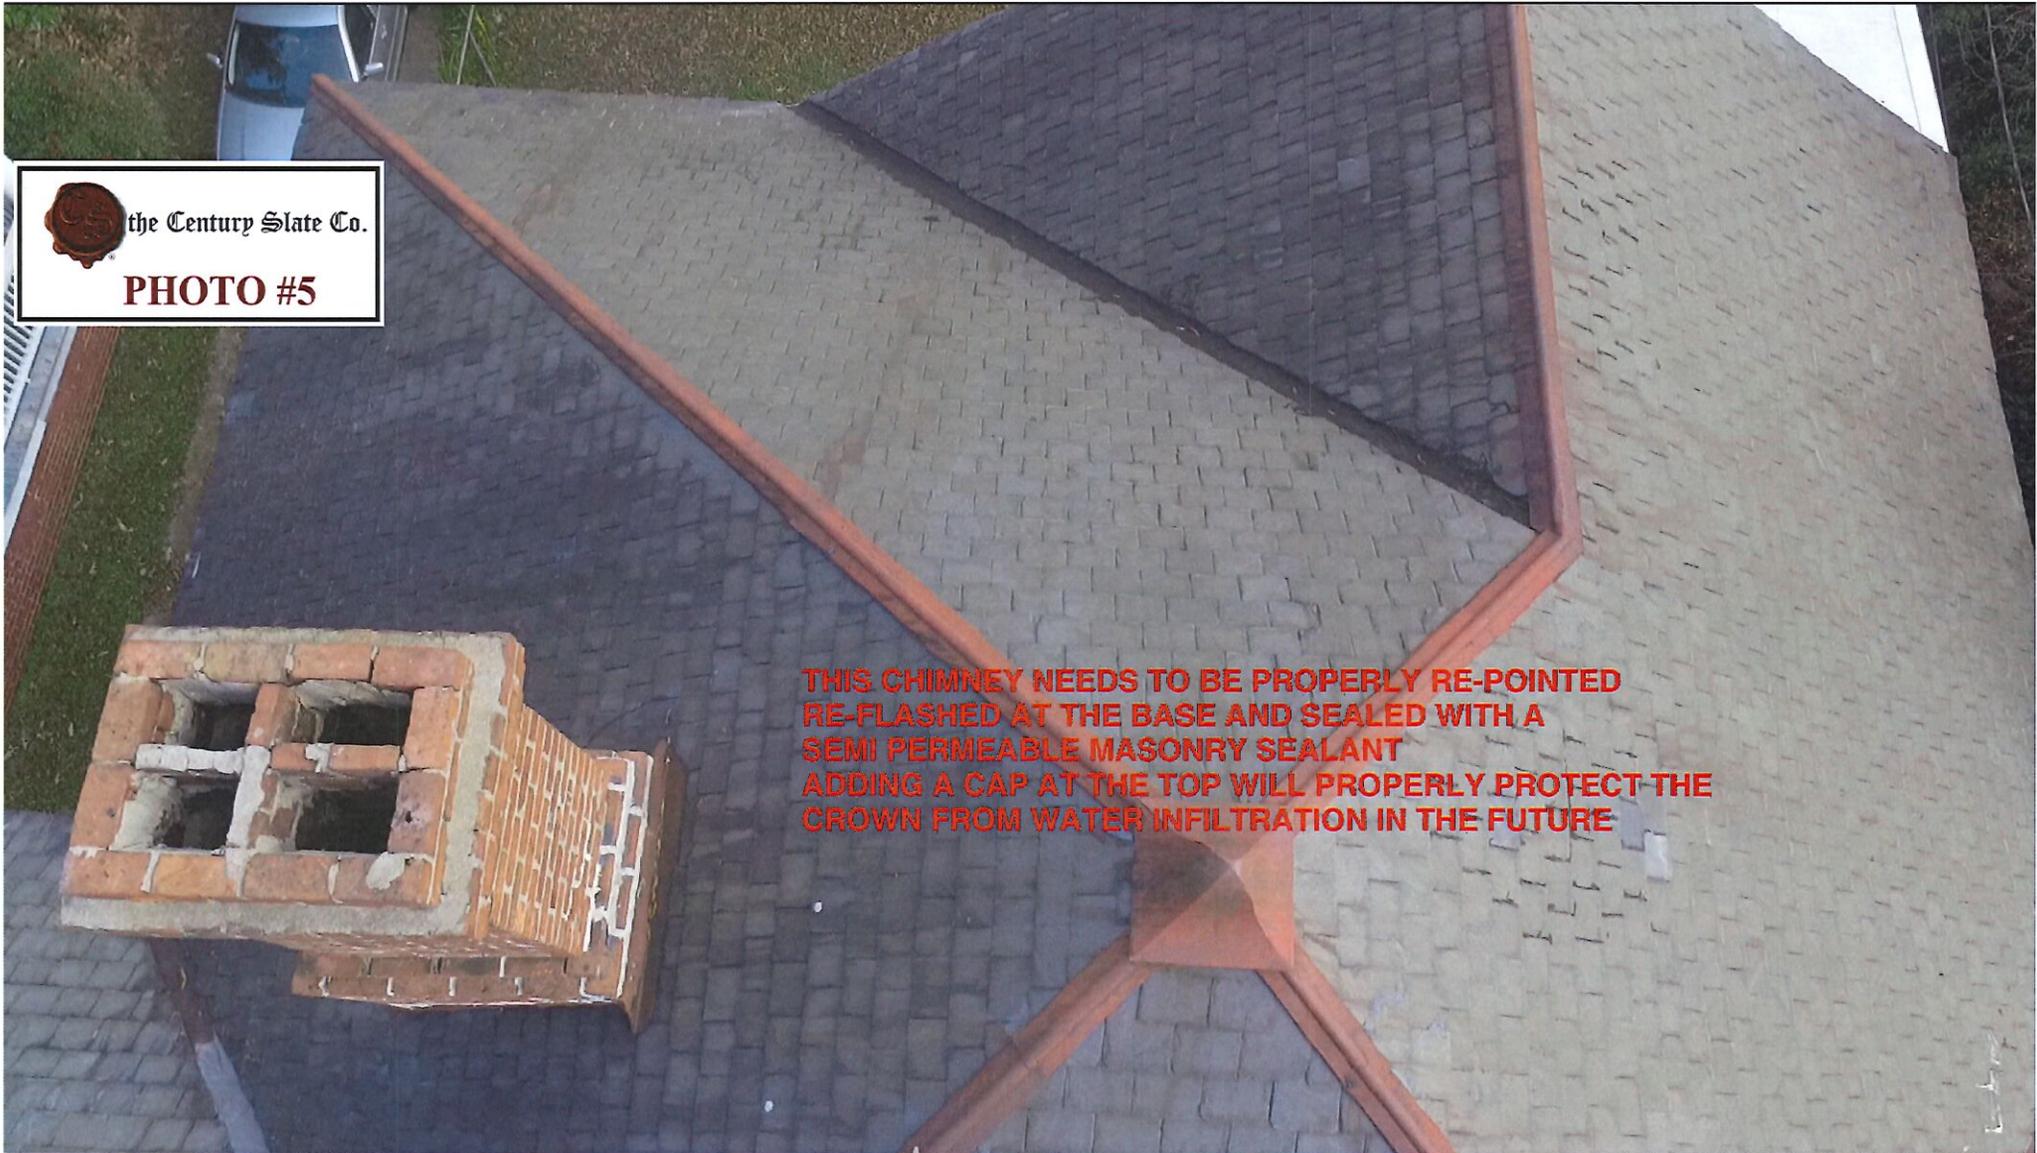
**PHOTO #5**

**THIS CHIMNEY NEEDS TO BE PROPERLY RE-POINTED  
RE-FLASHED AT THE BASE AND SEALED WITH A  
SEMI PERMEABLE MASONRY SEALANT  
ADDING A CAP AT THE TOP WILL PROPERLY PROTECT THE  
CROWN FROM WATER INFILTRATION IN THE FUTURE**

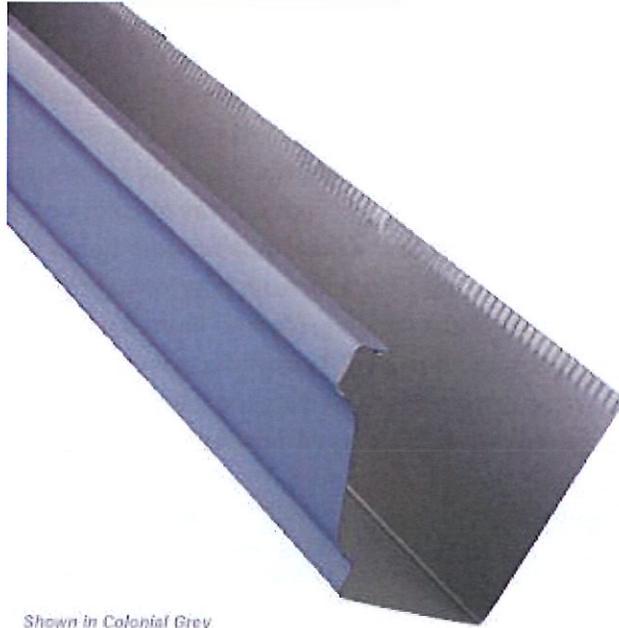
## 2. 0.032 K Style Aluminum 6" Gutter in colonial grey

- Description: Traditional K Style or Ogee gutter matching existing aluminum gutters on the property.
- Manufacturer's Description: "The 6 inch K-style gutter is perfect for any house or business with a large roof, it's even perfect for steel roofs. A steel roof sheds water faster than asphalt shingles, so you need a larger gutter to catch and divert that water where it won't do any damage. With a 6" K-style gutter we can also go further without the need for a downspouts, which allows us more choice in where the water disperses."

*Shown in Colonial Grey*

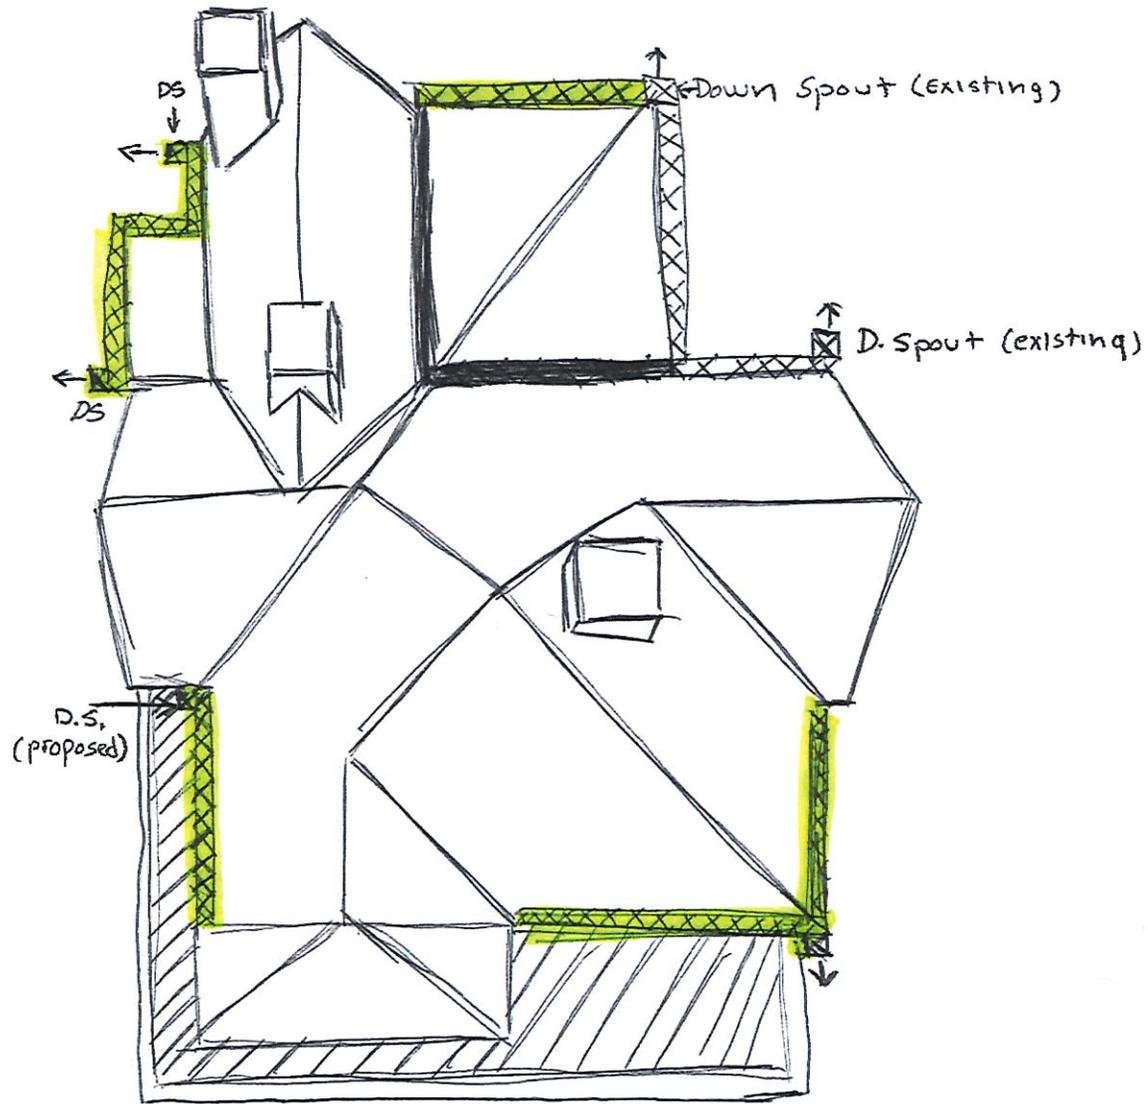
Key

Existing Aluminum gutter
