CERTIFICATE OF APPROPRIATENESS PLACARD

Alter existing retaining wall to add stair; install new retaining wall; replace accessory building stairs; remove patio; install new patio and walkway; install new strip driveway; alter existing splash pad; relocate shrubs

523 N Bloodworth St

BURD RESIDENCE

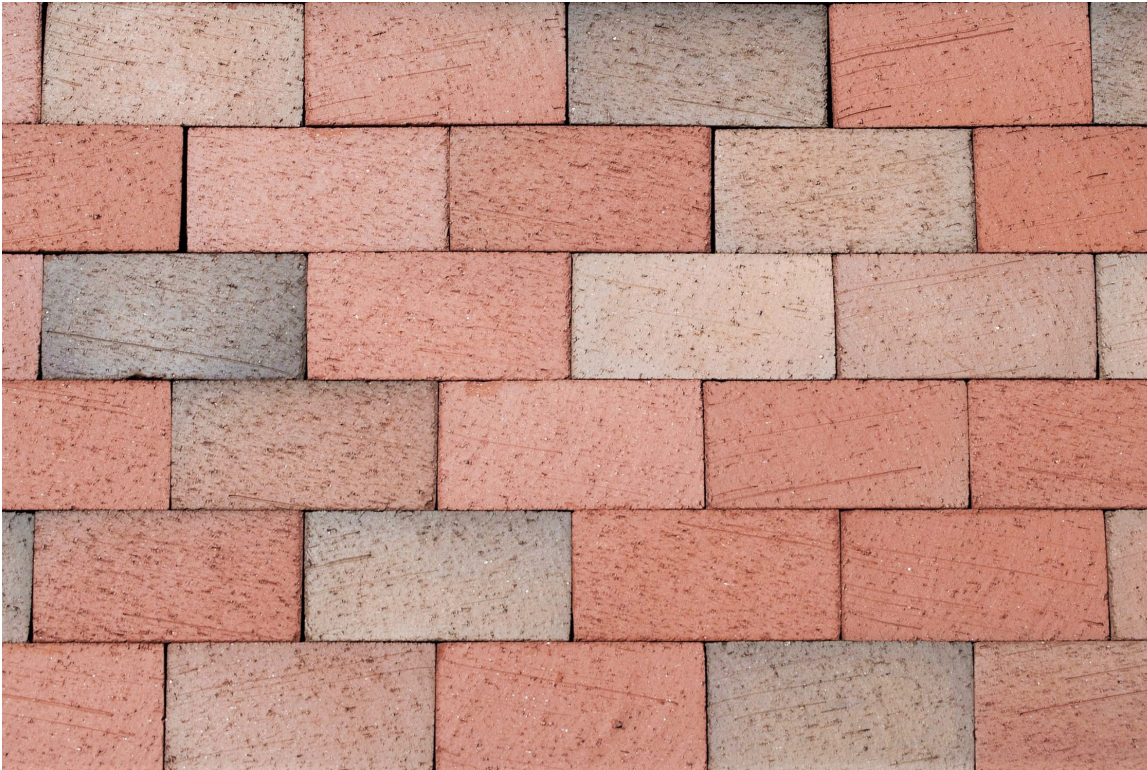
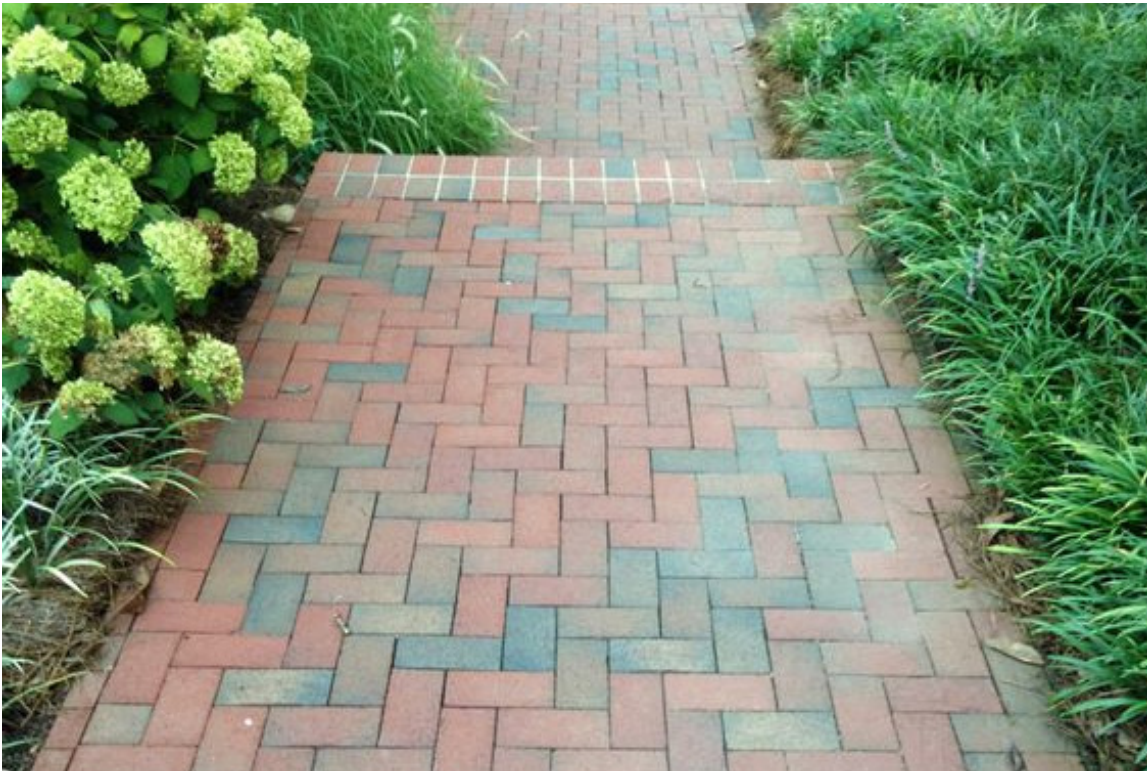
Material Palette - Brick Pathway & Driveway Paver

Manufacturer: Pine Hall Bricks

Line: Pathway Pavers

Finish: Full Range

Size: 4"x8"x2.25"

Pictured: Example of
herringbone layout with border

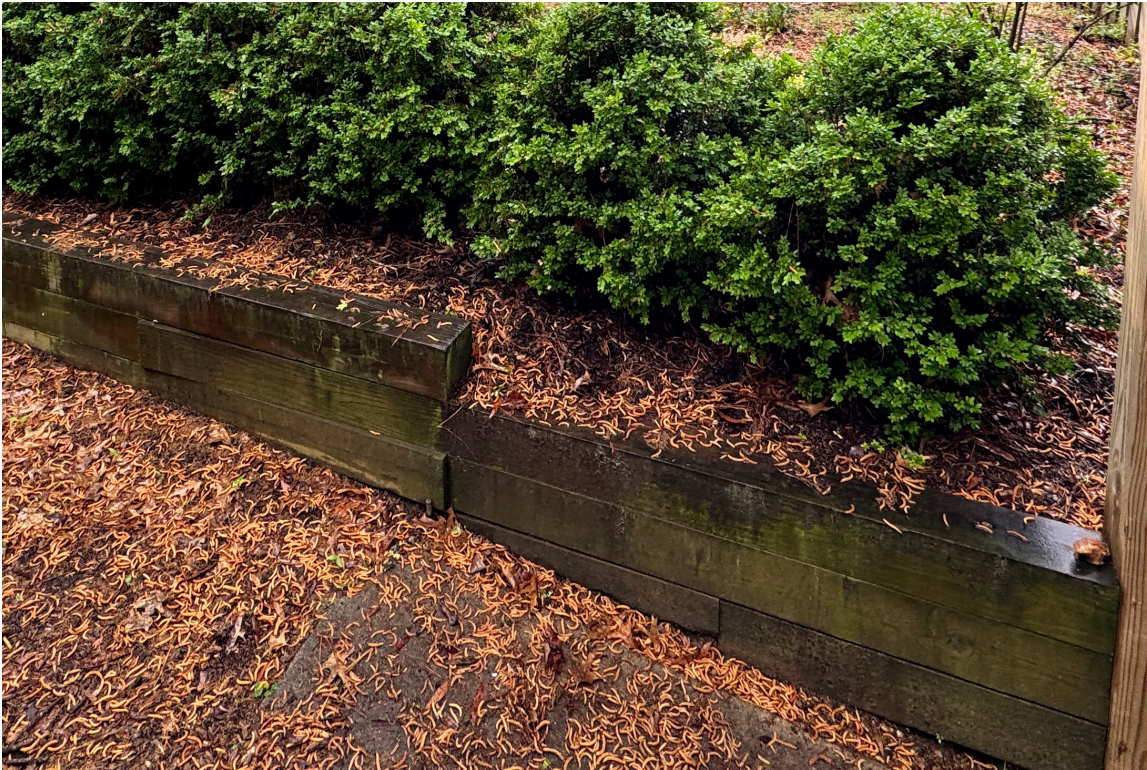
Photo of existing timber retaining wall

Proposed to re-use existing material, and mix new 6"x6" members as necessary

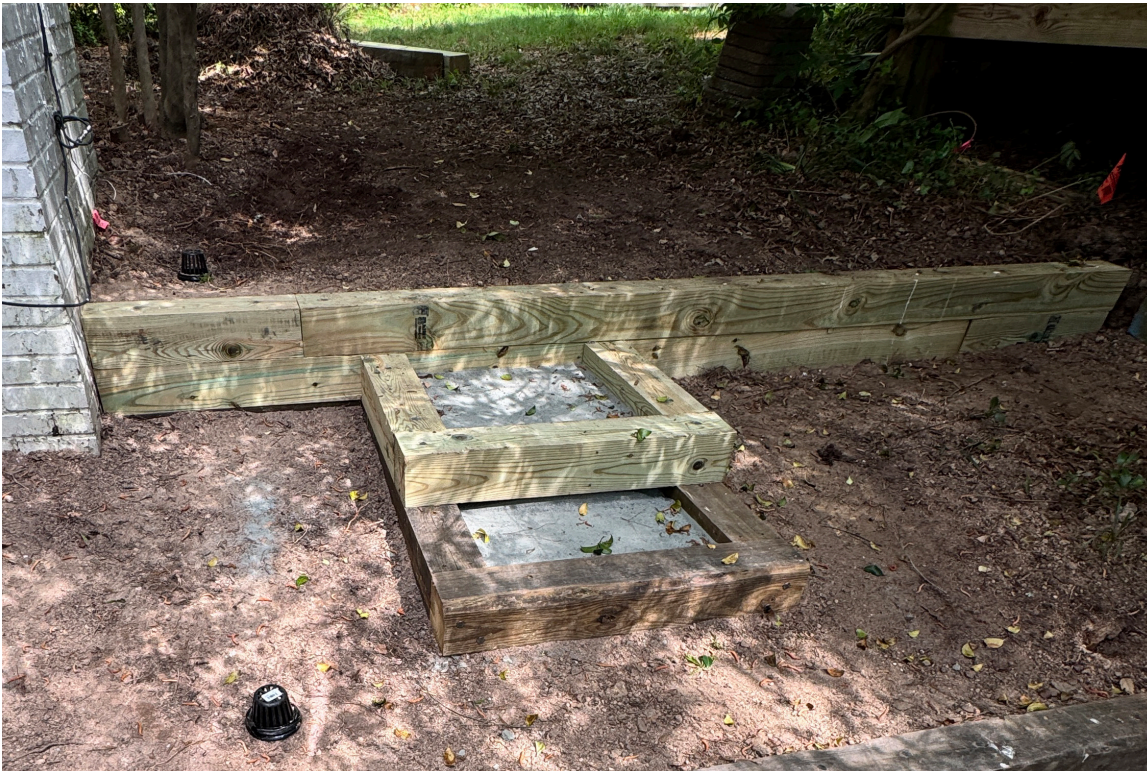
Reference photo of 6"x6" southern pine timber, mixed with exiting timber members

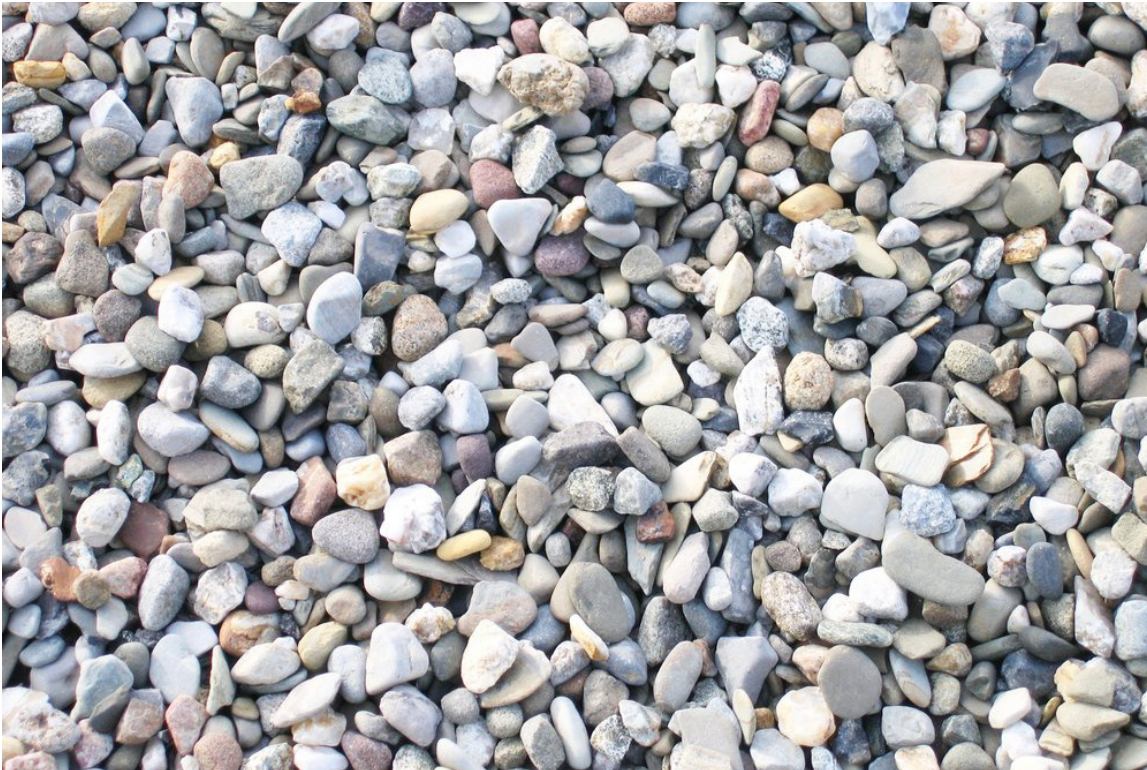
Decorative Gravel

Finish: Delaware Blend
Size: 3/8" - 1/2" dia.

The final change is to the existing gravel splash pad. Currently, a generic bulk aggregate (#57 Wash Gravel) is used. We are proposing to remove, and replace this material with a decorative gravel that is larger in diameter and composed of a blend of colors better meant to match the palette of colors on site.

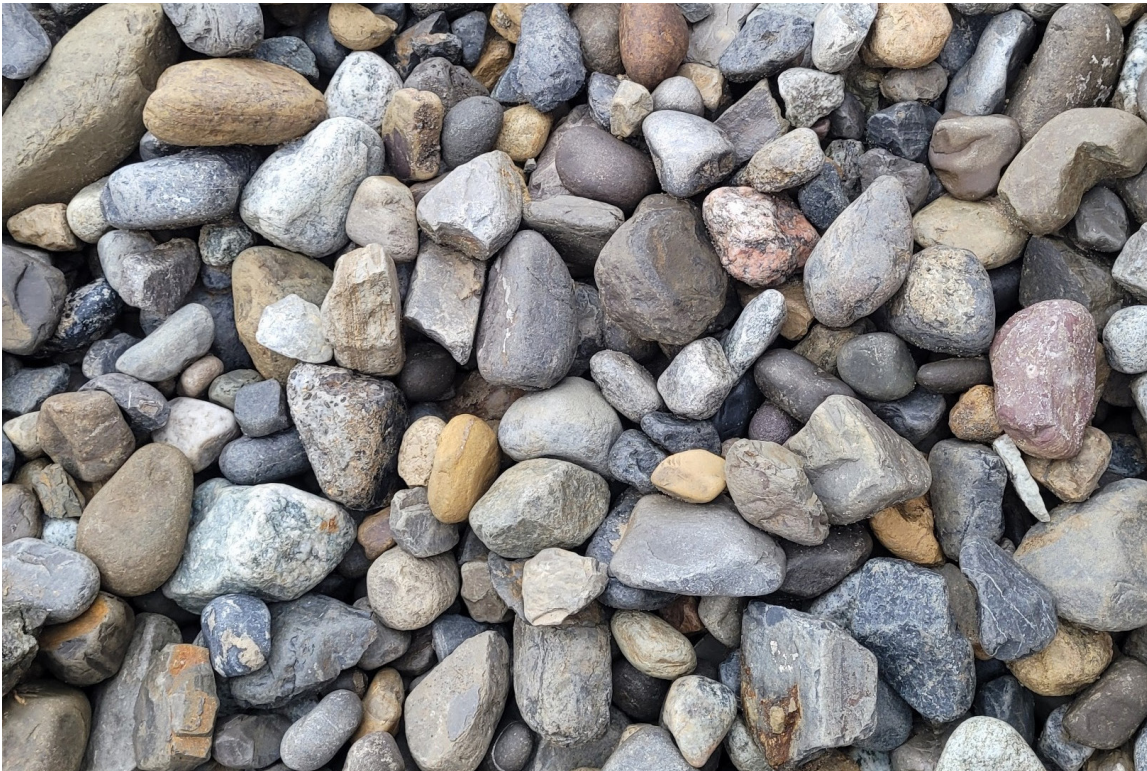
Decorative Gravel

Finish: Delaware Blend
Size: 1" - 3" dia.

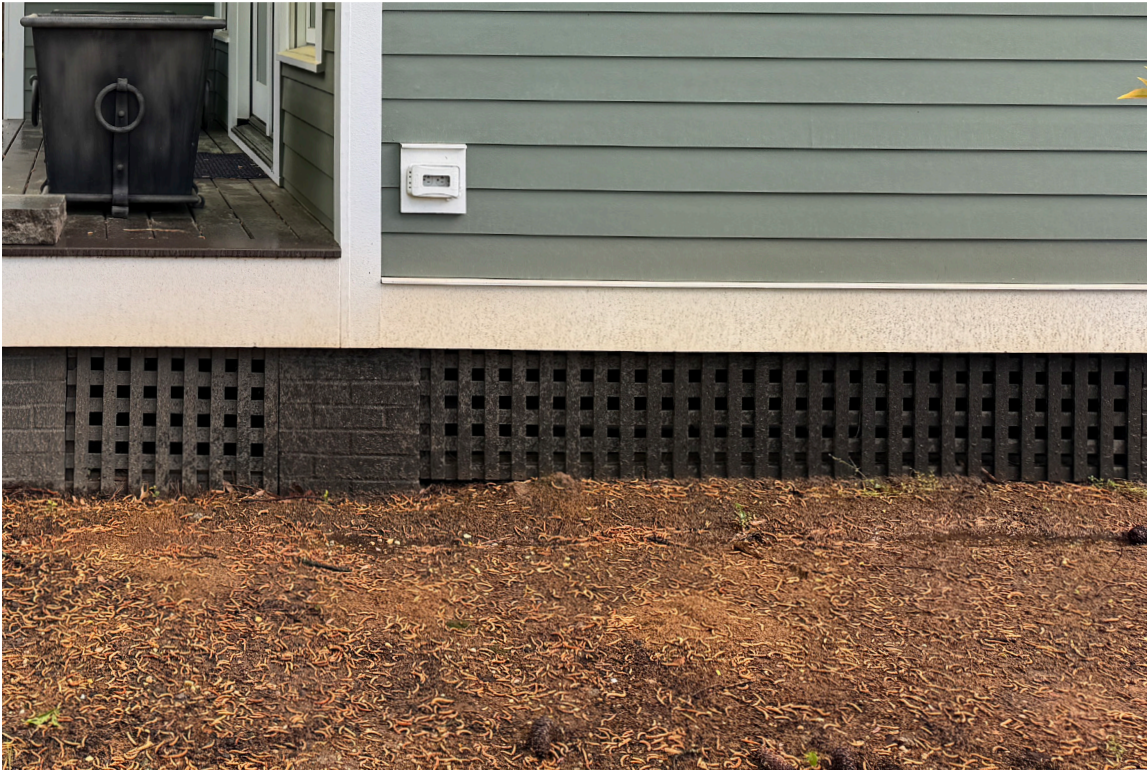
Lattice: Existing shown

Proposed wooden lattice on stair to match existing 1.5" square, paint color TBD.

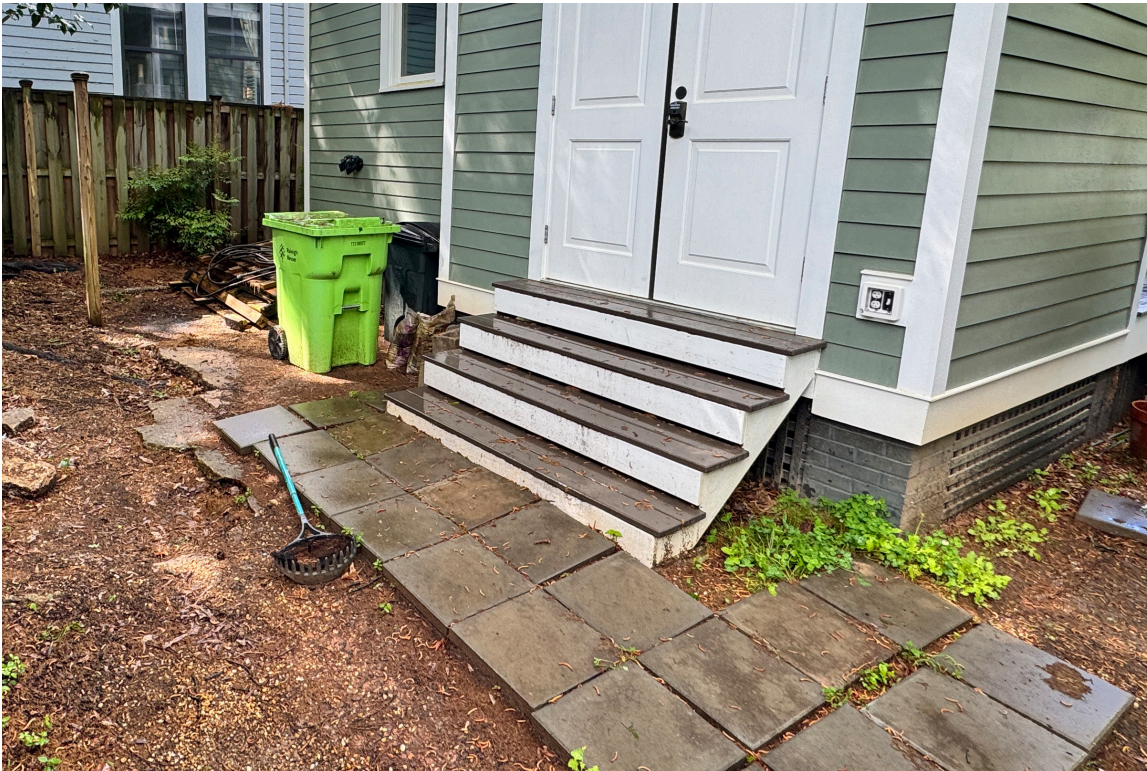
Photo: Existing stair shown for reference

Proposed: Paint TBD
Stringer: Painted Timber
Fascia: Painted Timber
Tread: Painted Timber
