# CERTIFICATE OF APPROPRIATENESS PLACARD

Alter porch roof covering

414 New Bern Ave

COA-0097-2020

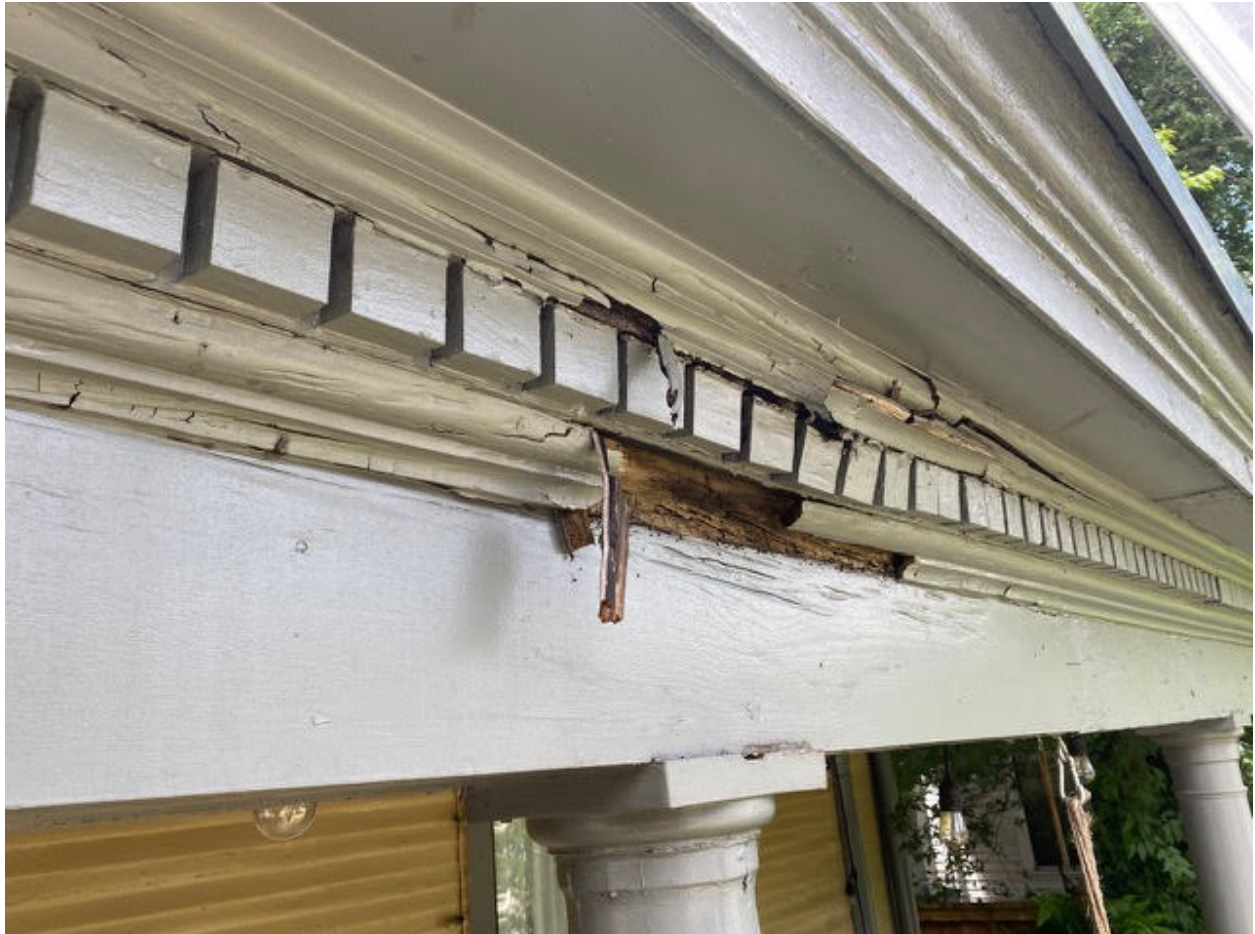
*Rot on ornamental trim wood, I suggest to pay attention to this issue that might be left unattended for too long, at this point we don't know if structural damage has occurred, most likely some sheeting to be replaced; Will confirm upon opening your roof.*

*As mentioned in our conversation, would suggest a new flashing with a "kick out" to help divert water away from fascia boards.*

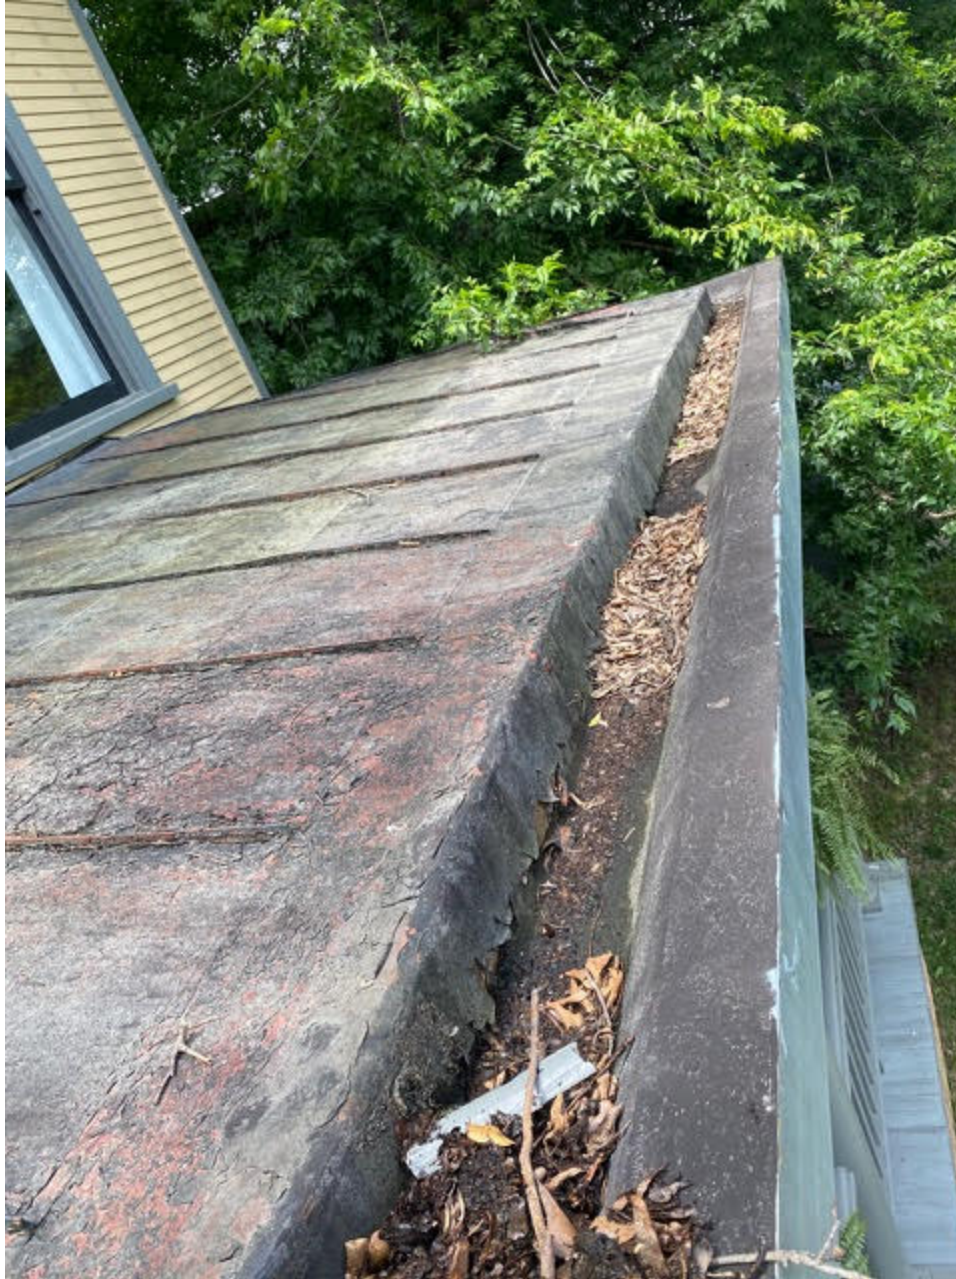
*Roof and built-in gutter shows some repairs were made but accumulation of dead leaves and sediment might have been a problem that accelerated the corrosion process. What you have was a nice roof, most likely original with proper folding techniques but with tin/tern coated steel (material failure), is time to replace with a long lasting material that will not corrode, suggested material: 16 OZ copper.*

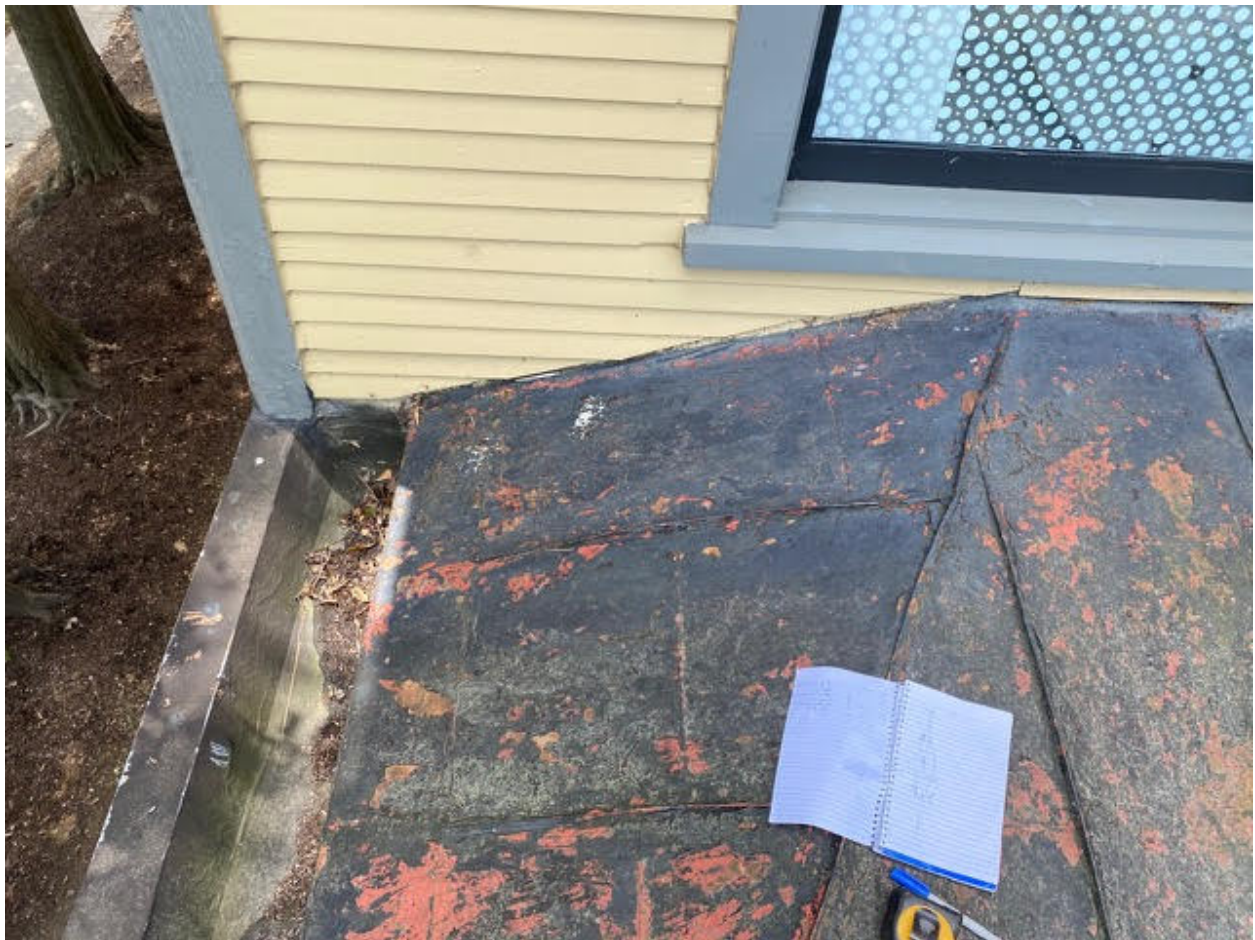
*Picture shows a double standing seam hip (nice detail rarely seen nowadays); Siding to be removed to tuck copper flashing appropriately, replace siding with new, will show more pictures where shows signs of deteriorated siding not worth keeping.*

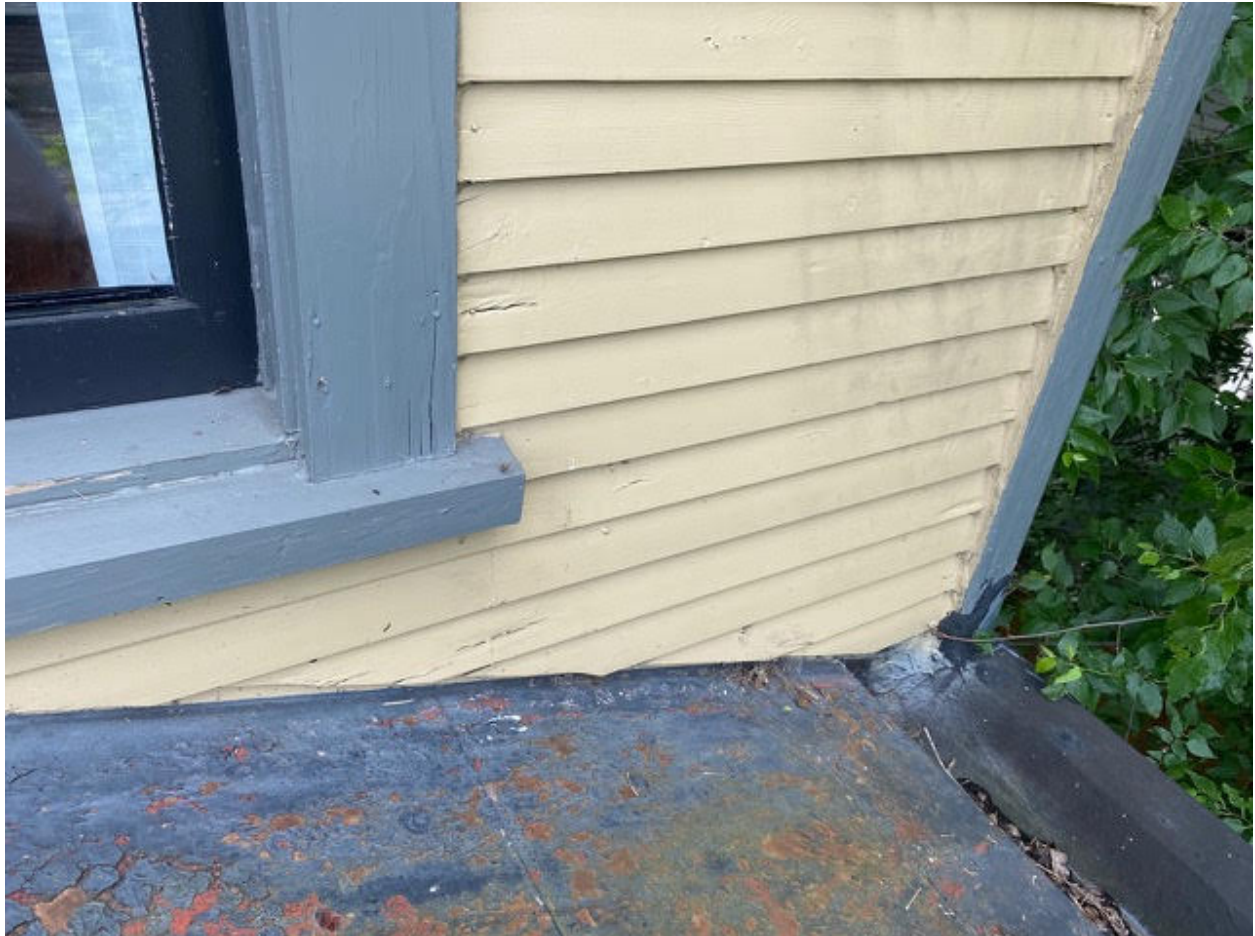
*Siding splitting, once we try to pry out wood, prone to break. For watertightness suggest to have replaced with new siding.*

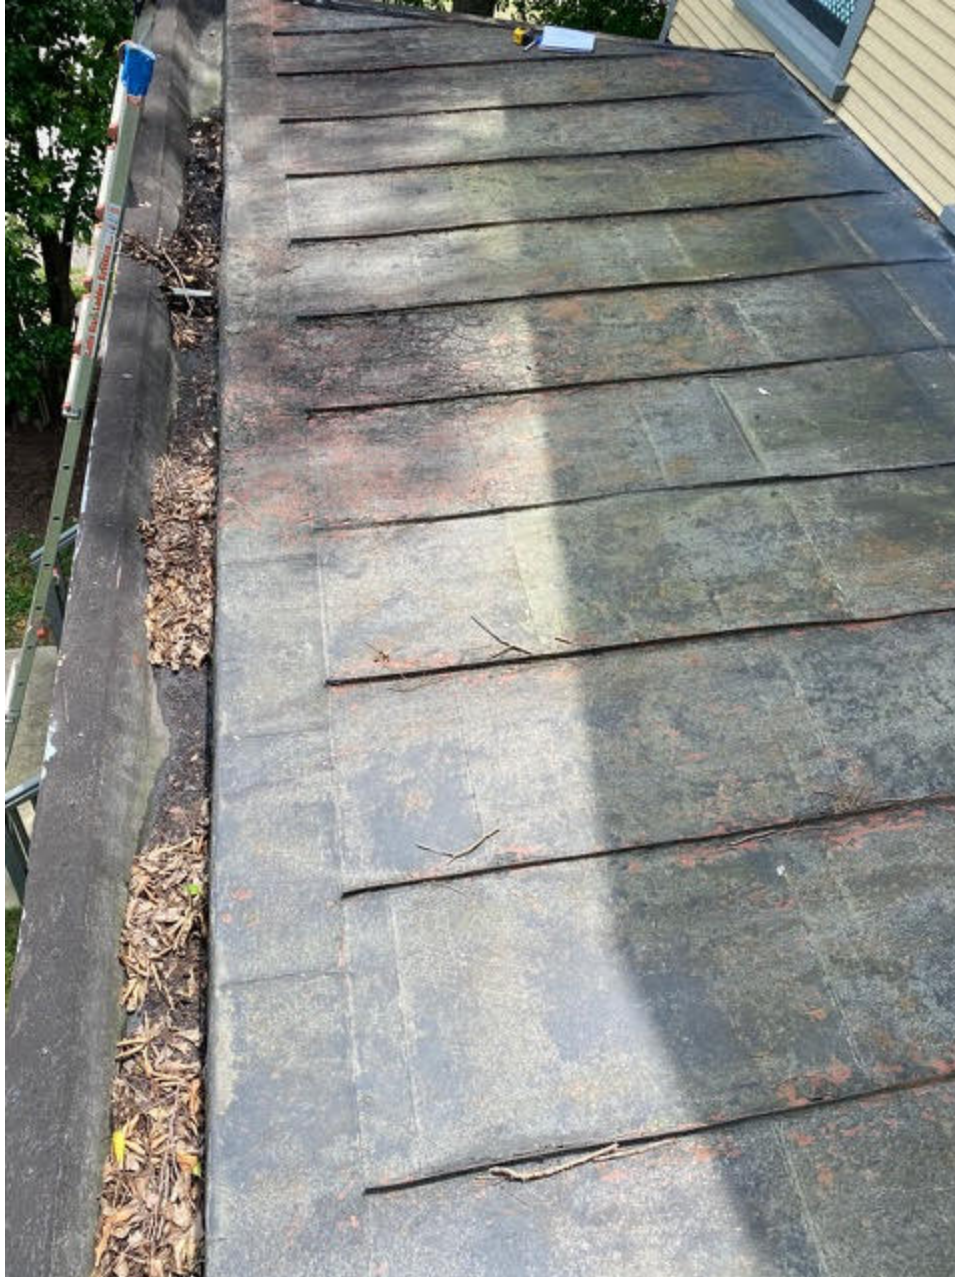
*Heavy sediment formed at the bottom of built in gutter.*

*Both drains clogged. Pay attention to give maintenance cleaning gutter at least twice per year, cut branches closer to the house.*

*Some exposed fasteners through built-in gutter, what I offer you is a concealed fasteners system with 304 stainless steel, will not corrode.*

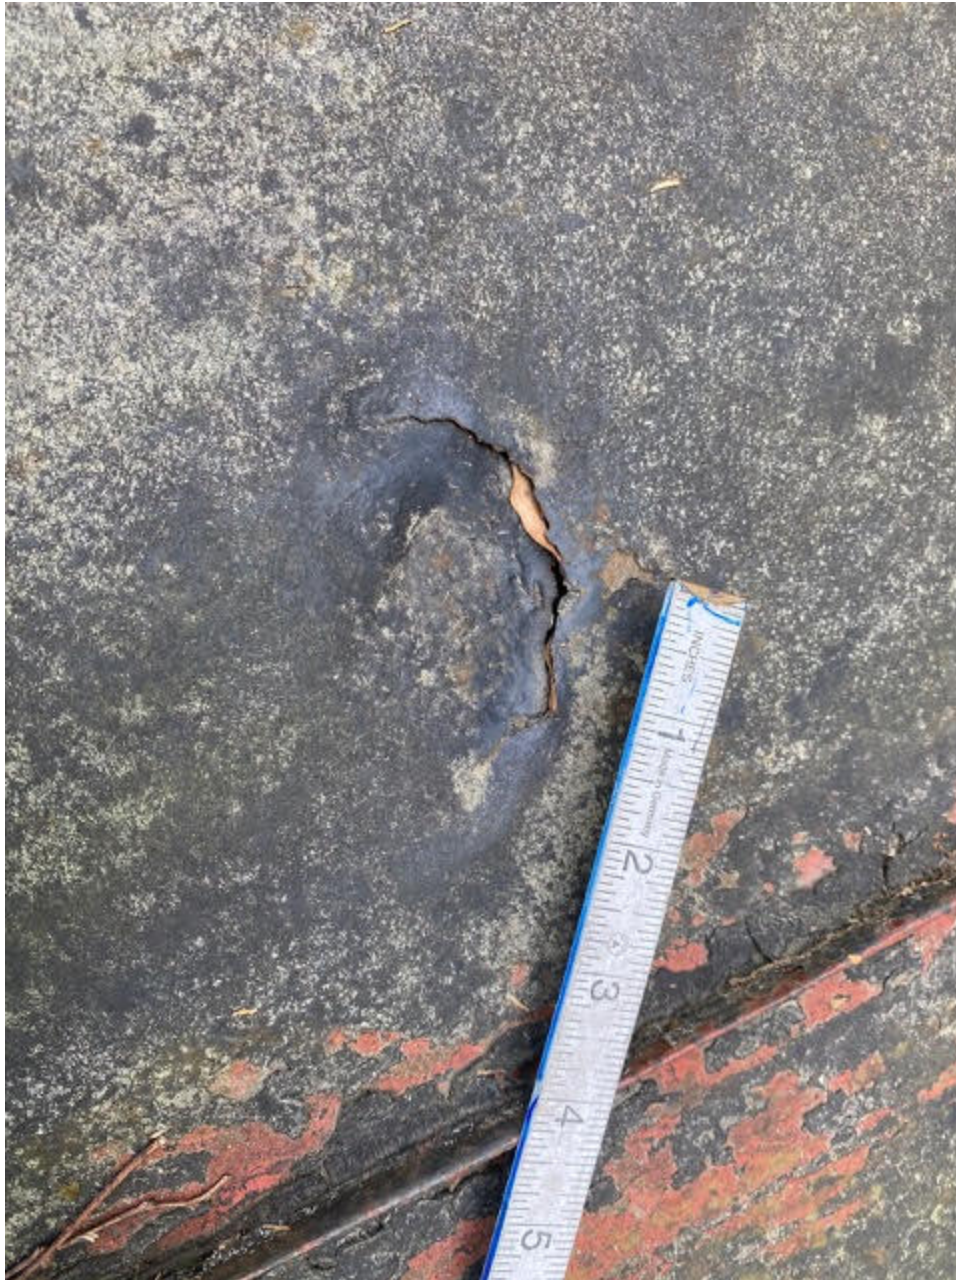
*Found a couple of holes, set my ruler to give an idea of size, these located around the center and to the right of porch roof. Soffit underneath shows cracks on wood.*

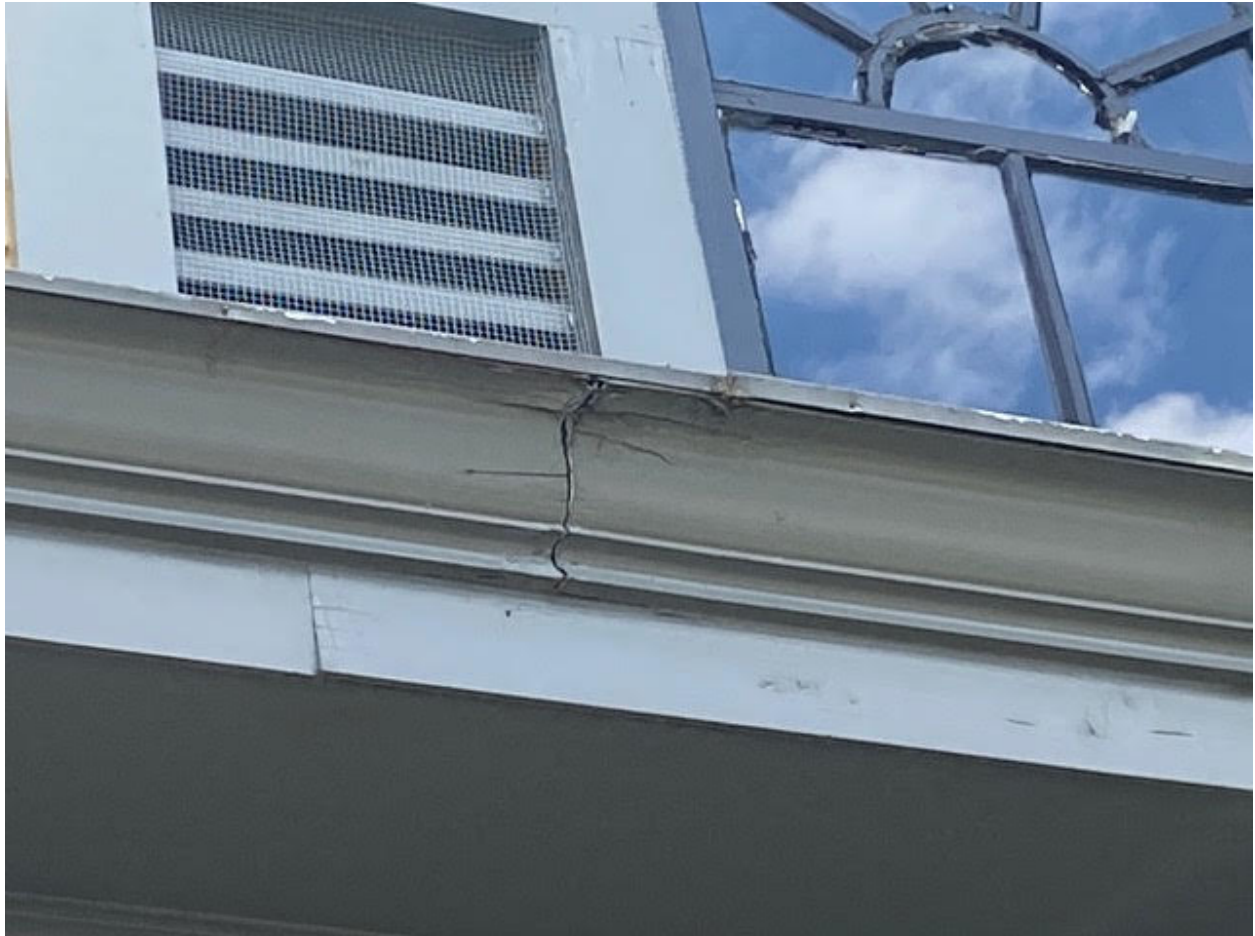
*This wood splitting makes me wonder if there is a leak on water table above porch, something to consider giving maintenance as well before it gets severe damage.*

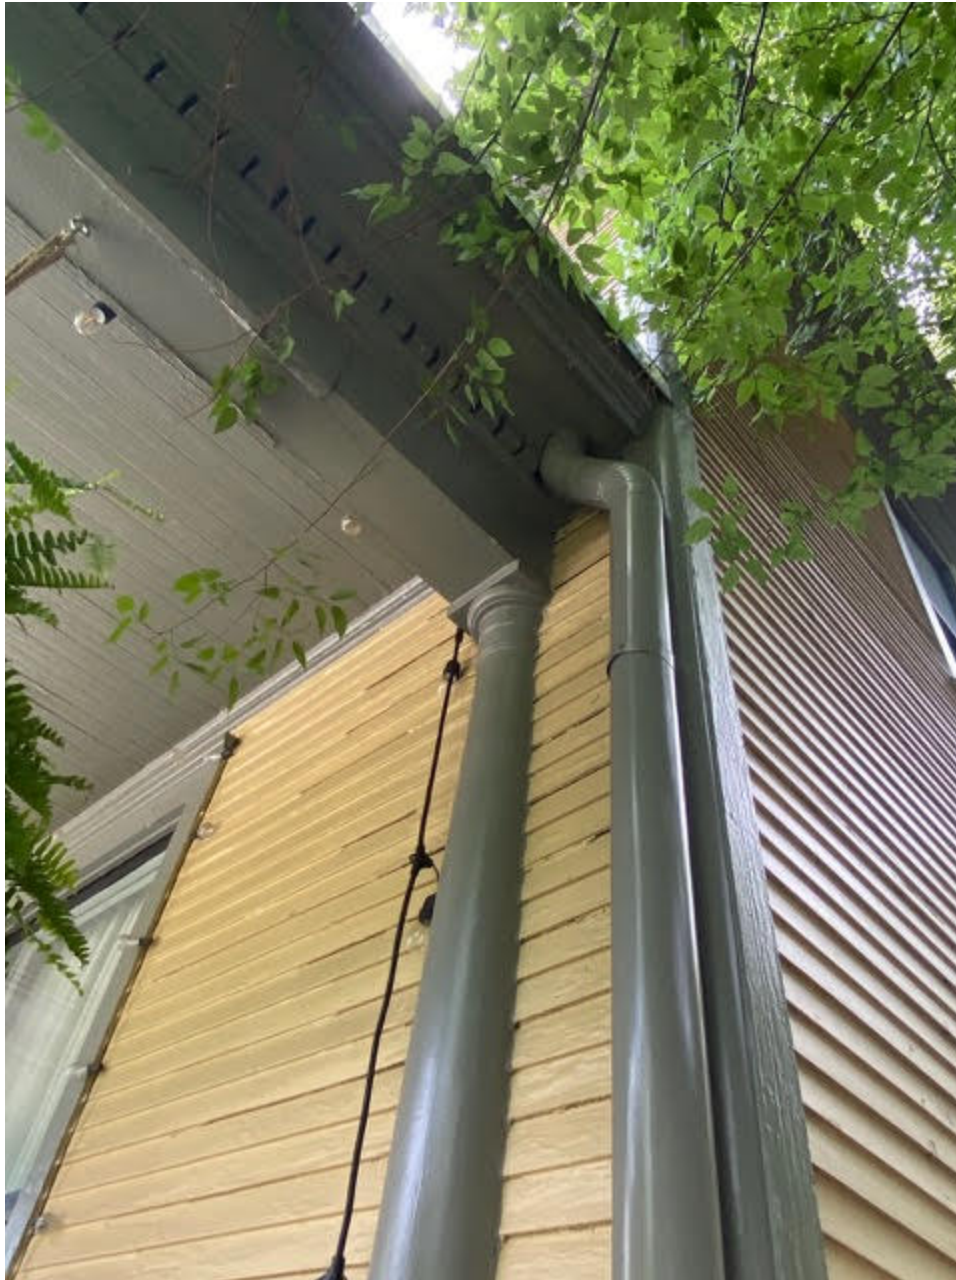
*Both downspouts will leave in place, can make new drains from the top and properly solder to insure watertightness.*
