CERTIFICATE OF APPROPRIATENESS PLACARD

Replace concrete front steps and terrace pavers in-kind; enlarge front weeping holes, install front ground scuppers; construct low-profile stucco cap at building/ front step joint

99 N Salisbury St

First Baptist Church, Salisbury Street, COA Application, August 2022

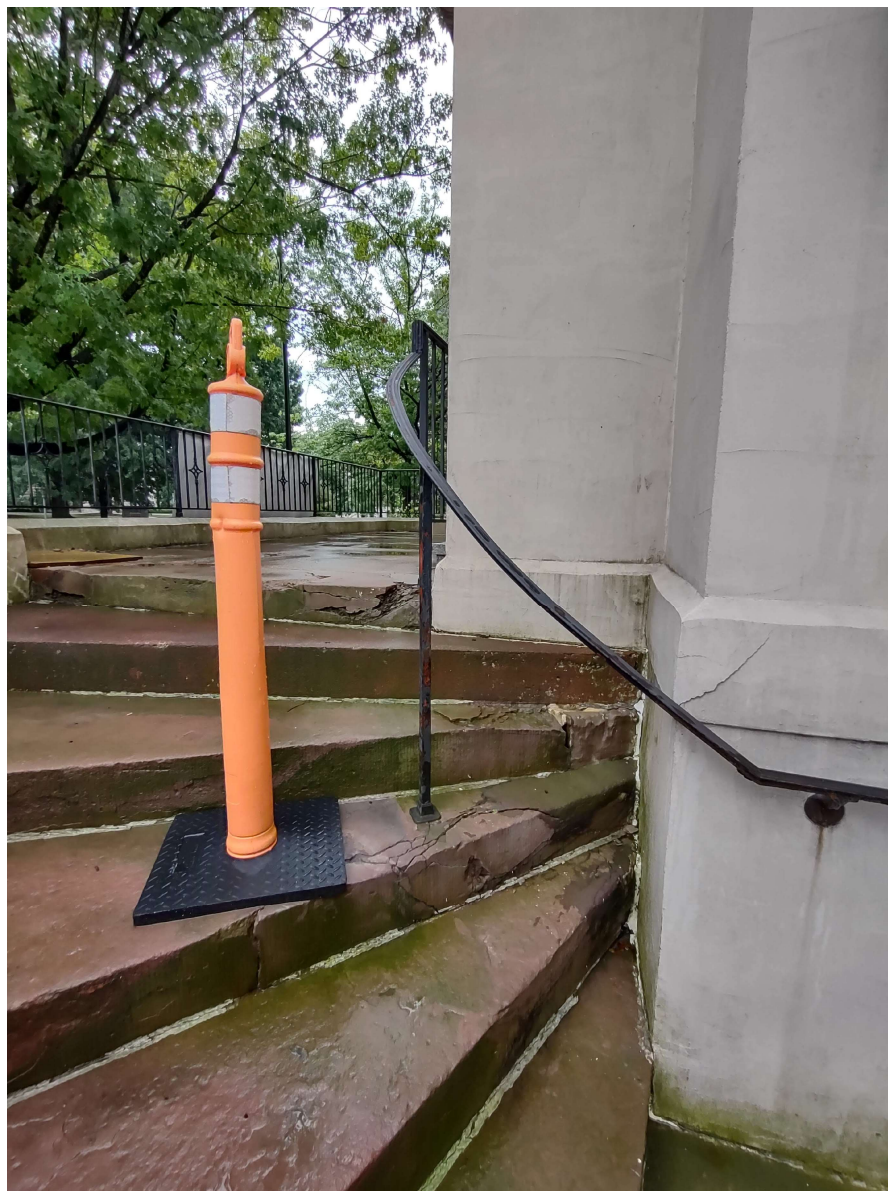
Proposed cap to
cover interior corner

2. improving the intersections between the steps and the building by creating a low stuccoed housing over the interior corners to more effectively shed water away from the building and away from the corners where it currently collects;
3. improving drainage within the wall that fronts the terrace and steps by enlarging the existing weep holes slightly and adding a modest scupper to each hole;
4. repairing crumbling stucco along the base of the front wall.

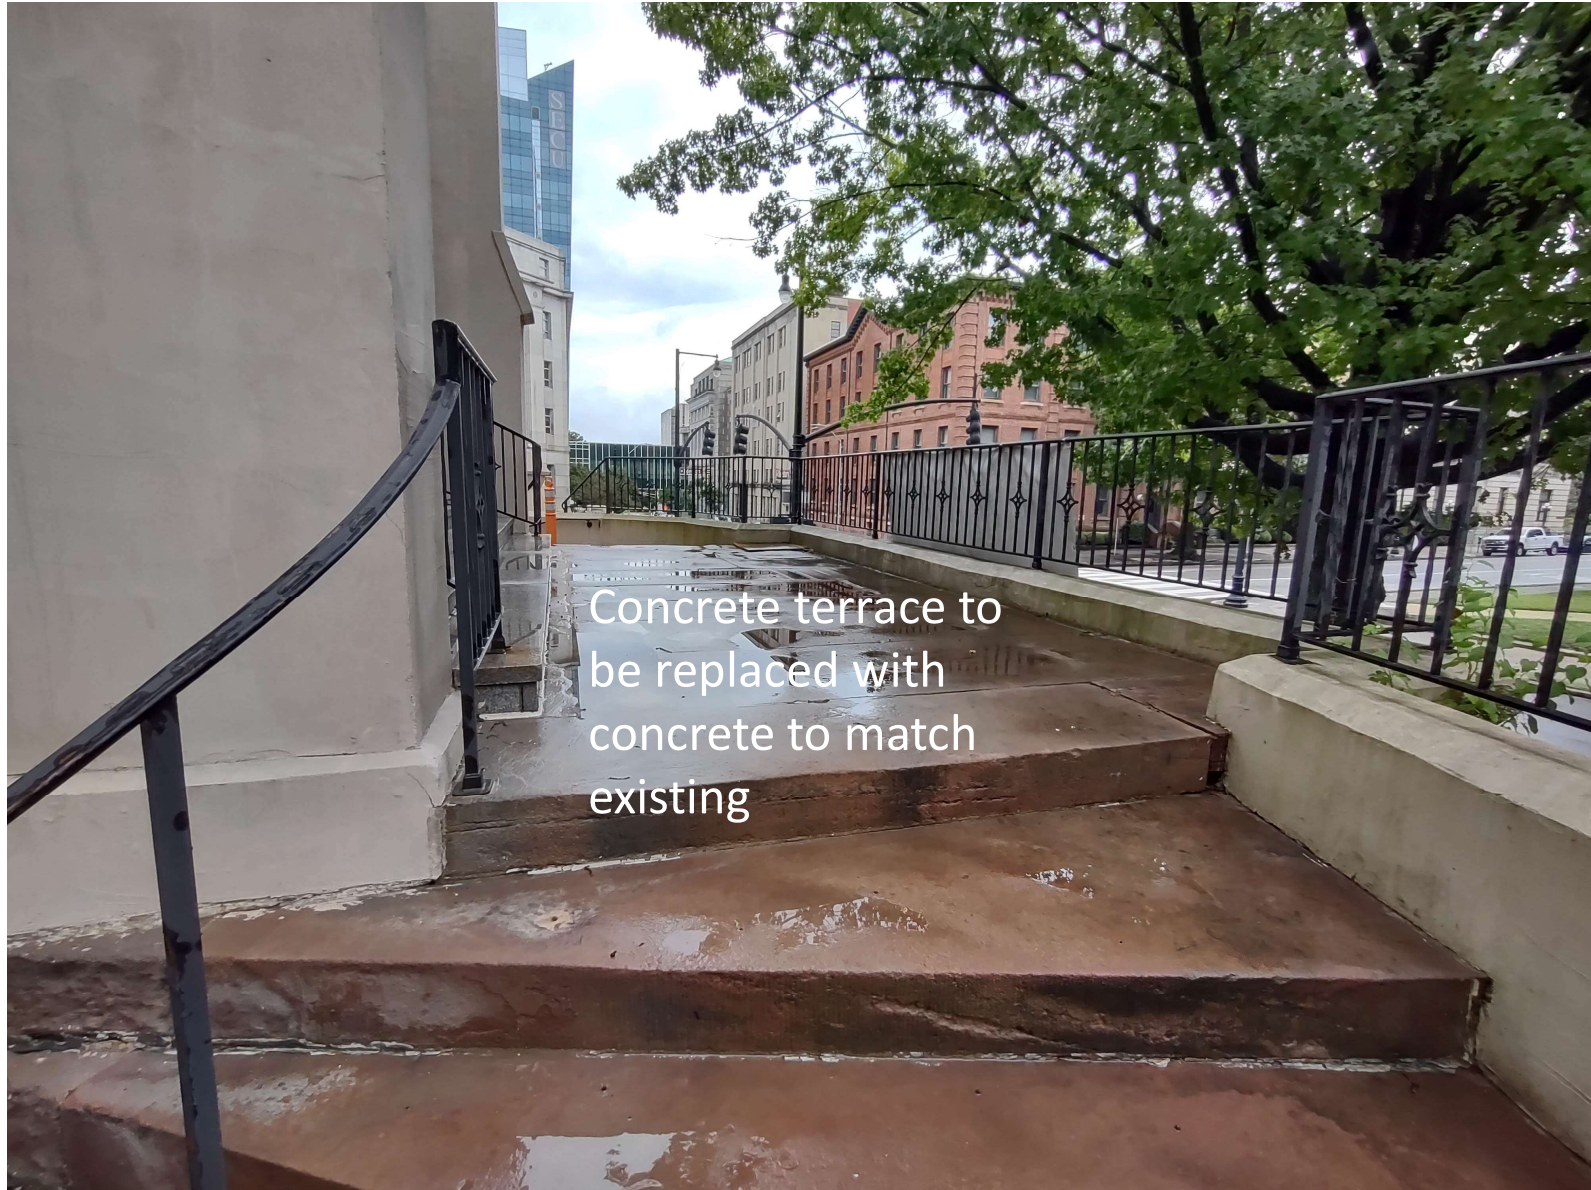
Concrete terrace to
be replaced with
concrete to match
existing

1. replacing the deteriorated concrete steps and concrete terrace pavers

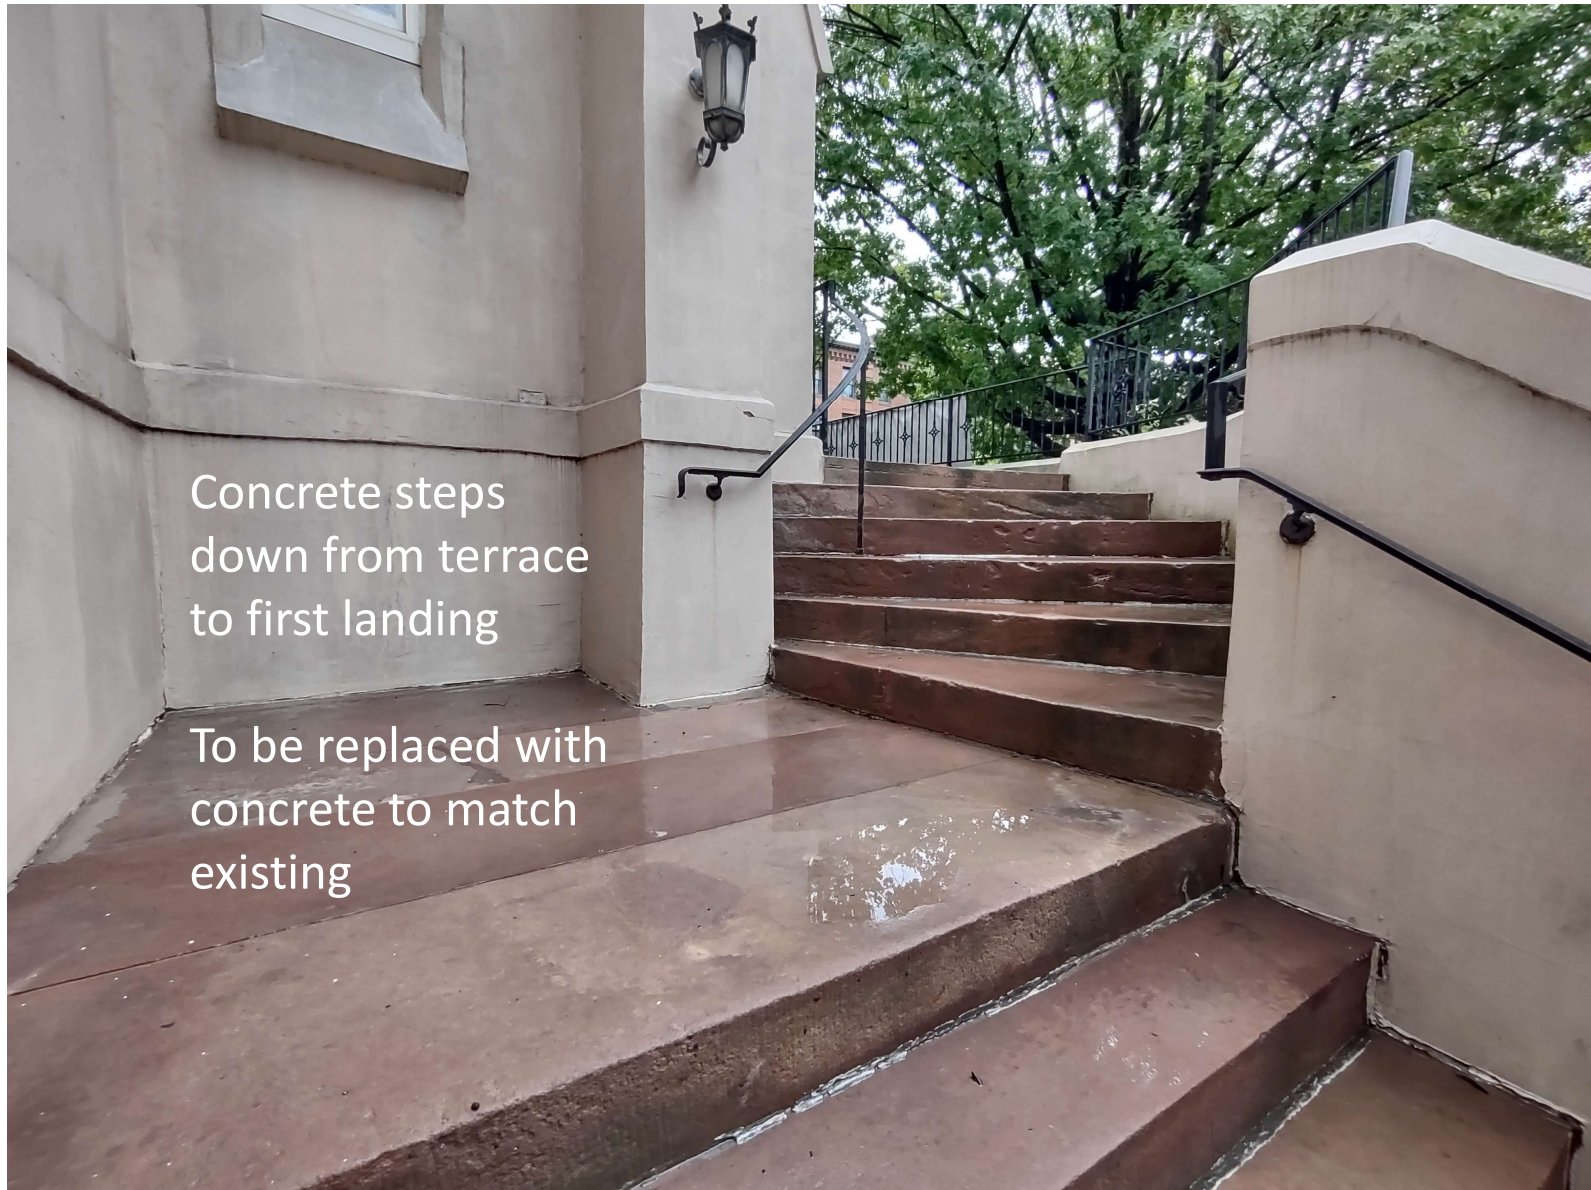
Concrete steps
down from terrace
to first landing

To be replaced with
concrete to match
existing

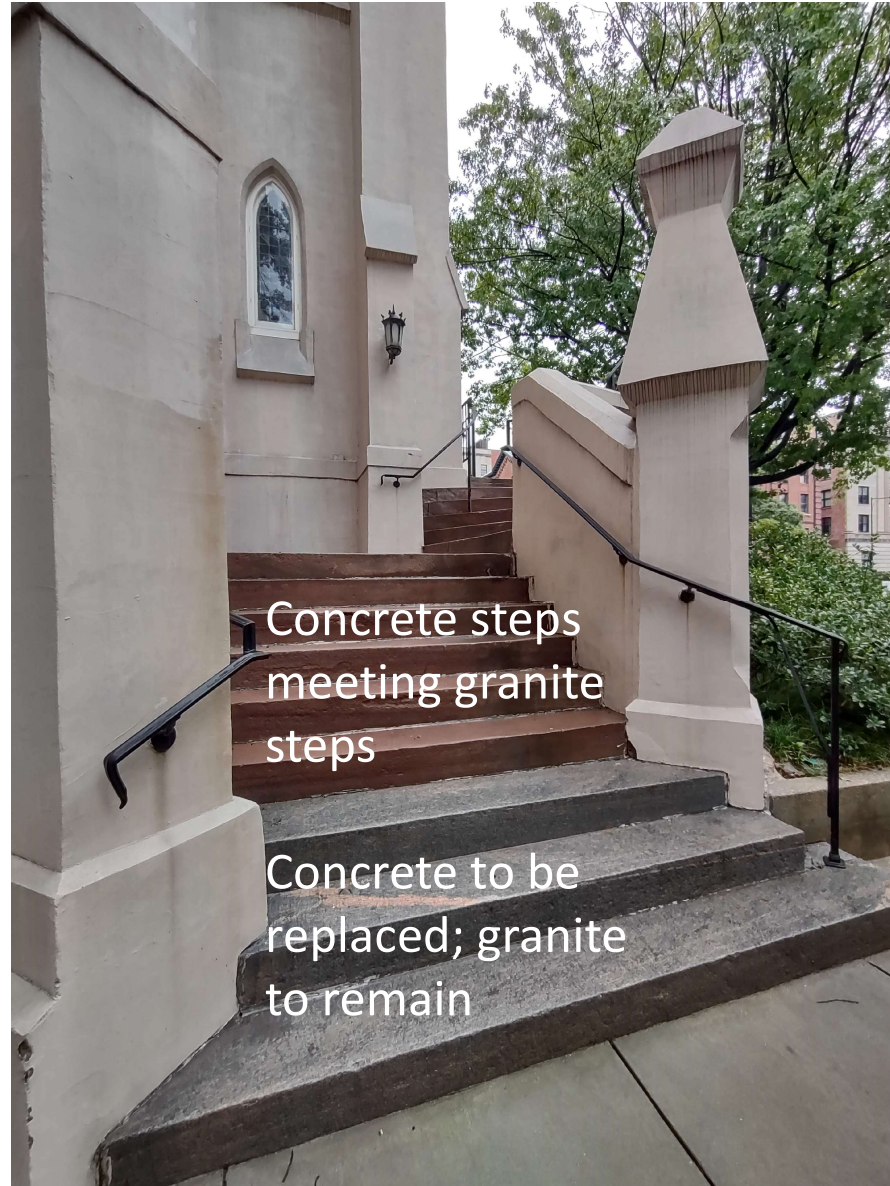
Concrete steps
meeting granite
steps

Concrete to be
replaced; granite
to remain

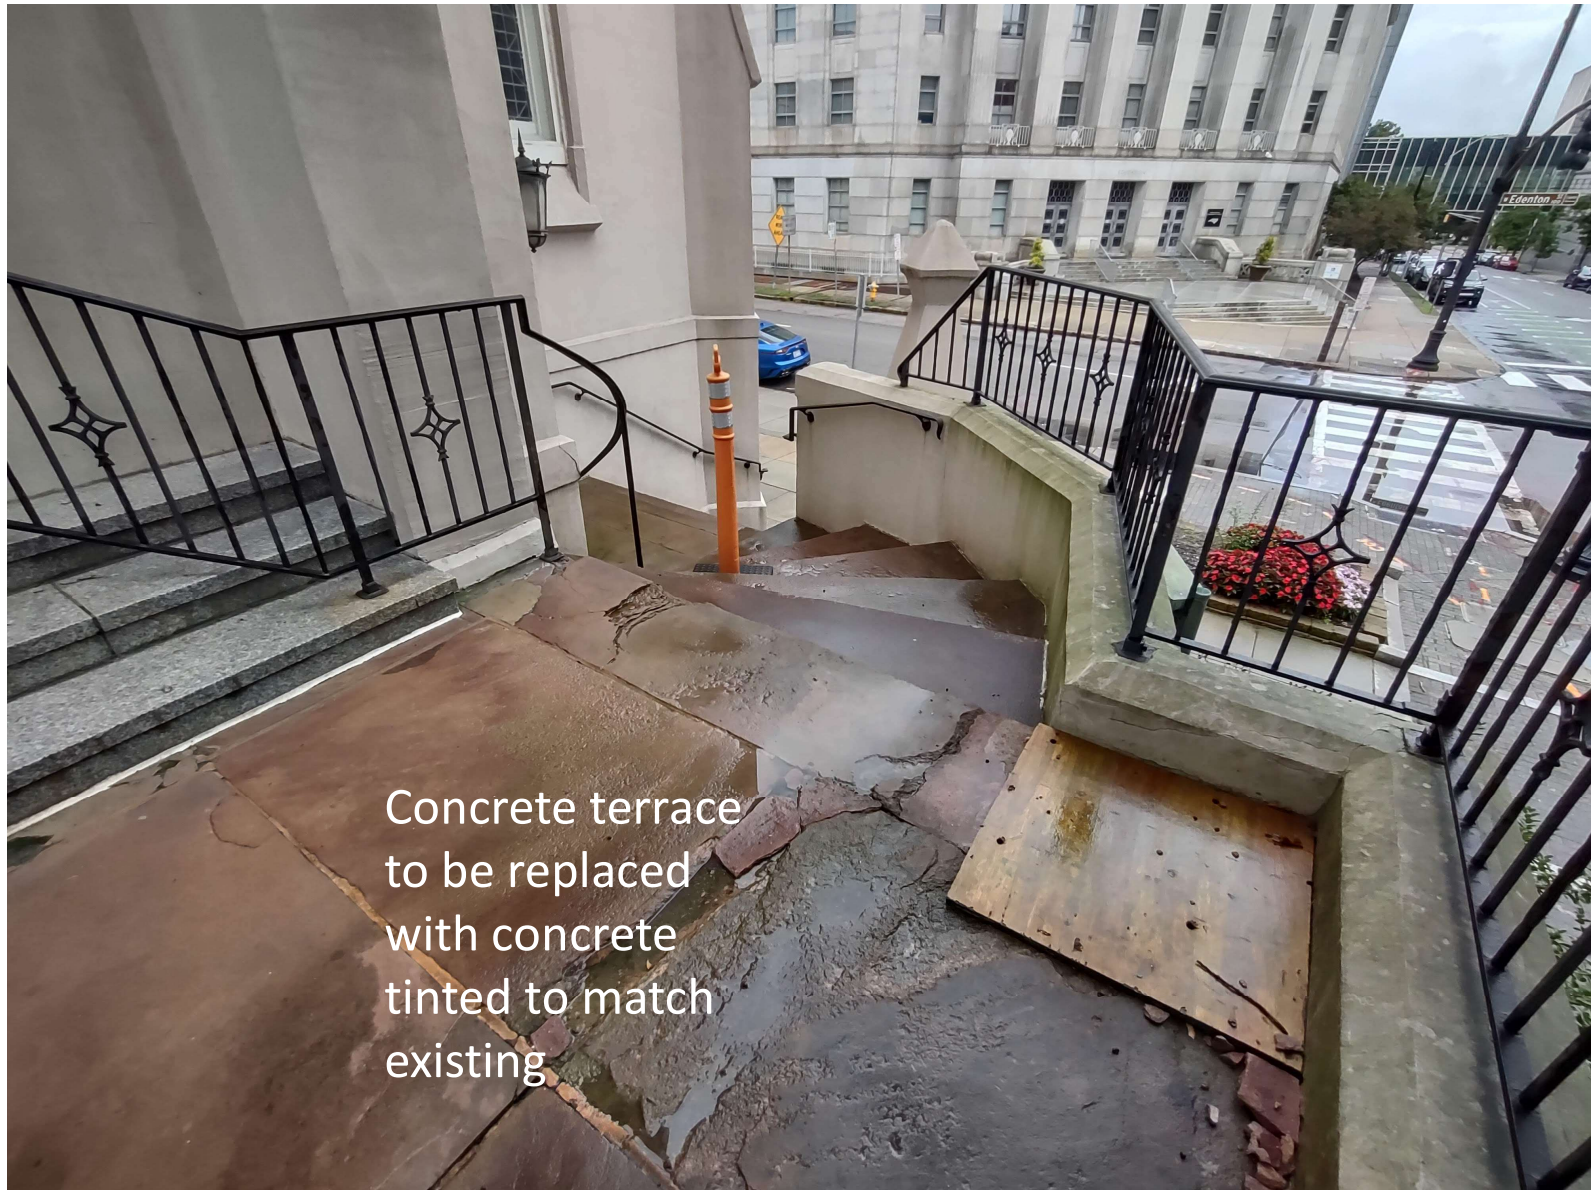
Concrete terrace
to be replaced
with concrete
tinted to match
existing

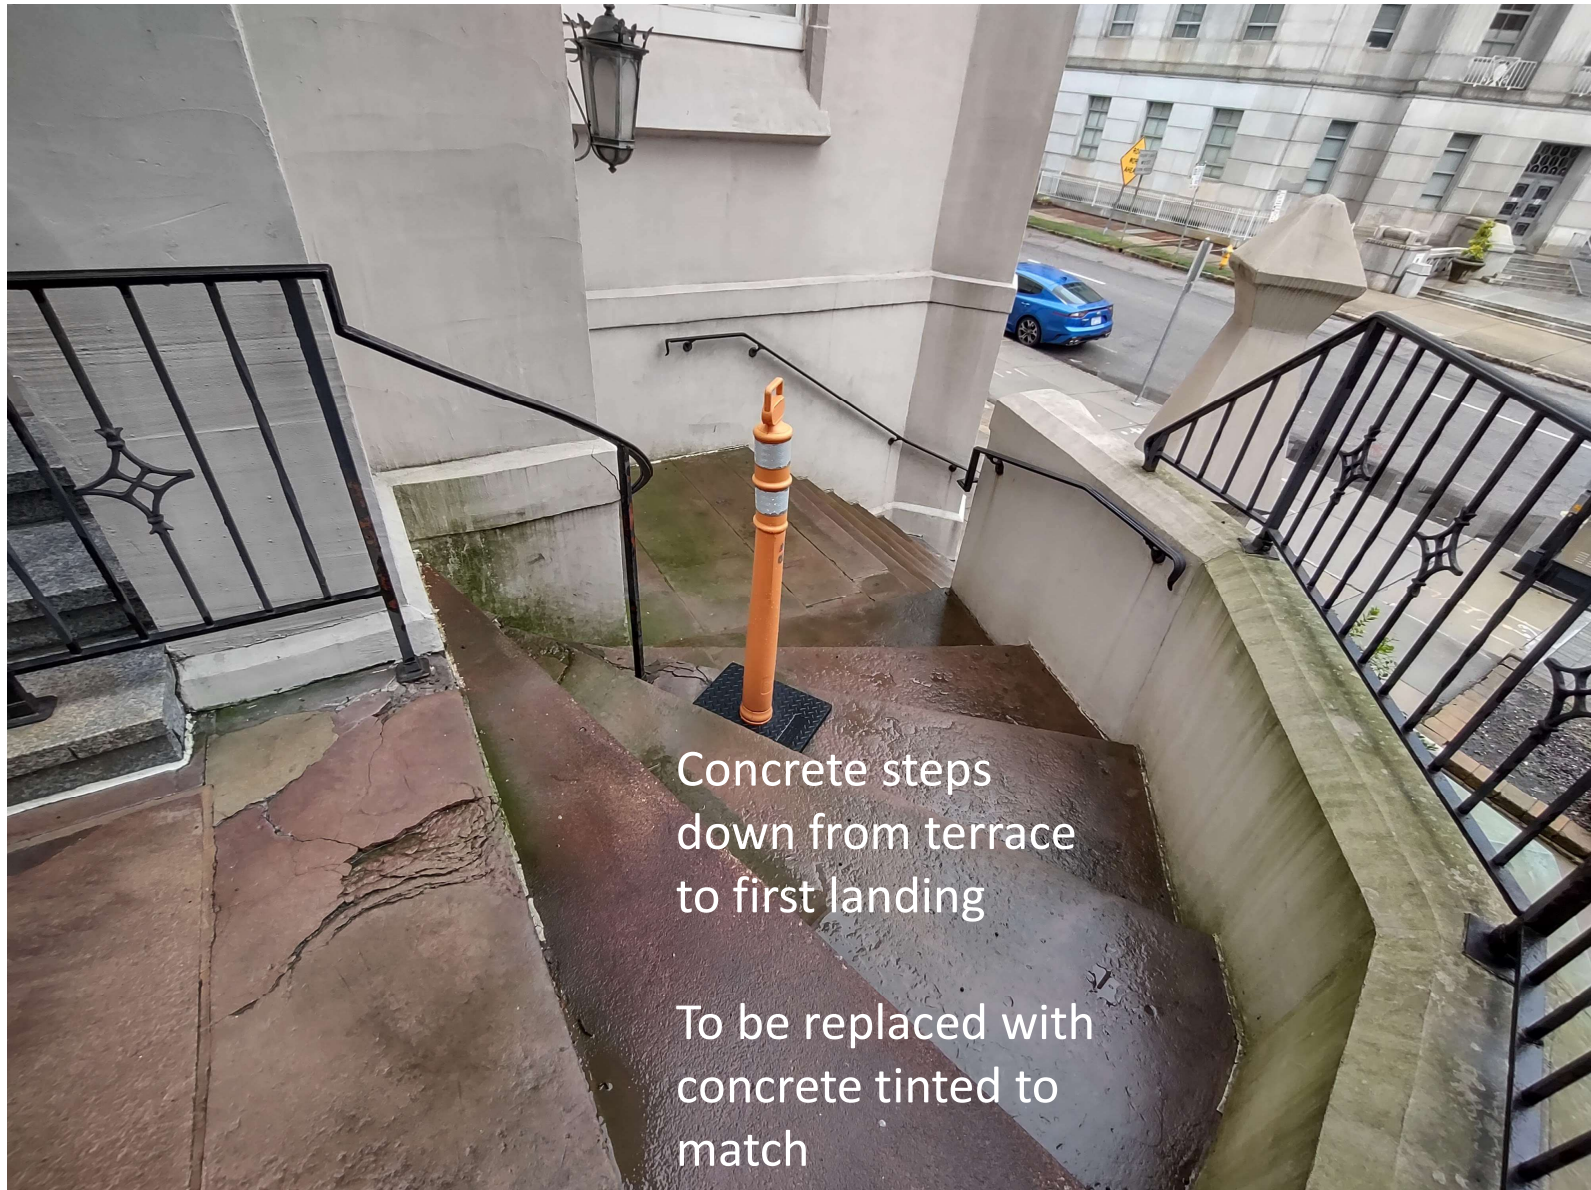
Concrete steps
down from terrace
to first landing

To be replaced with
concrete tinted to
match

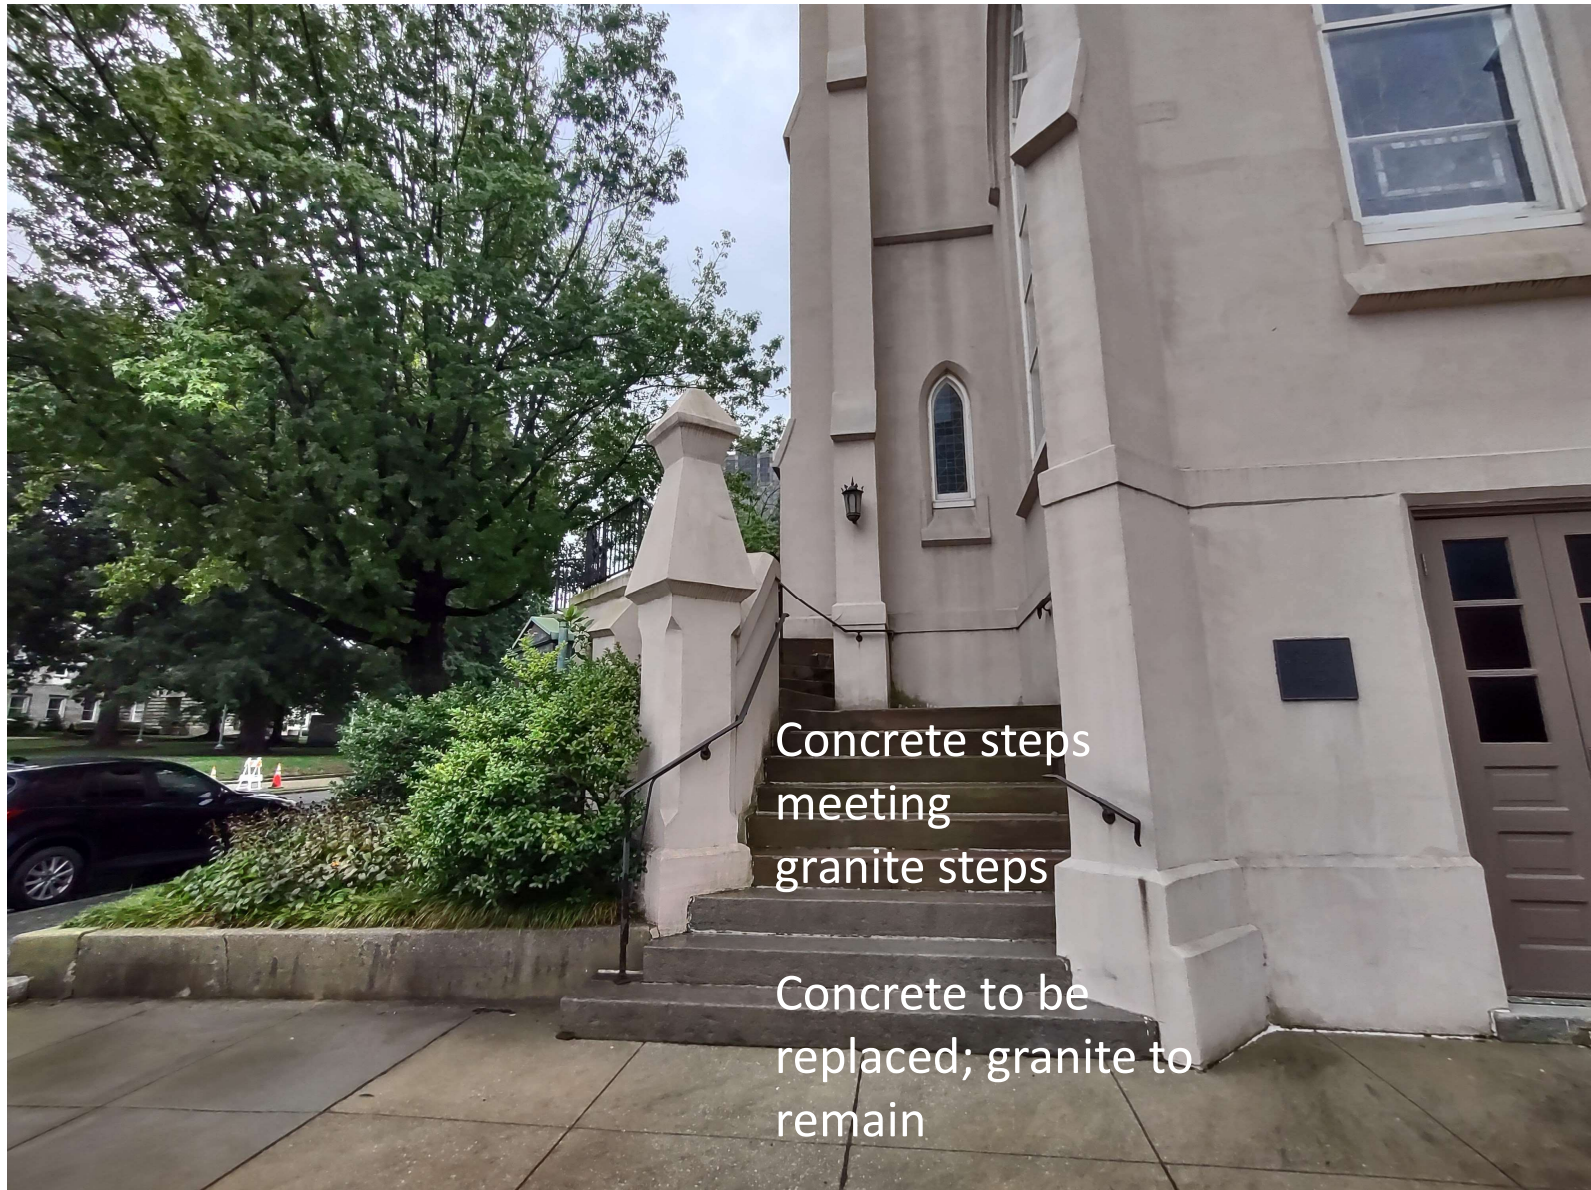
Concrete steps
meeting
granite steps

Concrete to be
replaced; granite to
remain

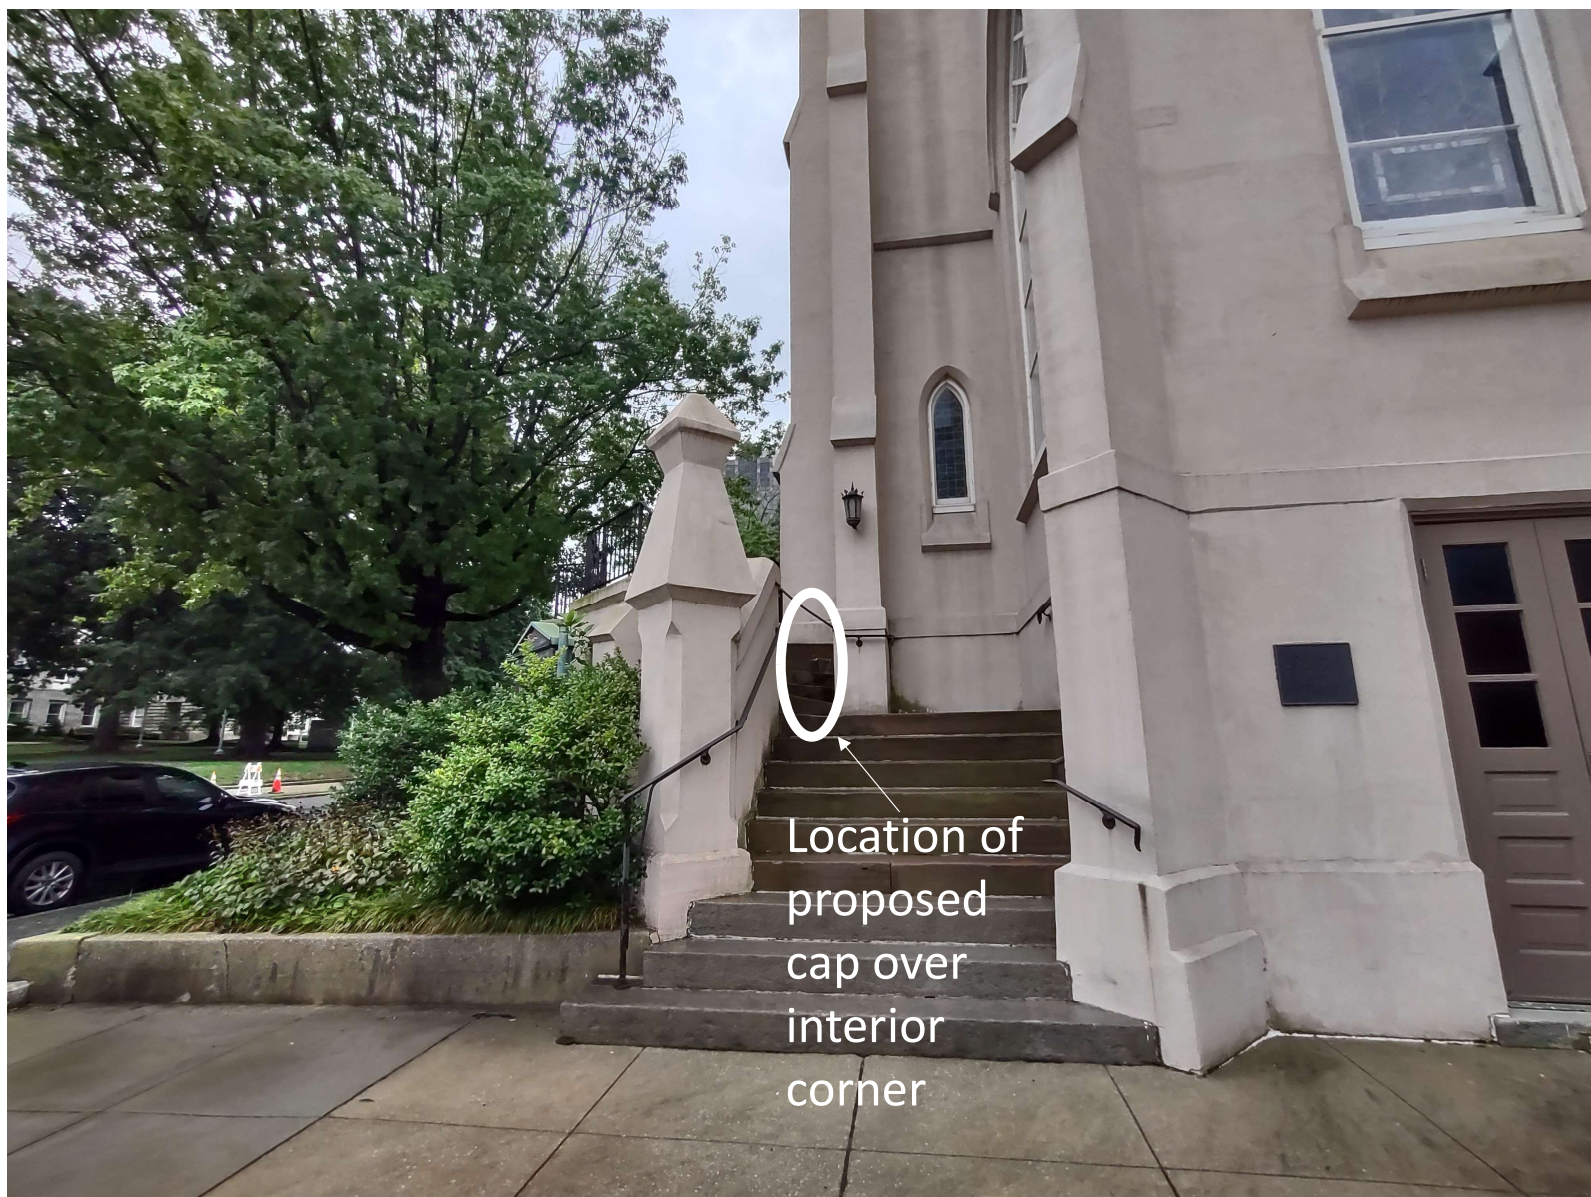
Location of
proposed
cap over
interior
corner

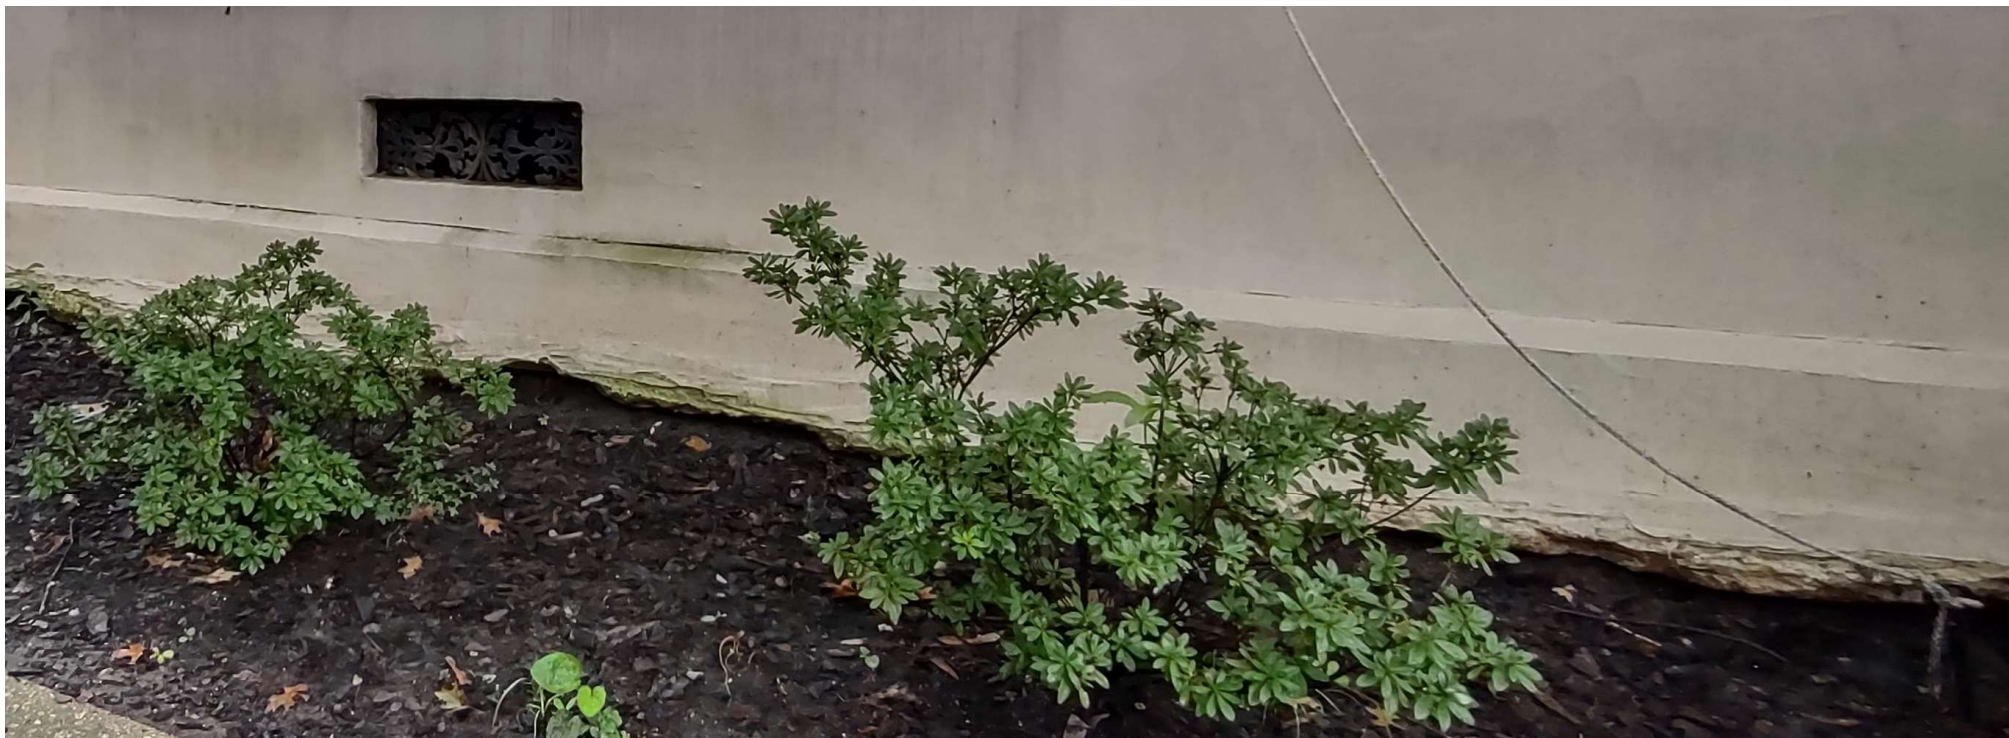
Deteriorated stucco along the base to be patched; this occurs around the entire base of the structure.
