CERTIFICATE OF APPROPRIATENESS PLACARD

Remove rotted cornice moulding; install K-style gutters

209 Linden Ave

COA-0100-2023

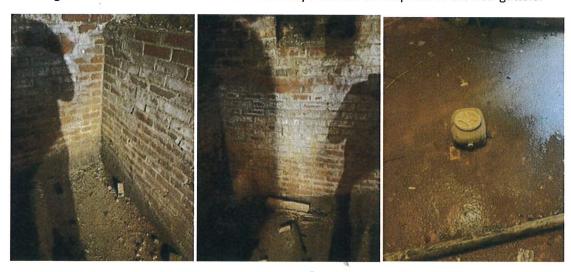
I need to add gutters around the entire perimeter of the home to help with water management. Currently there is standing water in the crawlspace after any sizeable rain event and there is water damage/mold from years of water intrusion through the foundation. I have spoken with the Raleigh Stormwater team and have a consultation scheduled for 8/22 to find an appropriate approach for handling the stormwater runoff in a sustainable way from the downspouts of the new gutters.

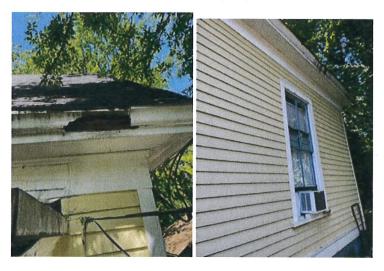
Our first approach was going to be using half-round gutters to preserve the trim. But approximately 60% of the fascia and/or soffit was damaged and in need of repair. When beginning repairs it became apparent that much of the cornice trim was also not in good condition and not salvageable. Unfortunately, due to years of roofing neglect much of this has rotted away.

Now that $^{\sim}70\%$ of the trim that was removed is not salvageable/able to be re-installed we will have to have it all custom milled to match.

So this led to the K-stlye gutter approach, to be mounted direct to the fascia. While doing a quick walk around the block I found several homes that seem to have K-style gutters flush mounted to the fascia, so I do believe that this will be congruent.

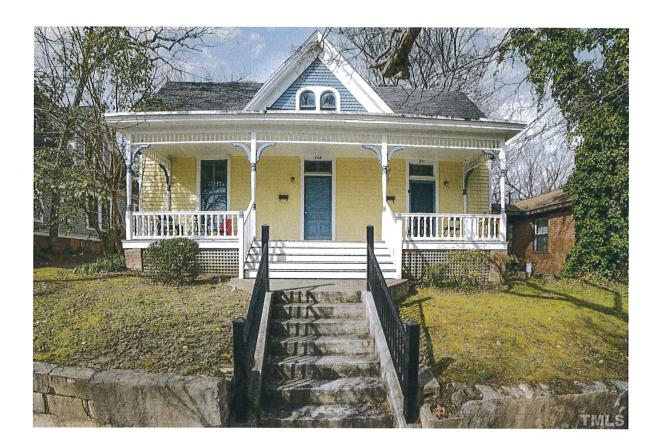
The gutters will be white seamless gutters, and will extend on each horizontal fascia to create a consistent profile around the home. The cornice crown trim on the vertical/diagonal fascia will remain and be repaired when necessary. The flashing on the front membrane roof that is covering the top of the crown now will be tucked into the k-style gutter.
