CERTIFICATE OF APPROPRIATENESS PLACARD

Remove utility chimneys

604 Oakwood Ave

COA-0123-2025

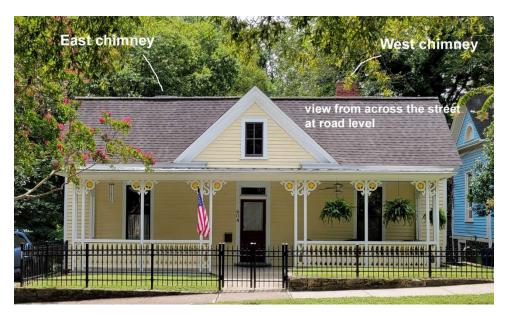
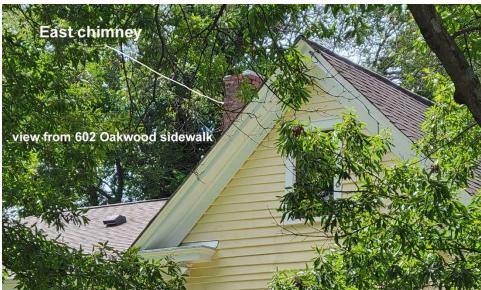
The top few rows of brick on the west chimney are visible only from the front. Only the mesh wire covering the top of the east chimney is visible. The east chimney is somewhat visible from the sidewalk going towards Linden Avenue.

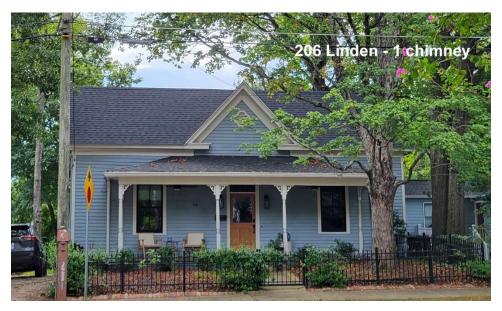
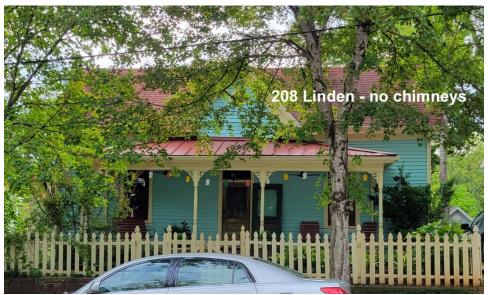
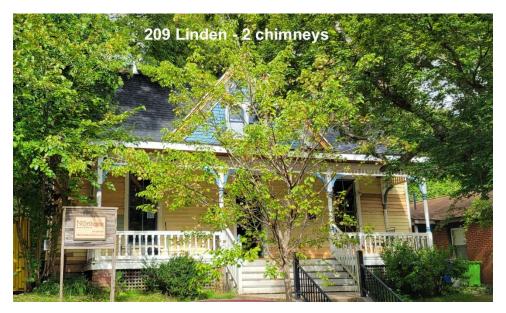
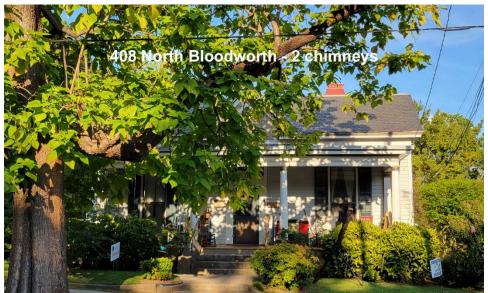
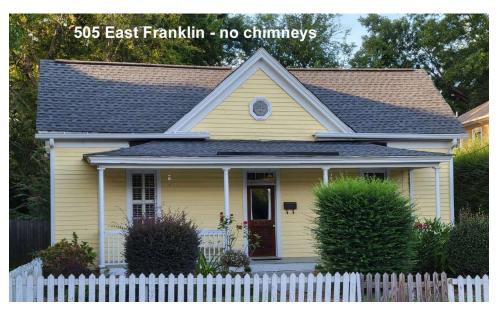
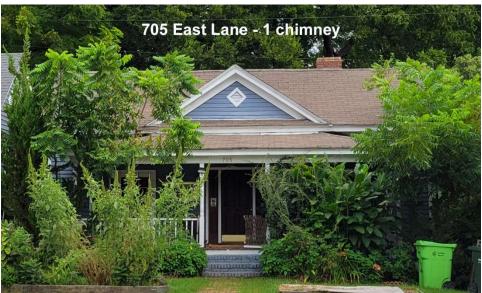
According to Matthew Brown's 2018 "Inventory of Structures in the Oakwood National Register Historic District", there are six additional Historic Oakwood properties of the same style:

As chimneys are visible only on some of the structures - and barely visible on the 604 Oakwood property - I would argue that they are not character-defining and should be classified as service/utility chimneys.
