APPLICATION FOR A CERTIFICATE OF APPROPRIATENESS – STAFF REPORT

COA-0157-2018 405 E FRANKLIN STREET

Nature of Project: Demolish house and garage; remove 3 Willow Oak trees; seed and straw parcel

RE: Single Family Home
405 East Franklin Street
Raleigh, NC 27601
Structural Evaluation Report

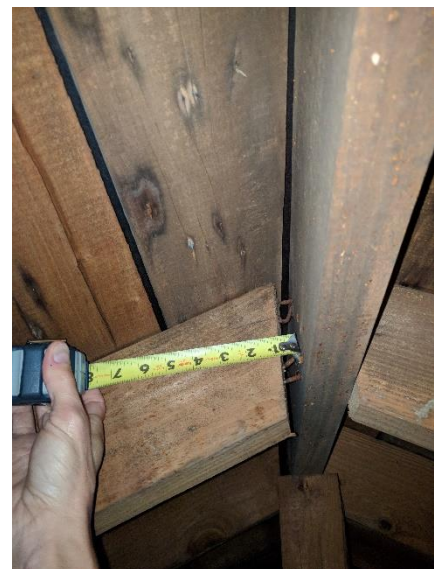
Photo 1

- Approximately 20% of the roof rafters have shrunk due to moisture loss (Photo 1 / previous page). A number of these have significantly disengaged member-end connections at the ridge.

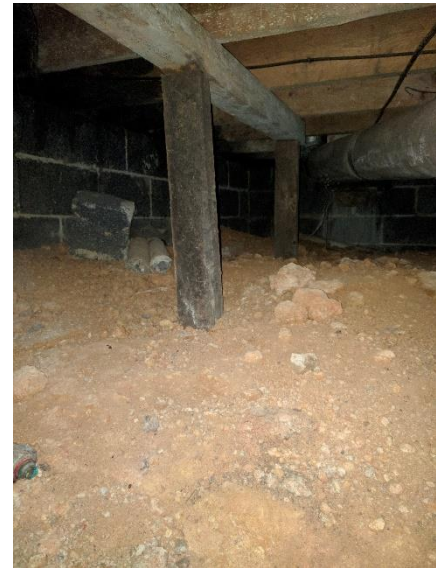
Photo 2

- Clusters of floor joists throughout the crawlspace are supported by wood cribbing. Cribbing posts are founded directly on the crawlspace soils. Many post bases are damp and deteriorated (Photo 2). Some cribbing has racked.

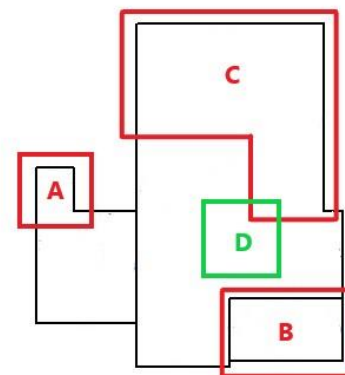
There were five significant structural or whole building concerns observed during my visit. Four zones of concern have been labeled A thru D on the Floor Plan to the right. A fifth zone (not labeled) applies to the entire crawlspace. Note - The bottom edge of the floor plan faces East Franklin Street. Zones in red occur at the floor level. Green zones occur at the basement.

- Zone A: This small room does not appear to be original to the house and is approximately 50sqft in size. The wall boards are soft and spongy. There is evidence of widespread termite damage and mold (Photo 3, Photo

- Zone B: The porch columns have rotted (Photo 6) and the roof structure is sagging. The porch is unsafe.
- Zone C: The northern bedrooms, closets, easternmost bathroom and central-eastern living space are riddled with mold (Photo 7, Photo 8 and Photo 9). The mold is black, white or brown. The living space's southern wall is also water damaged and rotting near its eastern end (Photo 10). Water infiltration at roof offsets, roof eaves and window surrounds appear to be the primary source of the mold and decay. A previous home owner installed circular wall vents in the drywall, presumably attempting to lessen moisture within the wall cavity (Photo 11). The bathroom ceiling was refinished but new mold has appeared. Both suggest that a significant amount of mold is in the wall and ceiling cavities, drywall and wood. Additionally, the easternmost bathroom's main sanitary line has an active leak in the crawlspace (Photo 12). This leak has rotted several floor joists and 1x floor planks. Heavy mold exists in proximity of the leak.

- Zone D: An unknown source of water has eroded the crawlspace soils and saturated a central basement wall (Photo 13). The depth of the flow channels suggests that infiltration has occurred for a prolonged period. Recent mud deposits on the basement floor suggest the infiltration is recent or ongoing (Photo 14). The source of water could not be determined during my visit. The seemingly large amount of water entering the crawlspace has saturated the soils at basement wall bearing. Significant settlement due to direct erosion and or saturation-drying cycles is likely.

I recommend that the entire home be razed. Given the types of mold and decay observed, a regulated "waiting period" would be counter-productive as the mold and rot will continue to spread. Conditions will worsen and could present a hazard to neighbors.
