APPLICATION FOR A CERTIFICATE OF APPROPRIATENESS – STAFF REPORT

COA-0171-2019 519 E JONES STREET

Nature of Project: Remove built-in gutter; install gutter; remove window

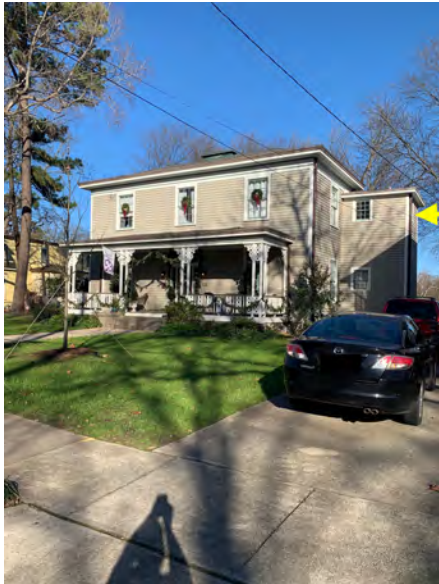
View from southeast corner of property (street side).

Removal of east facing (non-street facing) window to allow reconfiguration of second floor bathroom. Photos below show various views from all directions. In each image the window to be removed is marked by a yellow arrow.

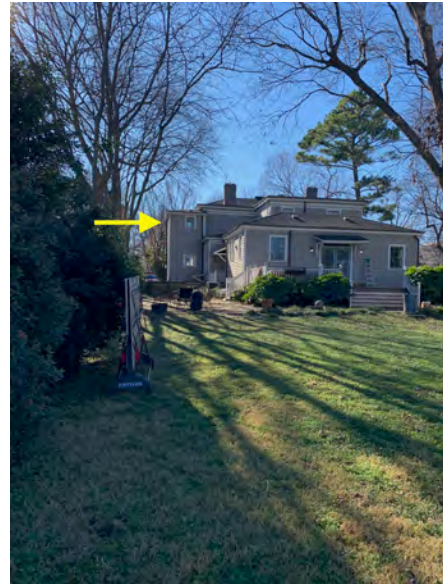
View from northeast corner of property.

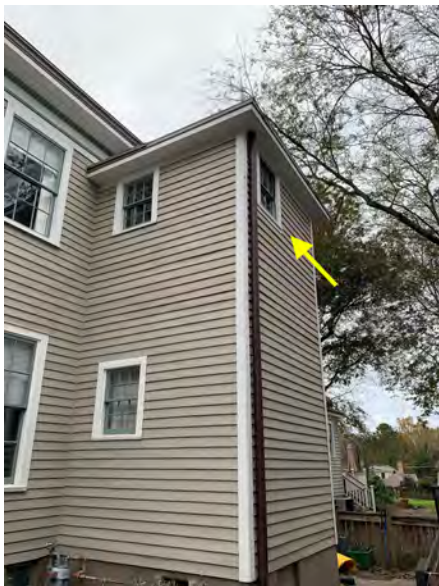
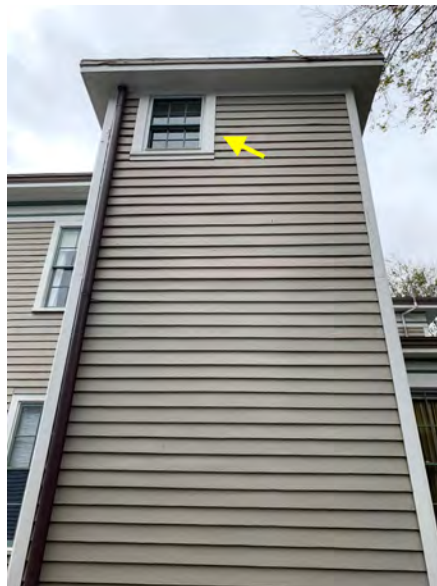
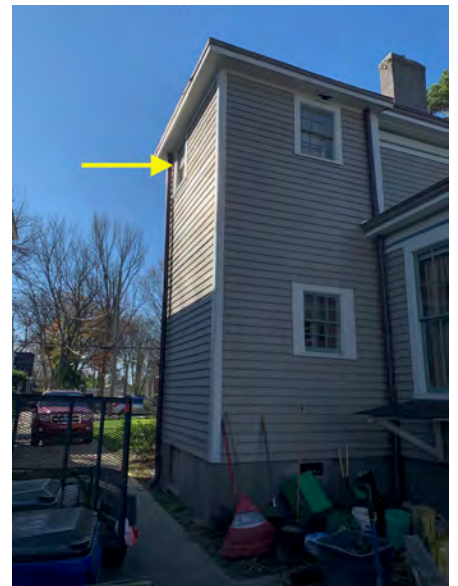
Views from east property line.

Matching wood clapboard will be installed and painted to match existing house color.

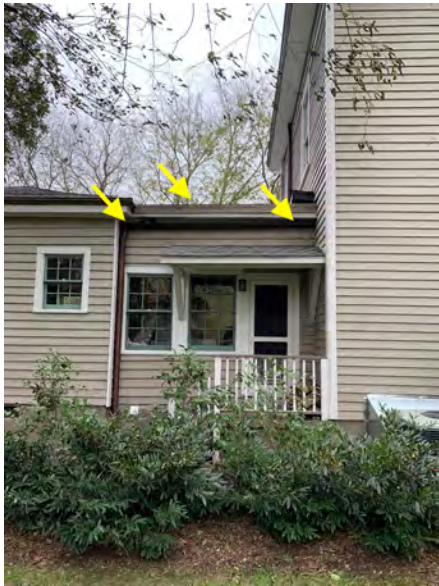
Conversion of built-in gutter on west wall of connecting structure between front and rear buildings of house. The west side gutter has been problematic over the years and we have attempted various repairs to prevent leaks and to control the flow of water, all have failed to some degree.

West side of connecting structure. Gutter system marked by yellow arrows.

The proposed work is to convert the existing built-in gutter to a spill-over gutter in a manner similar in style and materials to the gutter system on the east side of the same structure. The photos below show the gutter system on both the east and west sides of the connecting structure.

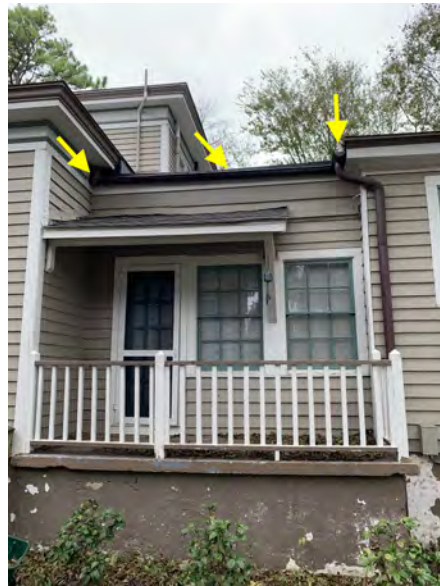
East side of connecting structure. Gutter system marked by yellow arrows.

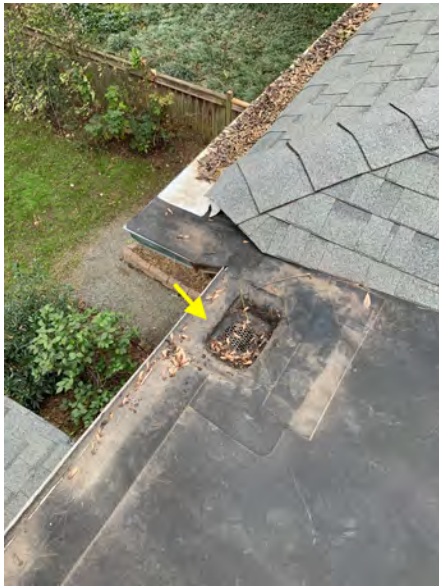
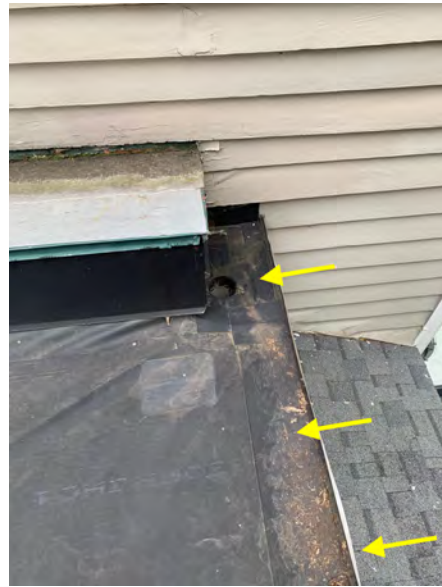
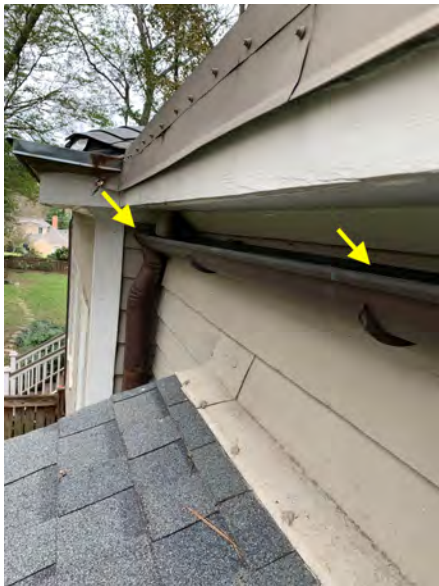
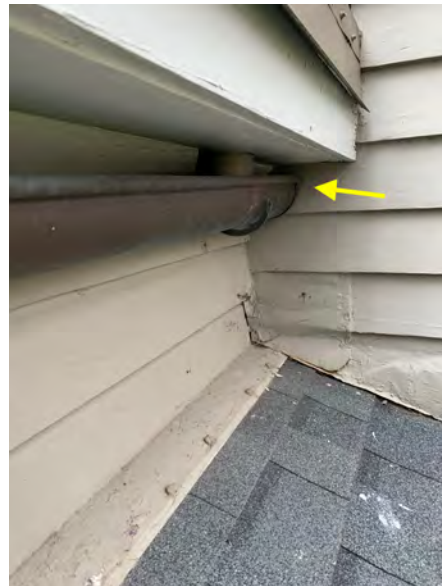
Existing west side gutter system.

The existing west side gutter system consist of two holes in the rubber membrane and decking to allow water to flow to the copper gutter hanging under the soffit.

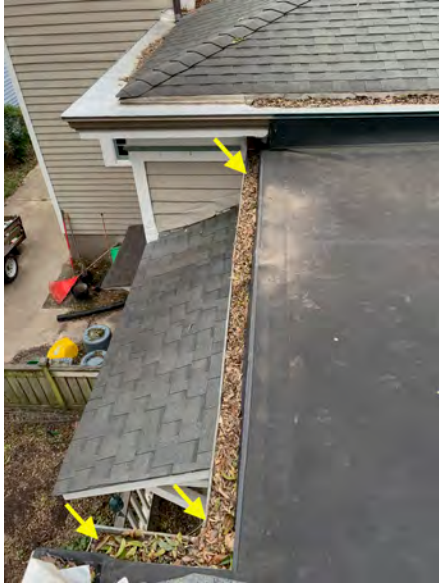
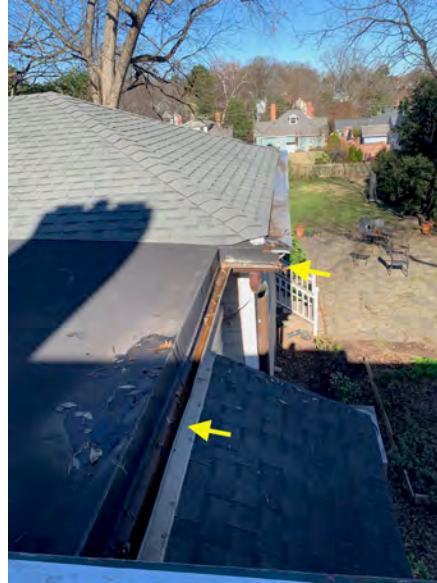
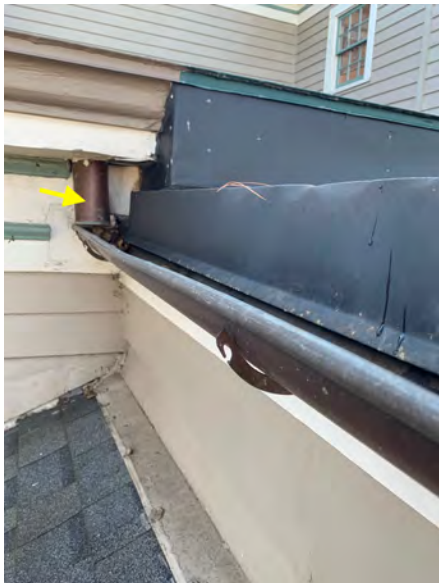
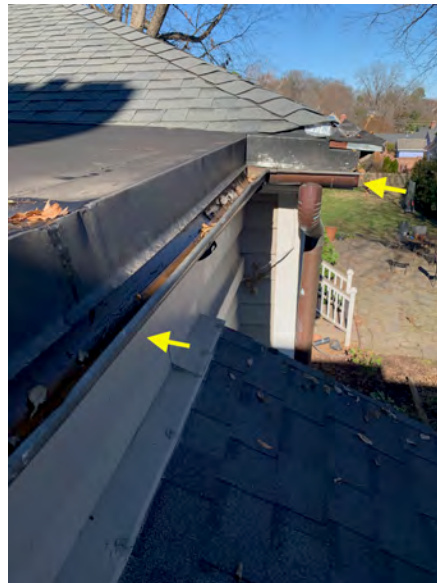
Existing east side gutter system.

The existing east side gutter system consist of rubber membrane, decking, and a drip edge to allow water to flow into the copper gutter hanging on the fascia
