# CERTIFICATE OF APPROPRIATENESS PLACARD

Remove two rear utility chimneys

515 Polk St

### Description of Planned Work

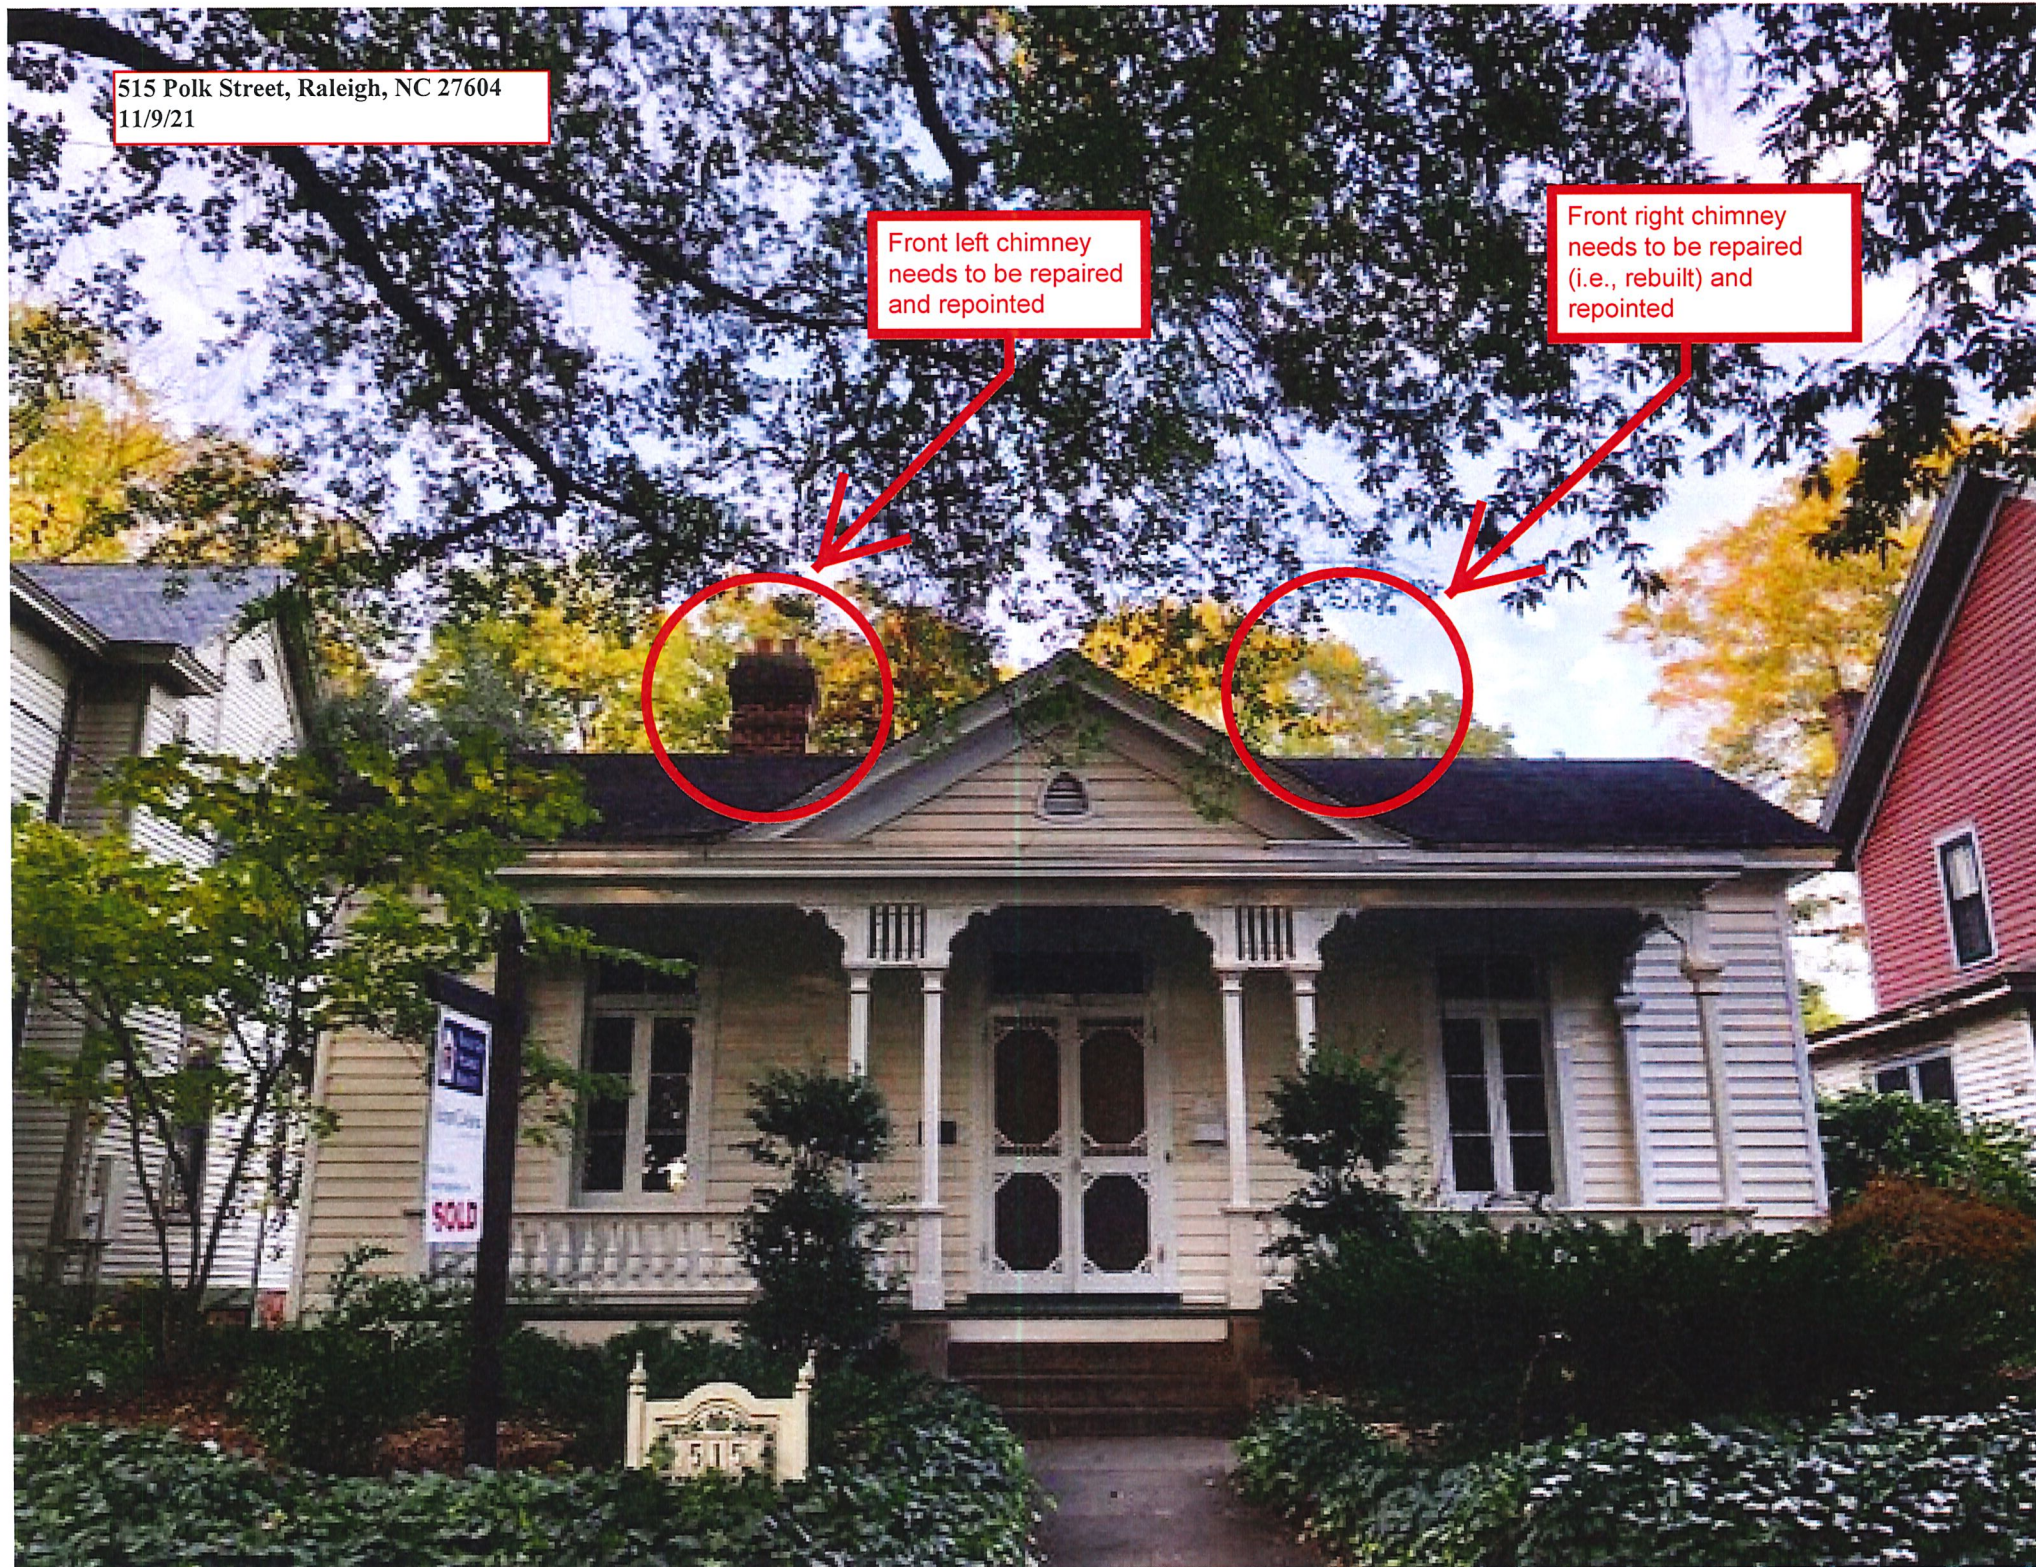
View from Front Right of House (Looking North-West)

Front left chimney  
needs to be repaired  
and repointed

Front right chimney  
needs to be repaired  
(i.e., rebuilt) and  
repointed

Rear right chimney  
only visible at this  
specific spot in front  
of property -  
otherwise not visible  
- would like to  
remove chimney

Plan is to repair  
these two front  
character defining  
chimneys

- Rear Left Chimney: Remove chimney to minimize risk of collapse and future maintenance / potential leak issues moving forward. Work is urgent given condition of chimney and the need to complete this work before replacing the roof.
- Rear Right Chimney: Remove chimney to minimize risk of collapse and future maintenance / potential leak issues moving forward. Work is urgent given that it must be completed before replacing the roof.

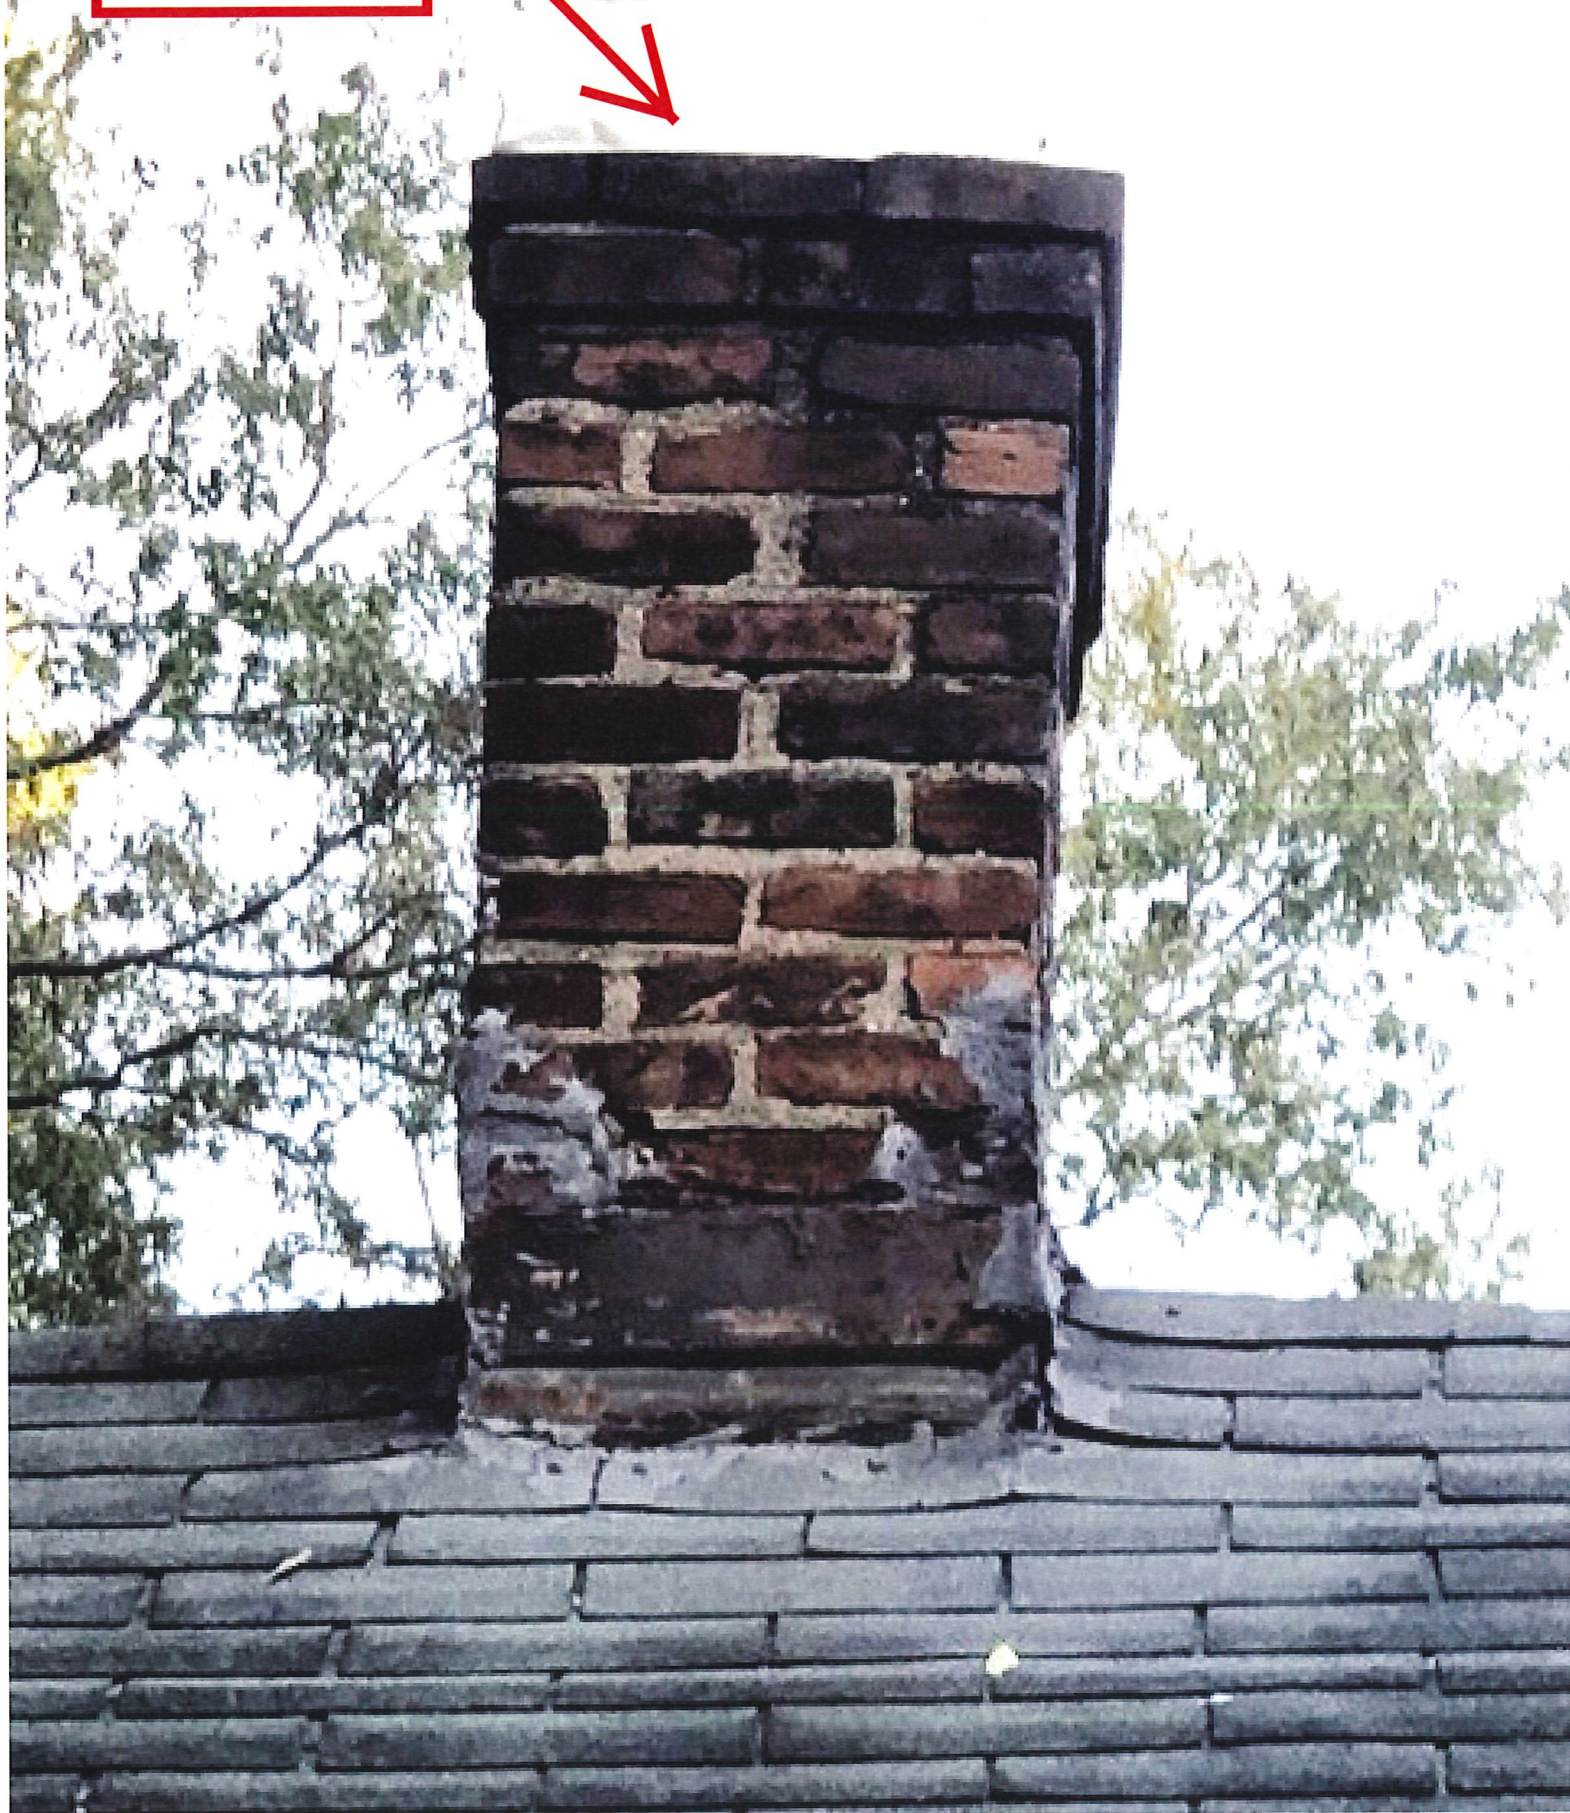
- Rear Left Chimney: This is a service/utility chimney and is a subject of this POA. Per our mason, this chimney is not serviceable and either needs to be removed or repaired. There is no stack below the roof line, and it seems that the chimney is entirely above the roof line and is in terrible shape. Notably, this chimney is only visible from the rear left side of the property or from the back – it is not at all visible from the front. Given its condition, location and lack of supporting structure beneath, we are concerned that the chimney will likely be a source of leaks and/or pose a threat of falling on the roof, so our strong preference would be to remove it to eliminate these potential adverse impacts.

Rear left chimney - in bad  
shape, leaning and not  
visible from street - also  
no stack below

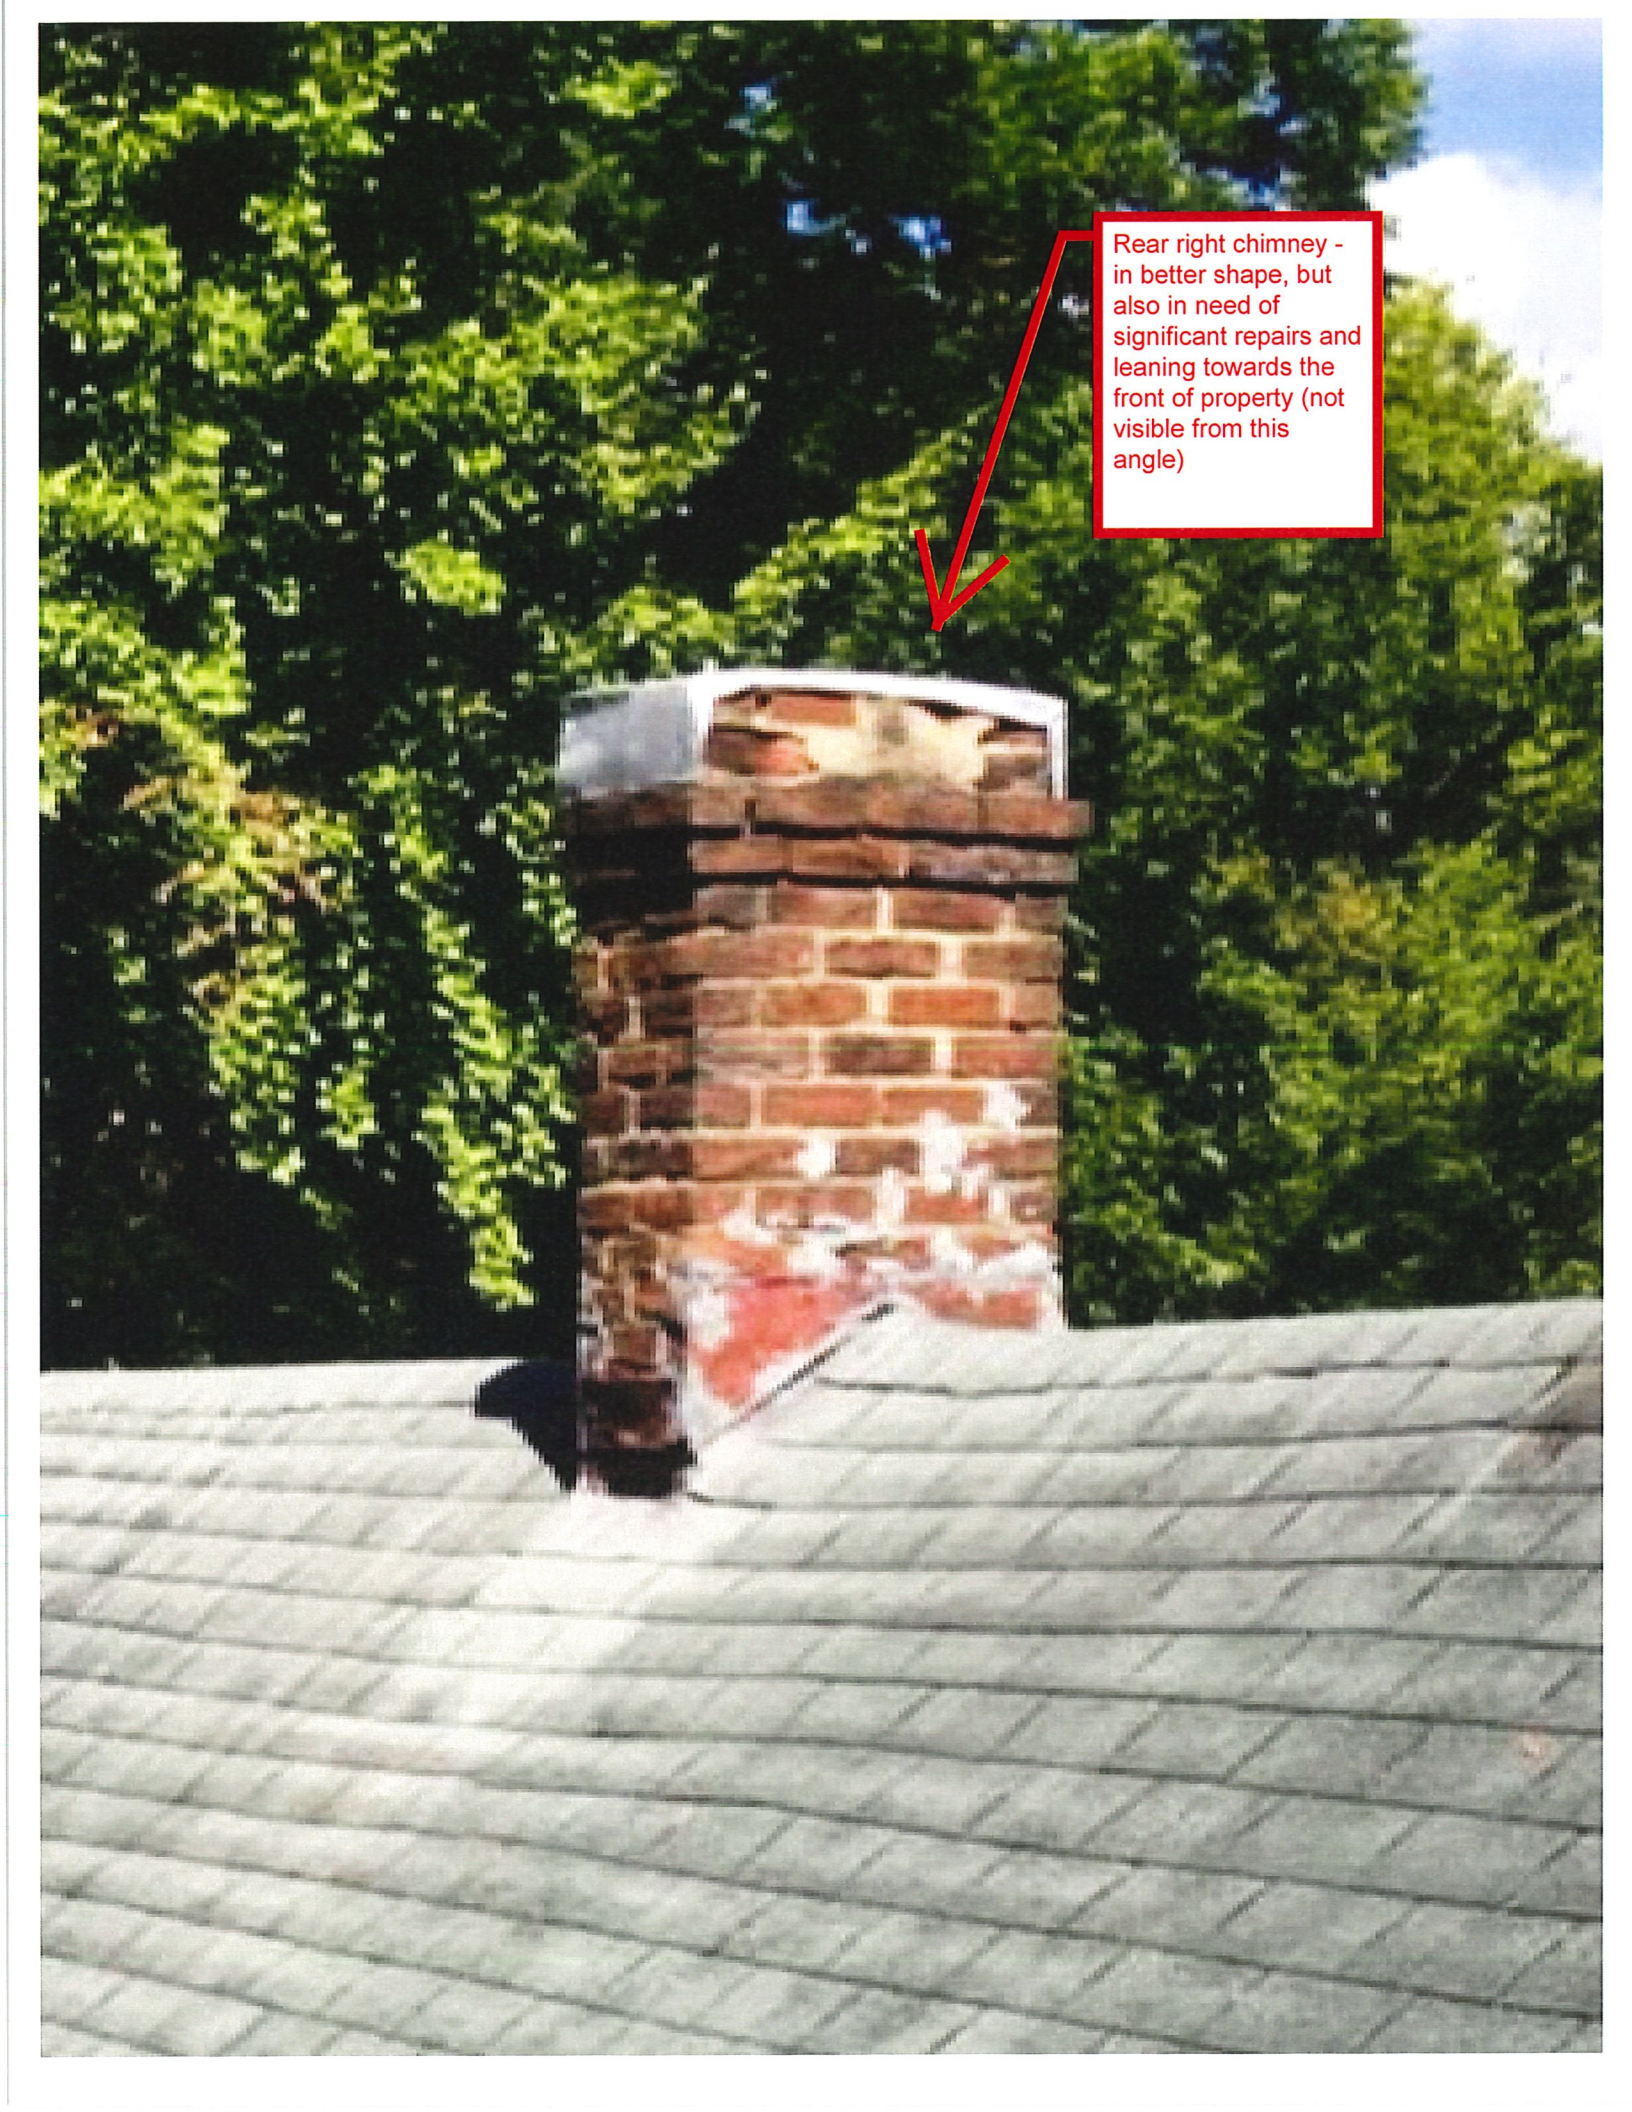
- Rear Right Chimney: This is a service/utility chimney and is a subject of this POA. This chimney was part of a structure that was built separately from the original four-square cottage and was only added to the rest of the cottage at a later date, though we are not sure when exactly. Per our mason, this chimney is not serviceable and is in need of significant repairs. It is also leaning towards the front of the house. This chimney is only visible from one spot in the front-right side of the property (see included picture). Given that we need to replace the entire roof and the chimney is barely visible from one spot in the front of the property, our strong preference would be to remove it to minimize the maintenance / potential leak issues moving forward.

Rear right chimney -  
in better shape, but  
also in need of  
significant repairs and  
leaning towards the  
front of property (not  
visible from this  
angle)
