APPLICATION FOR A CERTIFICATE OF APPROPRIATENESS – STAFF REPORT

COA-0190-2018 530 ELM STREET

<u>Nature of Project</u>: Install **72**" fence and gate [After-the-Fact]; remove and replace magnolia tree <u>Amendments</u>: **The original application requested installation of a 66**" fence but has been changed per the applicant. New length of fence is proposed to be 50'2".

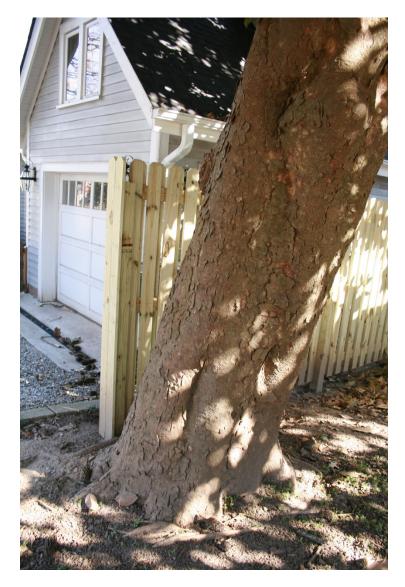
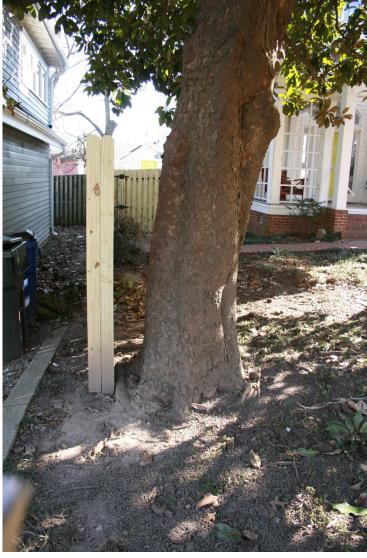
Staff Evidence/Photos: 530 Elm St, COA-0190-2018 February 28, 2019 COA Committee Meeting

Approximately 8" from face board on front post to base of tree trunk. Note the board is immediately adjacent to the exposed tree root.

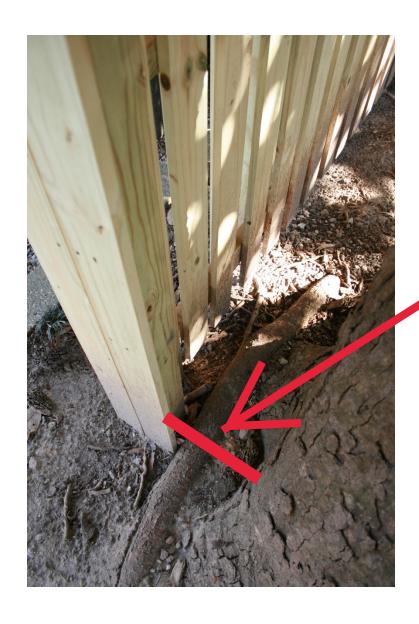
- 7* There is a distance of approximately 8" horizontally between the base of the magnolia tree and the front post, and as can be seen from photographic staff evidence. A face board attached to the front post is touching an exposed root on the ground level.

3. That fence footings be dug by hand and located to avoid damage to tree roots, should

any be encountered during construction of the fence. Roots larger than 1" caliper will be

cut cleanly using proper tools such as loppers.

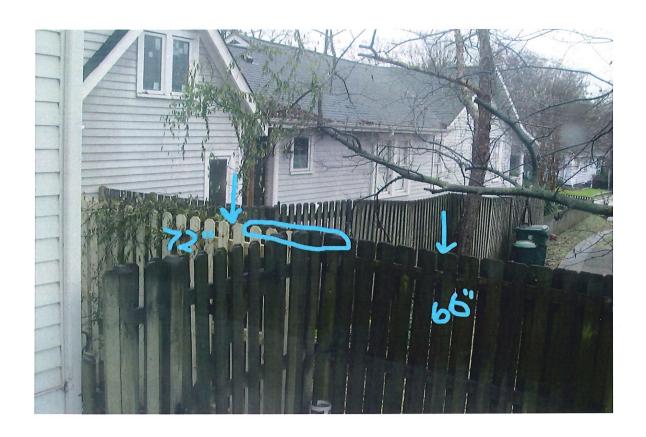
Image 2: Shows a perpendicular view of the tree, fence and garage that shows only a small portion of the top corner of the fence not obstructed by the tree. This is due to the fact that the tree leans toward the home and is not vertical.

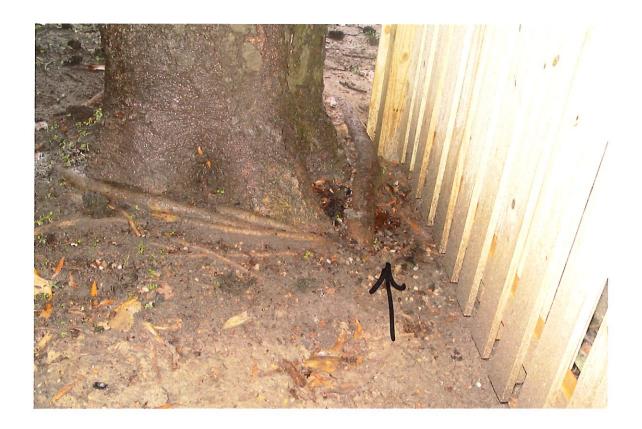
Image 4: Please note that we have had 4 to 6 inches of erosion since the garage was reconstructed. The goal of a second story on the garage that did not exist previously, required the previously level driveway be graded to provide the garage height necessary to remain subservient to the main home. The photo shows our utility lines are exposed in the vicinity of the tree. We will restore this soil which should resolve any height differences near the area of erosion.

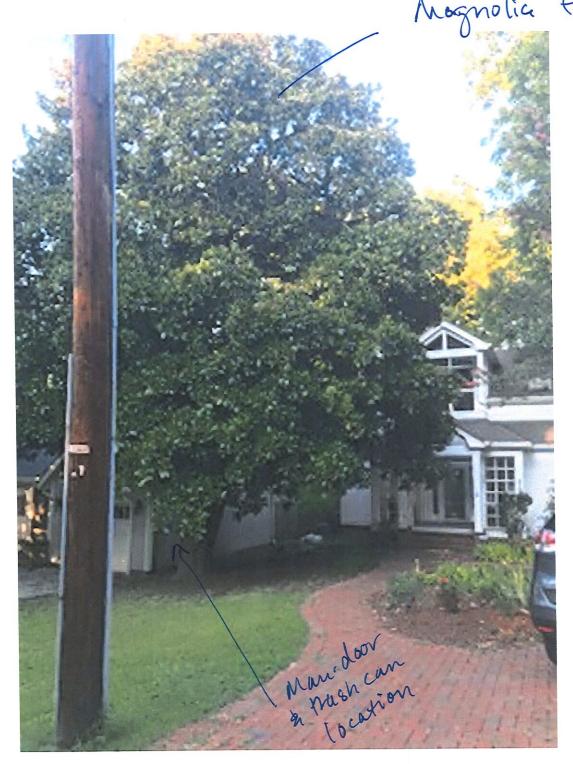
for removal/replacement. with Little Dem or similar.

Current tenant was agreeable to moving trash coms while we wonk out sence details. This groupe door plan was the irresponsible efforts of an owner & architect with disregard of the beautification of Elm St. this was approved as minor work instead of during COA review.

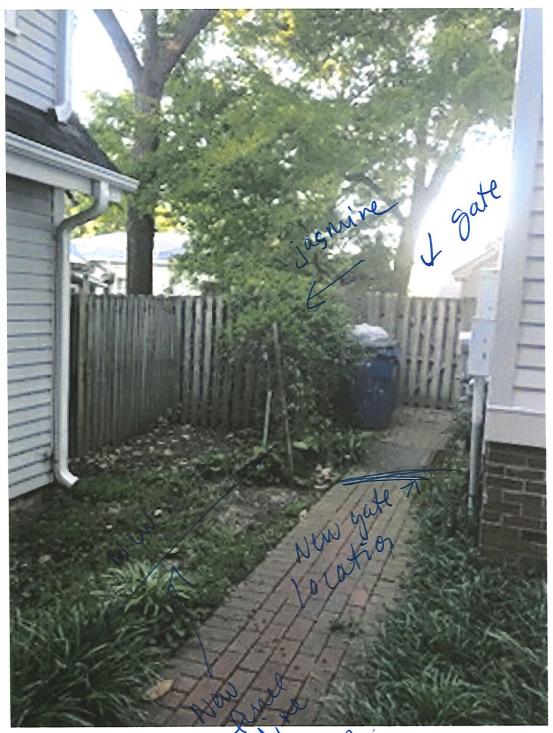
It is difficult to see but our tener is hidden by jasmine

Continue our Sense to end of garage
