System Integration Plan

Sierra Drive Property

Raleigh, North Carolina

Approved by City Council October 15, 2013

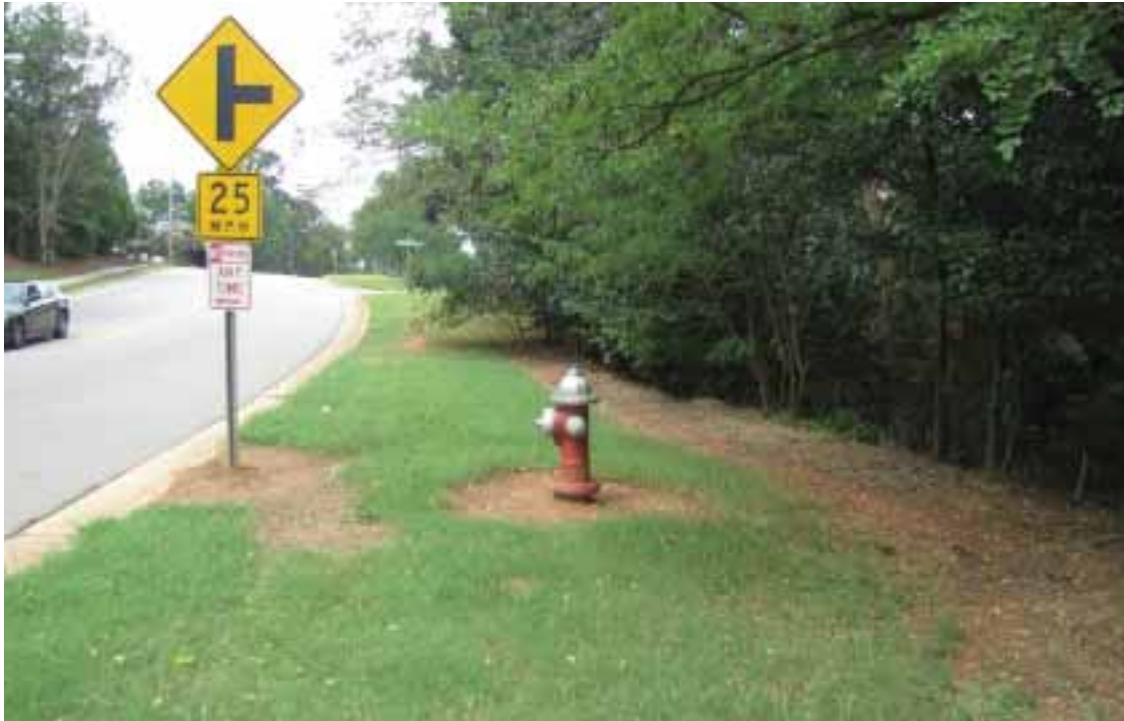
Fire hydrant and mowed strip along Lineberry Drive (56 linear ft of road frontage).
Sidewalk is installed on south side of Lineberry Drive.

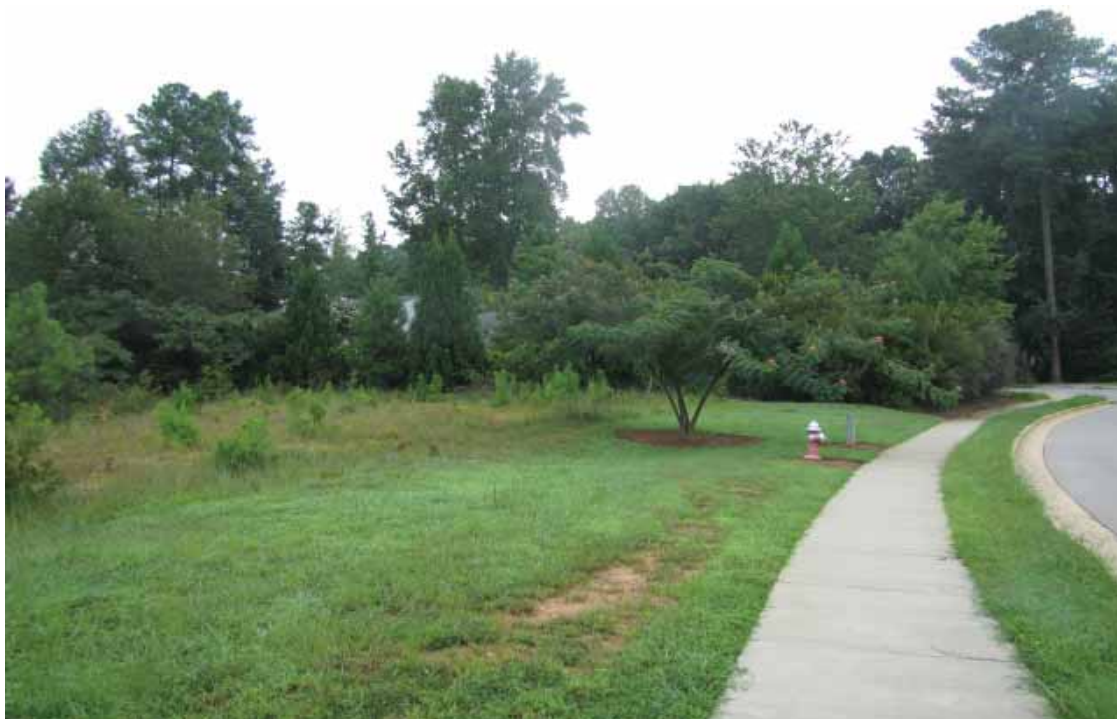
Sidewalk, fire hydrant, mowed strip along Sierra Drive (395 linear ft of road frontage)

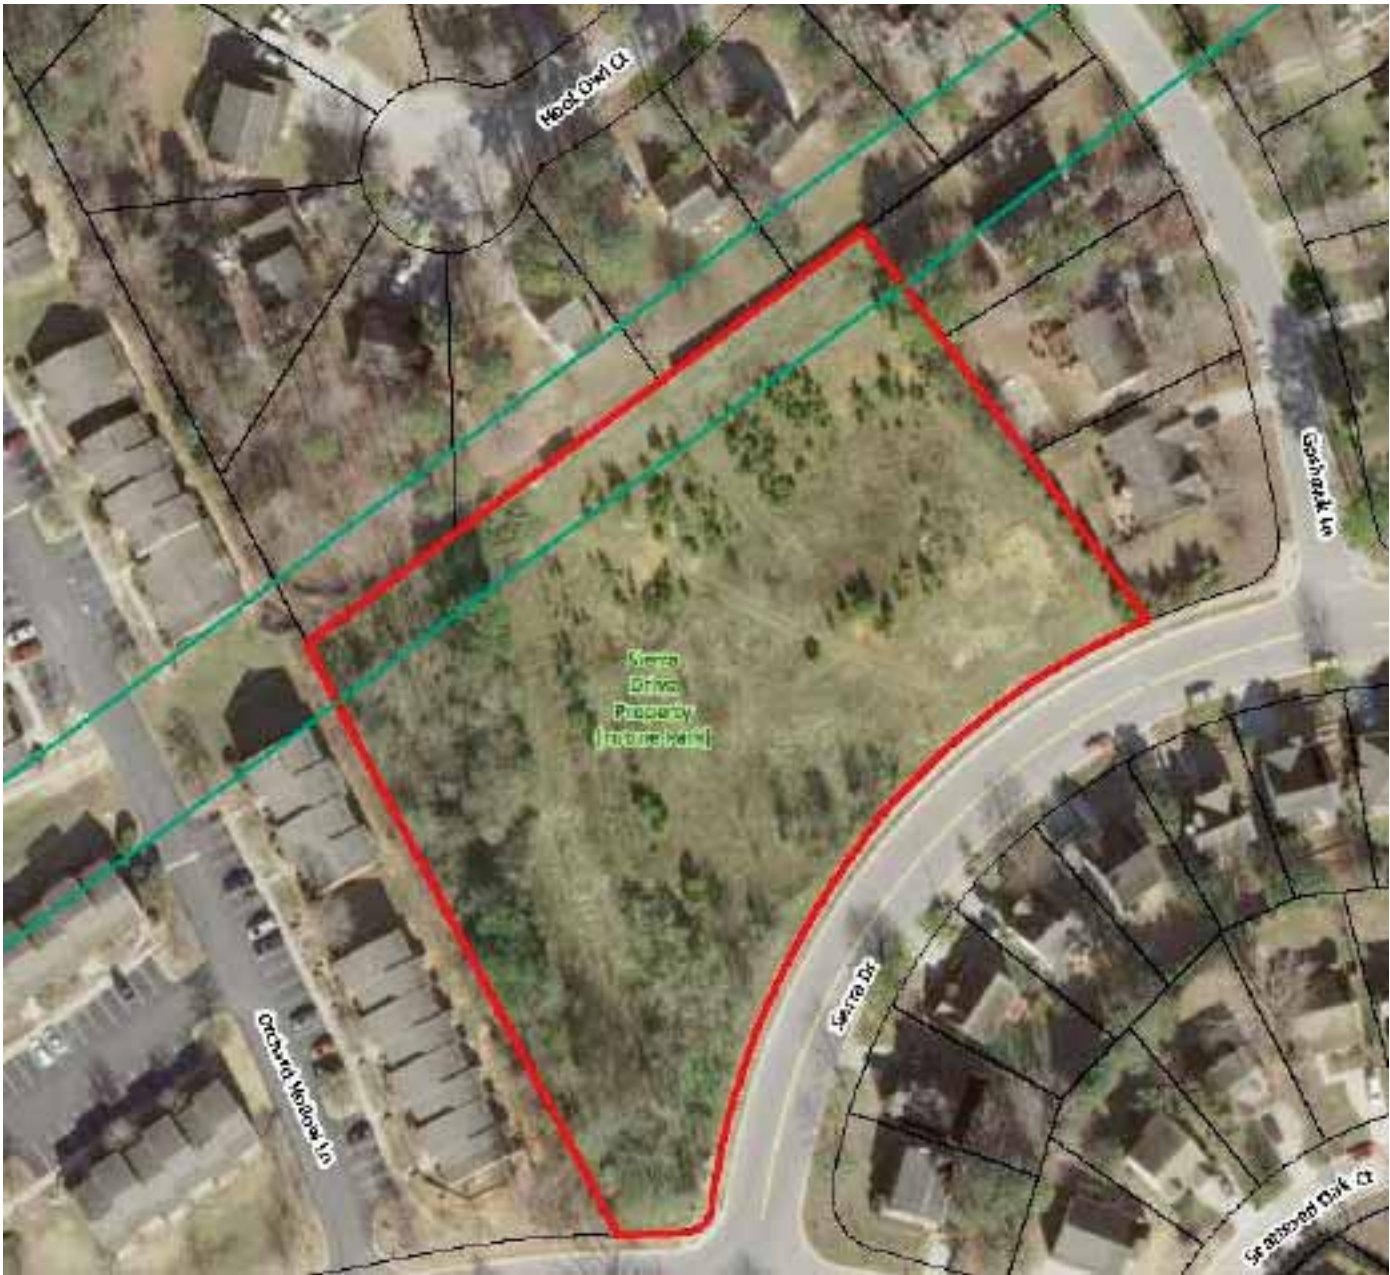
Duke Energy Progress Powerline Easement

A Duke Energy Progress overhead powerline easement runs along the northern boundary of the property. The easement width is 70 feet. A detailed description of vegetation within the easement begins on page 41 of this report.

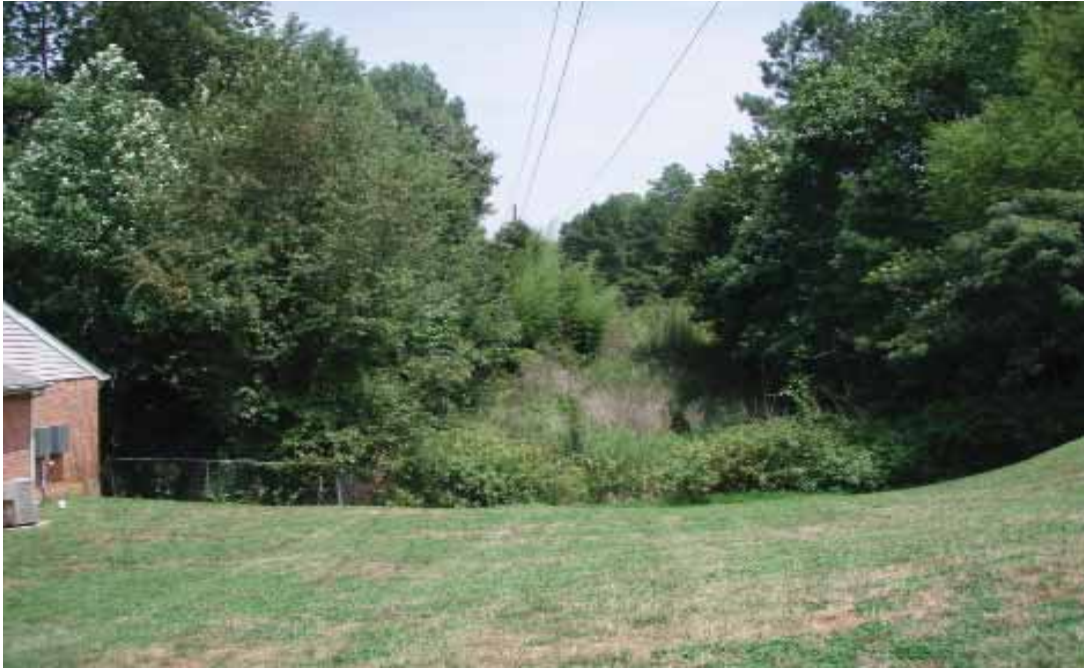
Overhead powerline easement along northern property boundary, view from multi-family housing unit at northwestern corner of property (facing northeast toward park property)

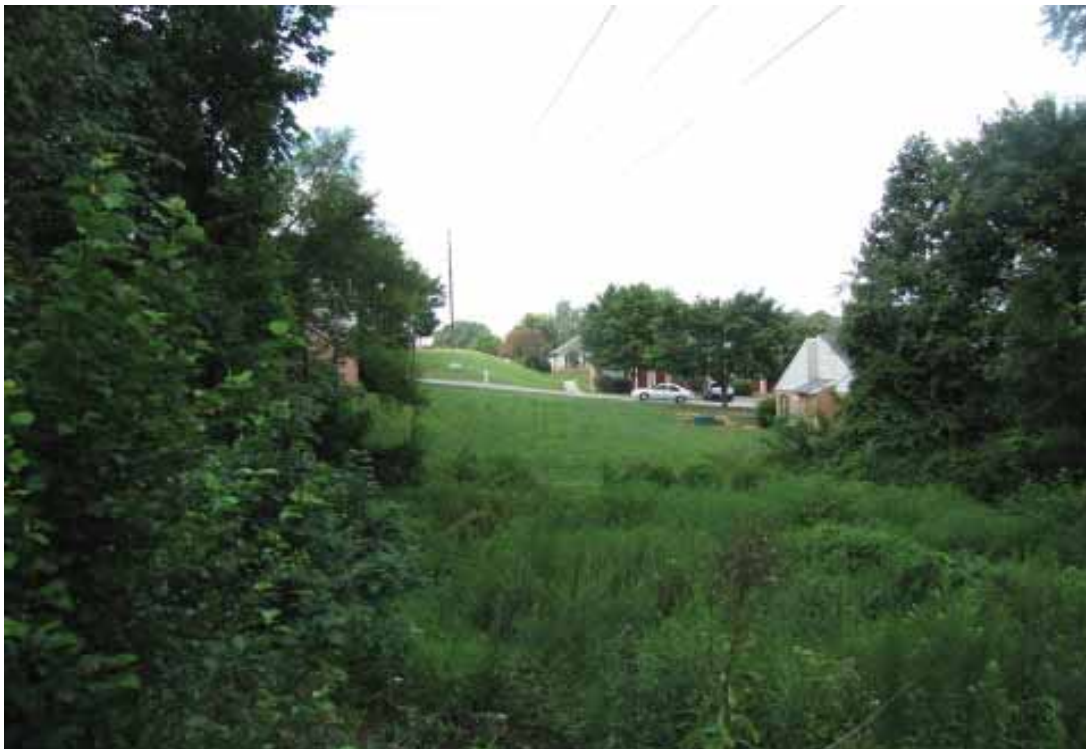
Overhead powerline easement (approximately 70 feet wide) from northwest corner of property, facing west toward adjacent multi-family housing unit

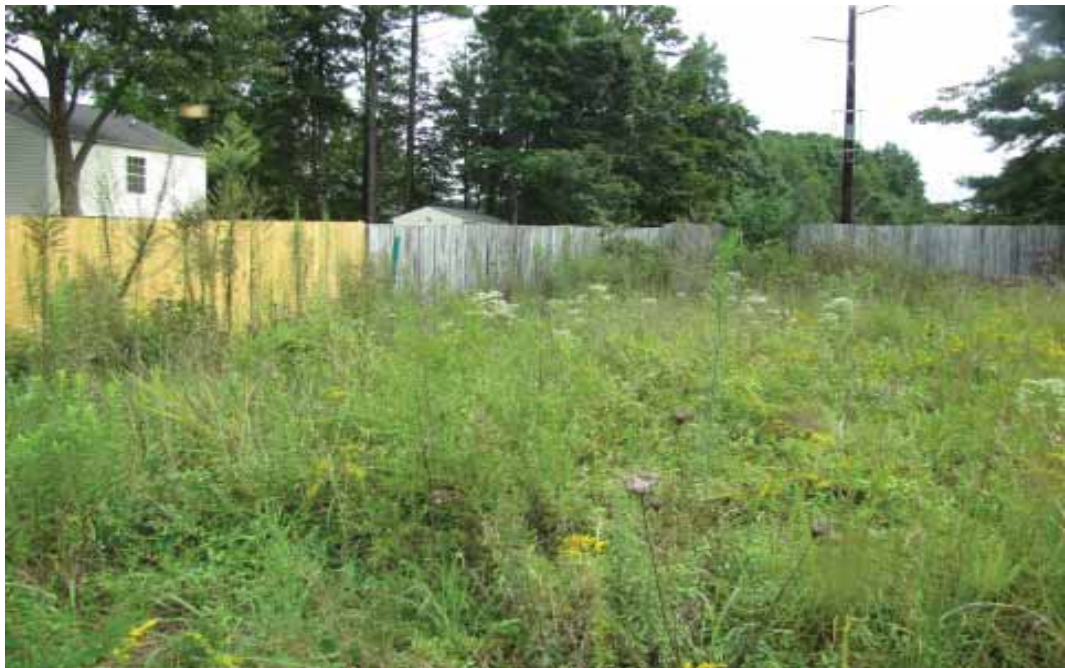
Wooden fences along northeastern and eastern property boundary (facing northeast)

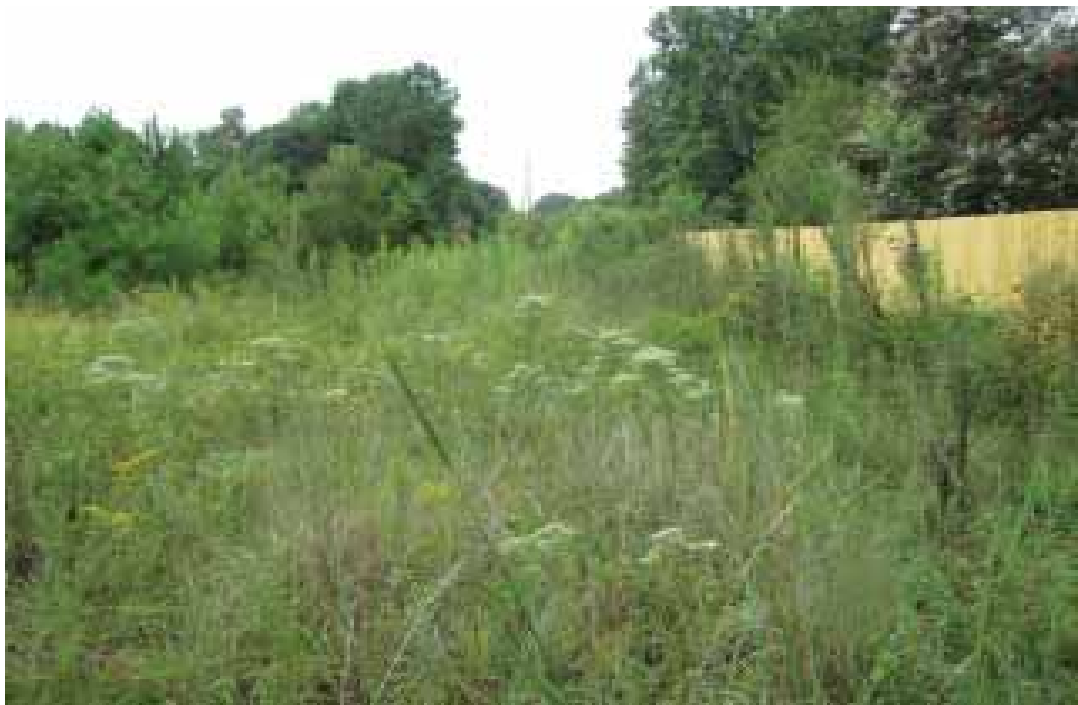
Wooden and chain link fences run the length of the northern property boundary, adjacent to the overhead powerline easement (facing west)

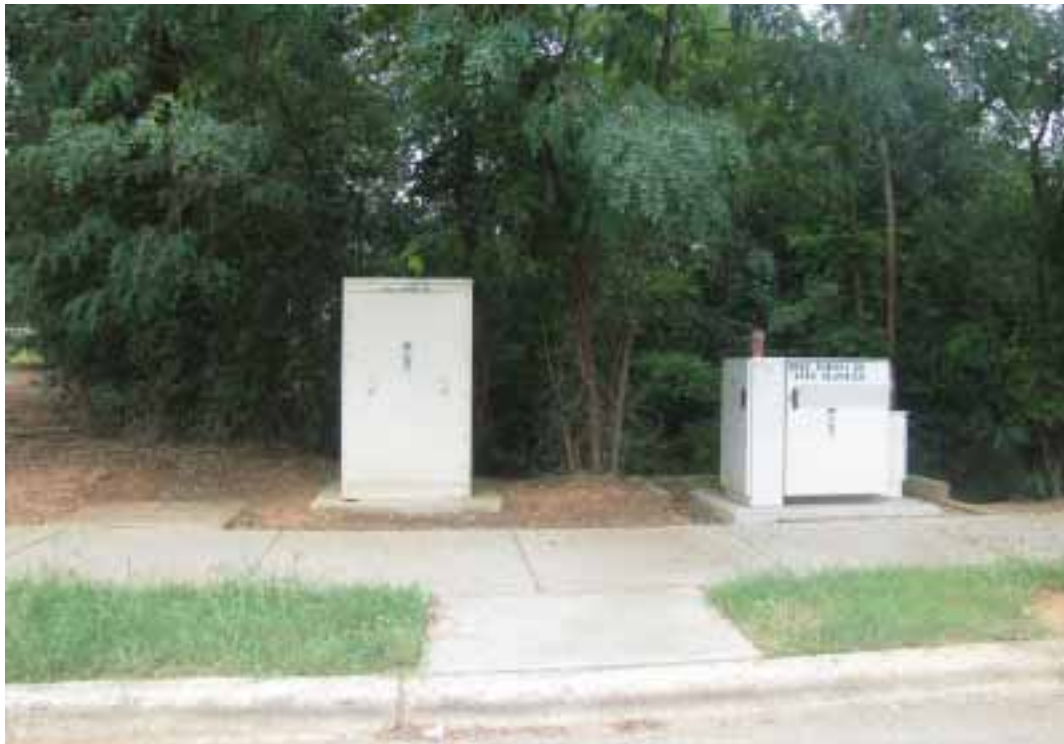
Utilities along Sierra Drive, at intersection with Lineberry Drive

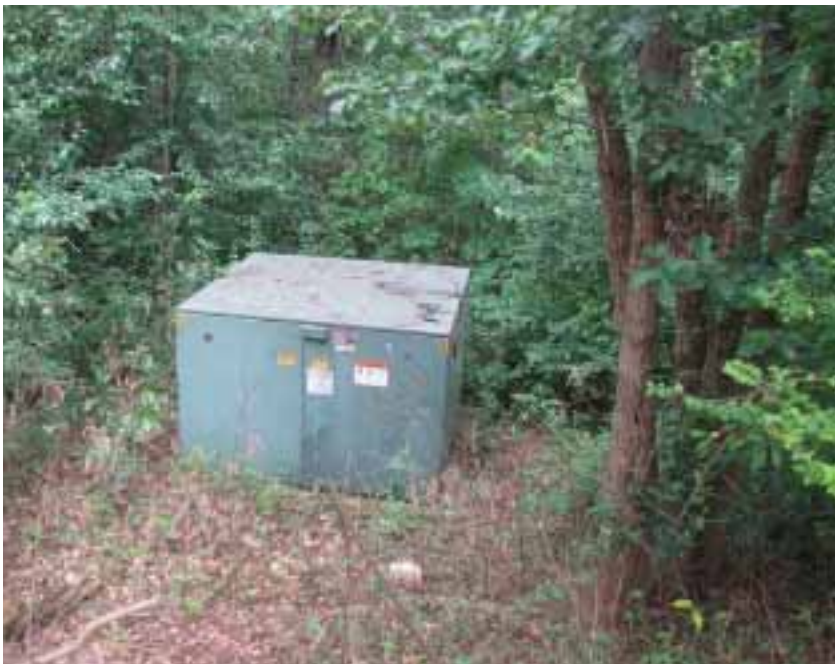
Large electrical transformer box in woods at southern corner of park property. This transformer box DIS No. 13086 is described in the Phase 1 ESA Report as unlabeled for PCB content.

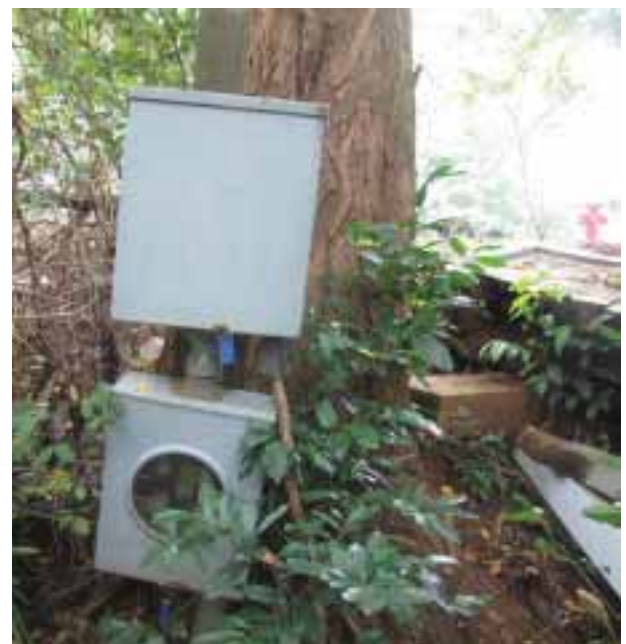
Additional utility boxes located in the woods at the southern corner of park property.

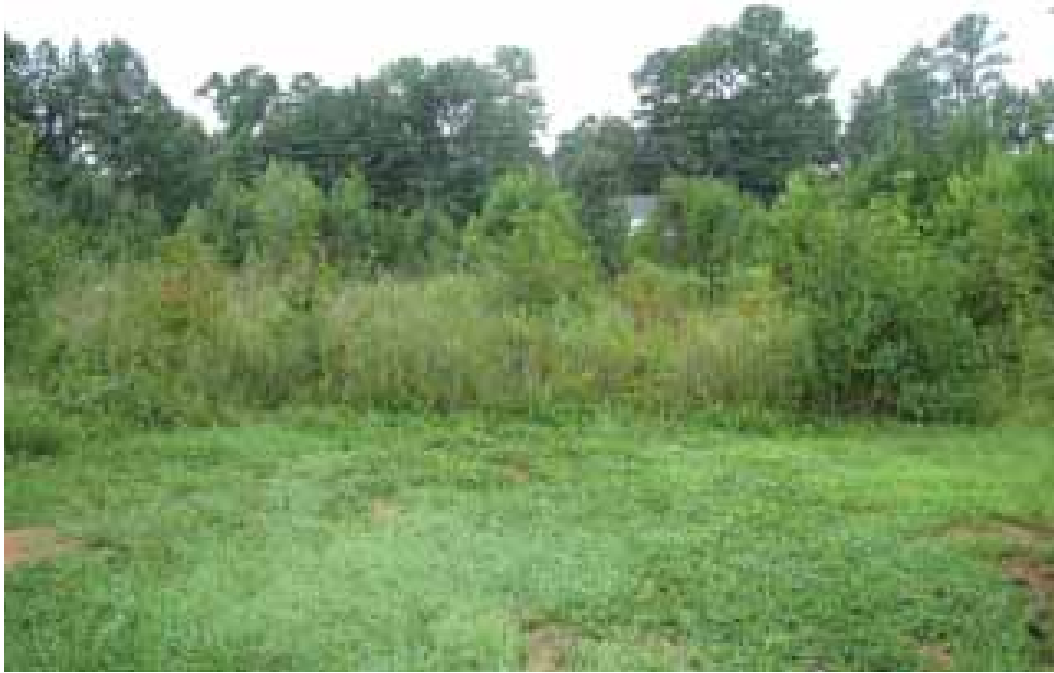
Tree seedlings such as pine and sweet gum interspersed with herbacious vegetation

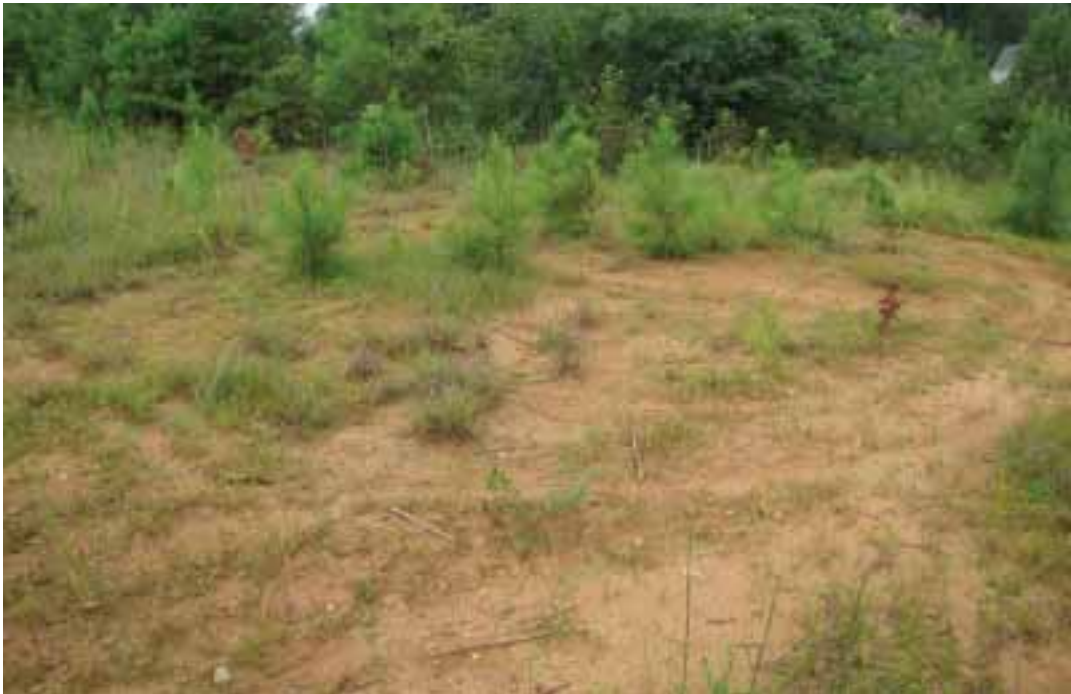
Site appears disturbed and includes areas of exposed, eroded Cecil soils

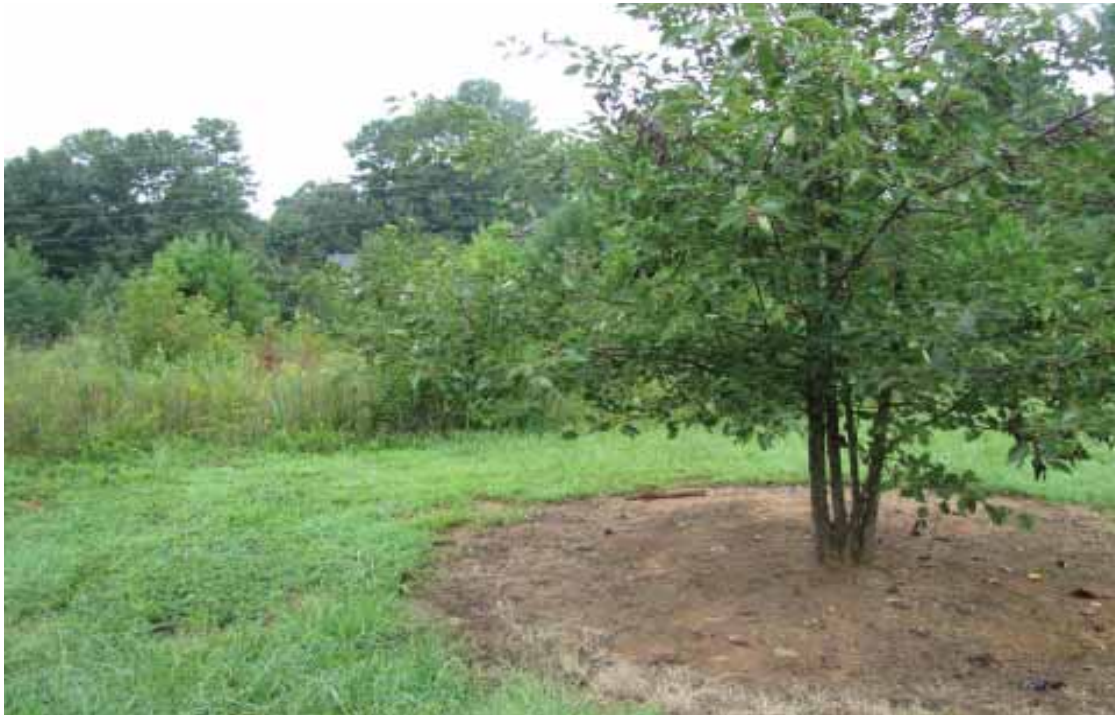
Small trees along Sierra Drive (invasive species such as Mimosa and Callery Pear)

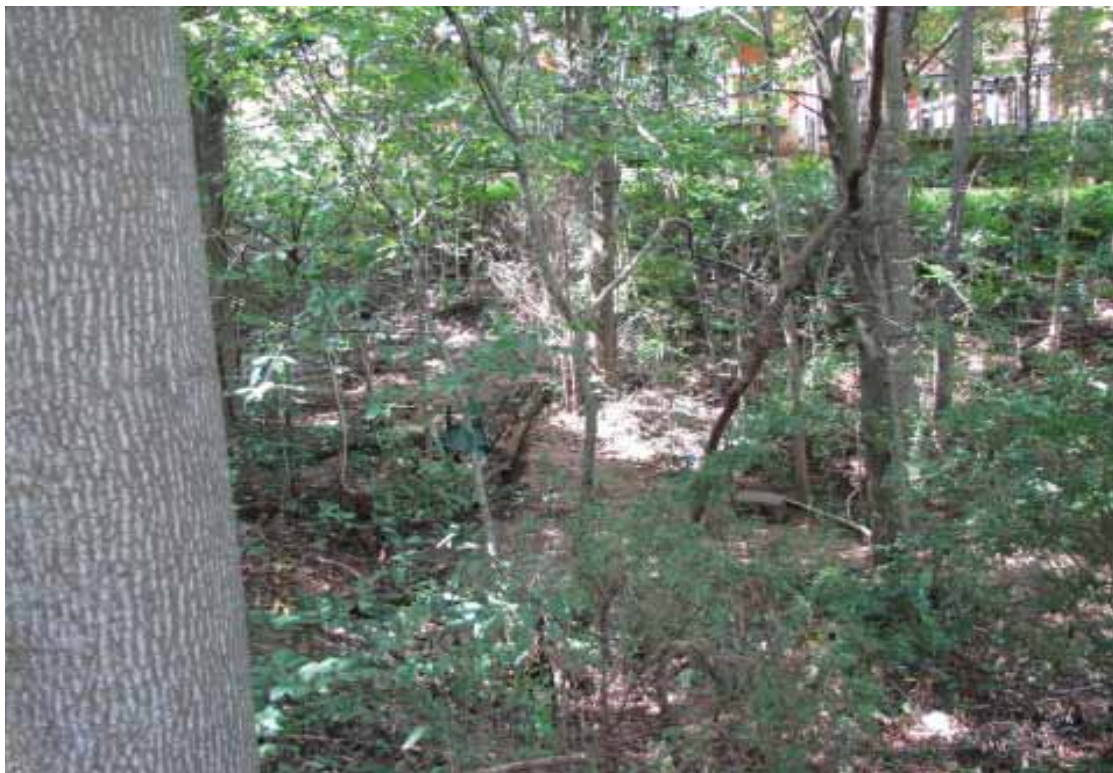
Wooded area along western property boundary, facing southwest toward multi-family housing unit. The wooded draw is described in greater detail beginning on page 32.

The western portion of Sierra Drive Property contains a small wooded draw with a young Piedmont Dry-Mesic Mixed Hardwood Forest. Red maple, sweet gum, oak, American holly (*Ilex opaca*), and red cedar (*Juniperus virginiana*) are present. There are some areas of invasive Japanese stilt grass (*Microstegium vimineum*) in the lowest portions of the stormwater draw where it meets the overhead powerline easement.

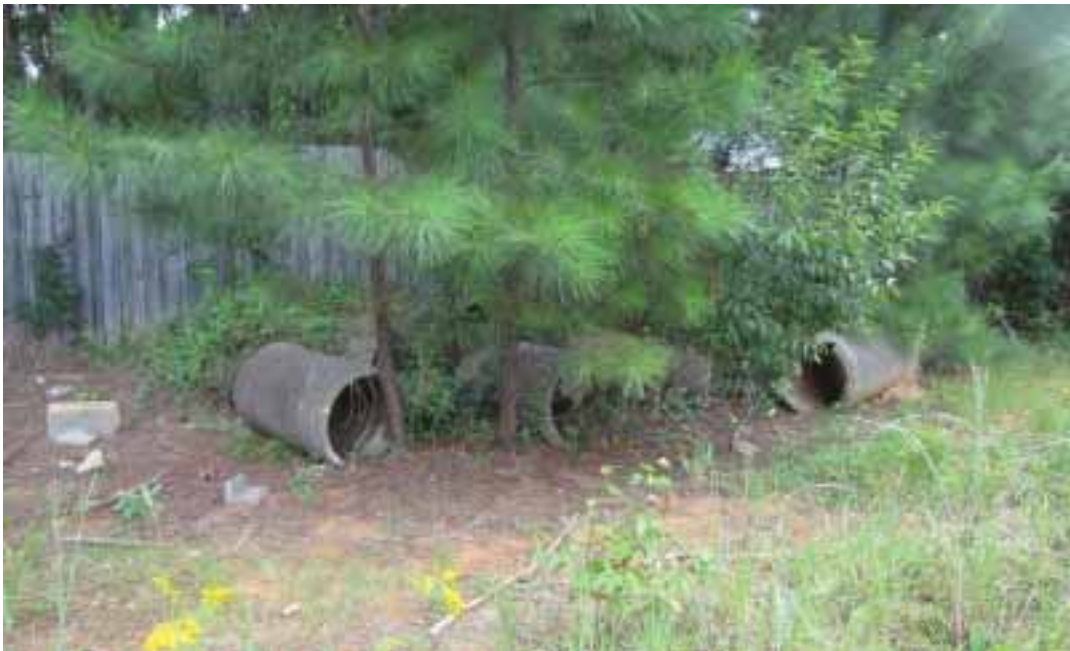
Concrete culverts on eastern portion of property.

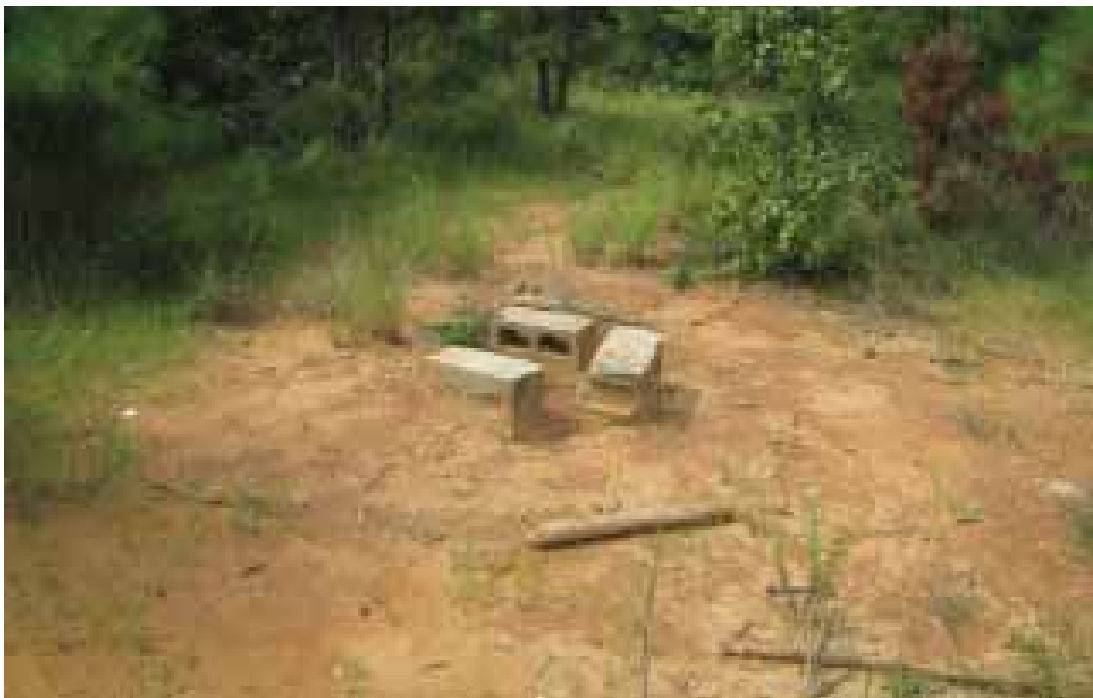
Cinder blocks in central portion of property

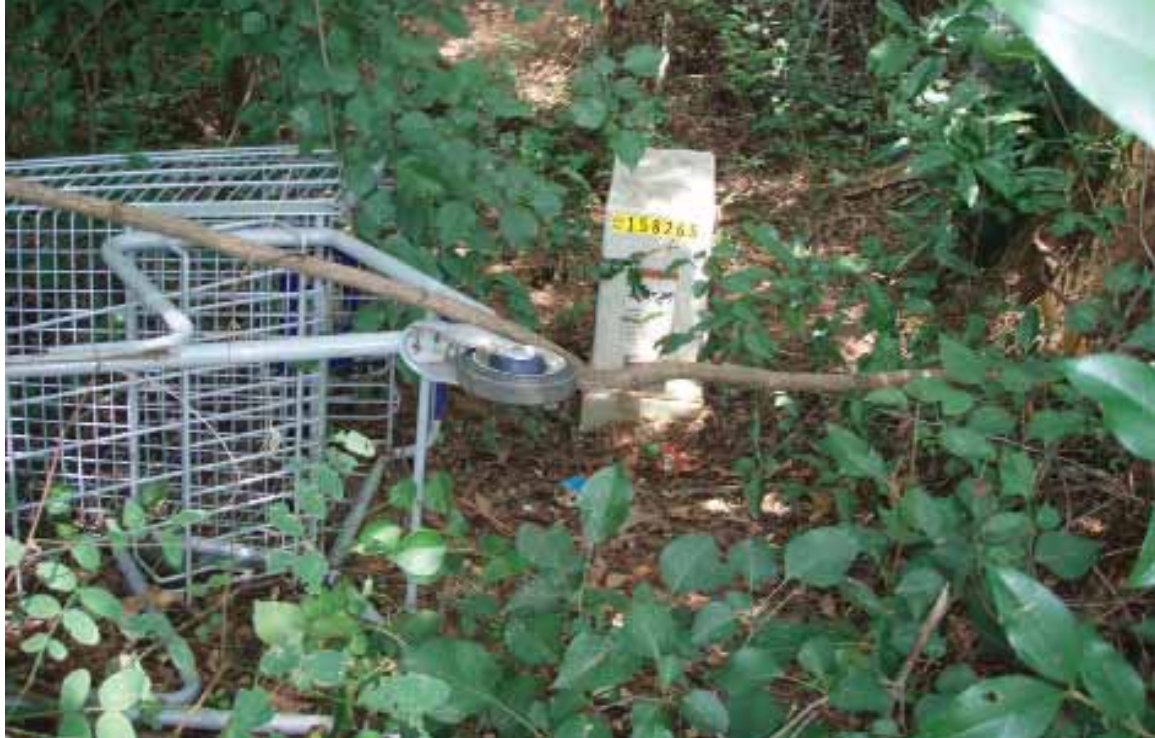
Dumping and potential vandalism occurs in the wooded area near the intersection of Sierra Drive and Lineberry Drive. The photo above was taken in Aug 2010.

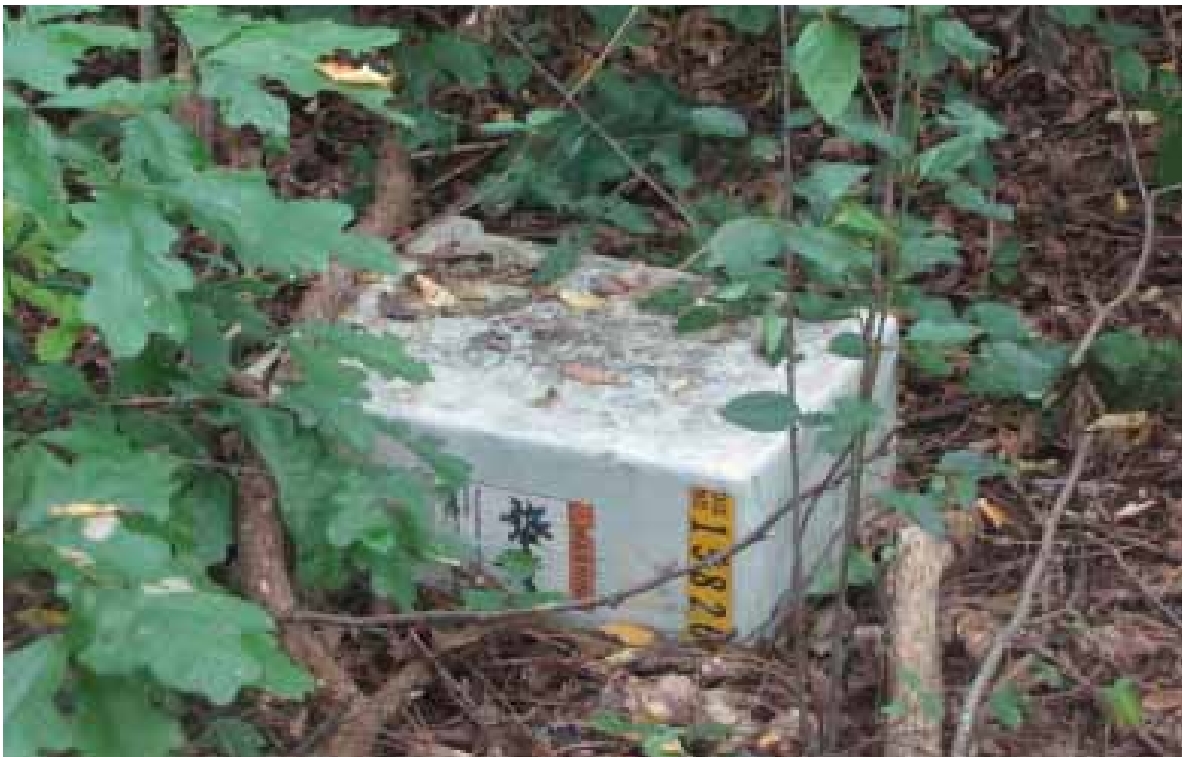
Vandalized or discarded utility box in August 2012.

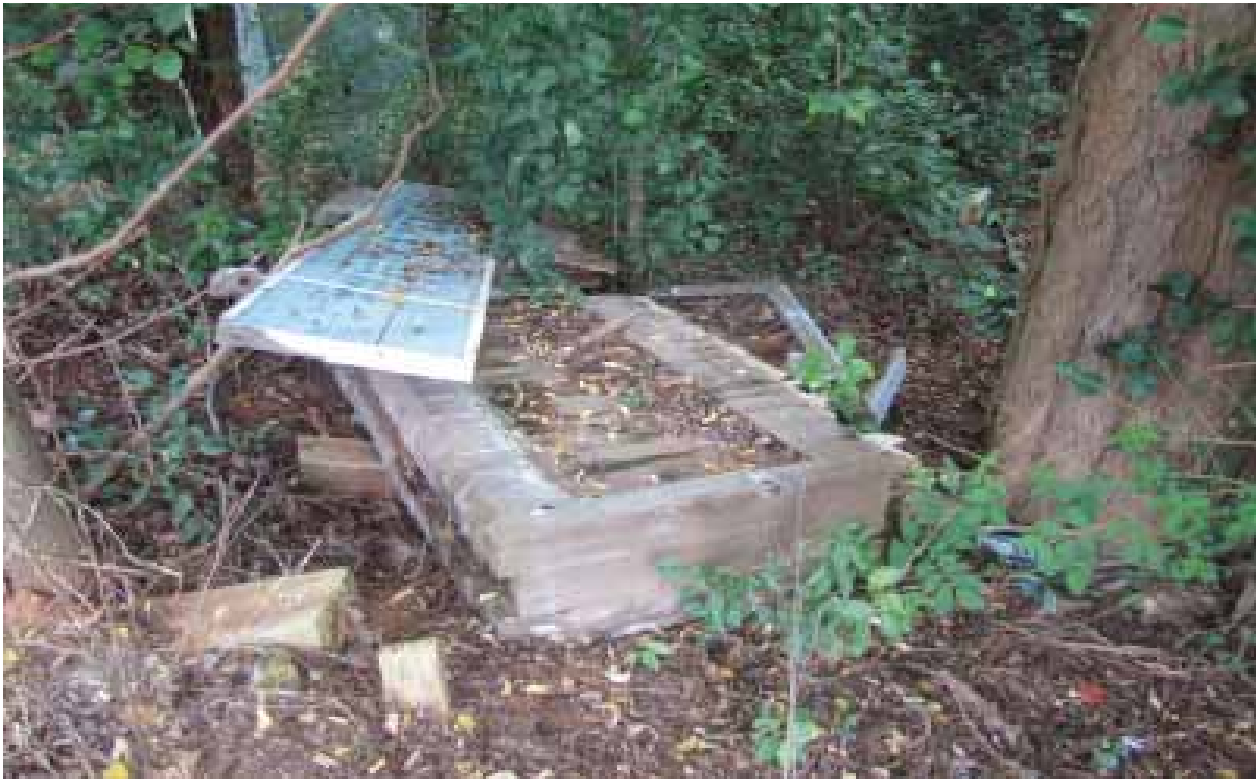
Potential vandalsim or dumping of the “Trailwood Glen” sign, photo taken in Aug 2012.

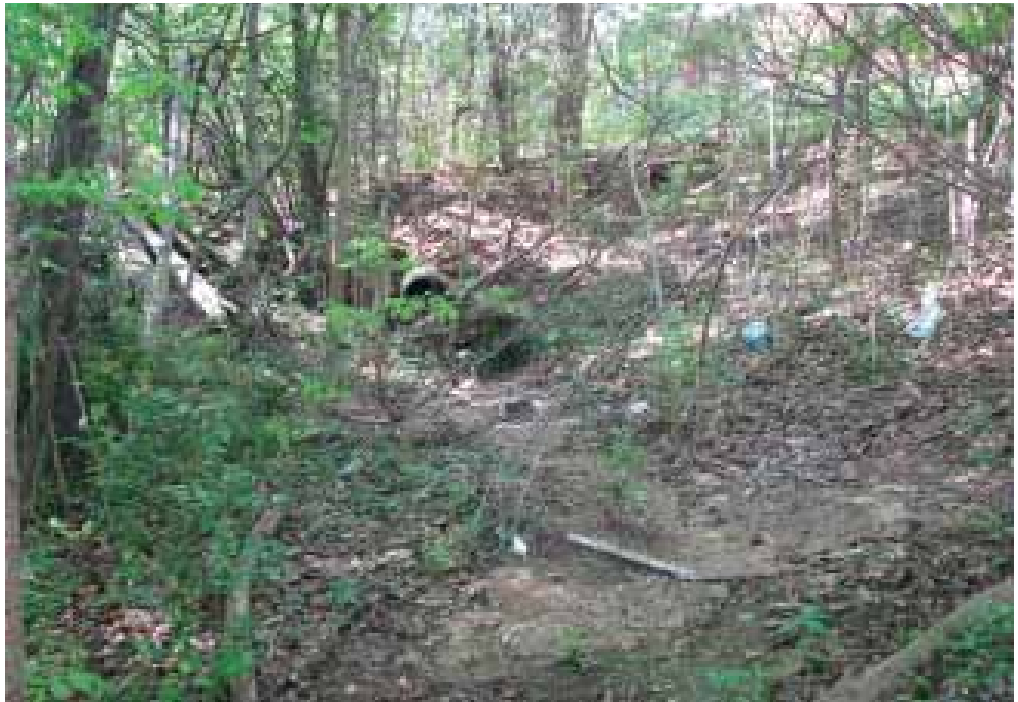
Stormwater Outlet Pipe in wooded draw

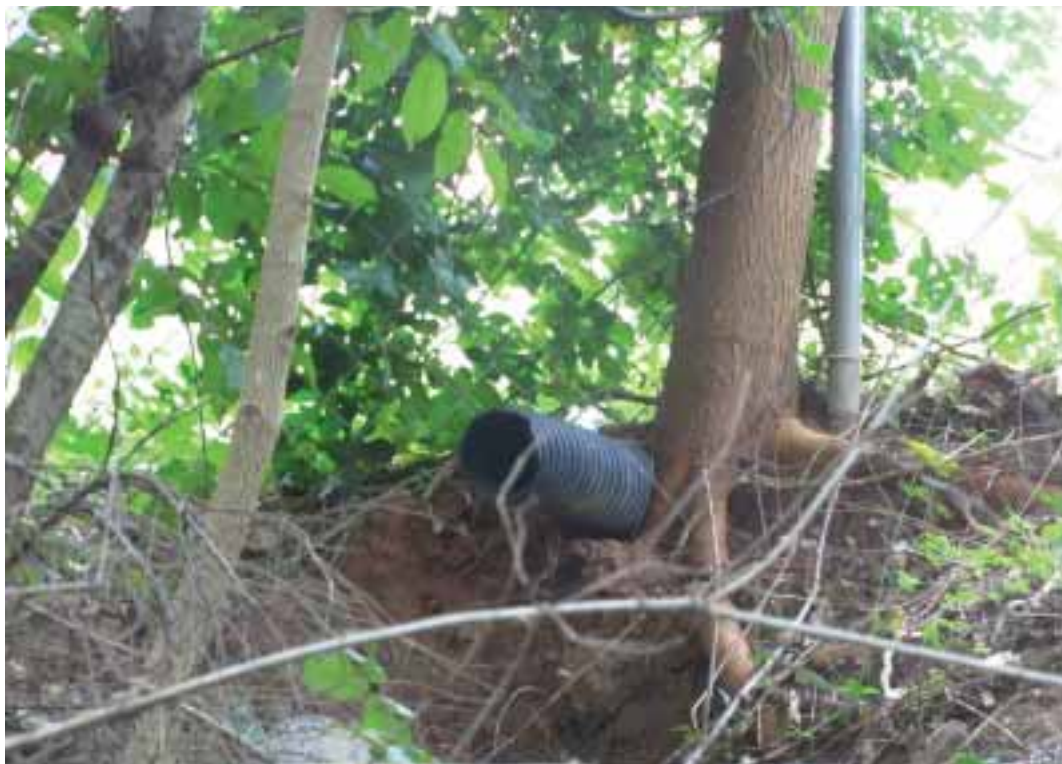
PVC pipe from multi-family housing unit, routing water to wooded stormwater draw. A section of chain link fence is located between the housing unit and woods.

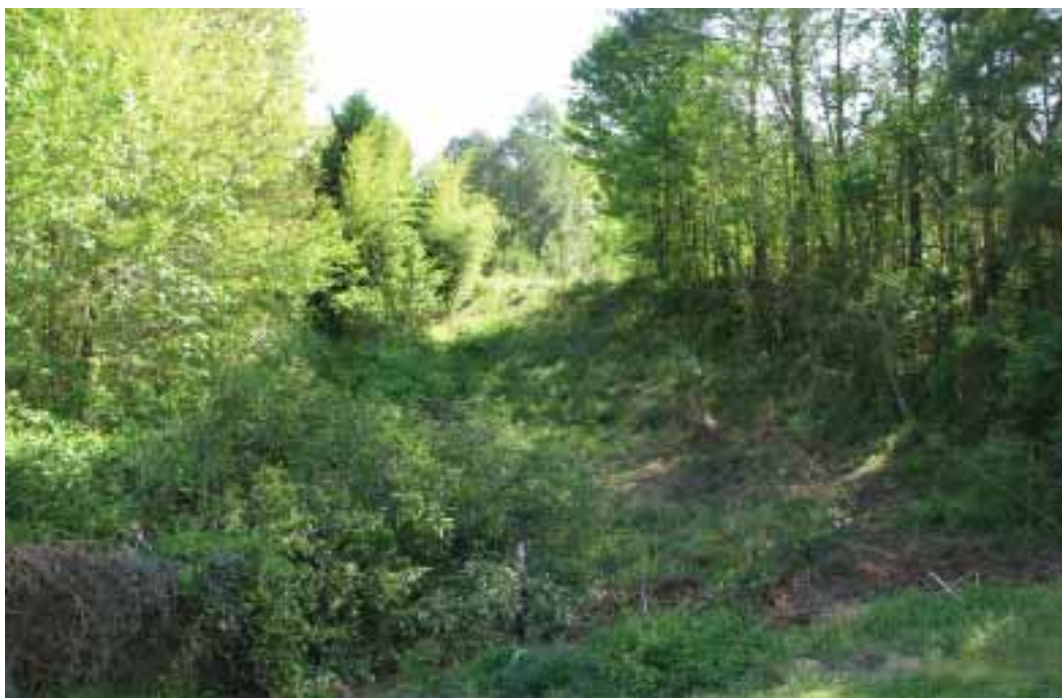
Stormwater draw at intersection with powerline easement, northwest corner of park property. Brown property boundary marker is visible in the foreground.

- Determine jurisdictional status of stormwater draw on western portion of property
- Forest management may be needed, for example to address storm damage, serious disease, insect infestations
- Continue inventory and mapping of natural resources including flora and fauna
- Consider collecting seed from uncommon plants growing in the powerline easement, such as the large flowered aster and the southern rosinweed
- Communicate with overhead powerline company (Progress Energy/Duke) to encourage best stewardship of the powerline easement, including use of mowing to maintain vegetation rather than herbicide application

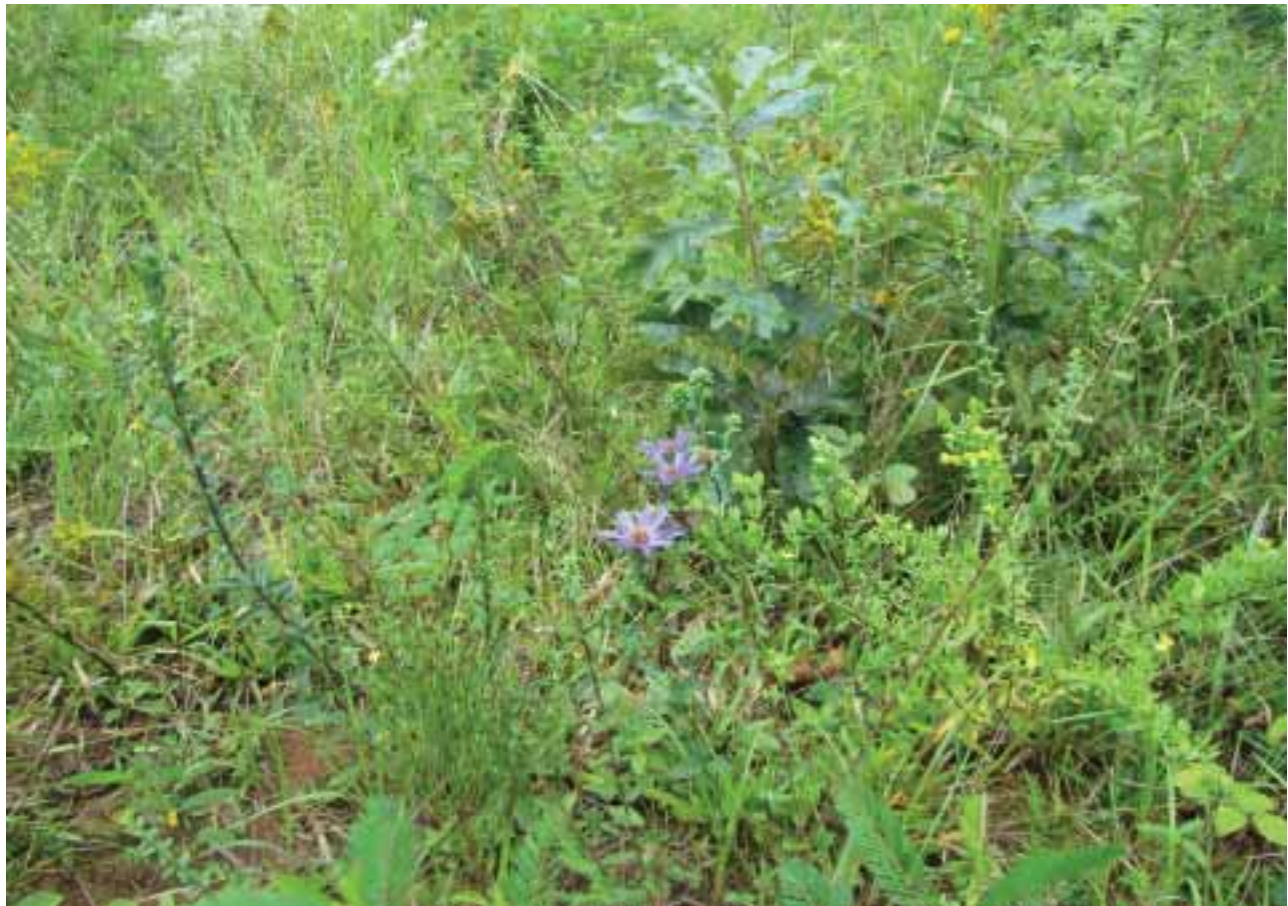
The photograph above shows the diversity of herbaceous vegetation present in the powerline easement along the northern boundary of the Sierra Drive Property. Large flowered aster, an uncommon wildflower in the Piedmont, is visible in the foreground, and attracted a variety of butterflies and other pollinators during the site investigation (August 2012). Other native vegetation visible in the photograph includes pineweed (*Hypericum gentianoides*), partridge pea (*Chamaecrista fasciculata*), St. Andrew's cross (*Hypericum hypericoides*), goldenrod (*Solidago* sp.), eupatorium (*Eupatorium* sp.), an unidentified yellow composite flower, native grasses and sedges. Additional inventory in the powerline easement will increase both the plant list and the butterfly list for this area.

An uncommon species of aster has been observed within the powerline easement at Sierra Drive Property.

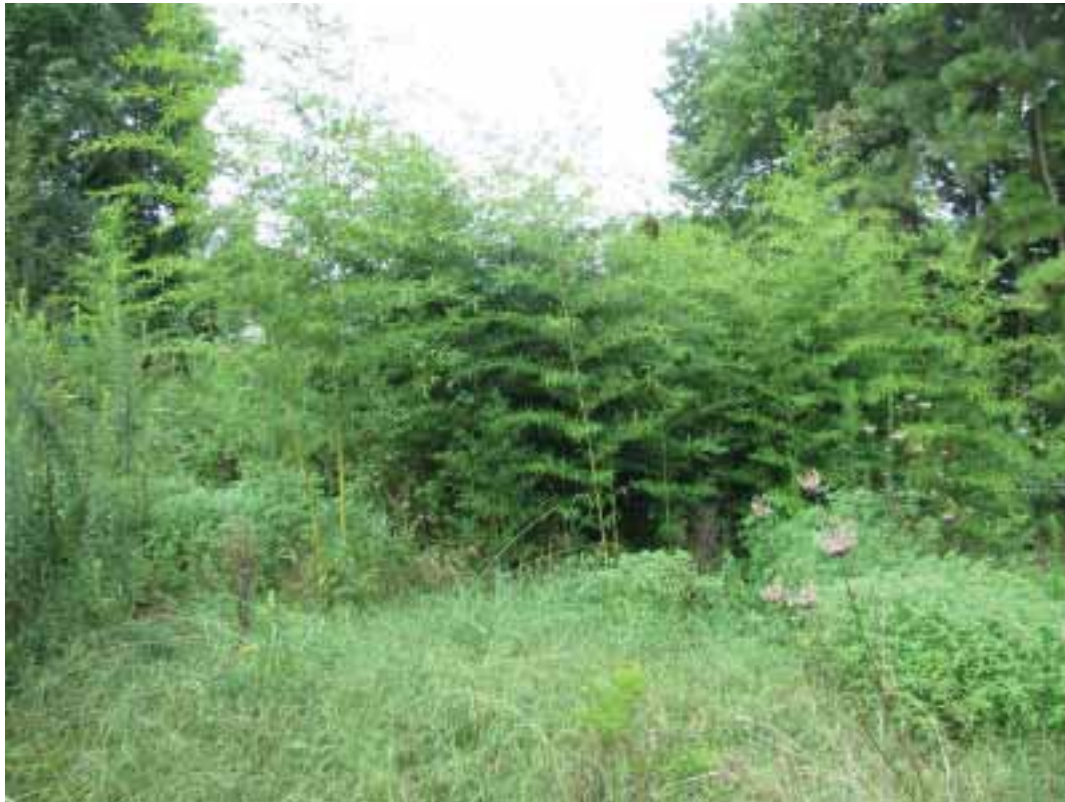
There is a patch of nonnative bamboo growing within the powerline easement near the northern property boundary. If not controlled, the bamboo will continue to spread and will outcompete the desirable native vegetation growing in the powerline easement.

Non-native, invasive bamboo (*Phyllostachys* sp.) at the northern property boundary
