City of Raleigh

**System
Integration Plan**

Trott-Strickland Park Site

June 2007

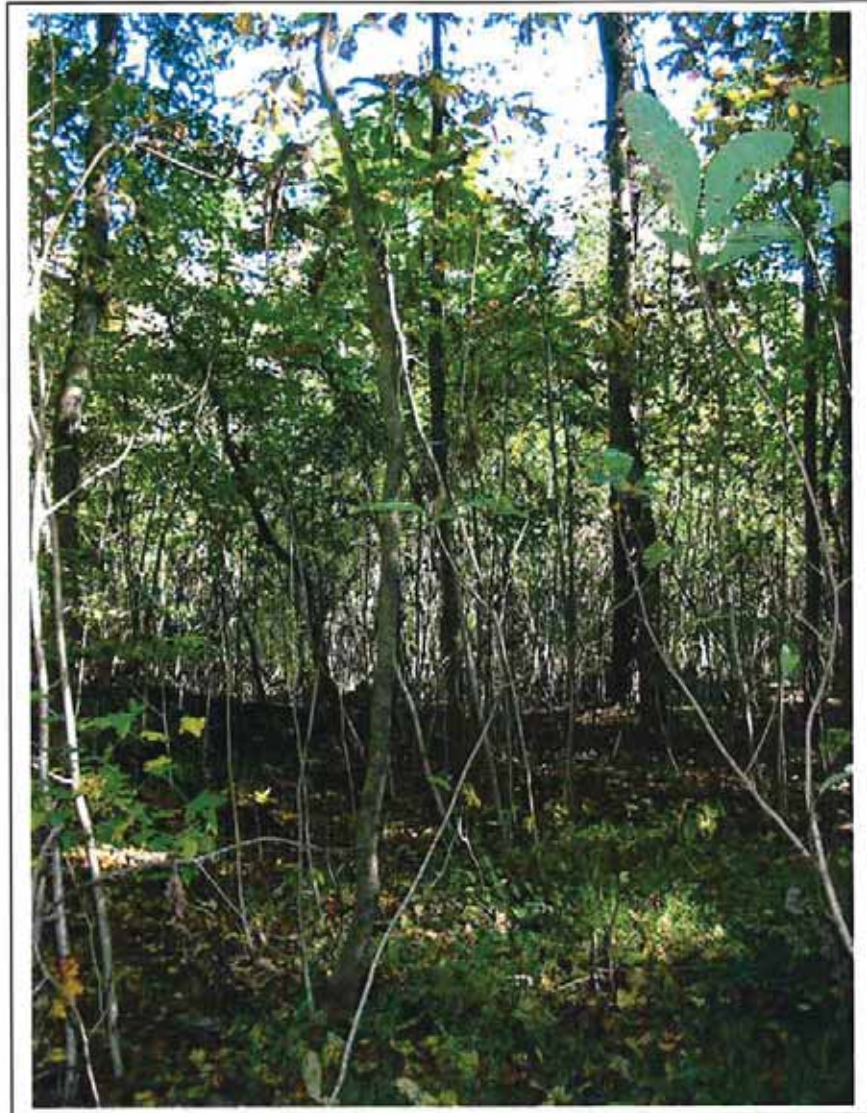
Figure 5. Umbrella magnolia-dominated area within Piedmont/Mountain Alluvial Forest.

grape (*Vitis rotundifolia*), and poison ivy (*Toxicodendron radicans*). Herbaceous species include Japanese stiltgrass (*Microstegium vimineum*), Southern lady fern (*Athyrium filix-femina* ssp. *asplenioides*), small-spike false nettle (*Boehmeria cylindrica*), and lizard's tail (*Saururus cernuus*). The understory in a portion of the west side of the project study area is strongly dominated by spicebush. The understory in a portion of the eastern portion of the project study area is strongly dominated by umbrella magnolia (Figure 5). There is regular flooding from Lower Barton Creek and its UT through the community, as evidenced by stratification within the upper 16 inches of the soil profile. The community occurs along the northern boundary of the project study area in the floodplain adjacent to streams SB and SC and encompasses approximately 5.89 acres (Figure 4).

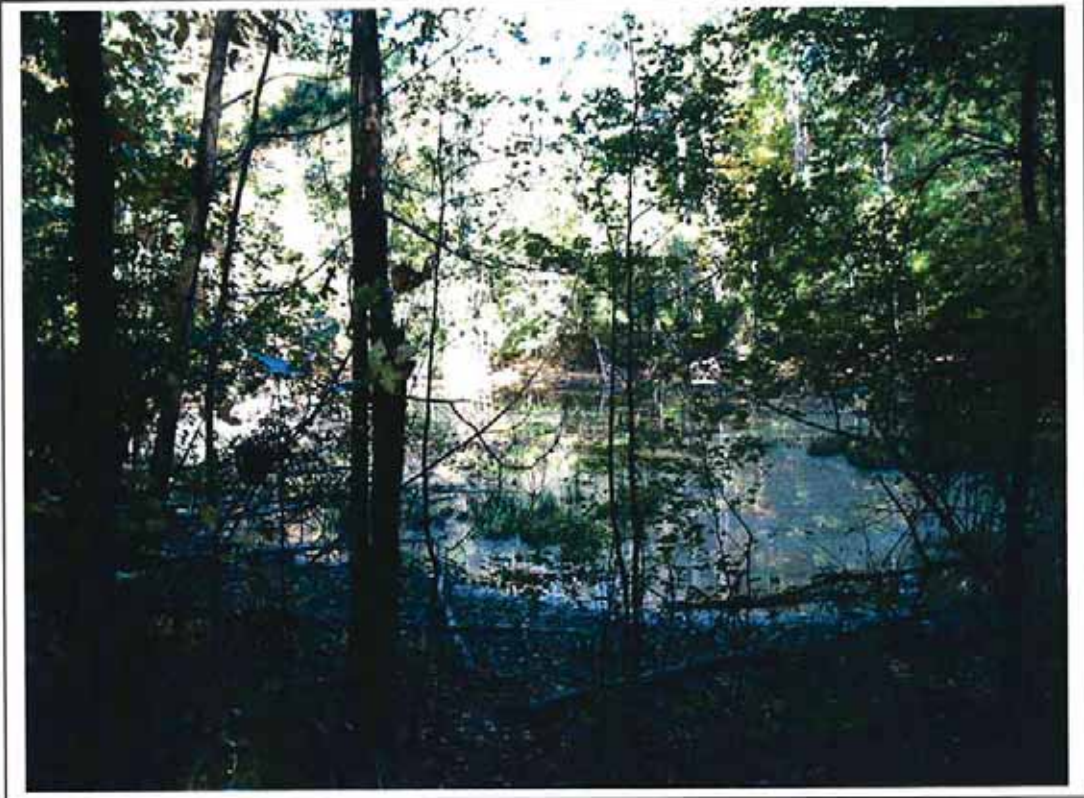
Figure 7. Impoundment PA from southern bank.

Two manmade impoundments exist within the project study area (Figure 7). The impoundments are dammed by earthen walls and are located at the head of two natural drainageways. An ephemeral drain is located at the downstream end of the western impoundment (impoundment PA). The drain contained no water at the time of site investigations, but it appears to carry runoff during large storm events. When water is present in the drain, it flows through wetland WF and into Lower Barton Creek within the project study area. Impoundments PA and PB cover approximately 0.55 acre and 1.56 acres, respectively.

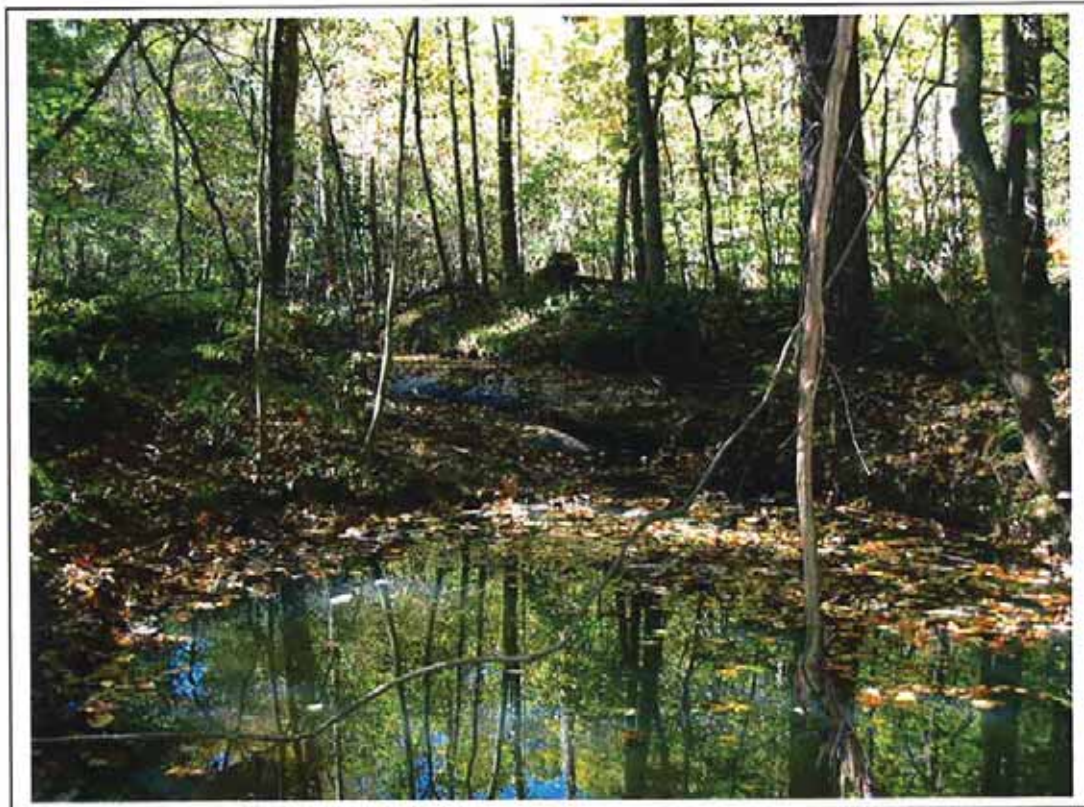
Figure 8. Exposed bedrock within Lower Barton Creek. The creek flows over the rock and into a large pool.

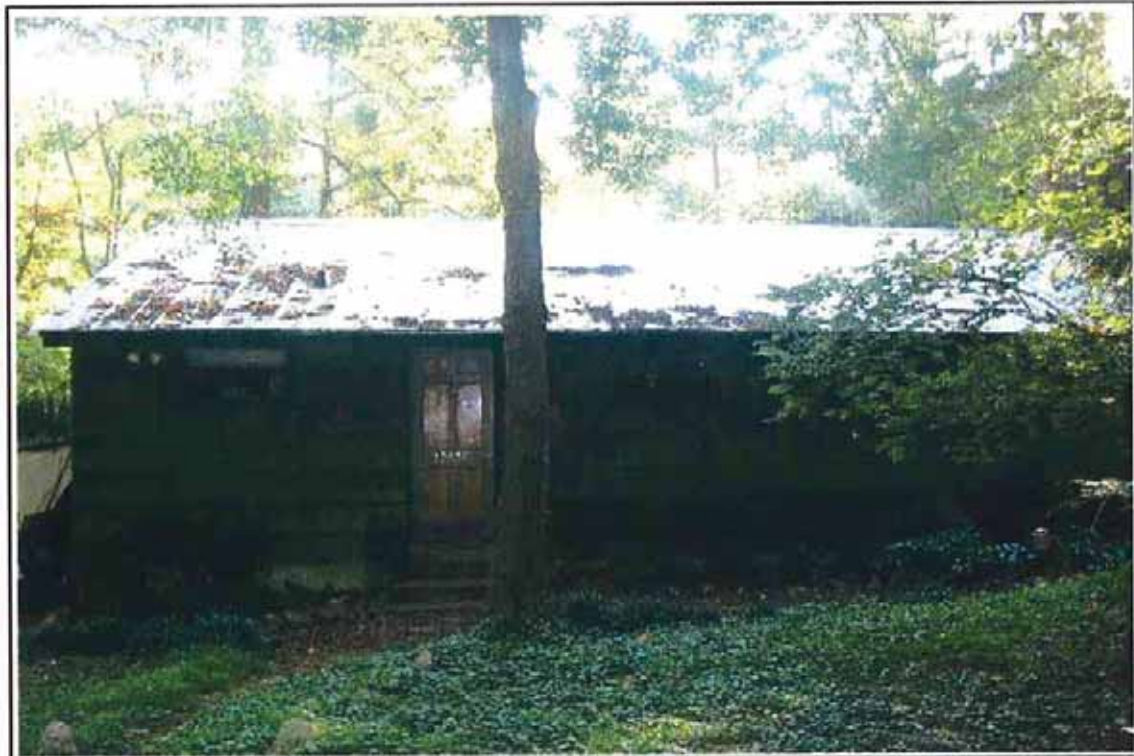
Figure 17. View of house at Trott-Strickland site, facing east.

The principal structure present on the Trott-Strickland tract is a one-story shallow pitched, side-gable, shingled house with a metal roof (Figure 17). Small windows are set under the eaves on the front elevation. A large brick exterior end chimney anchors the south elevation. A rear deck overlooks a manmade pond. Tax records date the dwelling to 1958, and this date of construction is supported by the building's style and appearance.

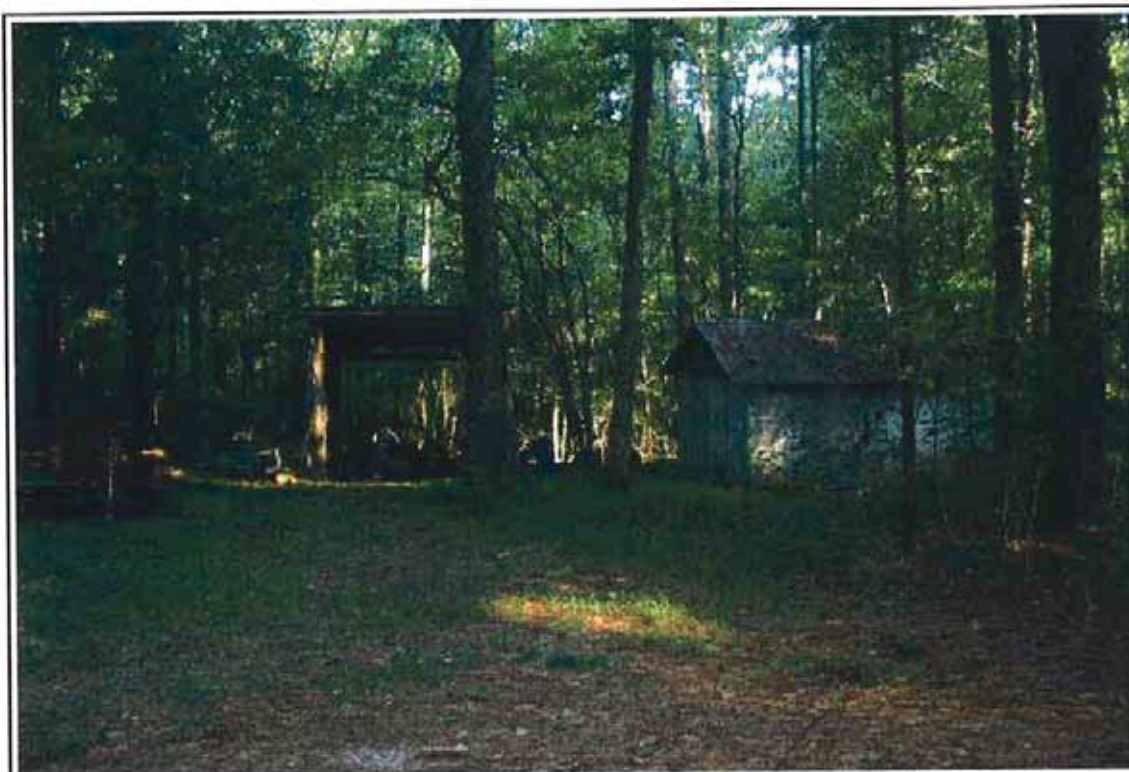
Figure 18. View of outbuilding cluster at Trott-Strickland site, facing north.

West of the house is a cluster of outbuildings (Figure 18). The first is a one-story, rectangular, side-gable, concrete block outbuilding of undetermined use (Figure 19). The building is surmounted by a metal roof with exposed rafter tails and weatherboarded gable ends. An open-air equipment shelter is located west of the block outbuilding (Figure 20). Round wood posts support a metal shed roof. Southwest of the shelter is a front-gable plywood shed topped with a tar paper roof (Figure 21). South of the outbuilding cluster is a small, front-gable livestock barn covered in both flush board and board-and-batten siding (Figure 22). The barn has a metal roof and exposed rafter tails in the eaves. Construction dates for these outbuildings could not be determined, but they likely date from the second half of the 20th century.

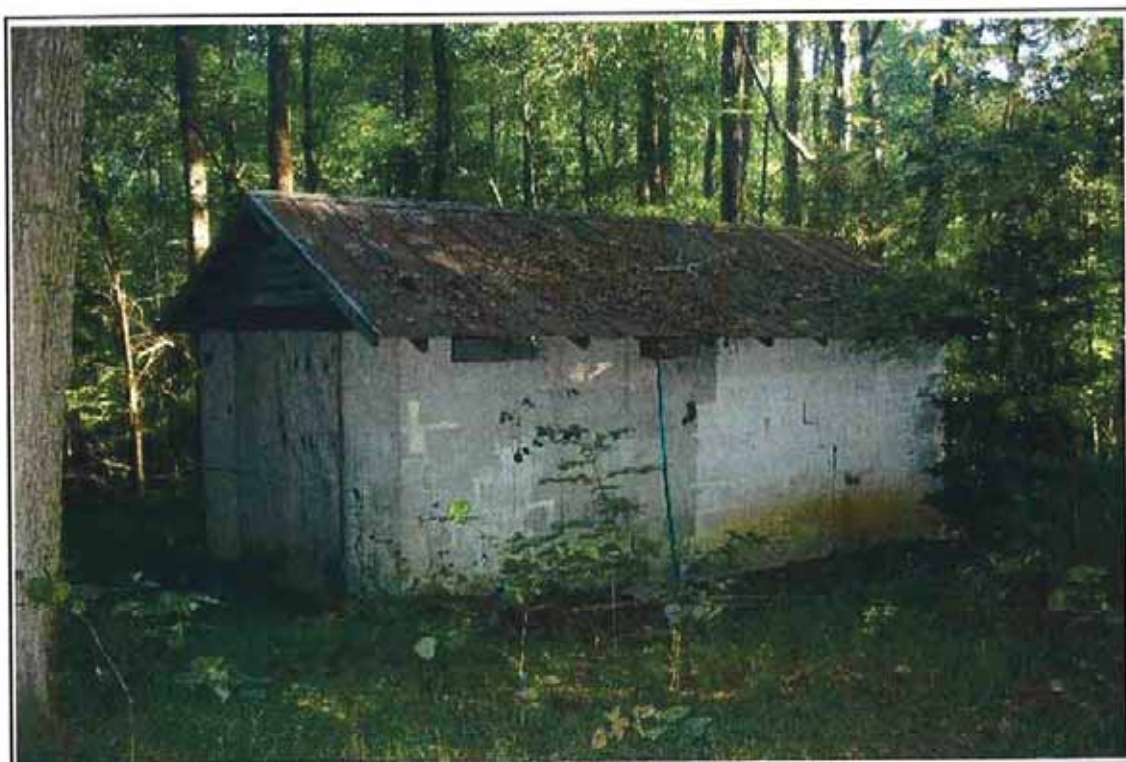
Figure 19. View of concrete block structure at Trott-Strickland site, facing northwest.

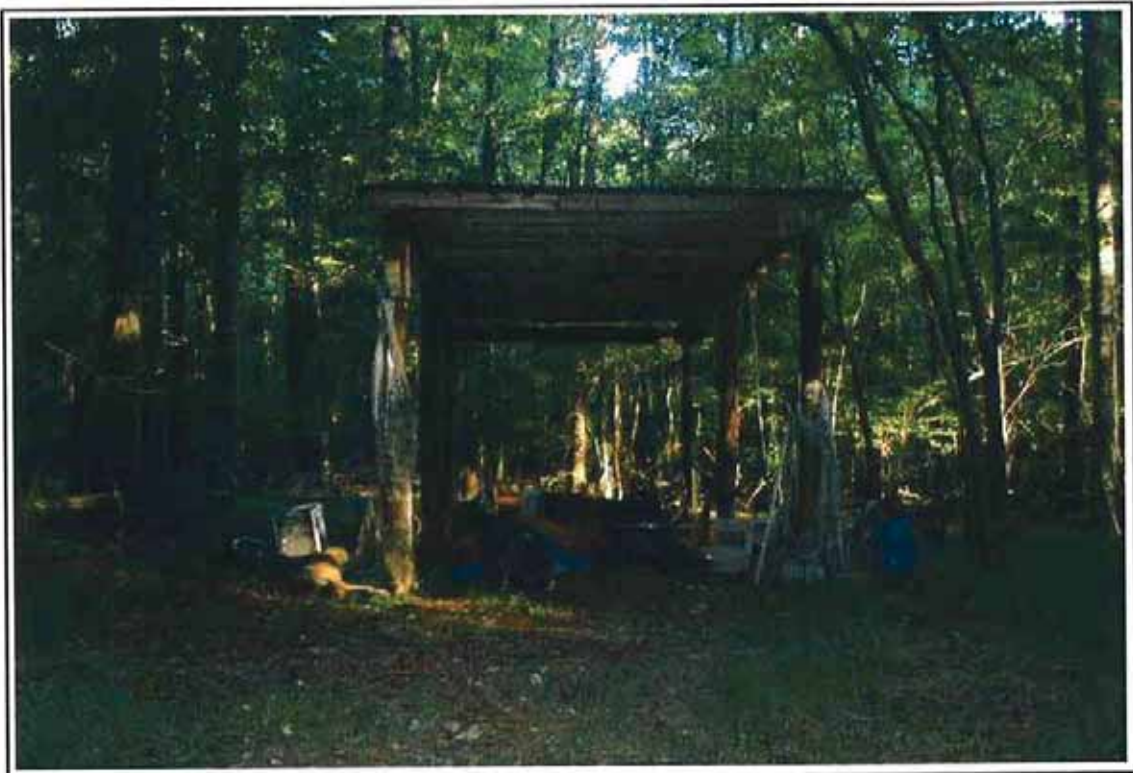
Figure 20. View of open-air equipment shelter at Trott-Strickland site, facing north.
