# System Integration Plan

Wooten Meadow Park

Raleigh, North Carolina

August 11, 2014

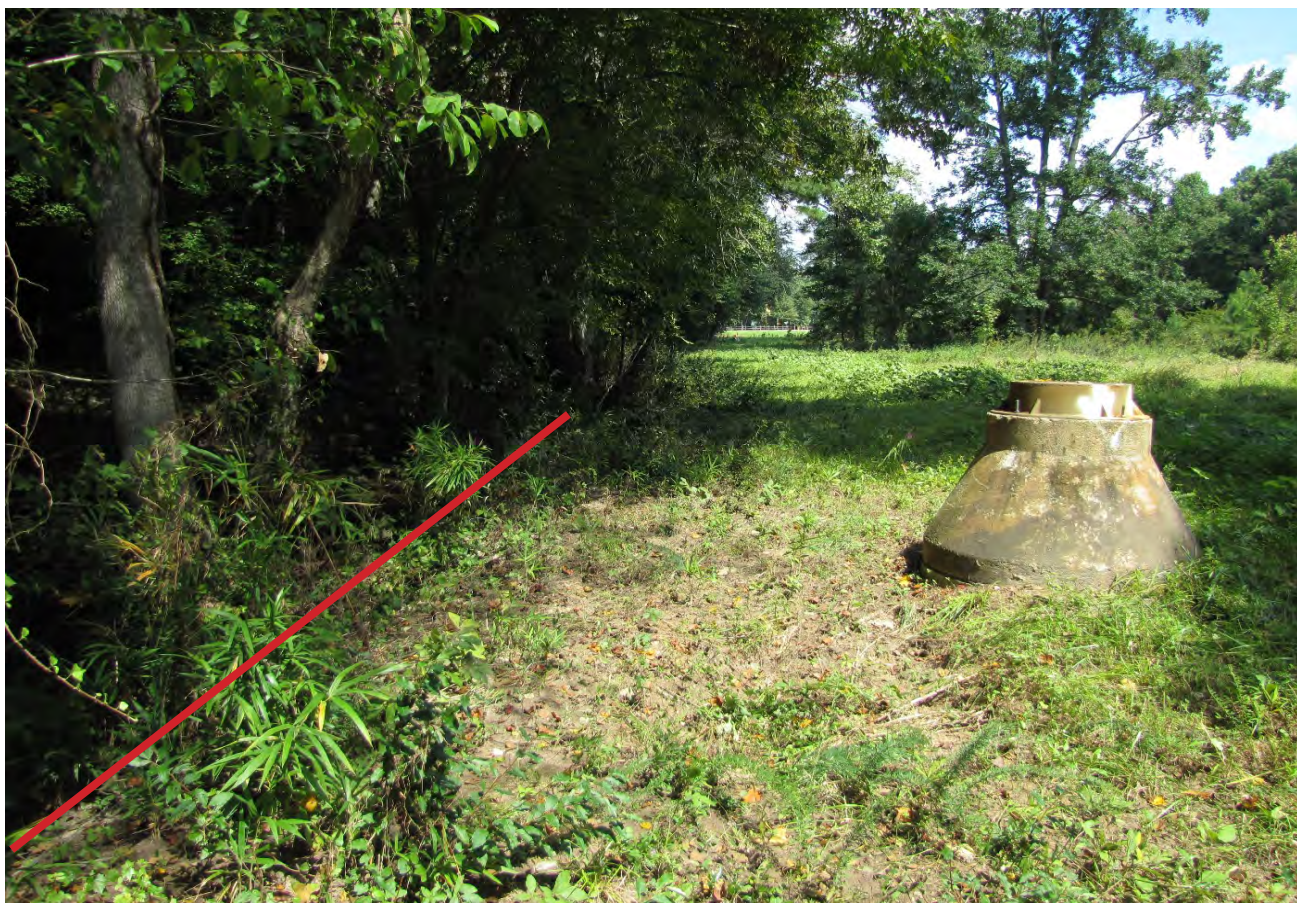
Sewer easements are located along both the west and east sides of Wooten Meadow. The western sewer easement along Hare Snipe Creek was installed in 1970 (see photo below). There are few trees established as a buffer between the sewer easement and the Creek. The Neuse River Riparian Buffer Rules require at least the first 30 feet adjacent to the Creek to be forested. Although the sewer easement is exempt from the rules, interim mangement recommendations for the site include partnering with City of Raleigh Public Utilities to manage easements.

Western sewer easement along Hare Snipe Creek. Creek bank is marked with a red line.

The sewer easement along Hare Snipe Creek on the park's west property boundary was installed in 1970. There are very few trees established as a buffer between the sewer easement and the Creek. The Neuse River Riparian Buffer Rules would normally require at least the first 30 feet adjacent to the Creek (Zone 1) to be forested, however if the land use existed prior to the Buffer Rules adoption in 1997, the land use is "grandfathered" or exempt from the Rules, as long as the use continues unaltered. Grading and revegetating Zone 2 (the next 20 feet) is allowed provided that the health of the vegetation in Zone 1 is not compromised, the ground is stabilized and existing diffuse flow is maintained. Additional information on the stability and condition of the riparian buffer along Hare Snipe Creek is provided in the Water Resources section of this report, beginning on page 48.

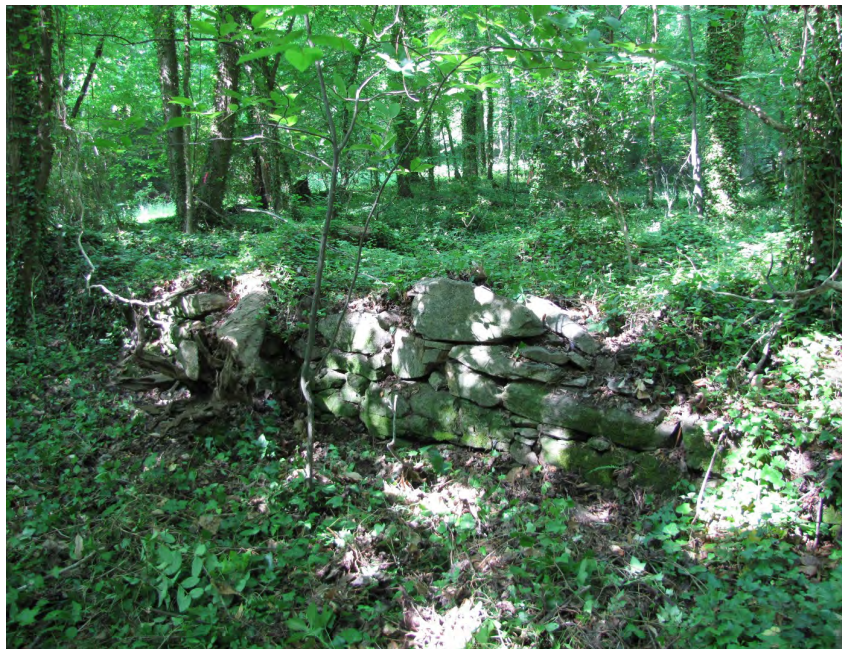
Signs of historic site use have been observed in the vicinity of the Wooten Meadow property and on privately owned properties in the vicinity. Structural historic remains observed thus far include a dry-stacked stone mill dam from approximately 1773 (see photo above). The City of Raleigh is working with the NC Department of Cultural Resources to follow regulations of the National Historic Preservation Act. Wooten Meadow has undergone an initial evaluation for potential park classification as a Nature Preserve or Protected Natural Area, using City of Raleigh Nature Preserves Criteria. Wooten Meadow does provide important stormwater benefits and contributes both riparian and aquatic habitat to a wildlife habitat corridor between Lake Lynn and Crabtree Creek. There are no known occurrences of protected plant or animal species on the property. At the time of this report, the extent of invasive species occurring throughout the park negatively impacts the quality of the natural area, and the site does not achieve the quality associated with a Nature Preserve or Protected Natural Area. The Wooten Meadow property is **recommended for classification as a Neighborhood Park**.

Structural remains and other signs of land use history have been observed in the vicinity of the Wooten Meadow property near Hare Snipe Creek. Structural remains observed on the park property include an old dry stacked stone dam. The dam is reported from various sources as the remains of a mill dam associated with the 1773 Moses Parks Mill and/or the JD Hayes Mill labeled on the 1871 Fendol Bever's Map of Wake County. Mill foundations and remains of a mill head race are located in the vicinity on adjacent (currently privately owned) property. More details of the mill history are included on page 13 of this report. Additional land use history in the vicinity of the property is evaluated with maps, aerial photos, and other supporting information.

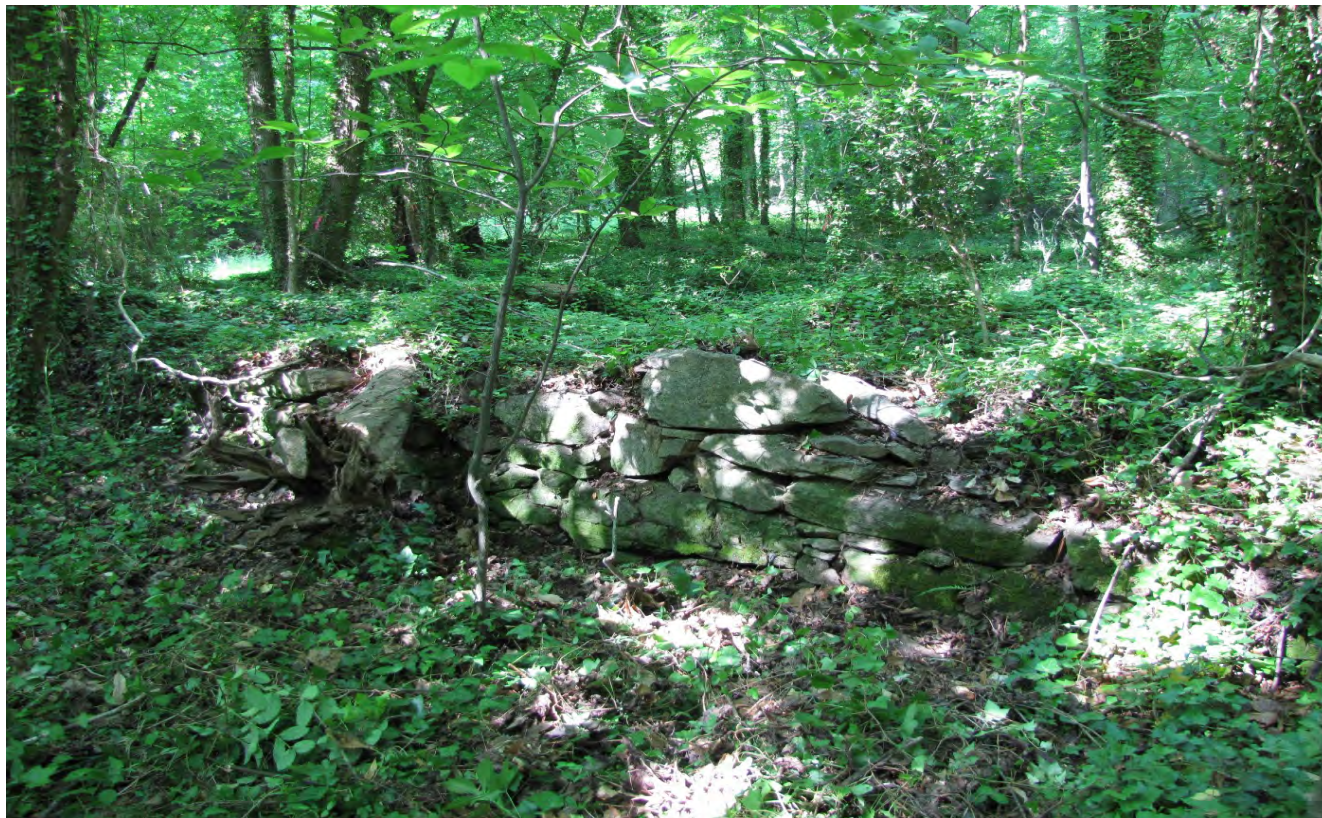
Dry-stacked stone dam remains covered by English ivy

- Remove English ivy from historic dam remains, after an archeological survey and only if approved by the NC Department of Cultural Resources
- Maintaining an un-mowed condition in the northern field area provides wildlife habitat during interim park planning

At Wooten Meadow, English ivy should be removed from cultural or historical site features as long as they will not be damaged by invasive plant removal efforts.

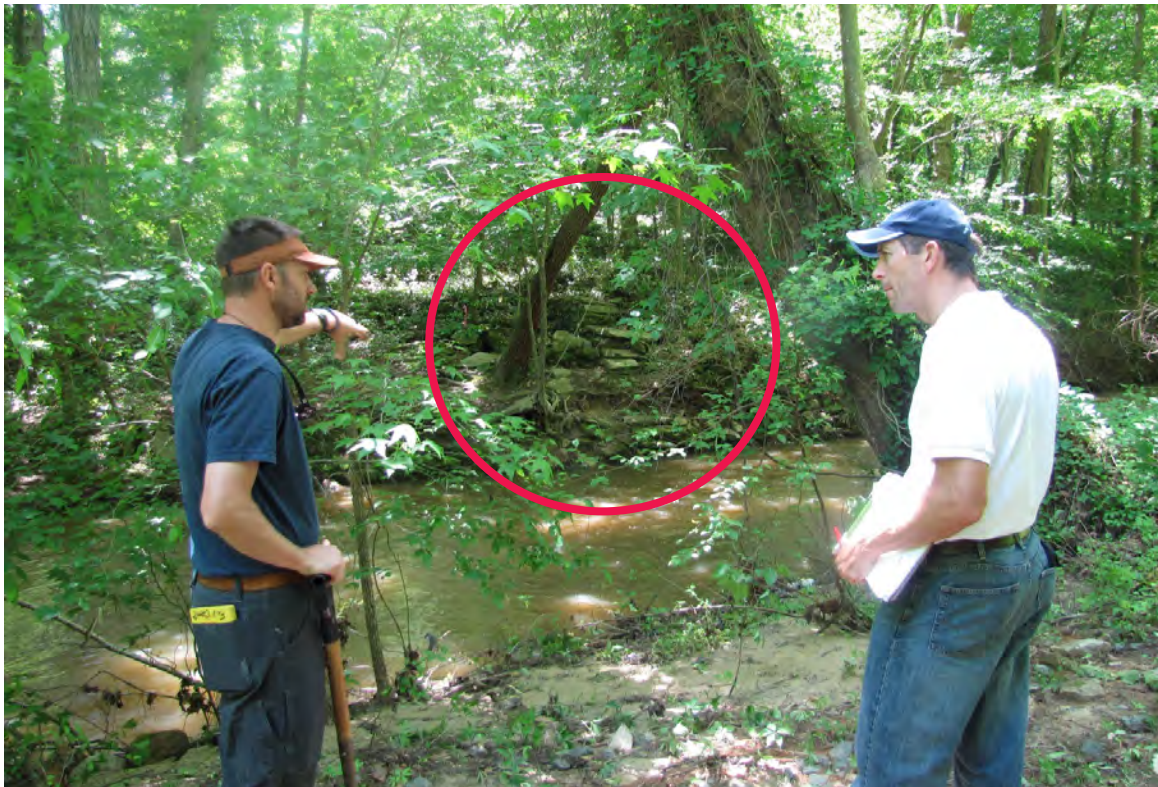
Dry-stacked stone dam remains are still visible on the west side of Hare Snipe Creek. Jumbled dam remains within the stream bed are also visible slightly downstream, as large dam rocks have been carried downstream over time by swift current.

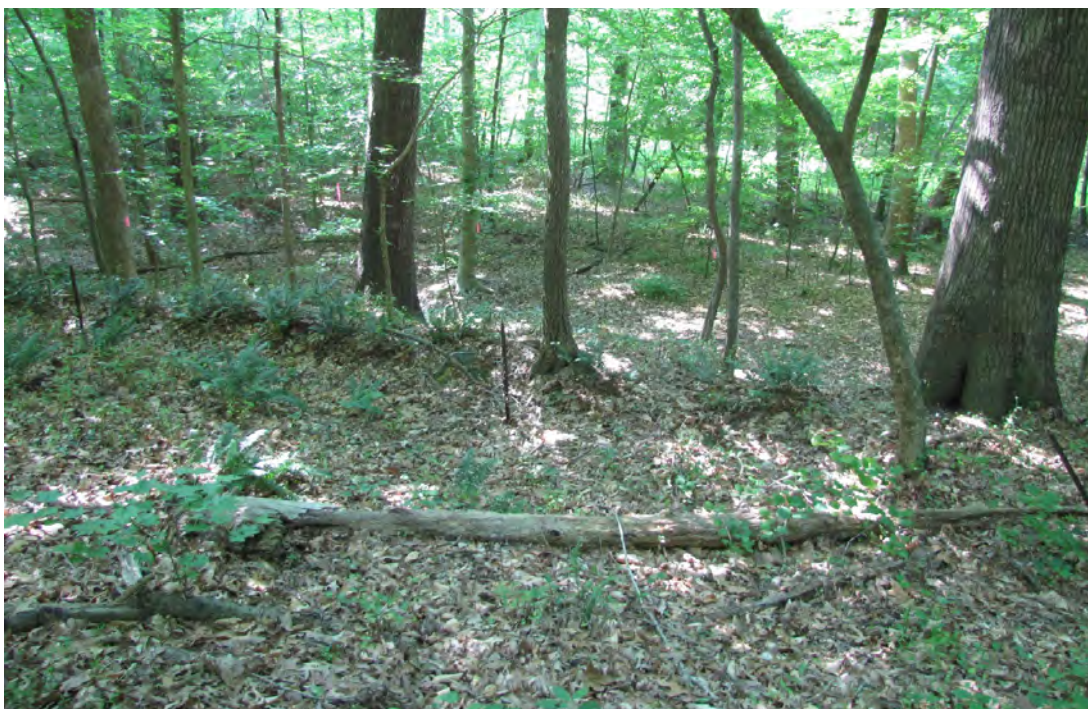
On the current Wooten Meadow property, on the east side of the dry-stacked stone dam remains, a worn path lies along the mid-ridge of the slope. Over thirty metal fence posts run along the length of this ridge. Aerial photos of the site, from as early as 1949, indicate several potential old roads or paths on the site that could be historically important. Archeological studies of the site should include investigation of historic periods and Native American history, and should include the park site and accessible neighboring properties in the vicinity.

Linear mid-ridge line occurring at east side of dam remains, visible on lidar map on page 18.

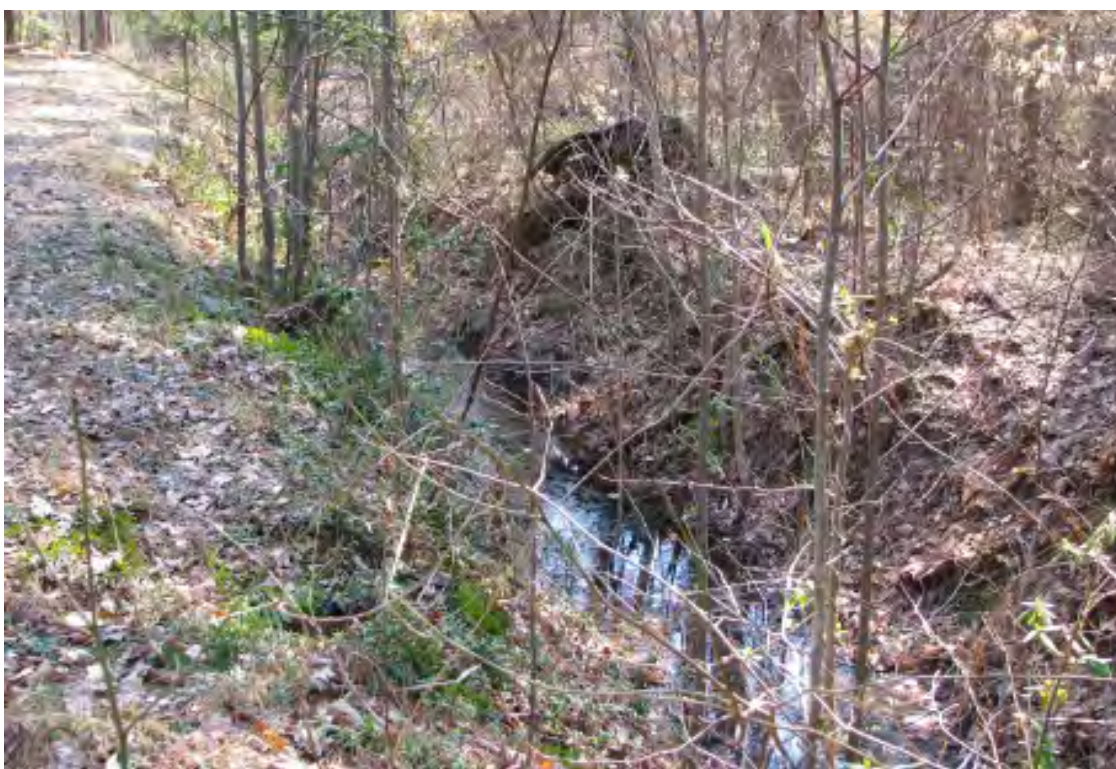
A portion of the eastern sewer easement is located on what may have been an old road bed. Water collects in the adjacent low area during the winter.

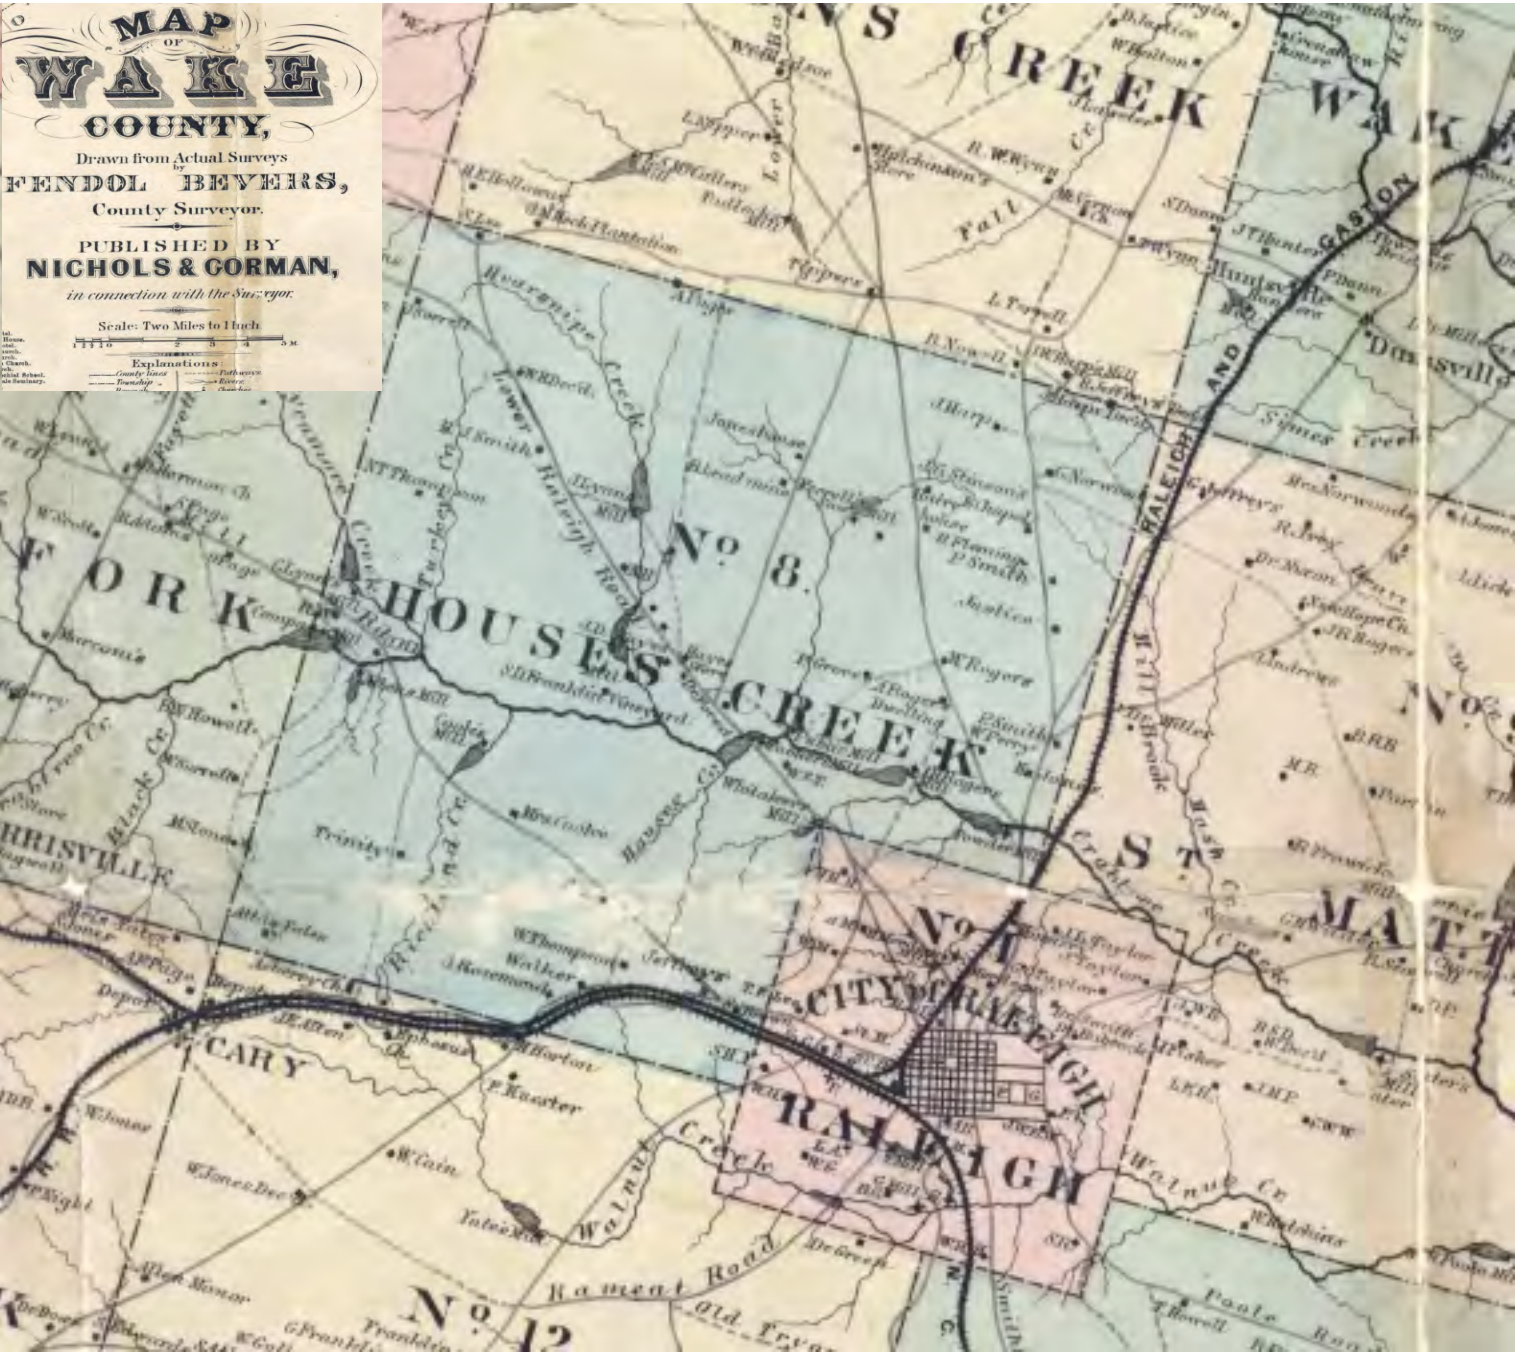
**House Creek Township on the 1871 Fendol Bever’s Map of Wake County**

Description of House Creek Township on the map: Rocky and broken, drak grey soils, red subsoil. Good water.  
Products: Corn, Wheat, Oats, Potatoes, Peas, Cotton    Wood: Oak, Hickory, Pine, Black Jack

Early maps depicted streams, main roads, property owners, and mills. JD Hayes’ Mill is mapped along Hare Snipe Creek in House Creek Township. the only other mill shown along Hare Snipe Creek is J Lynn’s Mill. The mill ponds associated with the mills are shaded in.

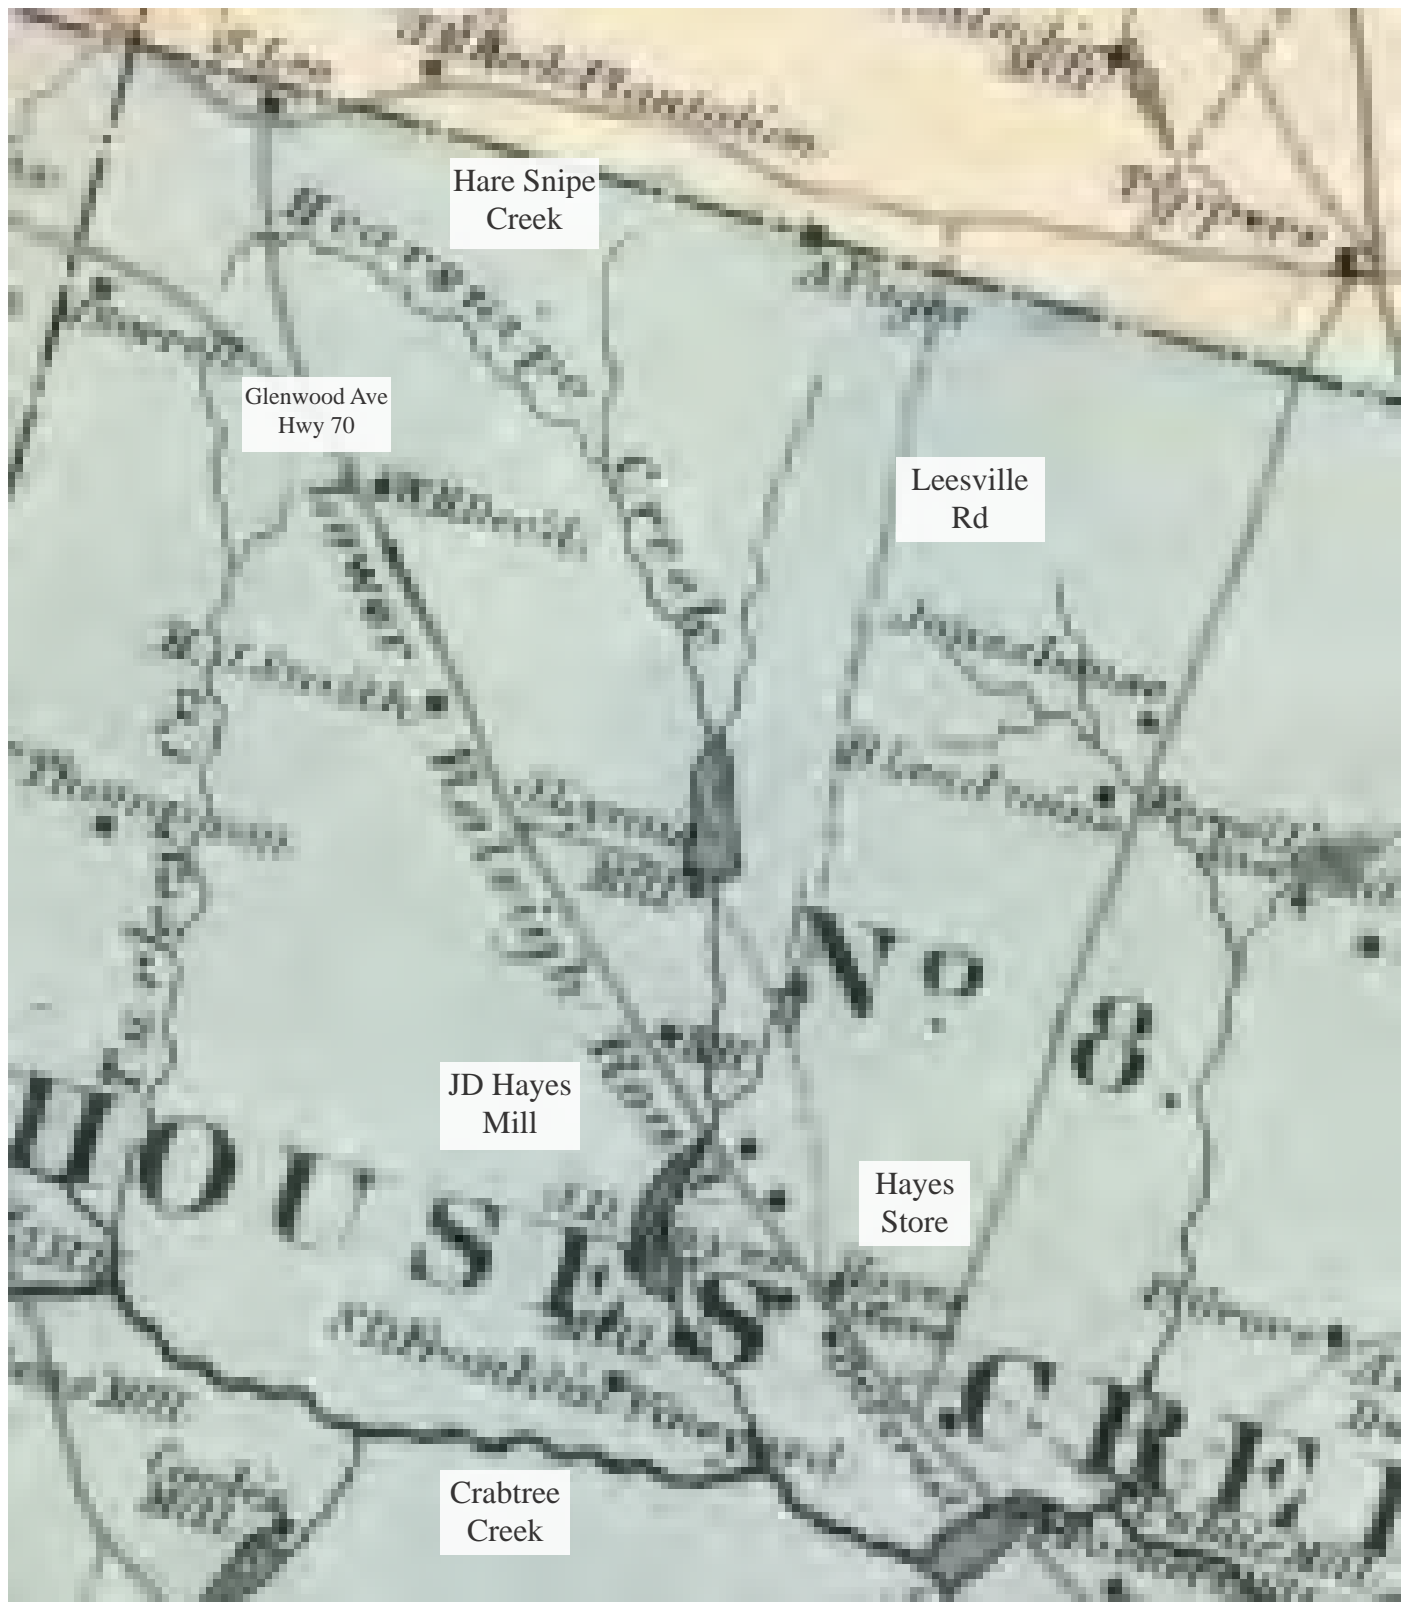
## Vicinity of Wooten Meadow property, 1871

The 1871 Fendol Bever's map shows JD Hayes mill and mill pond on Hare Snipe Creek approximately .93 miles north of Crabtree Creek. Hayes Store, also shown on the map, was a voting place and included a post office, and was in operation from the 1860s to 1880s. Glenwood Ave (US Hwy 70) was called Lower Raleigh Rd on the 1871 Fendol Bever's Map of Wake County. A winery "SD Franklin Vineyard" is shown to the south of JD Hayes Mill.

A “JD Hayes Mill” is shown in approximately the same location as the Moses Parks Mill on the 1871 Fendol Bever’s Map of Wake County (see page 17). It is unknown whether the JD Hayes Mill replaced the original Parks Mill or was built near the original mill. There are several structural remains in the vicinity; additional cultural explorations are needed to clarify and expand existing knowledge.

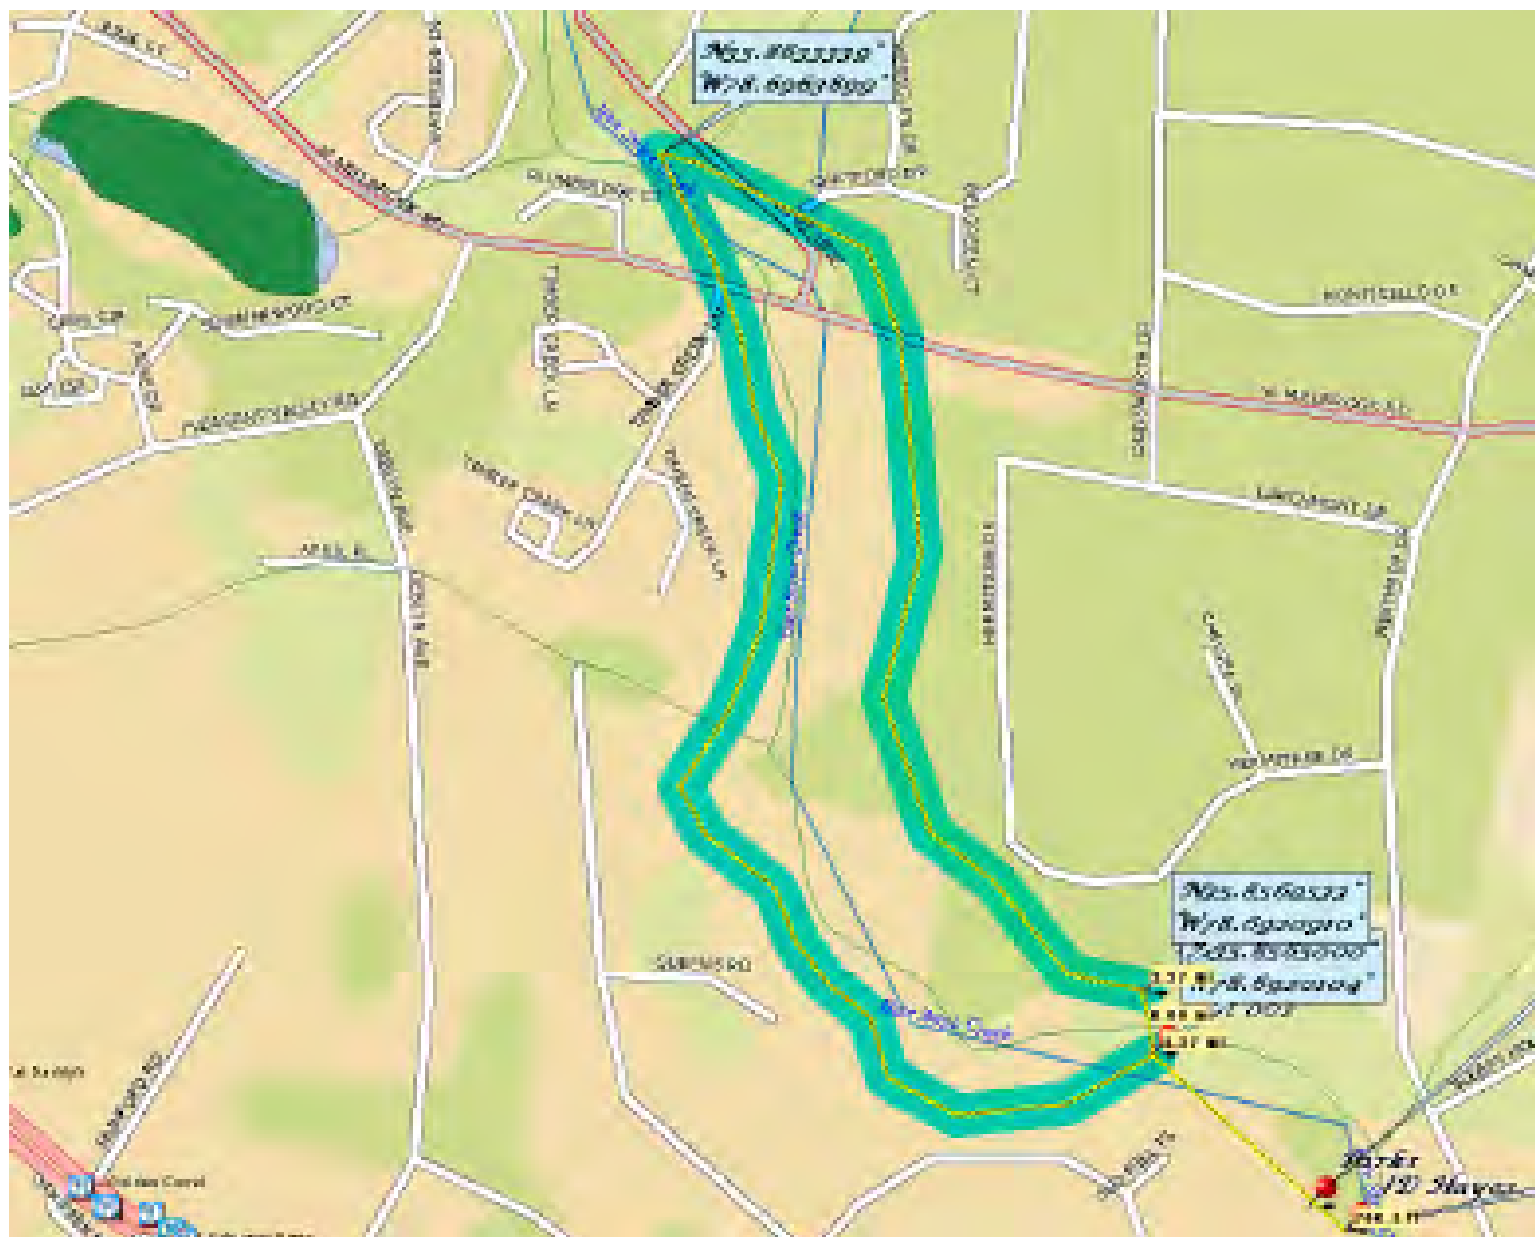
Historic JD Hayes mill pond extent estimated by Dr Karl Wegmann and Doug Swords. Coordinate point at the top of the map is where the stream bed elevation matches the approximate elevation at the top of the dam. Coordinate points lower on the map represent the dry-stacked stone dam remains, the mill foundations and head race.

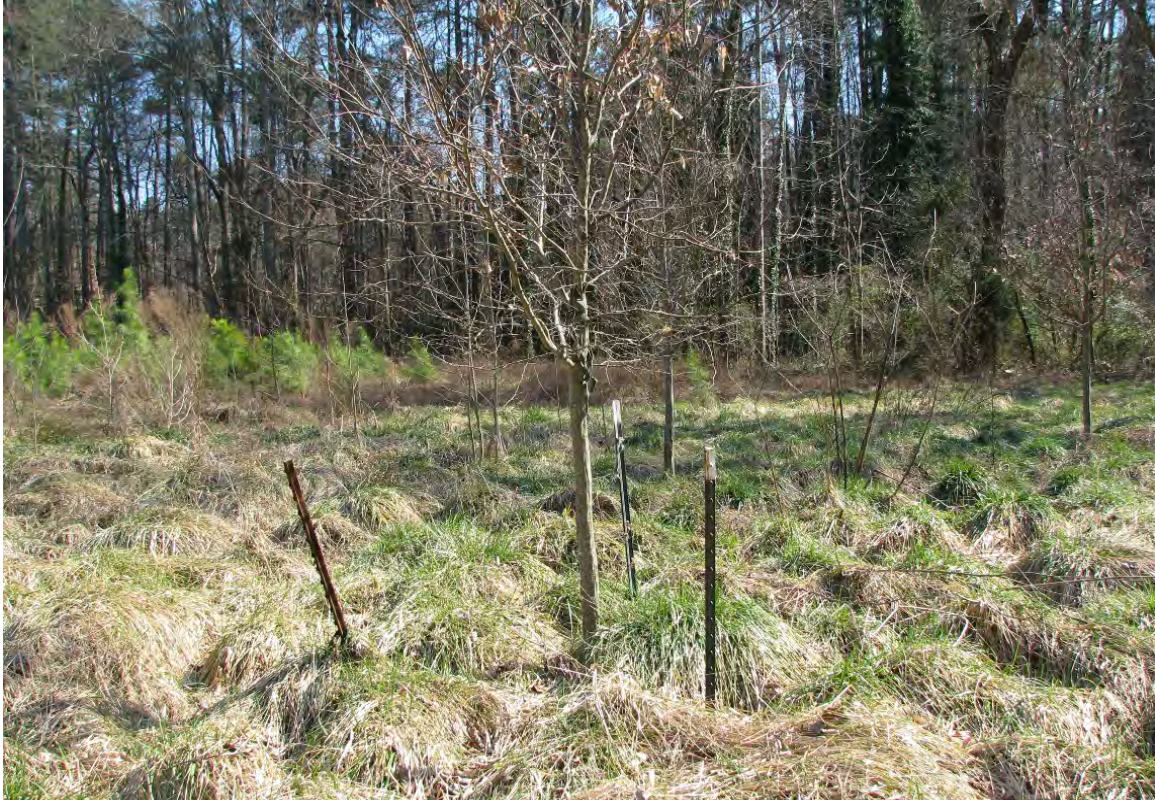
Tree stakes still remain on some of the larger trees in the planting area. Stakes should be removed after one growing season. It is best not to use stakes except when required, for example when conditions are windy. (*International Society of Arboriculture Planting Specifications*)

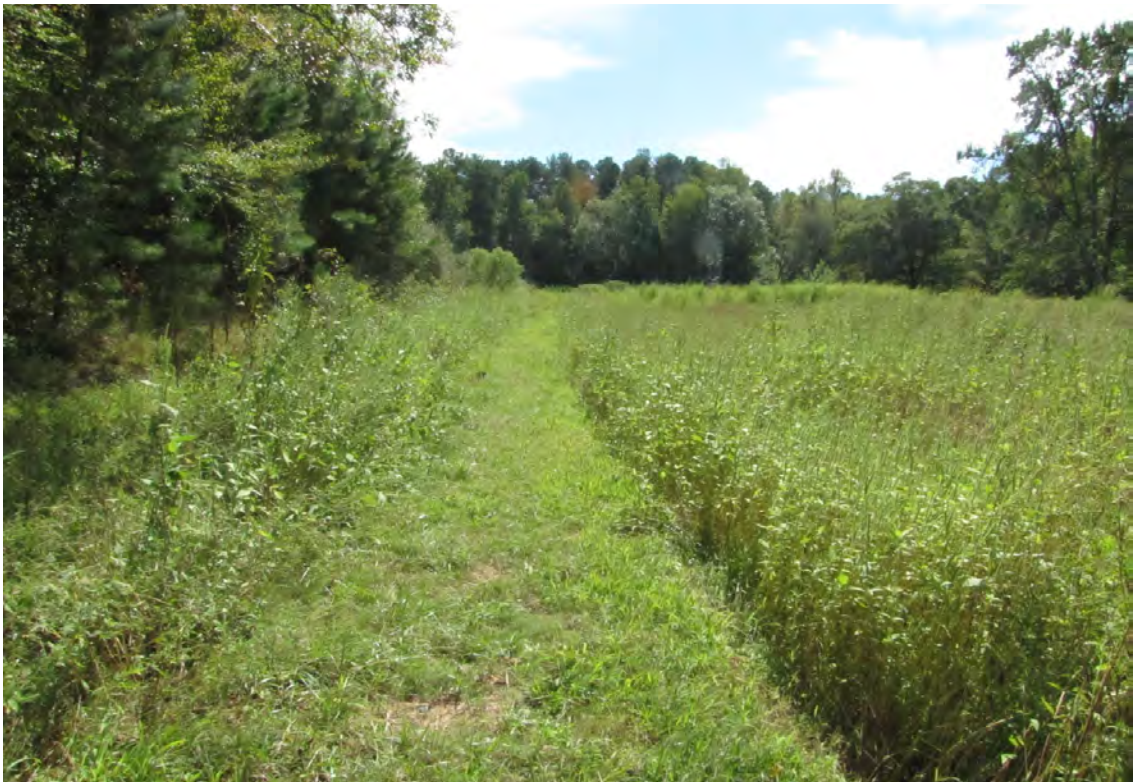
Interim management of the park’s mid-field area involves mowing alternate sections of the field on a rotational basis, so that winter wildlife cover is available every year, and to provide interim pollinator habitat. Leaf and/or mulch storage is periodically an additional interim use of the site.

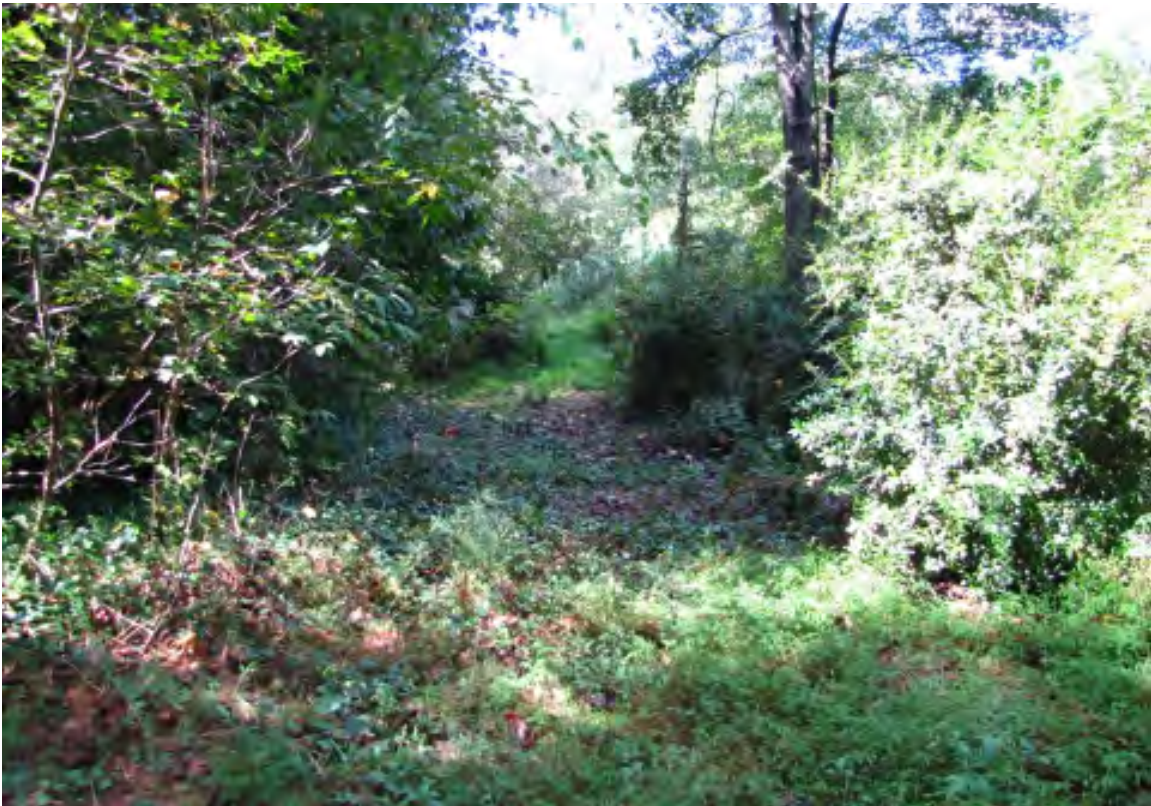
A path is generally mowed in front of the southern forested portion of the park. The photo above is taken from the eastern sewer easement, looking west toward Hare Snipe Creek.

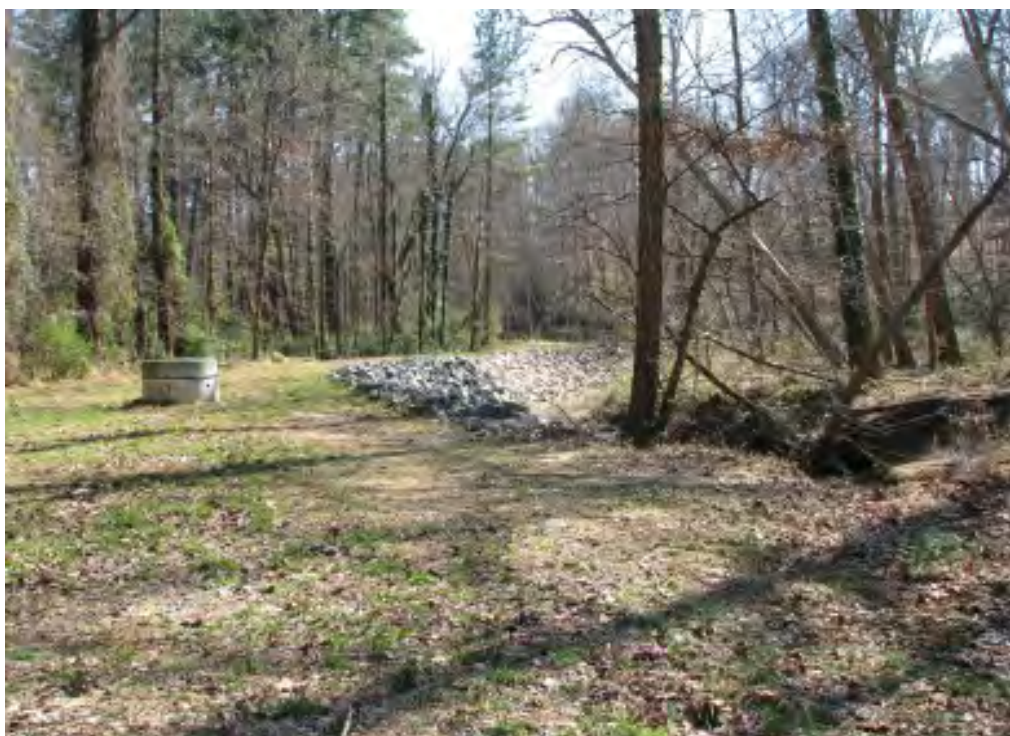
The 40-foot wide western sanitary sewer easement supports a 24 inch gravity sewer. Riprap has been added at various easement locations to increase stream bank stability.

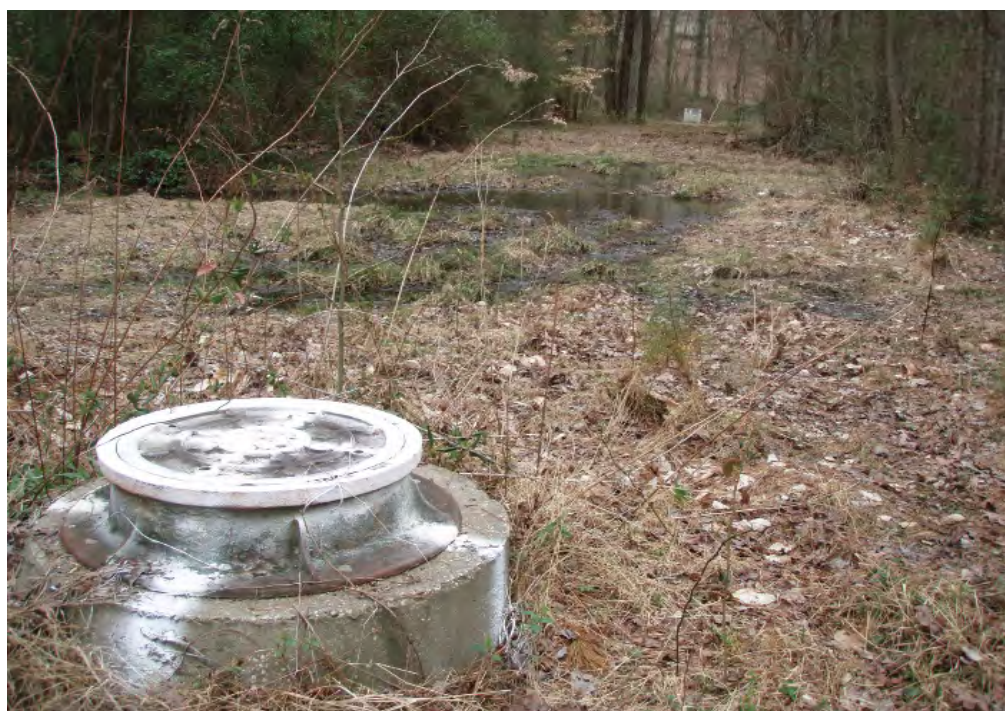
A lateral sewer easement connects the 24-inch western sanitary sewer with an 8-inch main sewer line running along the eastern park boundary, crossing the park near the middle of the property.

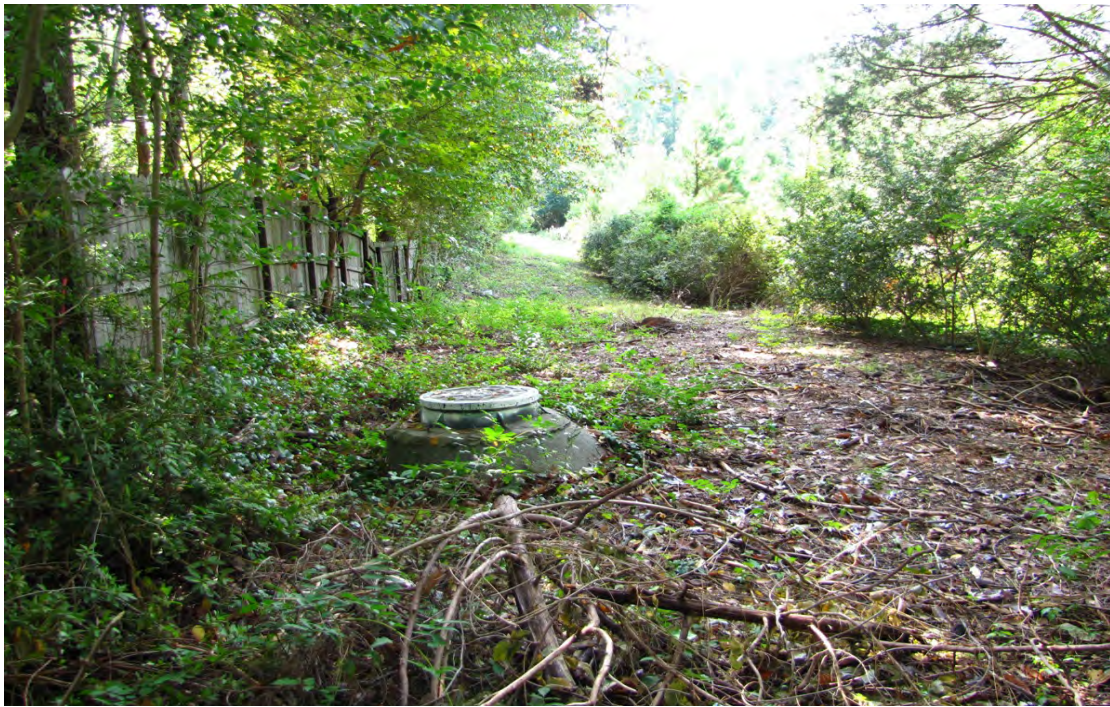
The eastern sewer easement traverses several habitat types, from upland forest to flood-plain. A portion of the easement follows what is potentially an old road bed. Several adjacent property owners on the east side of Wooten Meadow have fences erected. Park encroachment at this park is minimal. Park encroachment occurs when adjacent property owners use park property as their own yard, for example by dumping yard waste in the park, clearing park vegetation to expand their yard or modify their view, creating private paths into the park, or setting up a swingset on park property.

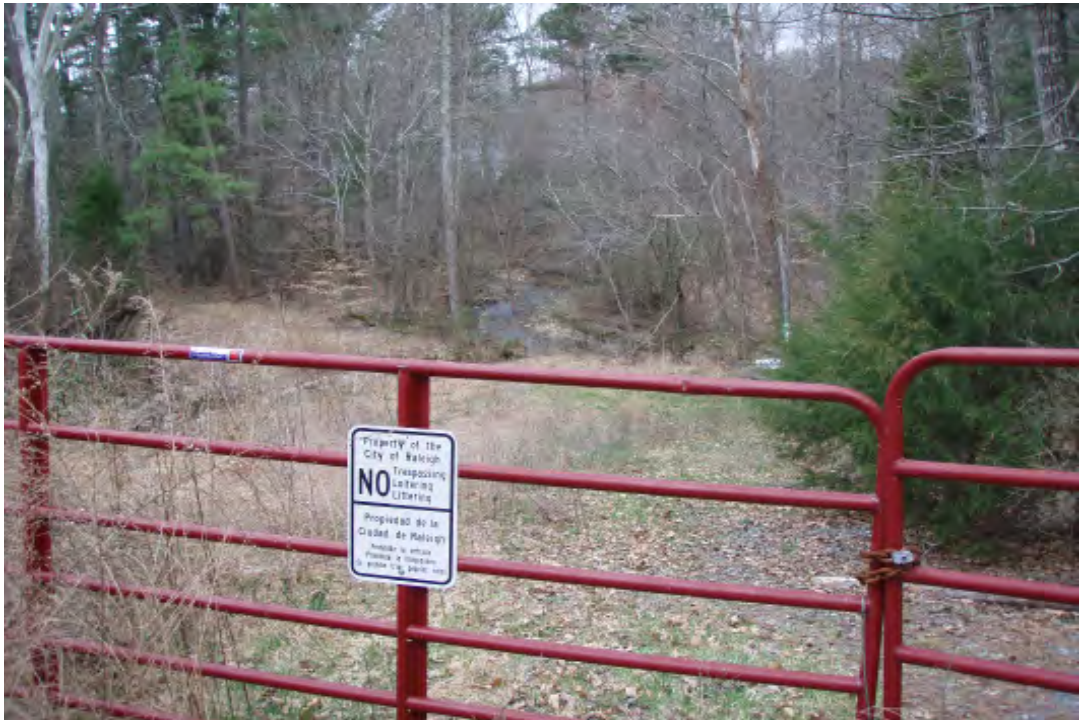
A gate is installed at a sewer easement extension intersection with Winthrop Drive. Photo above is from 2010, taken in late winter with meandering Hare Snipe Creek visible in the distance.

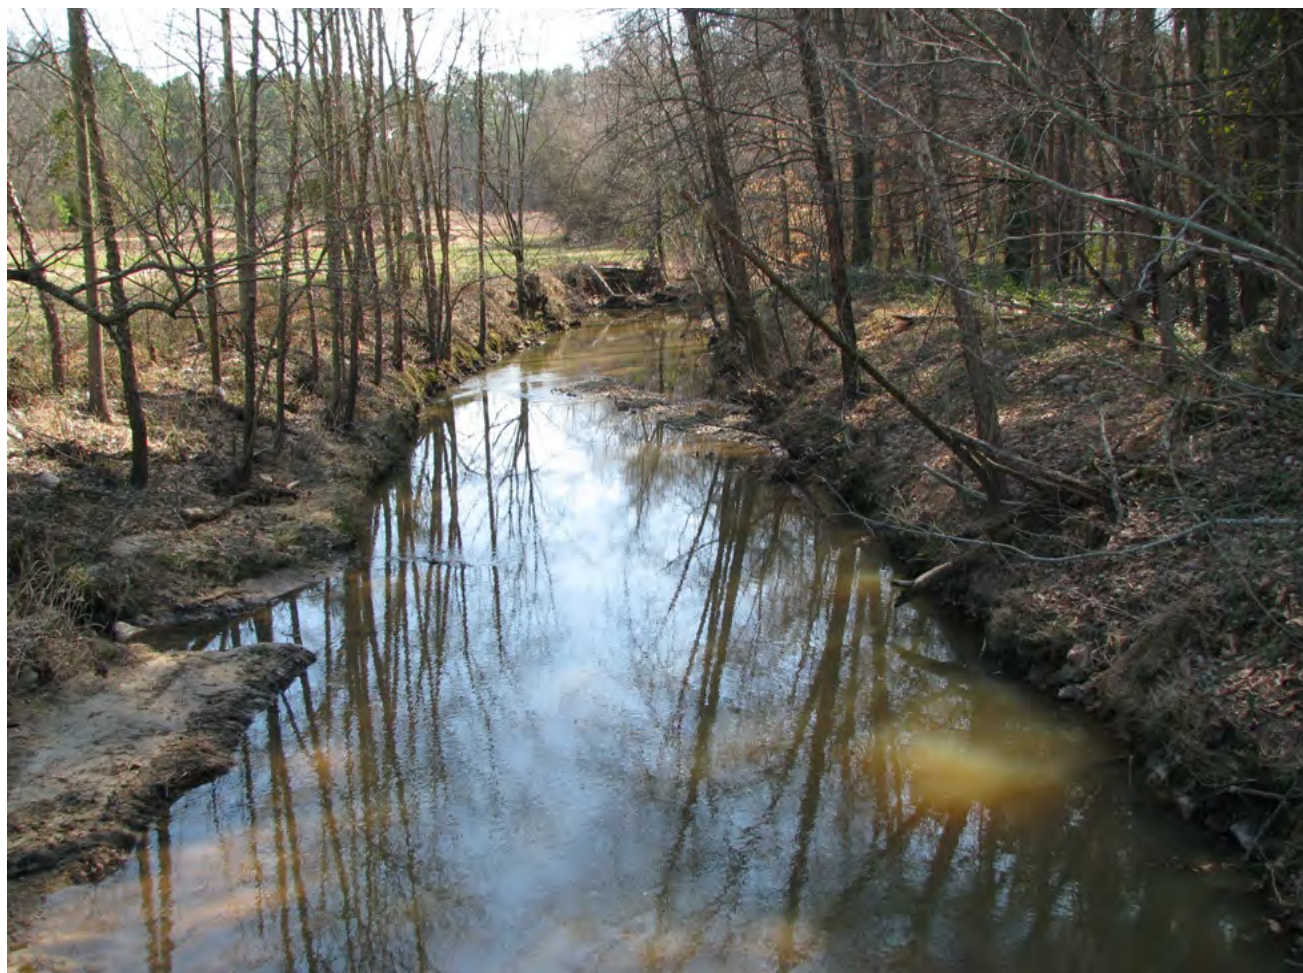
Hare Snipe creek is deeply entrenched and straight as it enters the north side of the park. Barbed wire fencing left over from when the property was a horse pasture, still runs along the east side of the creek, and is embedded in the trees in some places.

- Remove barbed wire from bank of Hare Snipe Creek and along eastern property boundary, after documenting barbed wire locations for historical records
- Remediate open ditch hazard in northern field near Hare Snipe Creek

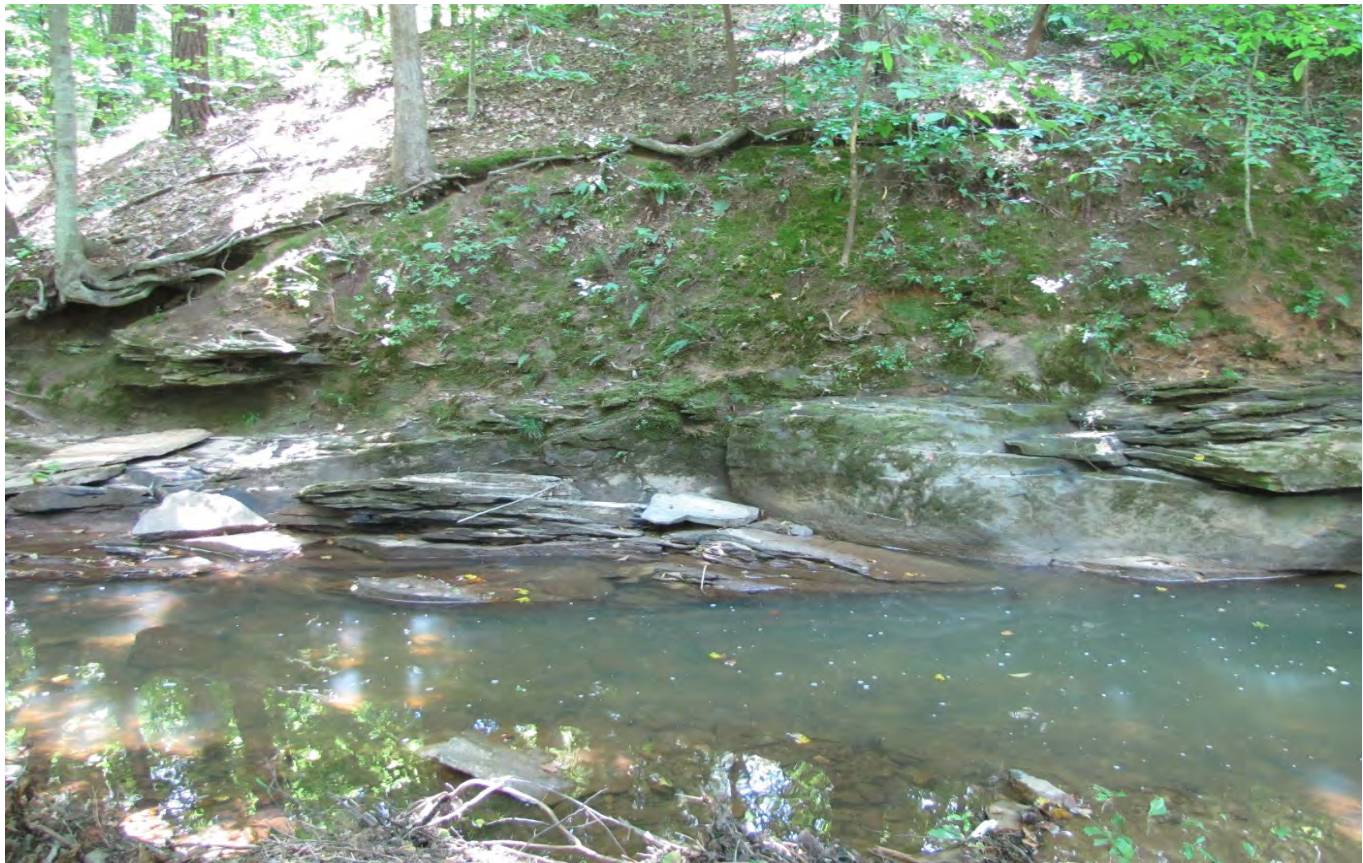
The main Hare Snipe Creek channel is quite picturesque, particularly along the southern end of the park where the topography on the west and south side of the creek is steep and the channel meanders.
