# System Integration Plan

Wooten Meadow Park

Raleigh, North Carolina

August 11, 2014

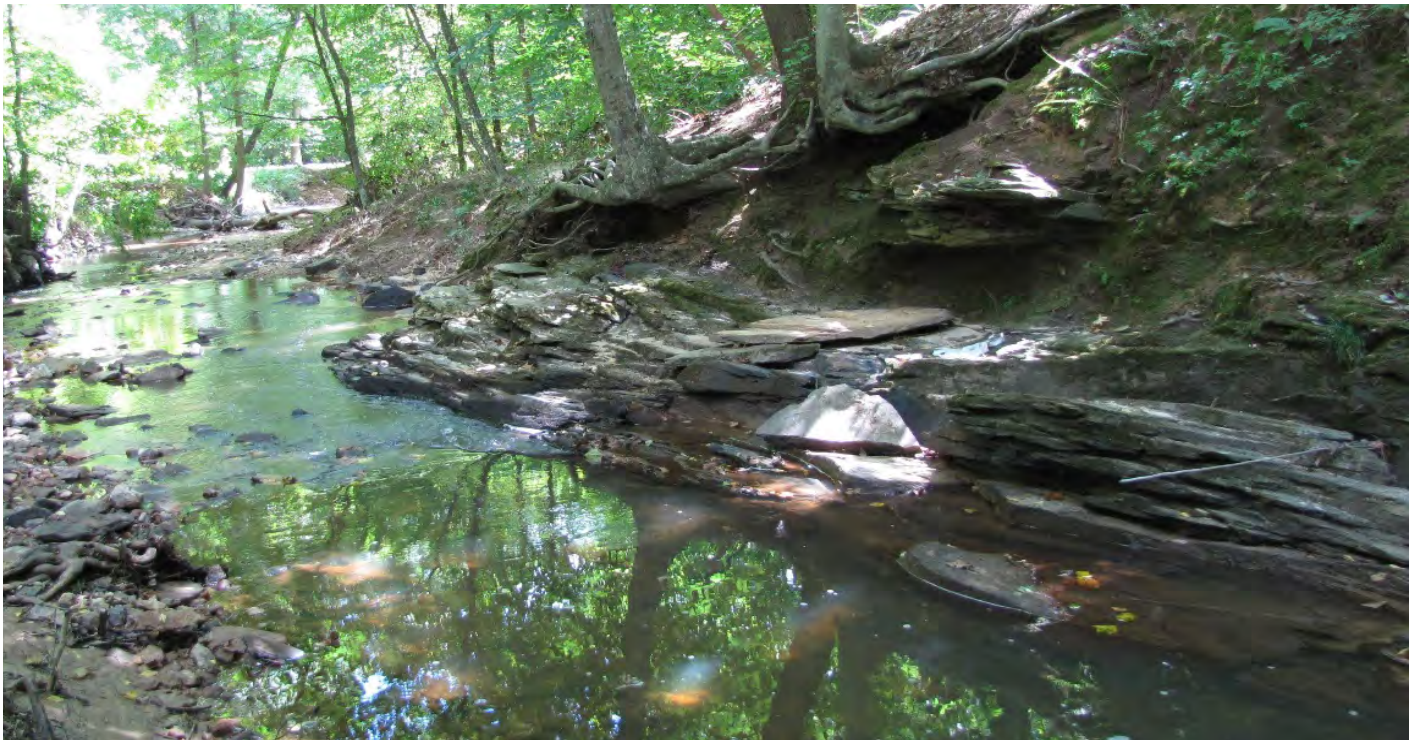
Hare Snipe Creek has well developed riffle-pool-run complexes. Several riffles and rapids within the lower reaches of the creek mask the sound of road traffic. Natural exposed rock and wildflowers along the creek bank add stream features that are not overly common in Raleigh.

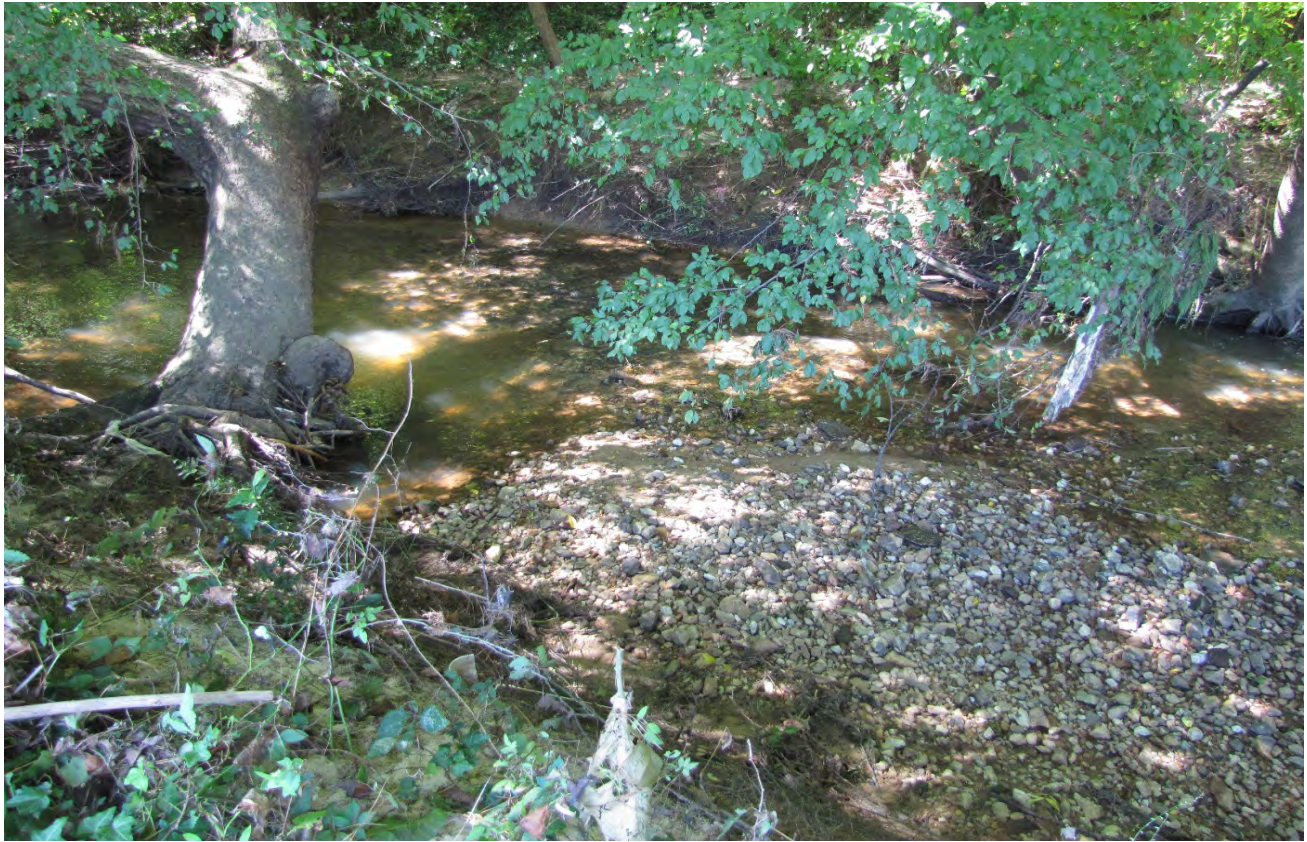
The stream bed substrate is a diverse mixture of pebbles, cobblestones and sand. Vegetation along portions of the creek bank is moderately diverse, discussed in more detail under the Flora Section.

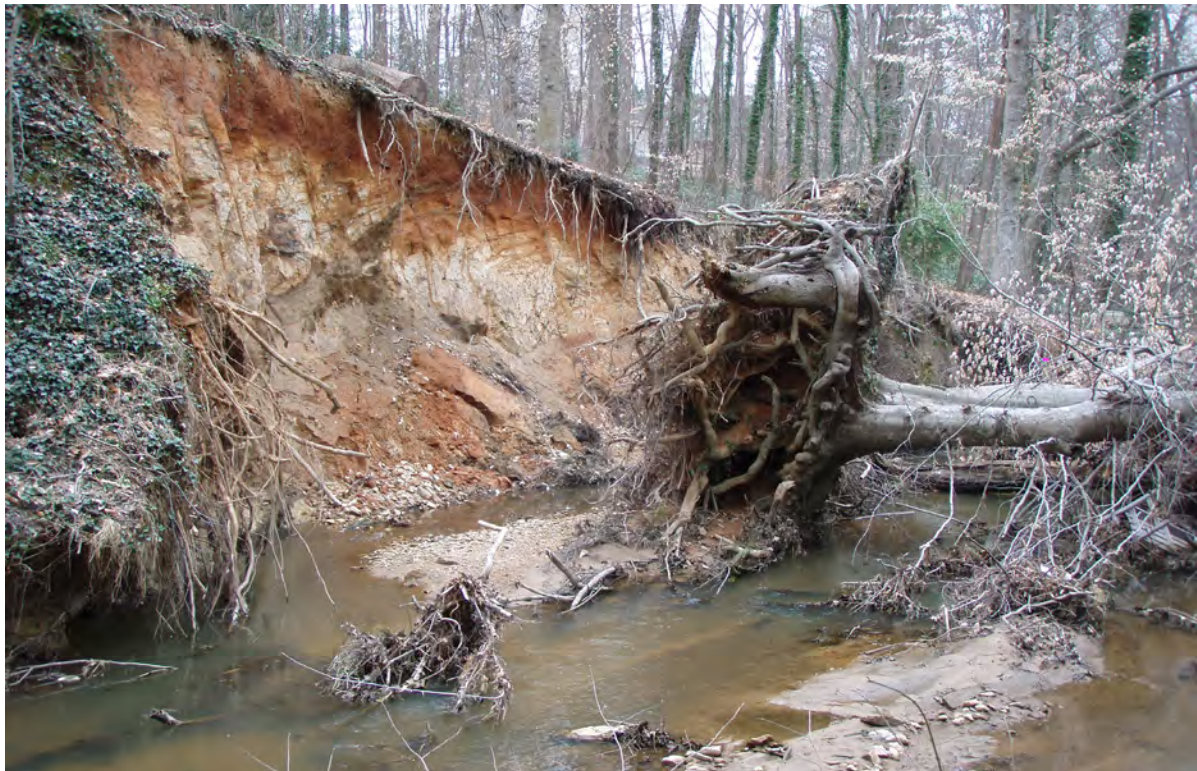
Major stream bank failures occur in several locations along Hare Snipe Creek adjacent to park property. Streams in North Carolina are under the jurisdiction of NC DENR Division of Water Resources and the US Army Corps of Engineers, so the City of Raleigh has limited options for stream bank management even on park property. The western park property line runs generally down the center of the creek.

- Work with City of Raleigh Public Works Stormwater Division and other partner agencies to stabilize the stream bank of Hare Snipe Creek
- Develop sewer easement management recommendations in cooperation with City of Raleigh Public Utilities. Recommendations may apply to Wooten Meadow as well as other easement locations. Management recommendations may include decreasing the width of easements after sewer line installation, increasing tree canopy coverage over the easements, increasing trees in the riparian buffer, managing fire ants and invasive plants, and seeding recommendations for newly constructed easements.

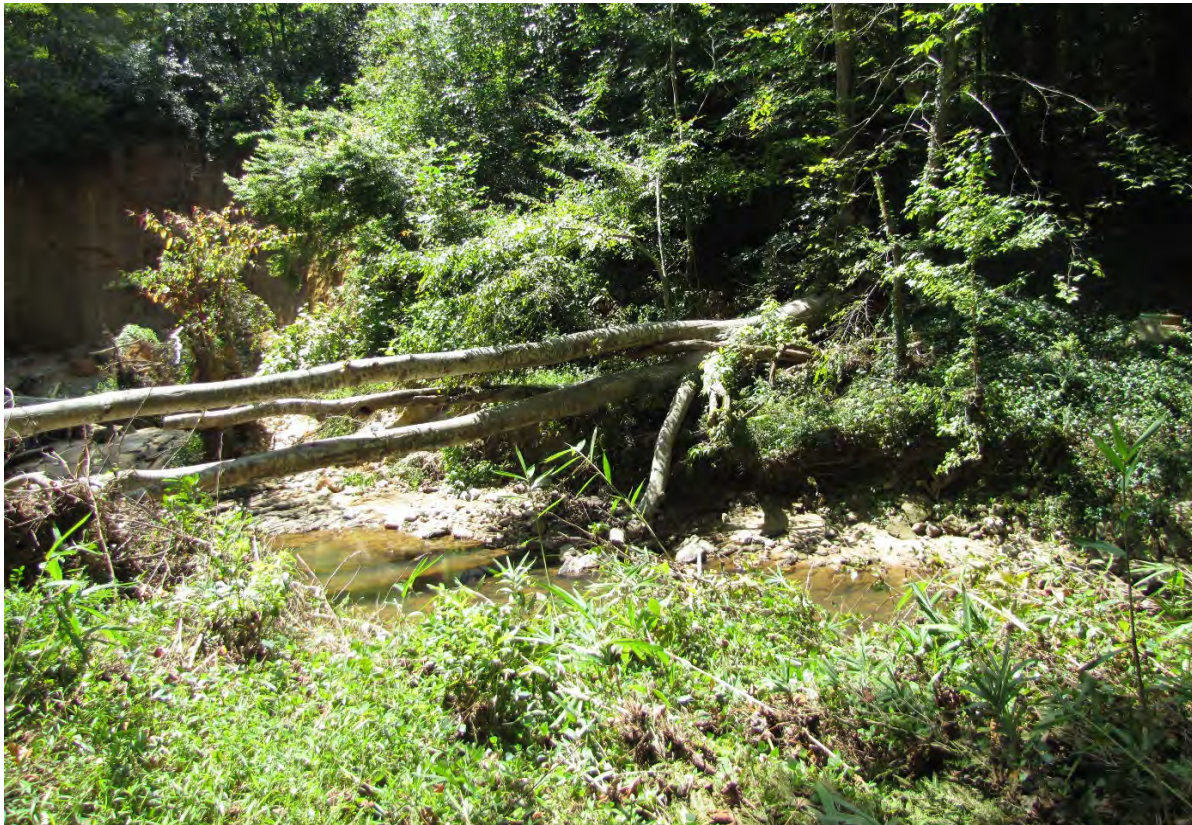
This large tree fell in September 2013, near the location of the bank failure shown in the top photo.

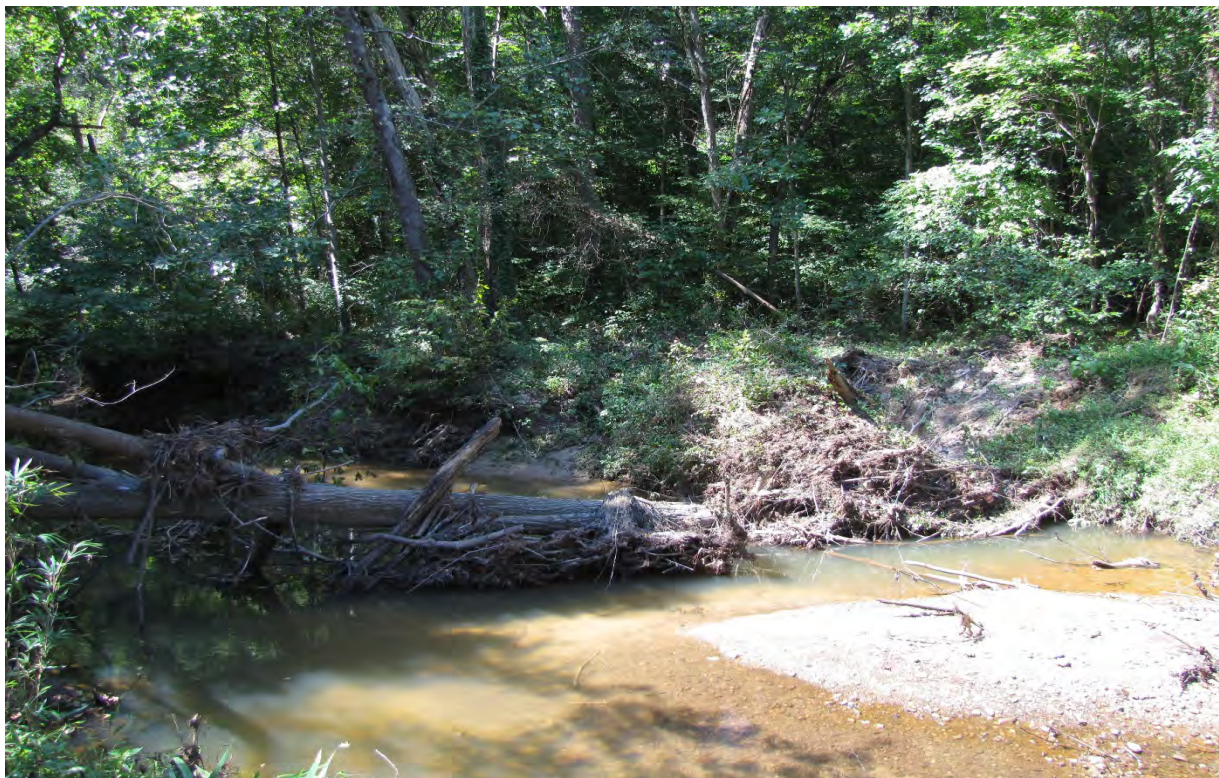
Tree root depth and density along Hare Snipe is unstable in some locations, sometimes leading to tree collapse, with large organic debris such as logs and tree limbs being deposited in the stream channel. Large piles of organic debris can lead to debris jams, which can impact stream bank stability, channel development, and flow.

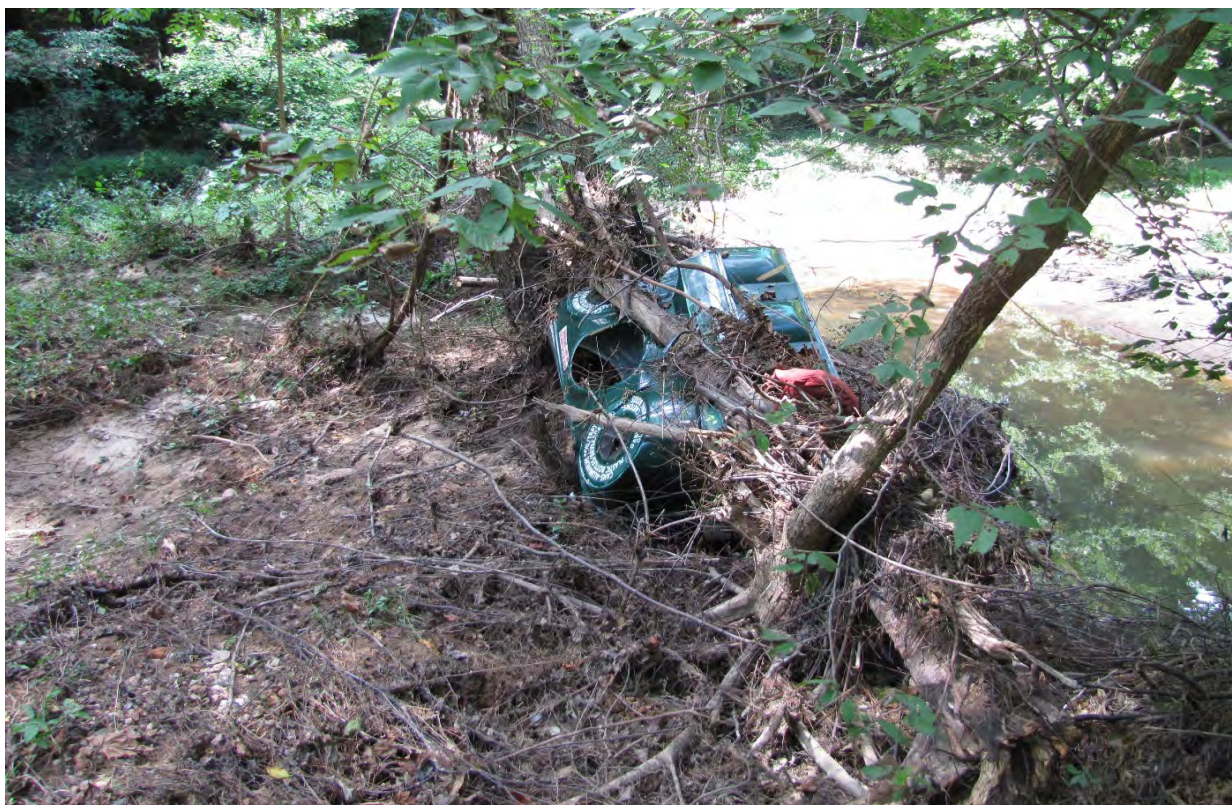
Trash and other solid waste (often deposited in stream channels during surface flow from storm events) can contribute to debris jams.

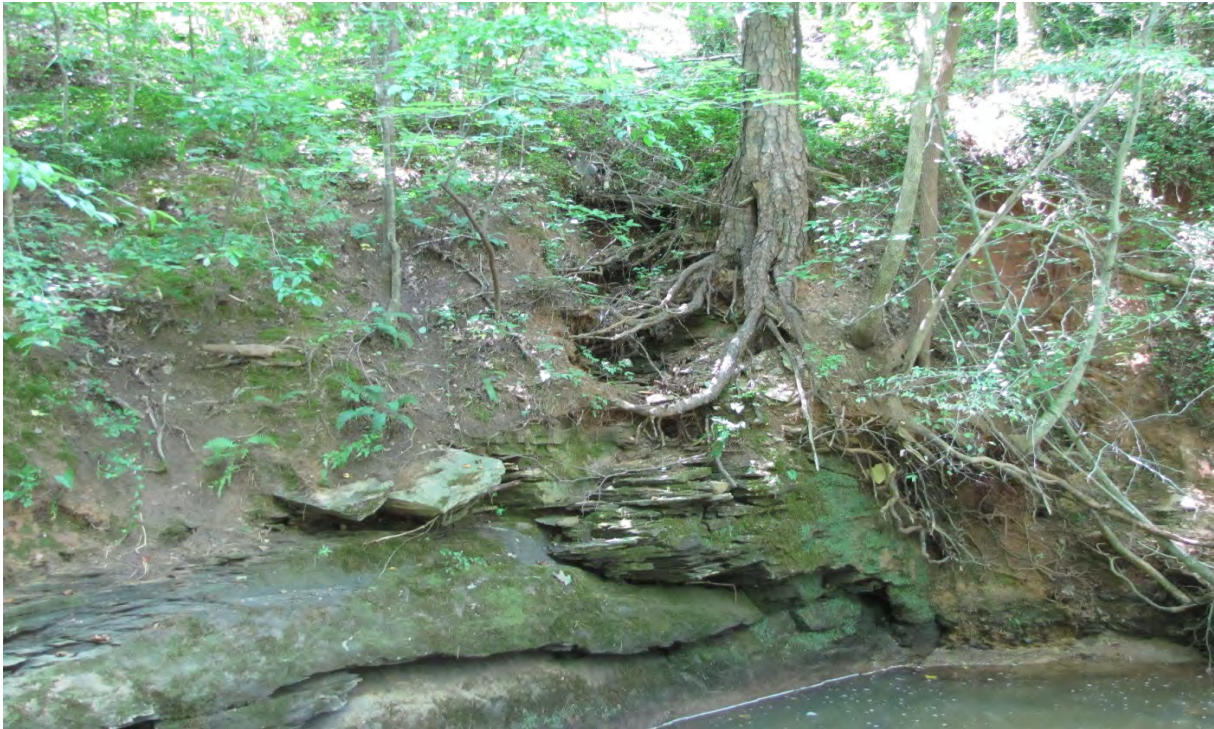
Significant bank erosion occurs along the creek, particularly in steep slope areas.

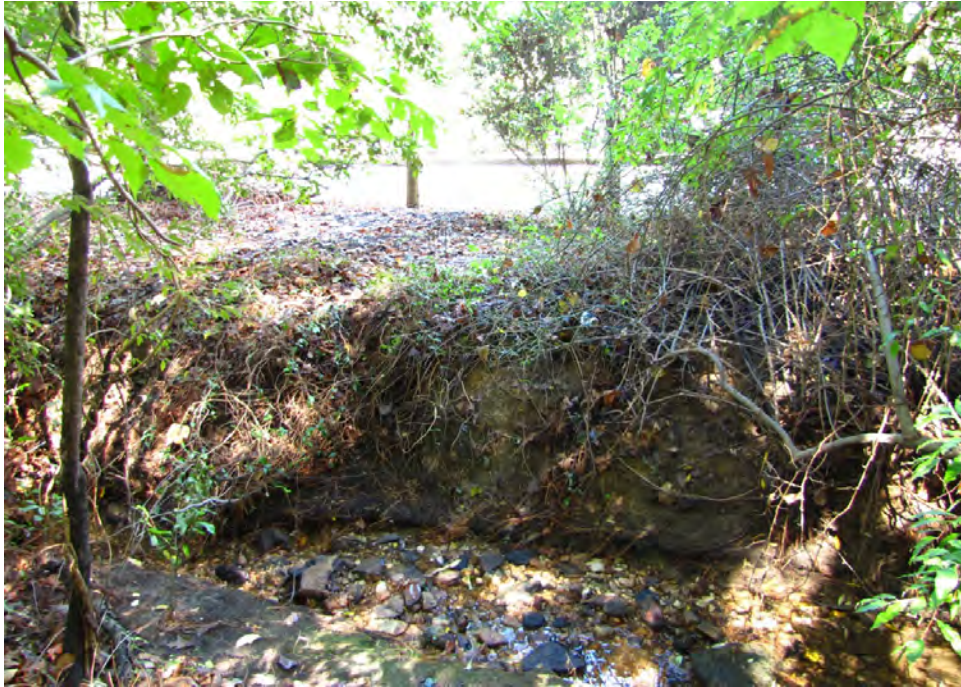
Northern tributary stream channel, eastern area of park property, before being piped across the managed field (photo taken near southeast corner of parking lot).

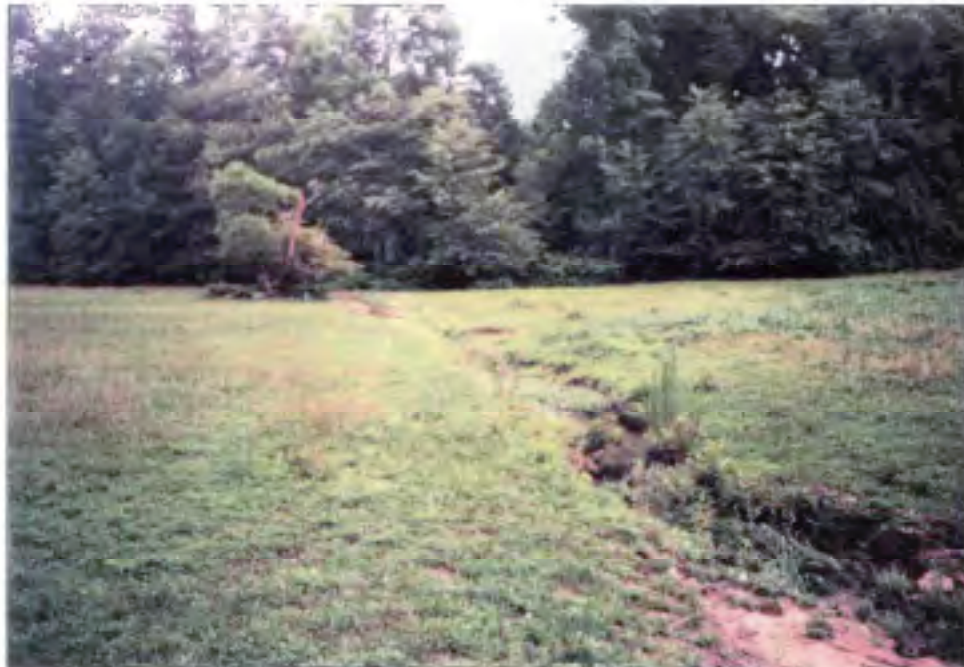
Drainage ditch/intermittent stream along center of horse pasture

Image of northern tributary above is from Phase 1 report, 1995

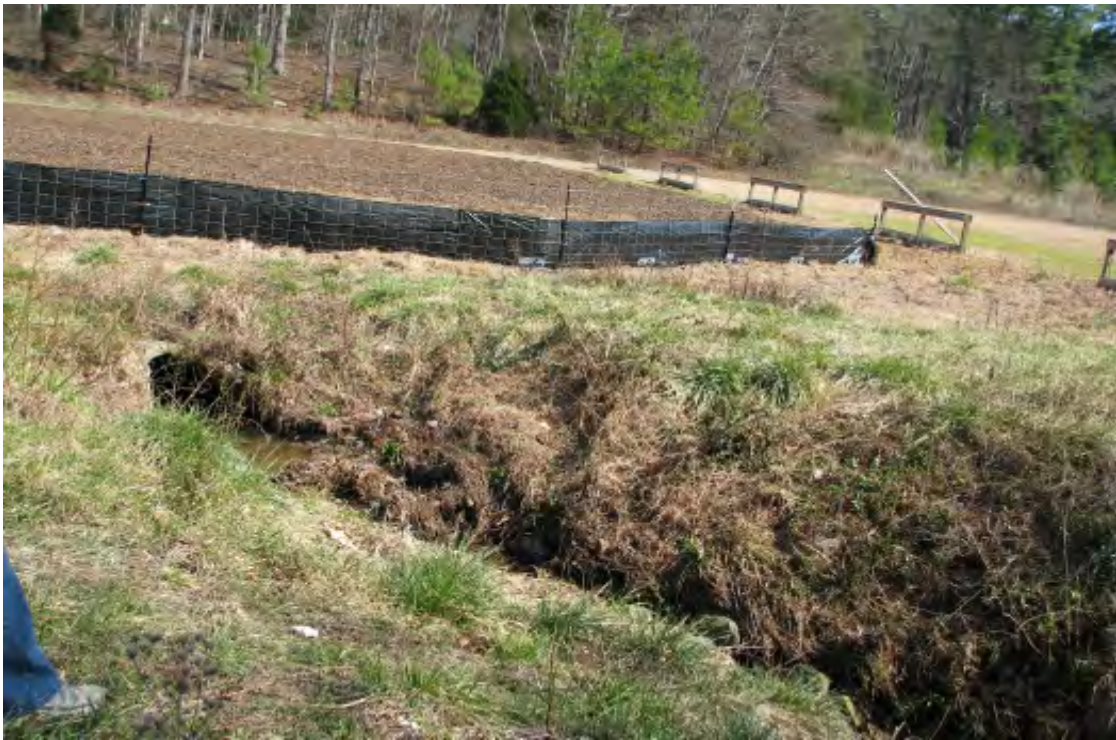
Current location of northern tributary pipe outlet

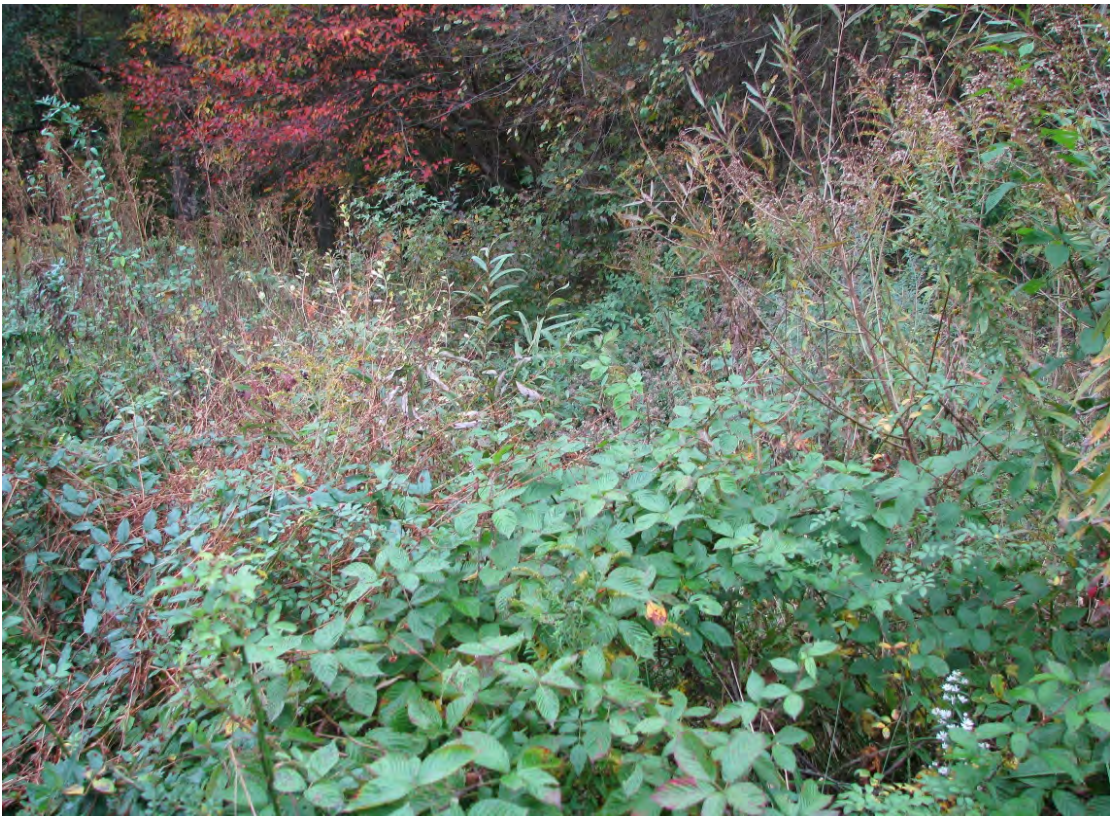
During the growing season, the visibility of the northern tributary pipe outlet is blocked.

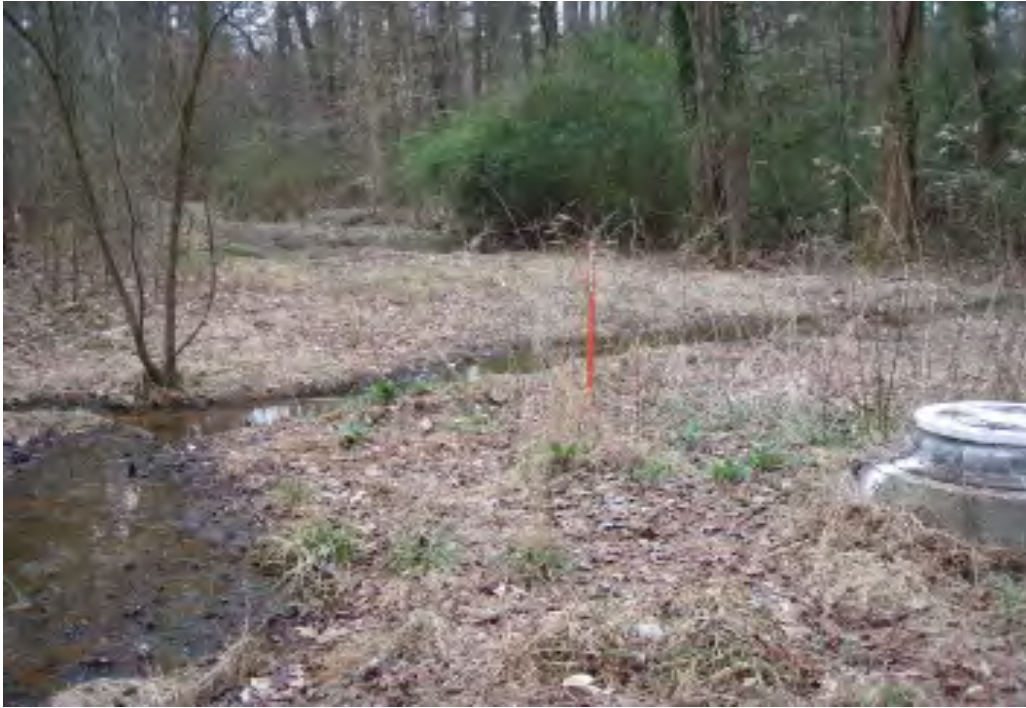
The southern intermittent stream branch runs through the eastern sewer easement, then flows south and through the western sewer easement to join the main channel of Hare Snipe Creek. The majority of the park is within the floodplain of Hare Snipe Creek, and inundated areas are scattered throughout the Wooten Meadow property, particularly in winter months. The green plants visible in the photo above are invasive chinese privet, abundant along the eastern easement.

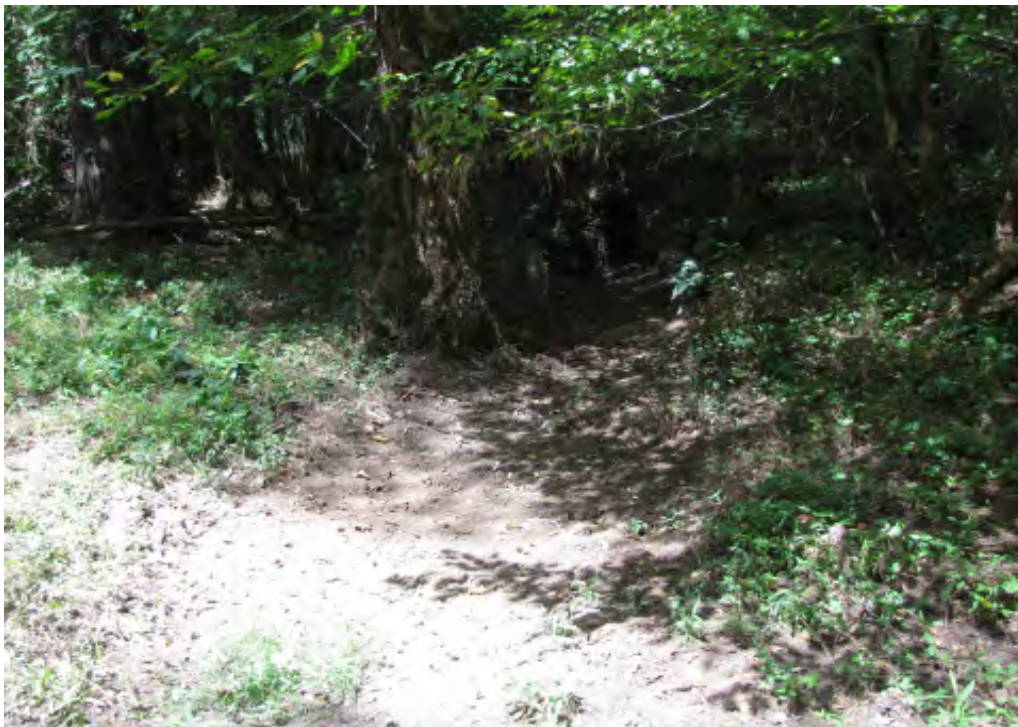
Southern intermittent tributary as it crosses the western sewer easement as a dry channel during the growing season, a characteristic of the stream's intermittent nature.

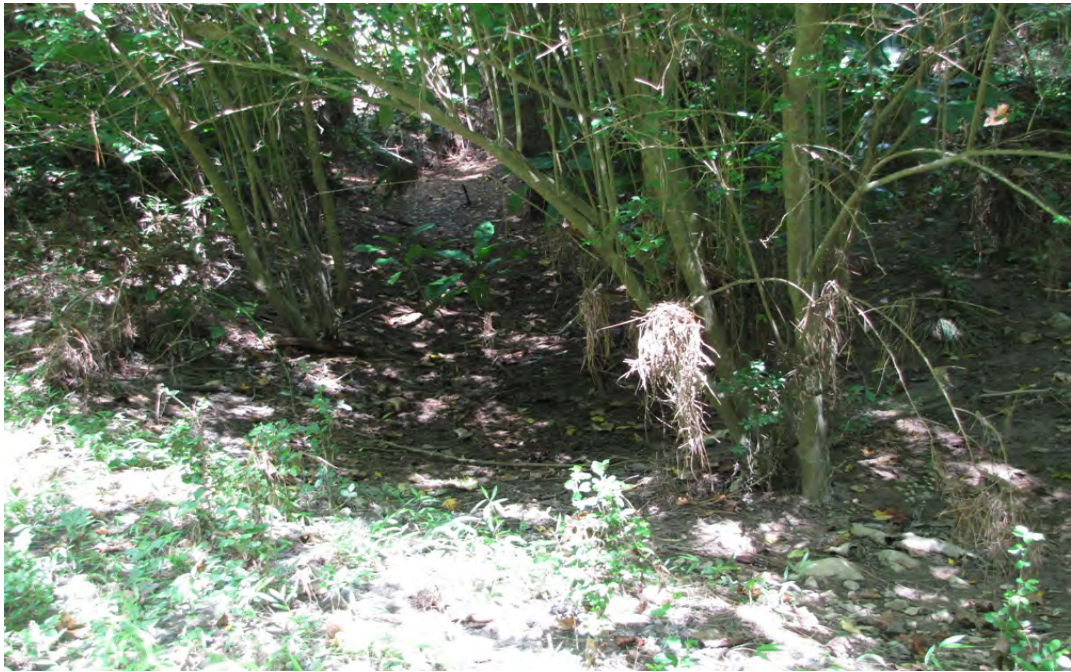
The riparian area around the southern tributary is particularly wet, and regularly has standing water. Plants growing near the tributary have adaptations to hydric conditions, such as epicormic sprouting, visible in the photo above.

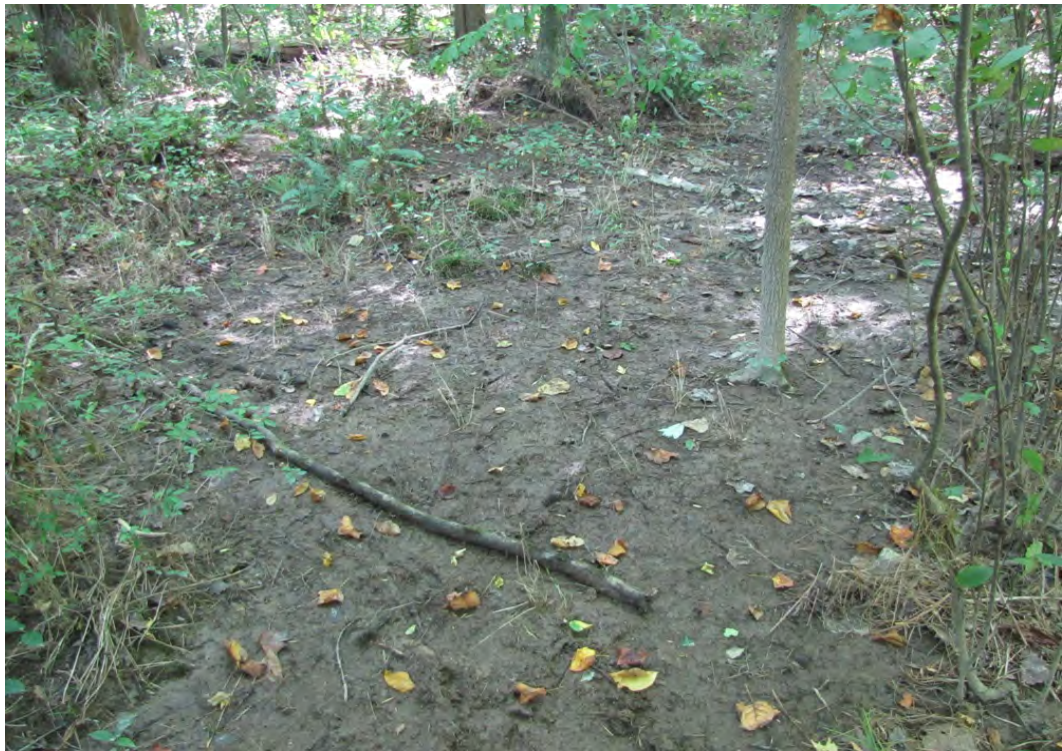
Scouring, standing water and ephemeral flow channels occur throughout the park's riparian area, indicating the active nature of the Hare Snipe Creek floodplain.

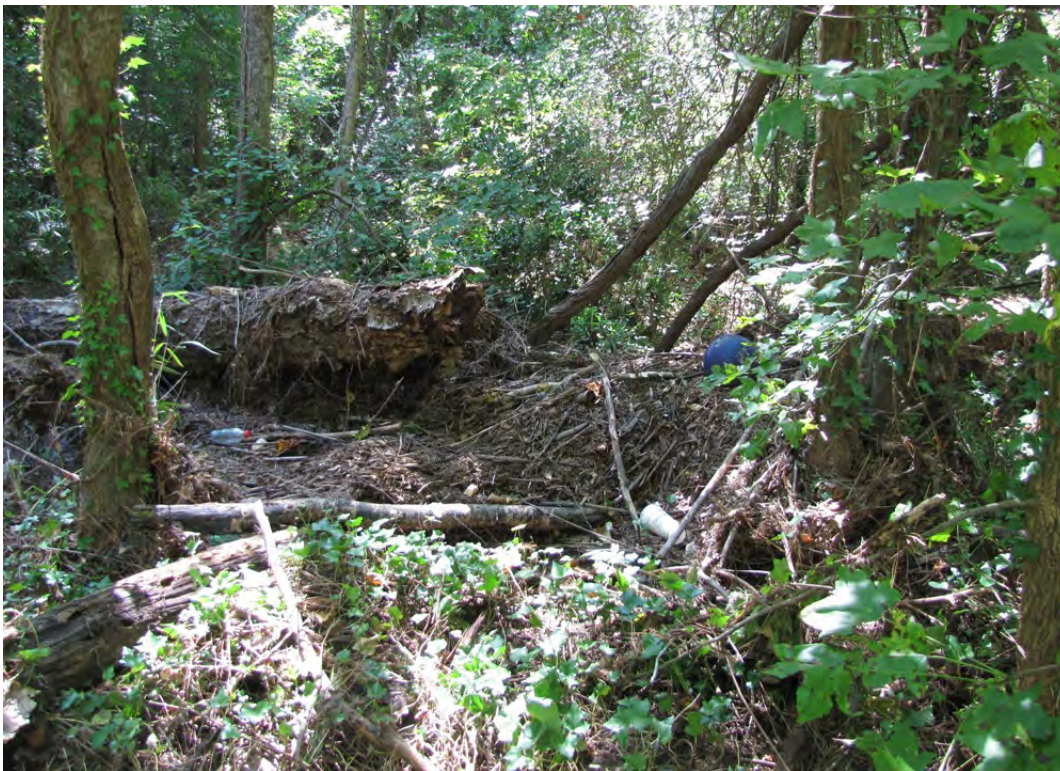
Debris accumulation from strong stormwater flow is particularly strong in the northern portion of the forested area, where hydrology has been altered.

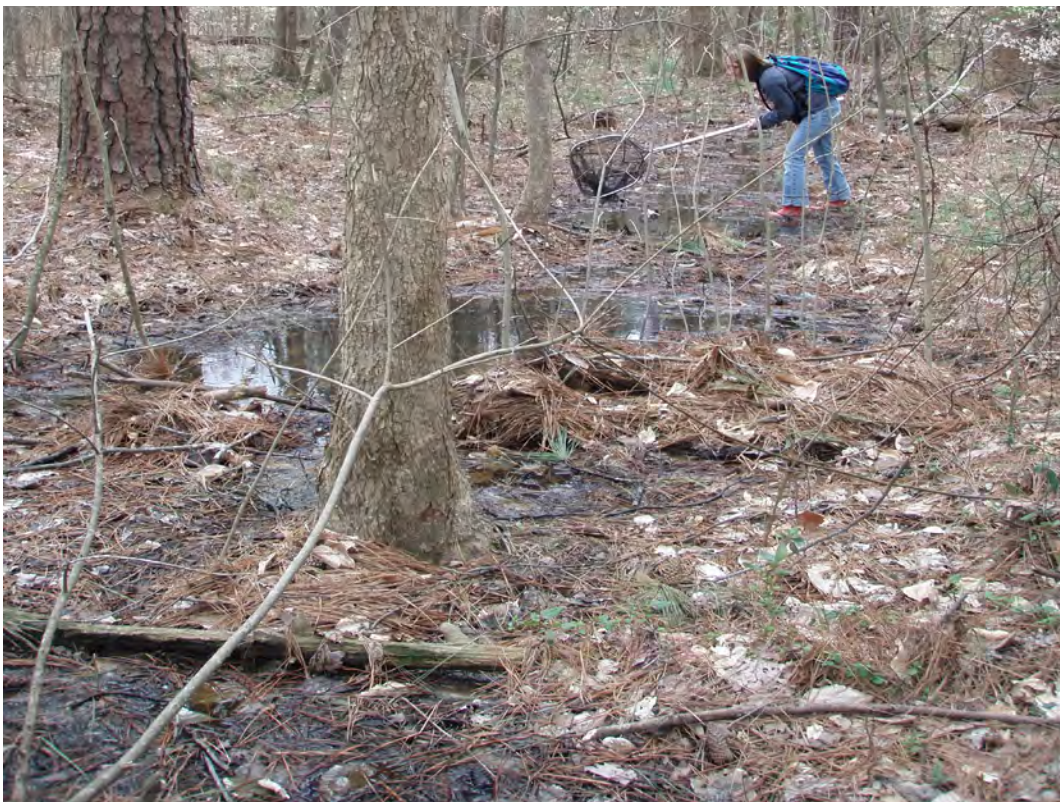
The southern portion of the park is more natural hydrologically. Winter inventory for salamanders is conducted in the ephemeral wet areas of the forest.

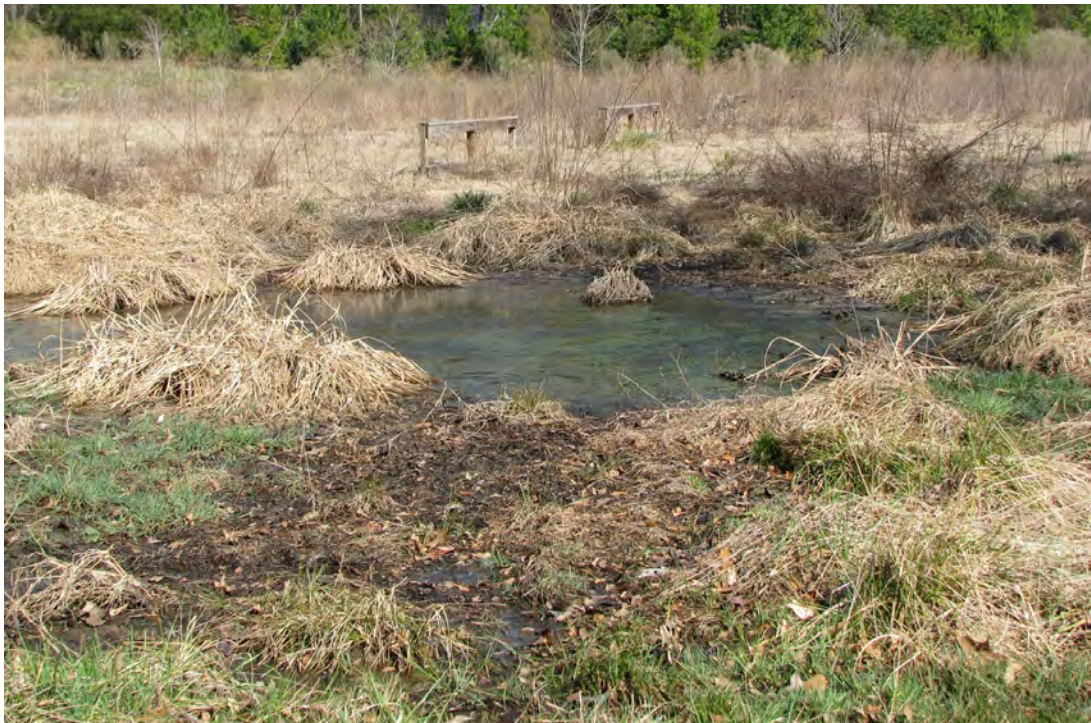
Wetland conditions are visible in the riparian zone of Hare Snipe Creek, particularly in the southwestern portion of the managed area of the park, nearest the Creek. Saturated conditions, hydric soils, obligate wetland plants, hummocks, and nesting Canada Geese occur in this area.

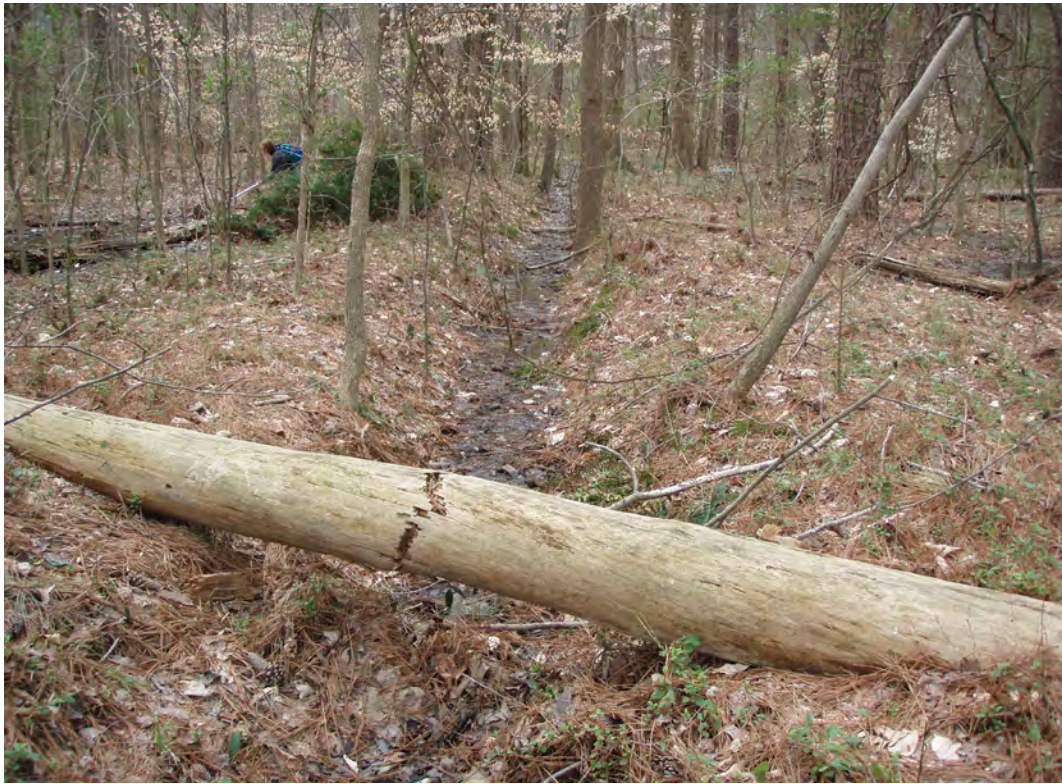
Drainage ditch in northern wooded area

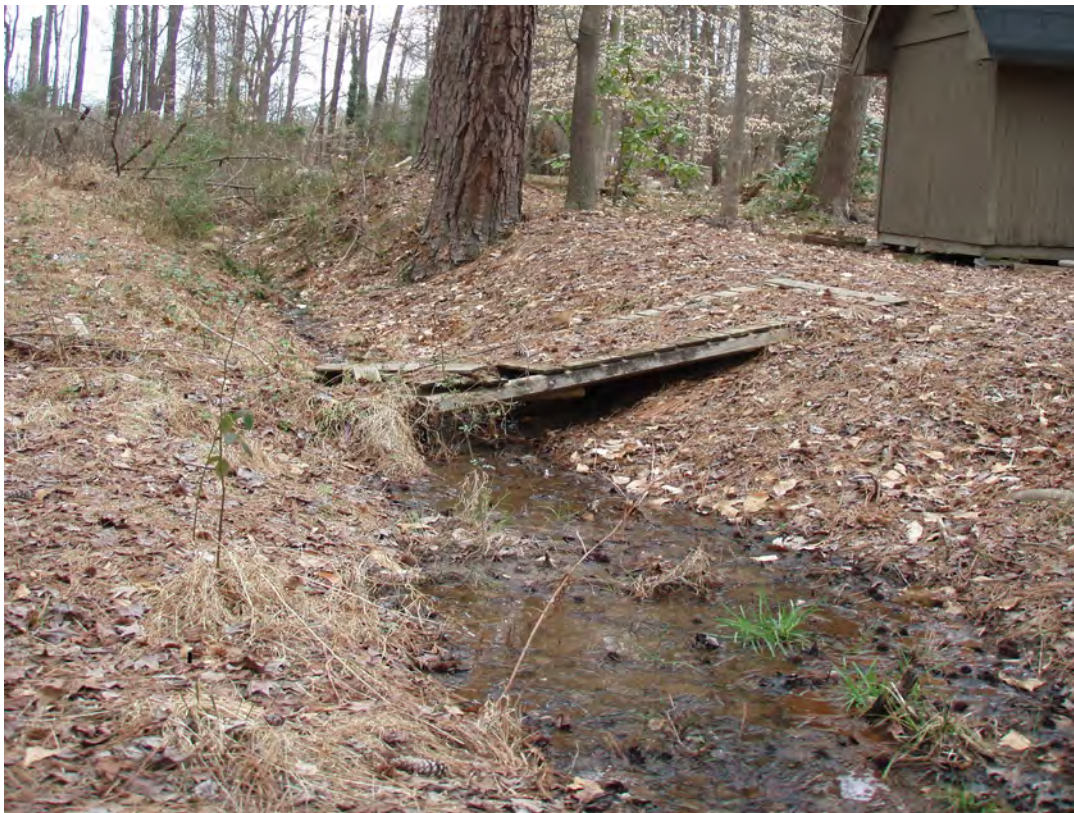
Altered hydrology along eastern sewer easement

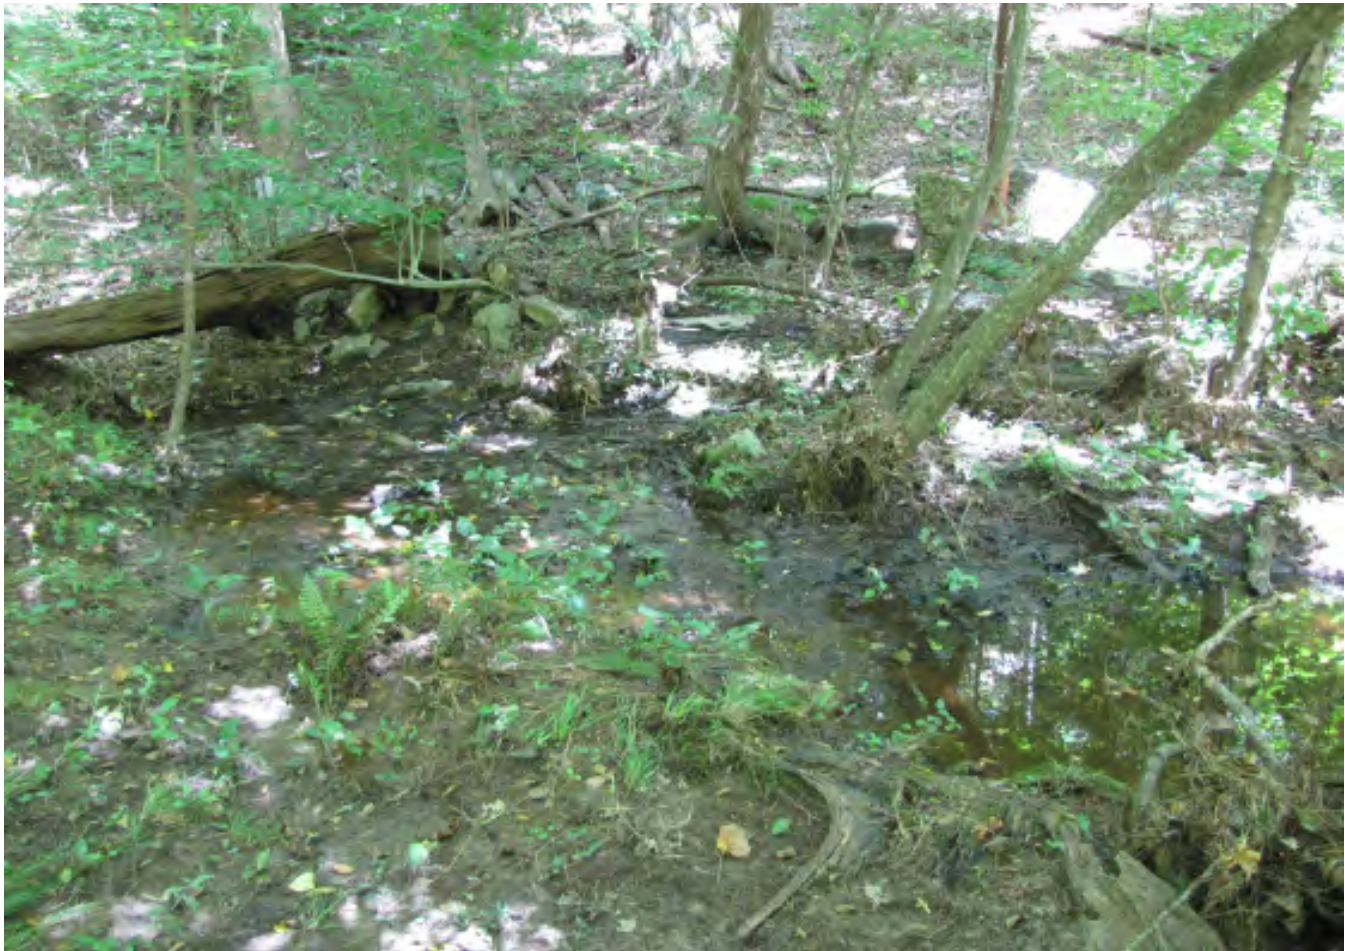
Groundwater seep near southeast area of park

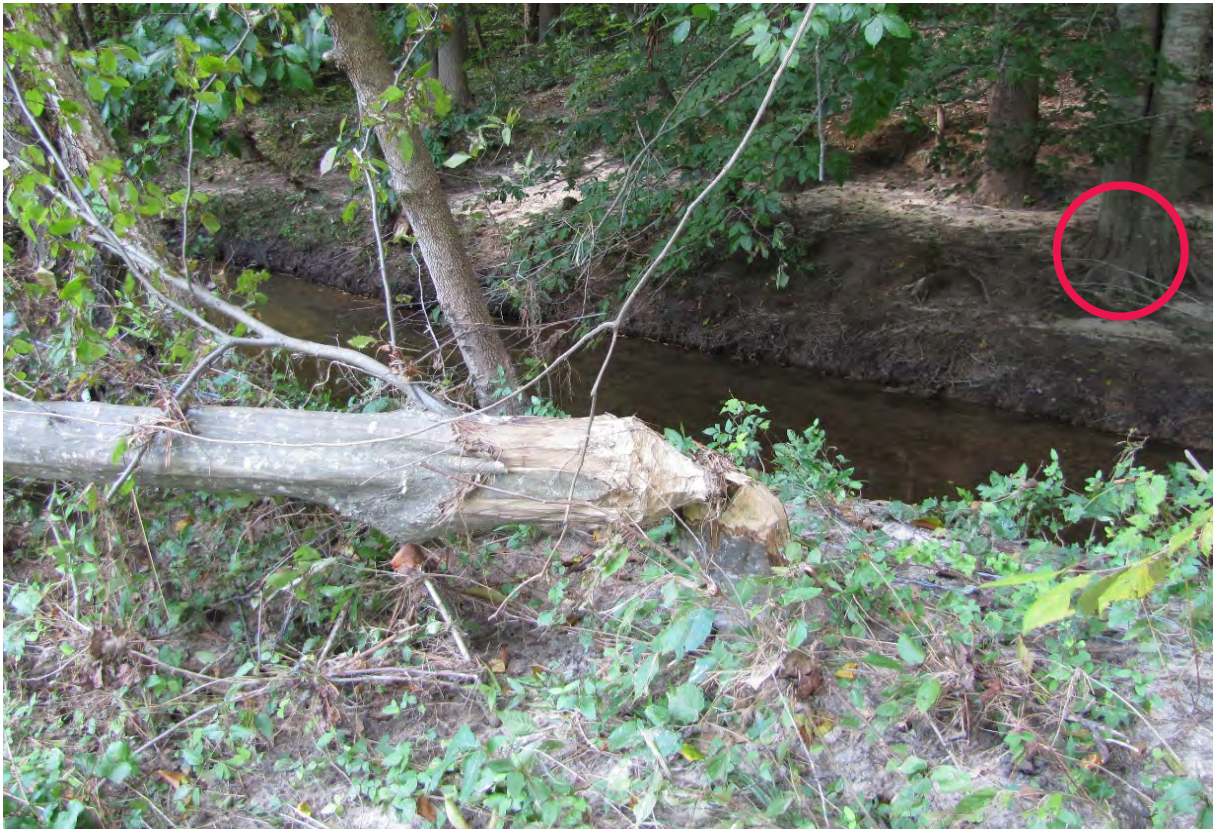
Musclewood (*Carpinus caroliniana*) felled by beaver along Hare Snipe Creek in September 2013. Notice the large girdled tree on the opposite creek bank.

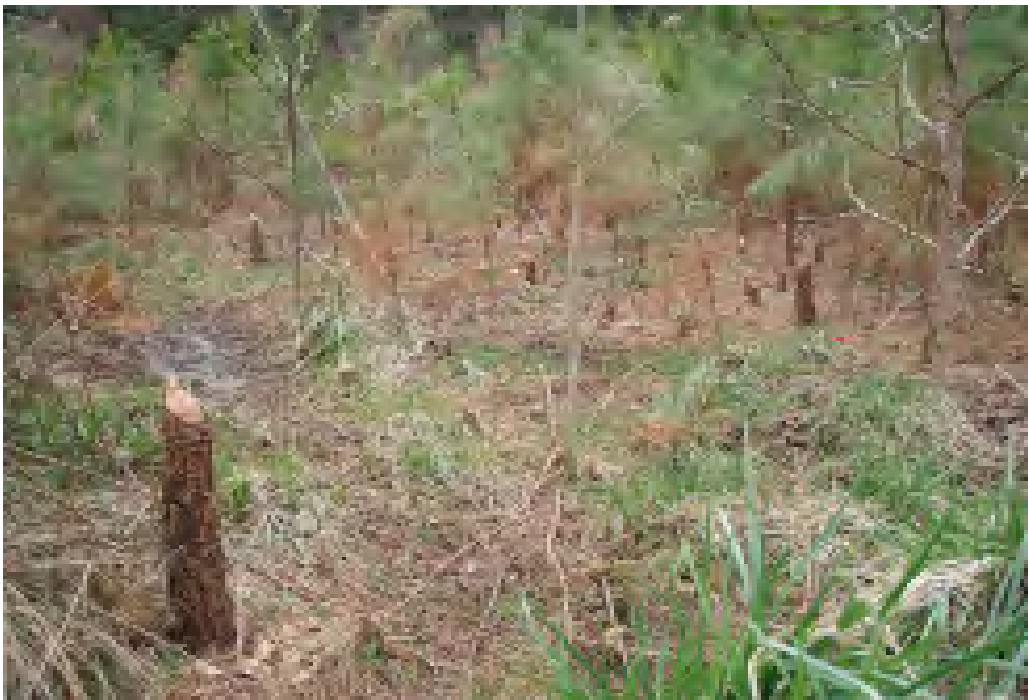
Small pine trees on the Wooten Meadow property were chewed by beaver in February 2010. Pine trees regenerate very quickly and are one of the first tree species to grow in an abandoned field.

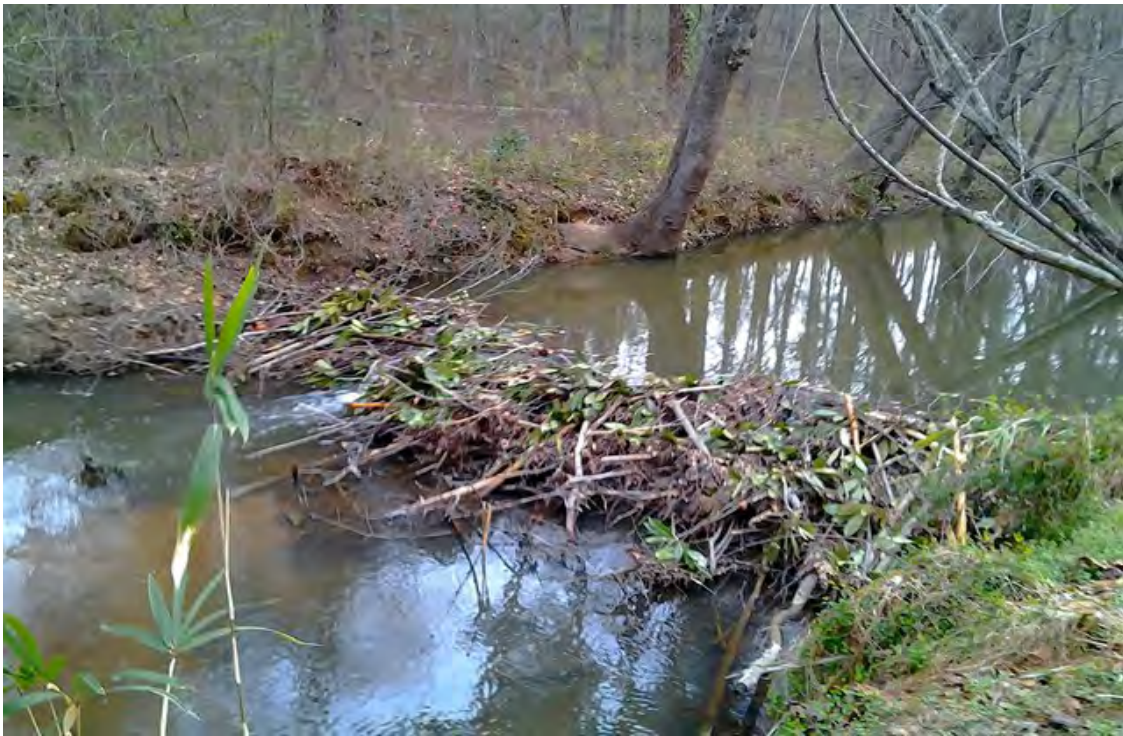
Beaver dam in Hare Snipe Creek, north side of Wooten Meadow Park, September 2013

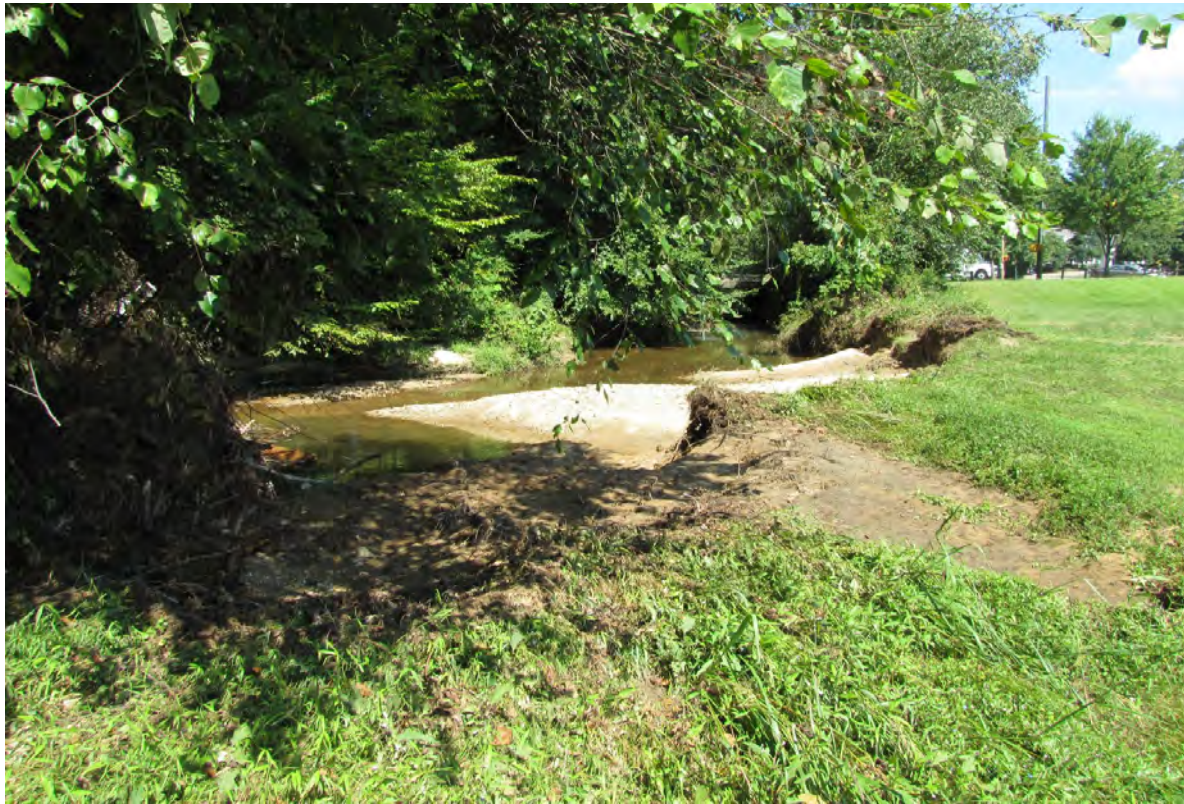
The beaver dam shown on the previous page blocked stream flow, causing Hare Snipe Creek to flow over its banks during a large storm event. Portions of the creek bank collapsed, causing significant bank failure on the northwest park boundary.
