# System Integration Plan

Wooten Meadow Park

Raleigh, North Carolina

August 11, 2014

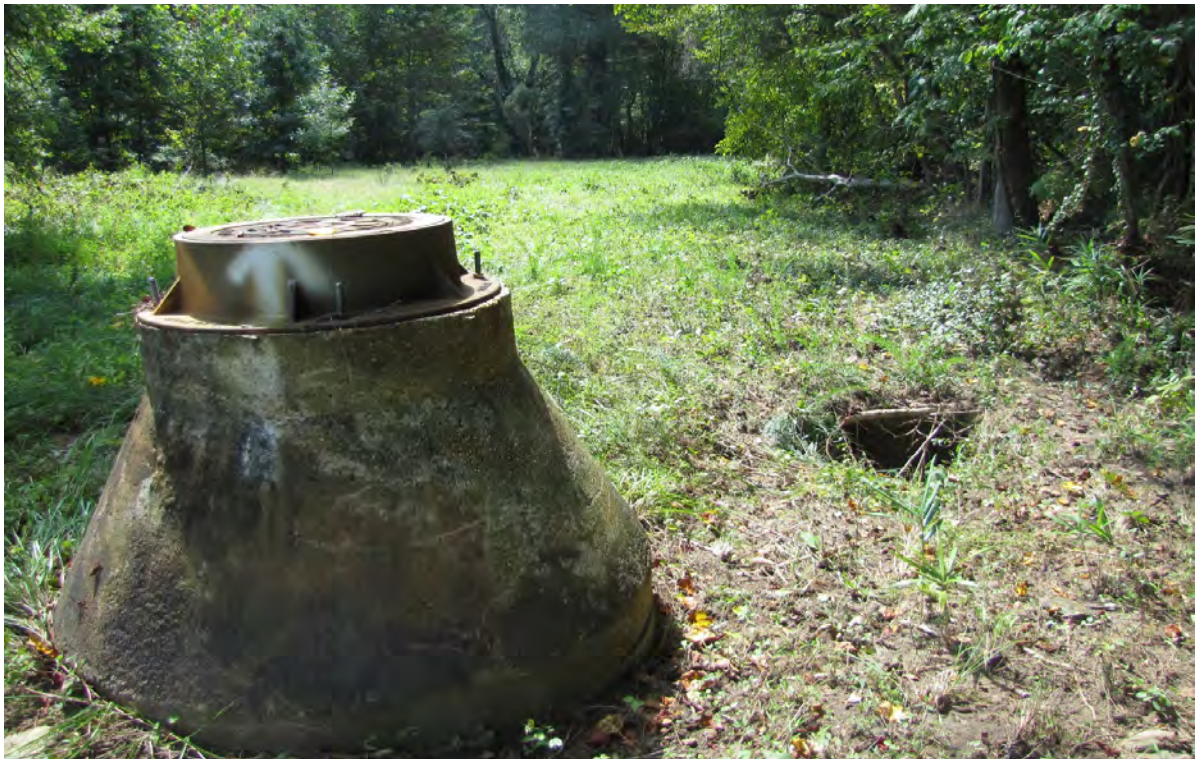
The photo above shows a new hole in the ground in the western sewer easement near the beaver dam. The hole may be a beaver bank den that collapsed after the large storm event and subsequent creek bank failure shown above.

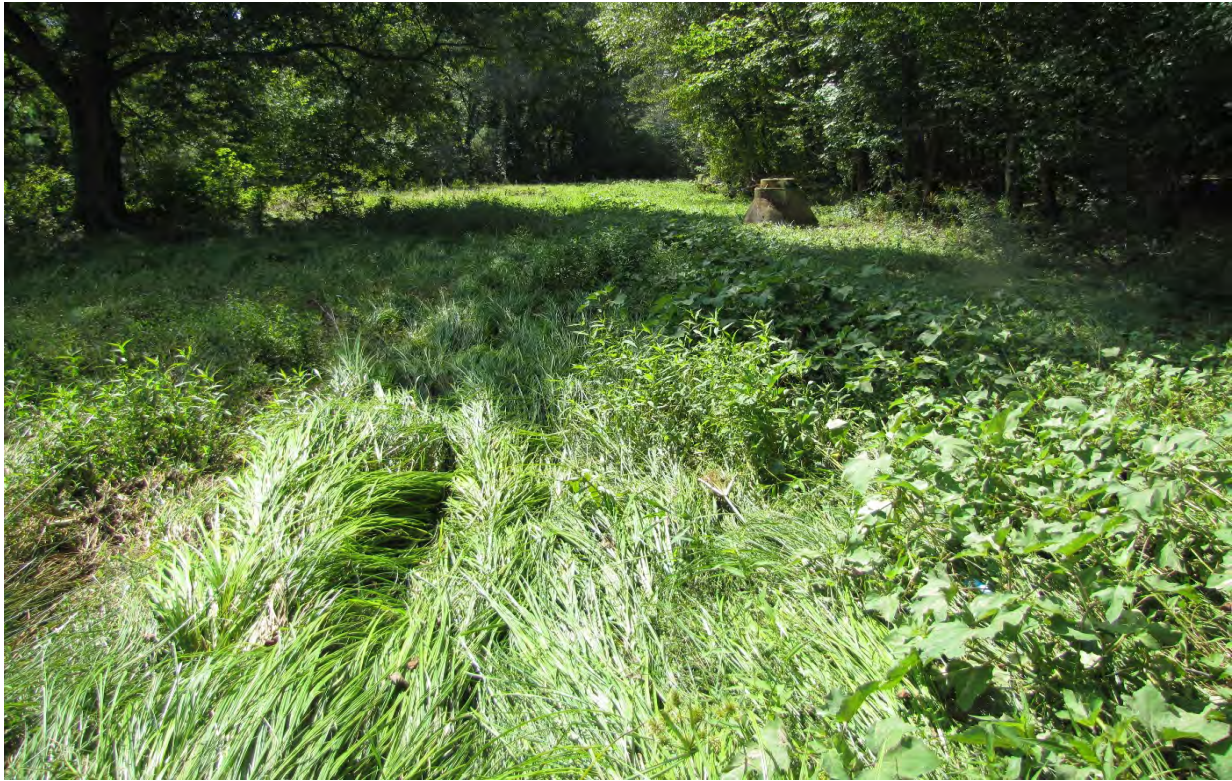
Vegetation in the riparian buffer is flattened and indicates the direction of surface water flow after beavers built a dam in Hare Snipe Creek.

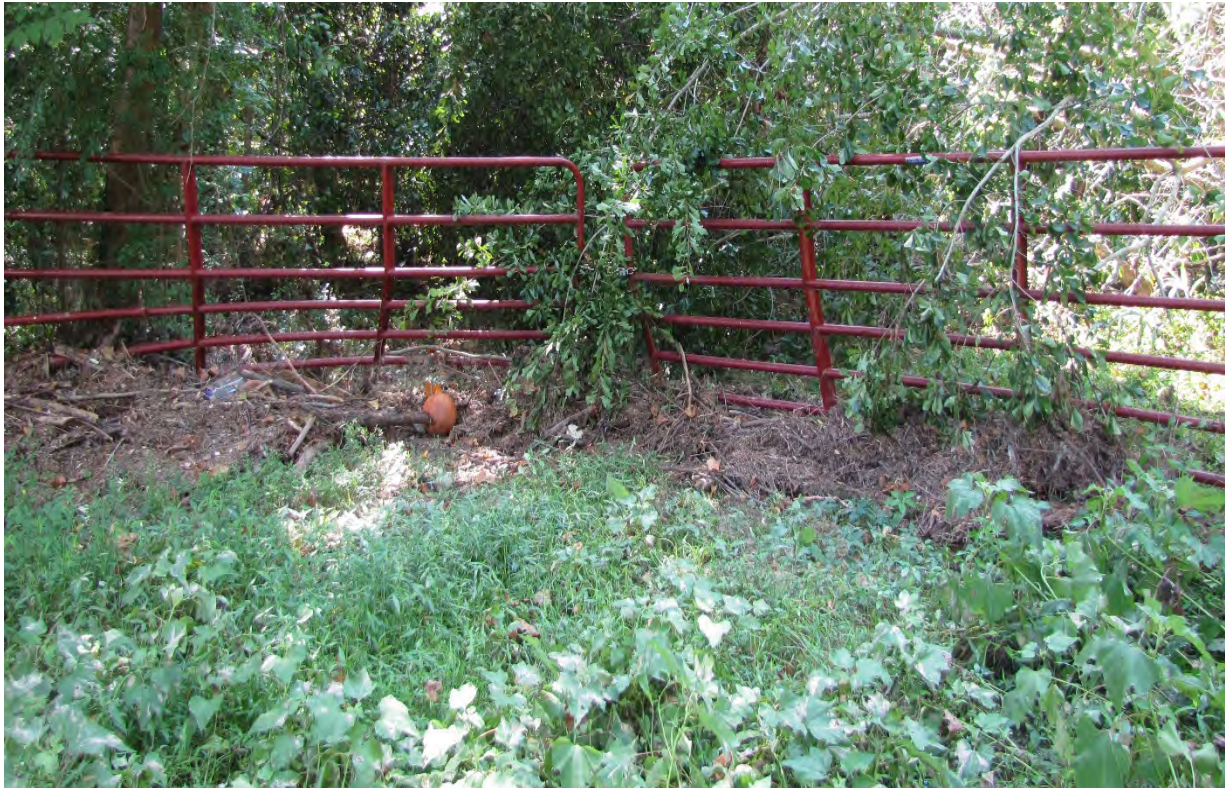
Western easement gate in Sept 2013 after damage from beaver dam in the Creek.
