Eastgate Park Dam Preliminary Engineering Report

Final Report Hazen #32511-005 October 31, 2023

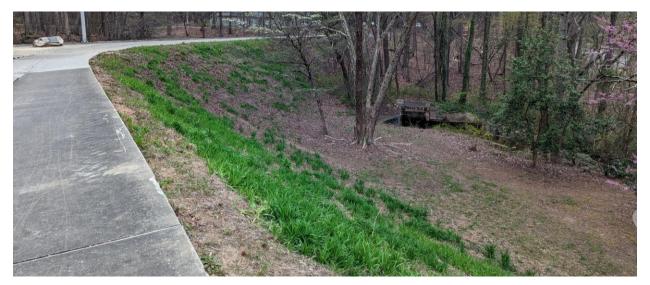
The downstream slope surface appears stable; however, multiple bare spots and large diameter trees are present. Additionally, vegetation on the slope consists various weeds, with a mix of ground covering and low-height species. There is also a substantial drop in elevation between the top of dam slabs and downstream face which is highly susceptible to erosion should the embankment overtop. The grout lining on the upstream slope is largely intact; however, numerous voids and fractures were observed in the vicinity of the drains and surrounding the large diameter trees growing through the lining. Large trees are also present within 15-feet³ of the downstream toe and both abutments. Lastly, embankment toe drains, presumably installed in accordance with the 1974 improvements (see Drawing #3), were unable to be located during site visits. As such, the presence and condition of the drains is unknown. A drain from the north is shown on the 1974 drawings as discharging into the riprap-lined portion of the outlet channel. A second drain, from the southern portion of the embankment, is shown discharging into a large, riprapped area downstream of the outlet structure; however, such an area does not appear to exist today.

Picture 2: Downstream Face of Dam

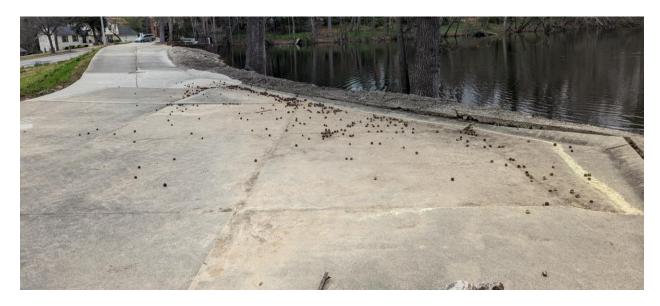
Eastgate Park Dam is an earthen embankment with a grouted curtain wall, grouted riprap on the upstream face, and vegetation on the downstream face (**Picture 1** and **Picture 2**). The downstream slope is relatively steep at a grade of 2H:1V, while the upstream is around 3H:1V. The top of dam is lined with concrete slabs that have embedded area inlets and small-diameter drains that discharge into the Pond (**Picture 3**). Slabs on the top of dam exhibit signs of downward displacement, multiple fractures, and open joints. Overflow spillway sections, discussed later, are present on each end of the embankment. The spillways appear to be situated on or immediately adjacent to the abutment contacts, and thus may be at least partially located on embankment fill.

Picture 3: Top of Dam

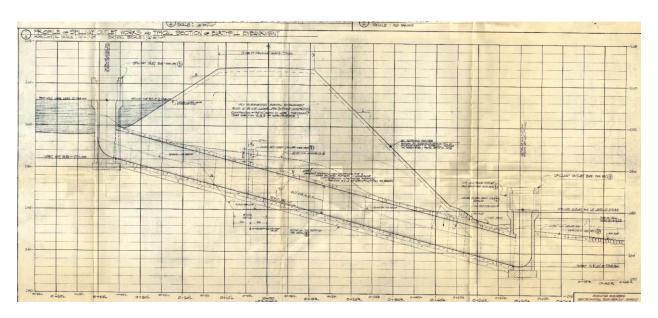
The principal spillway (**Figure 3**) is composed of an inlet structure within the Pond, a pipe barrel, and an outlet structure at the toe of the downstream slope. The inlet structure consists of a 4-sided weir with embedded vertical trashracks (**Picture 4**). The top of the structure is also open with a similar, but horizontal, trashrack. The inlet sits directly on top of an approximately 7-foot high riser which has a formed invert to smoothly transition vertical dropping flow into the barrel. The barrel is 42-inches in diameter, approximately 95-feet long, and has an elevation fall of 12.5-feet. The barrel terminates at the outlet structure which is of the same design as the inlet structure, except for being three-sided (**Picture 5**). The outlet structure sits approximately 2.5-feet above adjacent grade which consists of a concrete-lined spiral that protects the area from erosion and directs flows into the receiving channel. The receiving channel is concrete-lined nearest the outlet then transitions to a riprap-lined channel (**Picture 6**). The first half of the channel has relatively small riprap while the second half, adjacent to Quail Hollow Drive, contains larger stone and appears to have been recently reconstructed during a nearby water main replacement project (**Picture 7**).

Figure 3: Principal Spillway (Excerpt from 1974 Drawing #4)

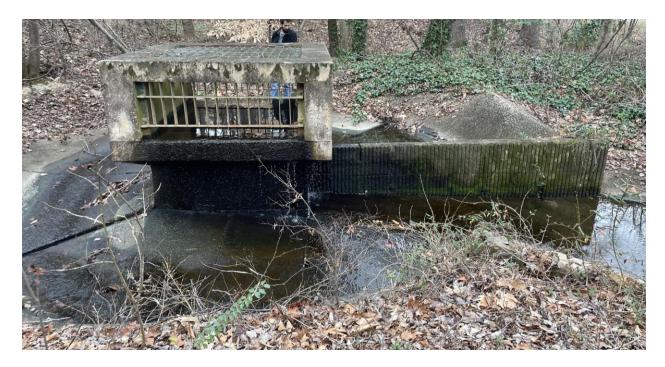
The inlet and outlet structure are in fair condition with typical concrete weathering and deterioration. Only minor debris accumulation was observed on the trashracks. Vertical displacement of the concrete outlet apron / channel was observed, as well as open joints and fractures. A substantial amount of seepage was also seen emanating from below / behind the concrete slope protection on the left (southern) side of the concrete-lined channel where the concrete lining terminates (**Picture 8**). A large-diameter tree is present at this same location and may be contributing to uplifting of the concrete lining.

Picture 5: Principal Spillway Outlet Structure

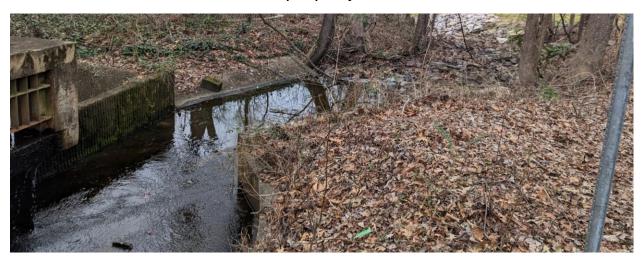
Picture 6: Upstream Segment of Outlet Channel

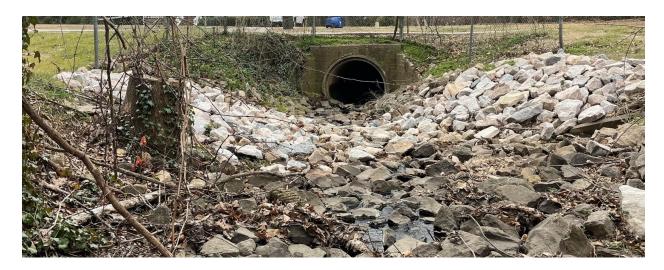
Picture 7: Downstream Segment of Outlet Channel and Quail Hollow Drive Culvert

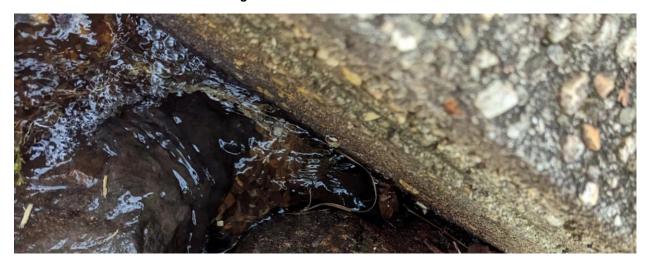
Picture 8: Seepage Emanating from Below Outlet Channel Concrete Lining

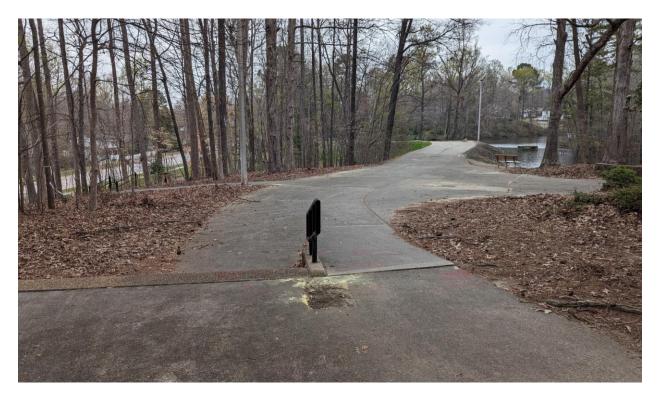
The first auxiliary spillway is a shallow overflow section located immediately south of the embankment and consists of reinforced concrete slabs on the upstream approach and top of dam. The downstream slope is not protected from erosion and contains several large-diameter trees with no formal ground cover. The control elevation of this section is approximately 1.7-feet below the top of dam and existing topography indicates overflows would be at least partially directed into the downstream groin which is also unprotected and has several trees present. While the concrete slabs are in relatively good condition, the lack of erosion protection and large trees downstream of the Dam present concerns should the spillway be activated. Additionally, with flows being directed into the unprotected groin, the Dam embankment may also be at risk of erosion. Further, given the relatively shallow nature of the spillway, the hydraulic capacity is fairly limited at Pond levels that do not overtop higher portions of the Dam. Combining risk of erosion with low hydraulic capacity, reliance on this spillway as part of safely passing the SDF may not be warranted.

Picture 9: South Auxiliary Overflow Spillway

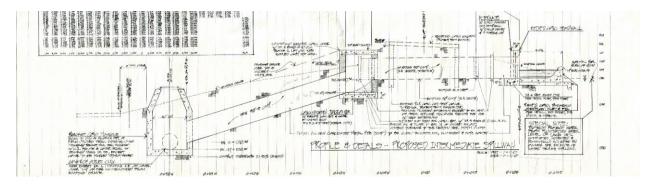
The third auxiliary spillway consists of small concrete u-shaped weir inside the Pond, and a 30-inch piped drainage system that connects to a 24-inch pipe located near the toe of dam. The weir structure was designed with the crest approximately 0.9-feet above normal pool, a depressed section immediately downstream of the weir, and the outflow pipe invert set at normal pool. The original design appears to imply unobstructed flow on three sides; however, existing grade partially blinds both the left and right portions of the crest. Further, the area round the weir and depressed inlet section are full of debris and sediment. Additionally, the weir and pipe appear to have been constructed slightly lower than designed (by 0.1 and 0.3-feet, respectively), though in a maintained condition, these likely function as intended. The pipe system runs from the inlet structure, downstream through the embankment to beyond the toe of dam, where a manhole realigns the system roughly parallel to the embankment. This manhole is also the location where the pipe diameter decreases to 24-inches. The pipe continues southward, ultimately discharging into the downstream receiving channel, approximately 35-feet upstream of the Quail Hollow Drive culvert.

Figure 4: North Auxiliary Pipe Spillway (1990 Drawing #2 Excerpt)

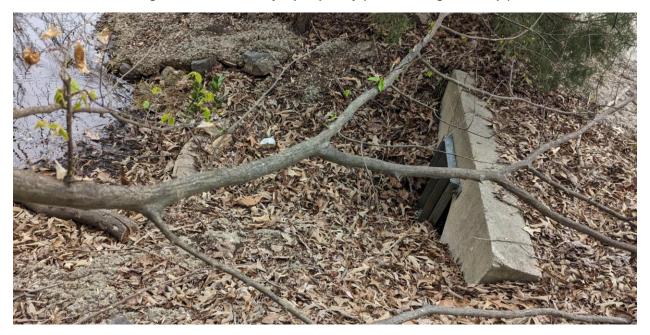
Picture 11: North Auxiliary Pipe Spillway Inlet Structure

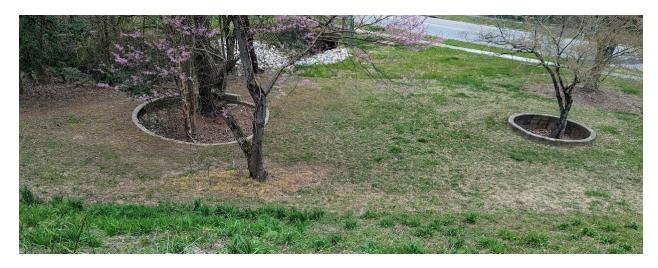
Immediately downstream of the Dam is a wooded area in the vicinity of the principal spillway outlet and southern end of the embankment (**Picture 12**). Downstream areas along the middle portions of the Dam are grass-lined, with a few trees present (**Picture 13**). The northern end contains both grass-lining and a concrete sidewalk (**Picture 14**). Downstream (west) of these vegetated areas is Quail Hollow Drive, which is asphalt paved (**Picture 15**). A 72-inch culvert beneath the roadway conveys flow from the Dam's outlet channel to another reach of channel before connecting to Big Branch located behind homes located on the western side of Quail Hollow Drive.

Picture 13: Area Downstream of Dam (Near Quail Hollow Drive Culvert)

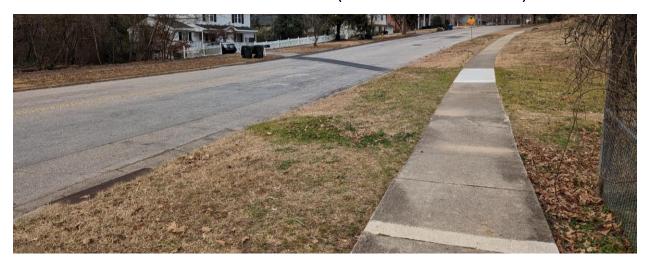
Picture 14: Area Downstream of Dam (North of Near Quail Hollow Drive Culvert)

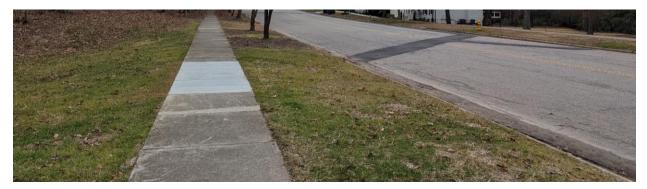
Picture 15: Area Downstream of Dam (South of Near Quail Hollow Drive Culvert)

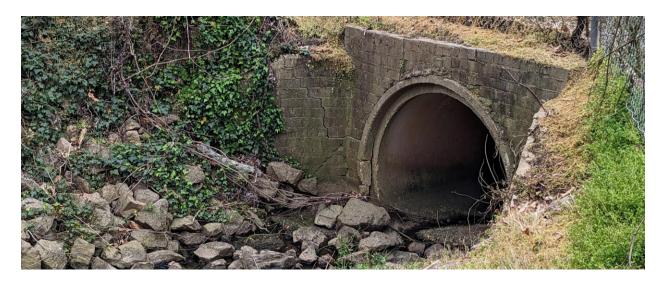
Though not directly related to dam safety, the culvert and downstream channel were also inspected since these are located immediately downstream of the Dam and may impact inundation if not performing properly. The culvert appears to be in fair condition; however, during a March 2023 inspection, the amount of flow entering the pipe appeared to be less than the amount exiting, potentially indicating that water was running below the culvert. Additionally, the upstream endwall is in poor condition with both large vertical fractures and horizontal displacement (**Picture 16**). The channel reach downstream of the culvert is also in poor condition, with a downed tree across the waterway immediately downstream of the outlet and extreme erosion on both banks, including vertical slopes and undercuts (**Picture 17**).

Picture 16: Upstream End of Quail Hollow Drive Culvert

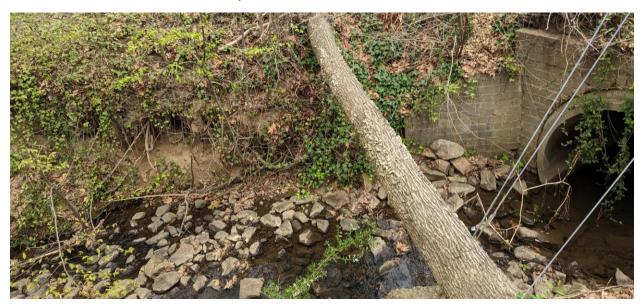
Picture 17: Downstream End of Quail Hollow Drive Culvert

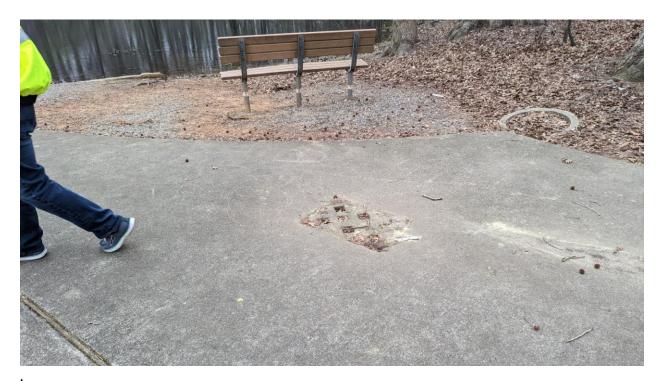
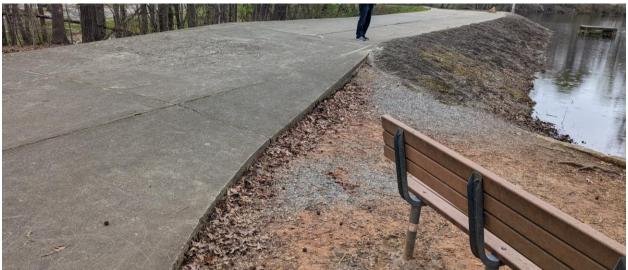
Location: South Auxiliary Overflow Spillway (Upstream Approach)

Area(s) / Component(s): Observation(s): Concern(s):

Abutment Contact Large-Diameter Trees Ground Stability

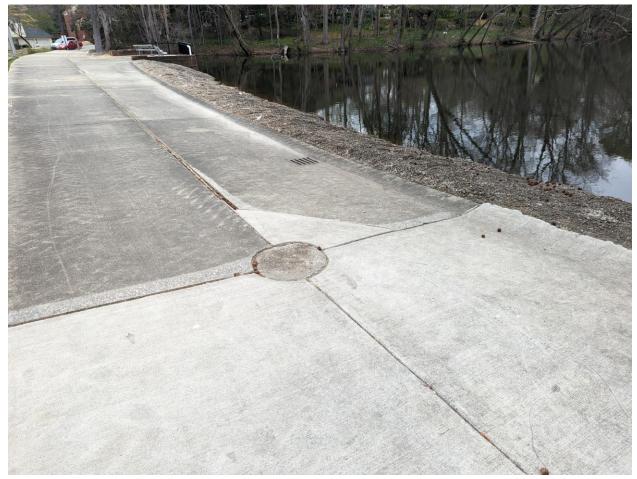
Location: Top of Dam near Midpoint of Embankment Direction: North

Location: Top of Dam near Midpoint of Embankment **Direction:** Southwest Area(s) / Component(s): Observation(s): Concern(s): Bare Areas Erosion Downstream Face and Toe, Weedy Vegetation Growth Competition, Erosion and Outlet Structure Large-Diameter Trees Slope Stability, Soil Piping

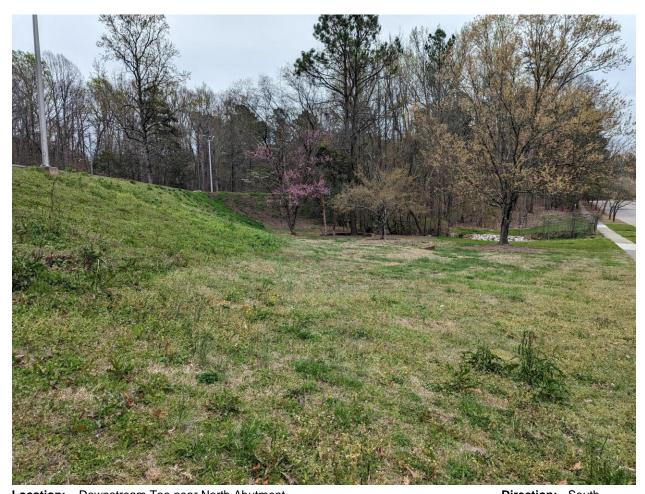
Location: Downstream roe near North Abutment		Direction: South
Area(s) / Component(s):	Observation(s):	Concern(s):
Downstream Face and Toe	Debris Accumulation	Growth Competition, Erosion
	Trees	Slope Stability, Soil Piping

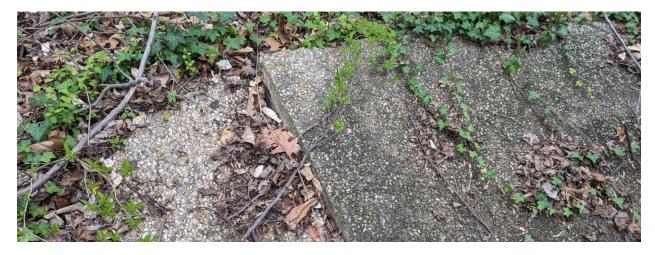
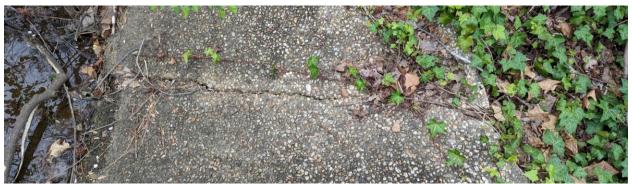
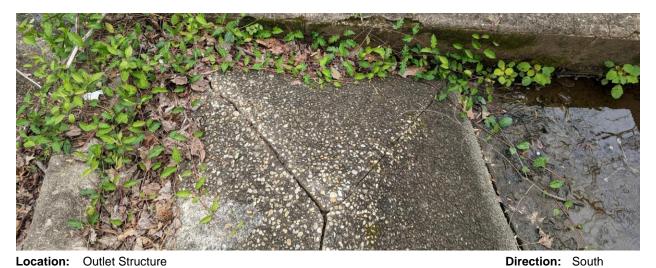
Location: Outlet Structure	9	Direction: South
Area(s) / Component(s):	Observation(s):	Concern(s):
Concrete Slab	Slab Displacement	Slab Uplift /Failure
	Fractures	Slab Uplift / Failure
Adjacent Area	Trees	Ground Stability, Soil

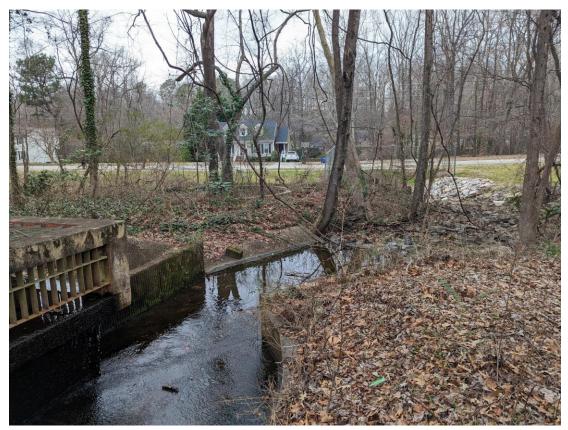
Location: Outlet Structure Direction: West

Area(s) / Component(s):	Observation(s):	Concern(s):
Adjacent Area	Trees / Woody Vegetation	Ground Stability
	Lack of Ground Cover	Erosion

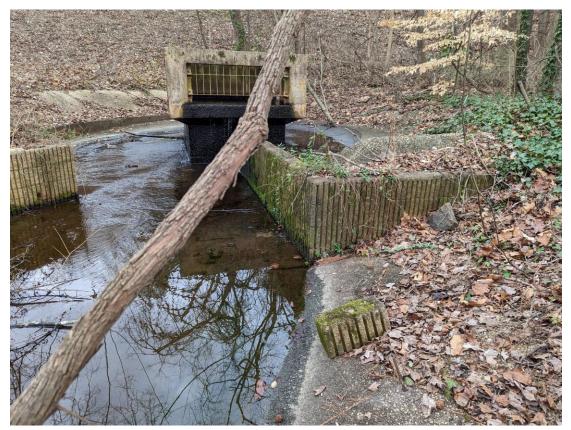
Location: Outlet Channel near Outlet Structure Direction: East

Area(s) / Component(s):	Observation(s):	Concern(s):
Adjacent Area	Trees / Woody Vegetation	Ground Stability
	Lack of Ground Cover	Erosion

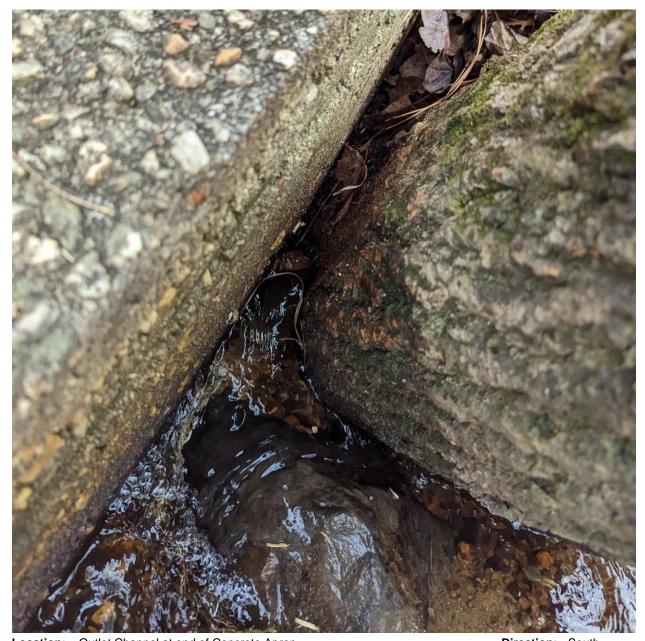
Location:
 Outlet Channel at end of Concrete Apron
 Direction:
 South

Area(s) / Component(s):
 Observation(s):
 Concern(s):

Concrete Apron
 Heavy, Clear Seepage Unknown Origin, Soil Piping, Material Loss

Trees
 Slab Uplift, Ground Stability

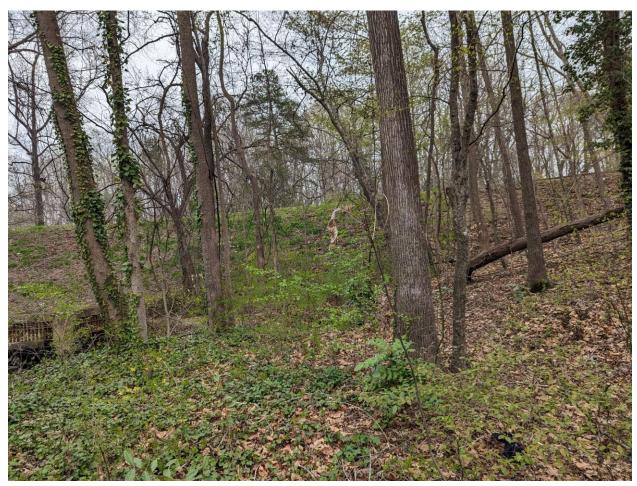
Location: Downstream of Dam near Outlet Channel		Direction: East		
Area(s) / Component(s):	Observation(s):	Concern(s):		
Downstream Face, Groin, and Toe	Lack of Ground Cover	Erosion		
	Trees	Slope Stability, Soil Piping		
	Weedy Vegetation	Growth Competition, Erosion

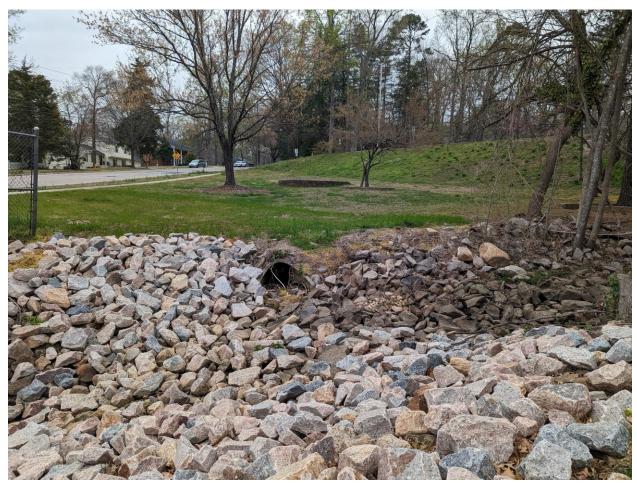
Location: Outlet Channel near Quail Hollow Drive Culvert Direction: North

Area(s) / Component(s): Concern(s):
