REPORT
AUGUST 2024

Marsh Creek Stream Assessment

Prepared for:
City of Raleigh

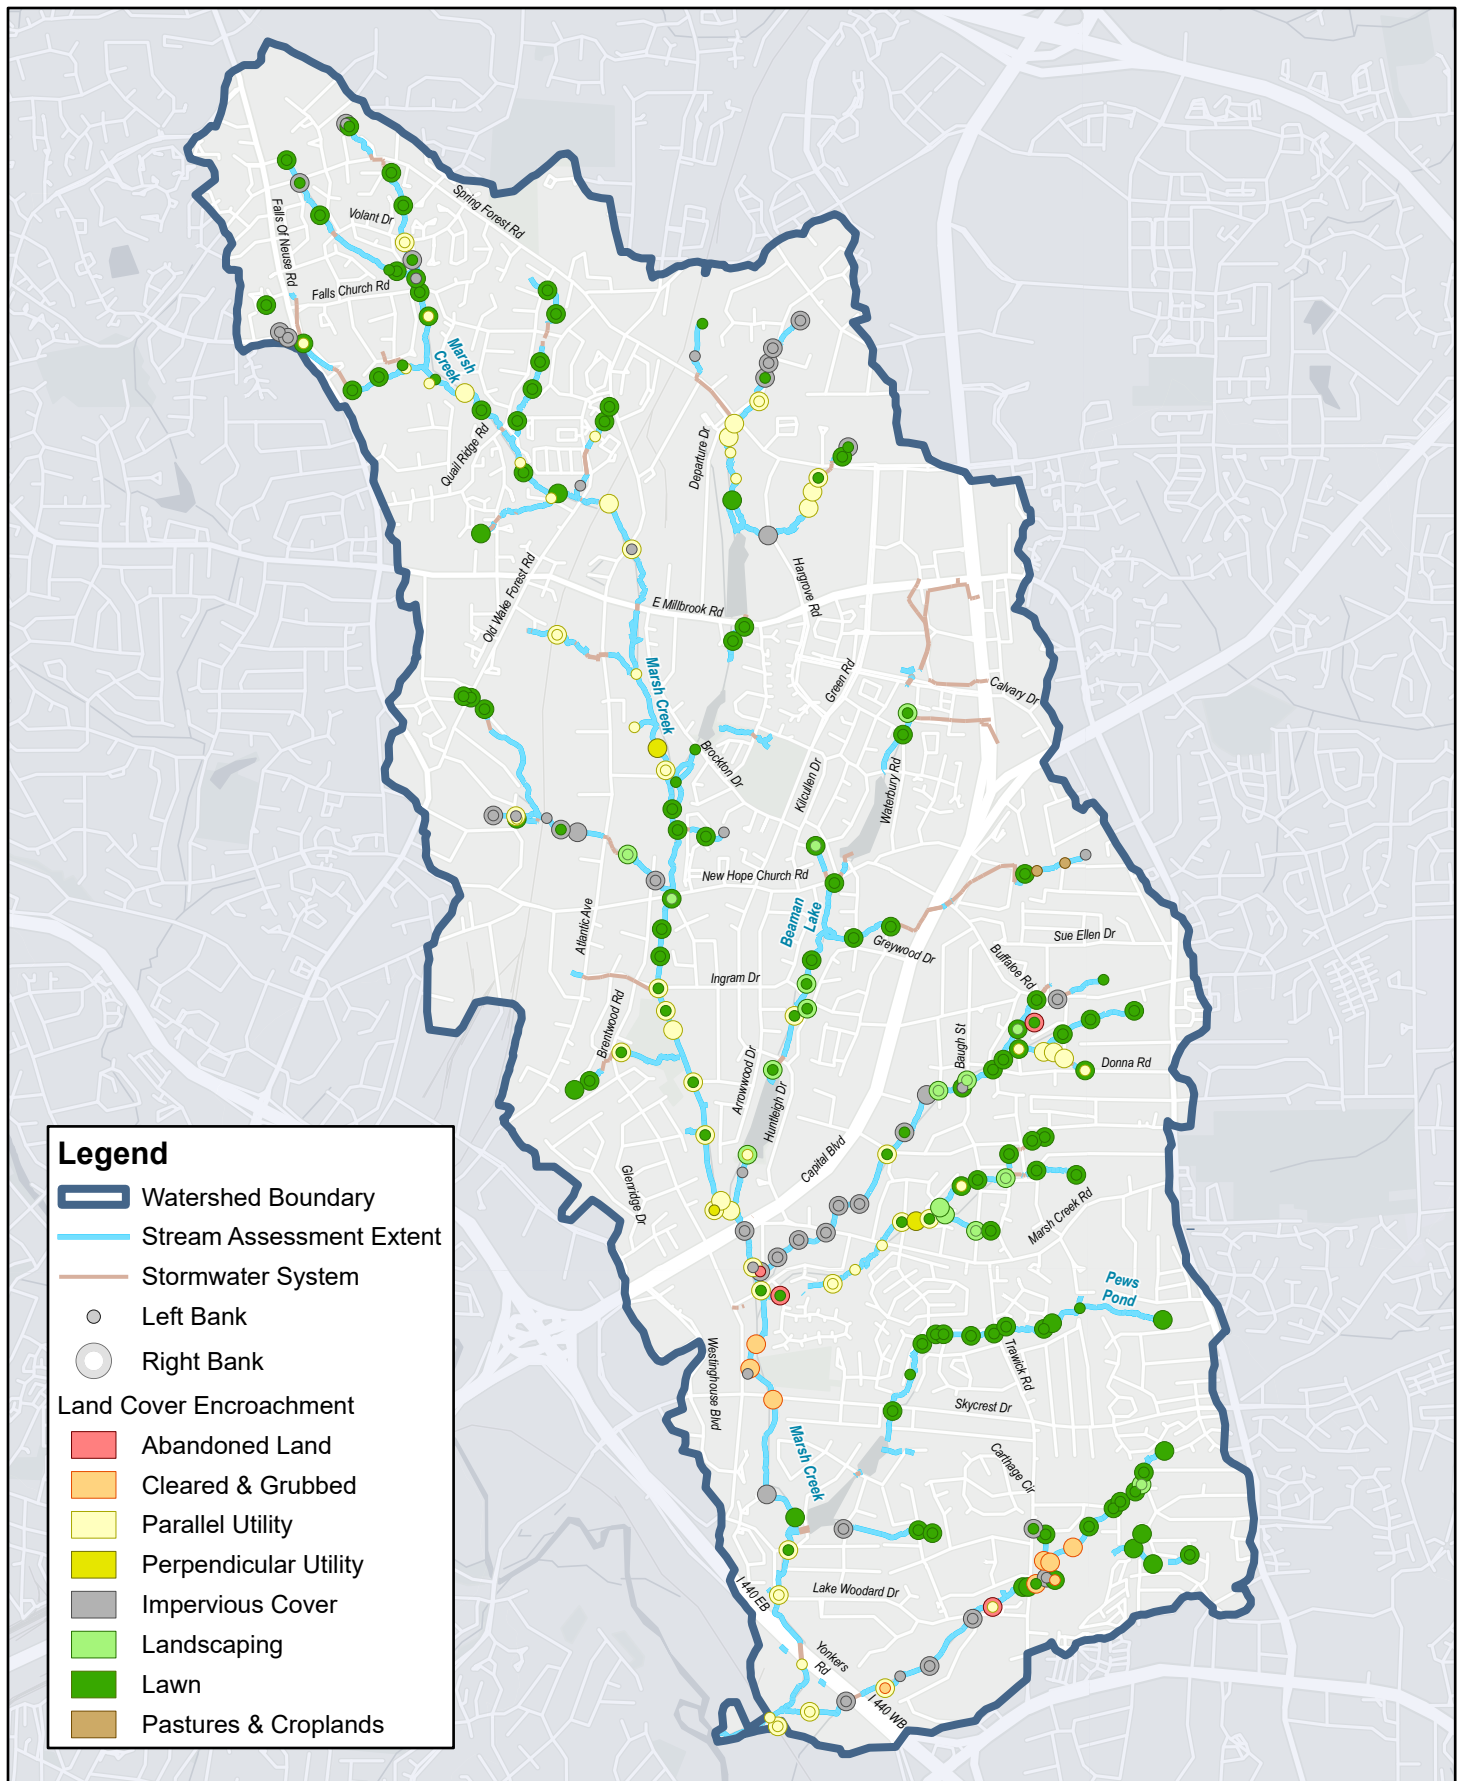
Figure 1-6 Riparian Buffer Encroachment Land Cover
Marsh Creek Watershed Study
City of Raleigh, North Carolina

Approximately 90 percent of the assessed stream bank lengths have full or at least partial buffer extents. Areas with no buffer or encroachment are generally near higher density residential and commercial areas, and adjacent to roadways and utilities (**Figure 1-6**). Additionally, approximately 75 percent of stream lengths with partial buffer extents are from encroachments of lawns (53 percent) or maintained utilities (22 percent) and provide some vegetative coverage in those buffer areas. While having some vegetation present in the buffer is better than none, utilities and lawns in the buffer will diminish the benefits provided by the riparian buffer. Consequences include increased runoff to the stream, less pollutant reduction with the potential for increases if lawns are fertilized, reduced cooling due to less dense vegetation and understory, and reduced bank stabilization from deep root systems when compared to a natural buffer.

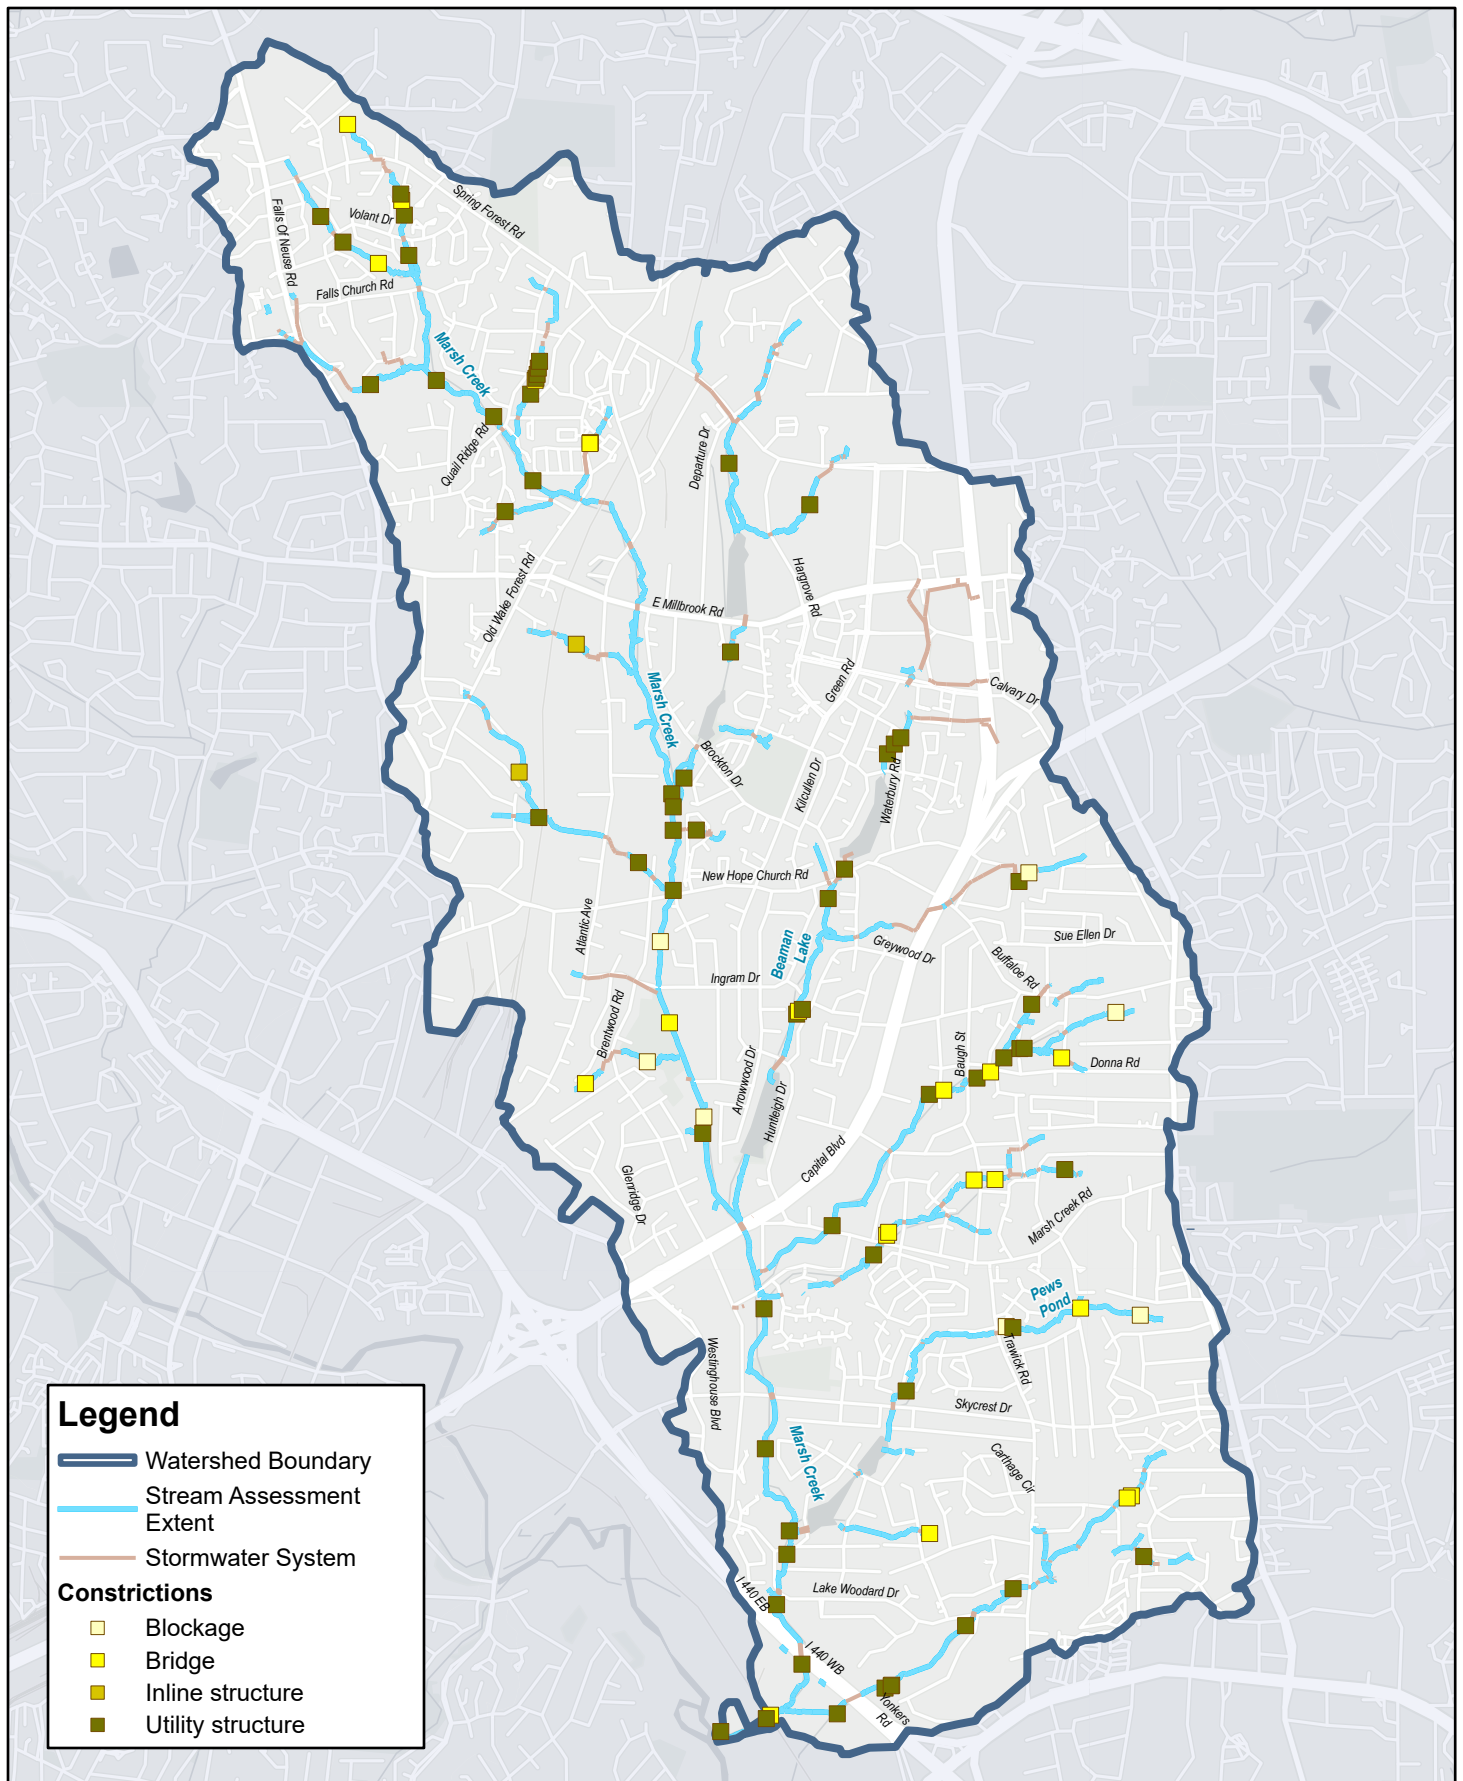
Figure 1-14 Constrictions
Marsh Creek Watershed Study
City of Raleigh, North Carolina

Stream constrictions where the stream channel cross section was reduced by debris or could potentially be blocked by objects such as bridges or utility structures were documented as part of the stream assessment (**Table 1-15** and **Figure 1-14**). There were 8 constrictions causing complete blockage of the stream channel, most of which were due to fallen trees accumulating debris.

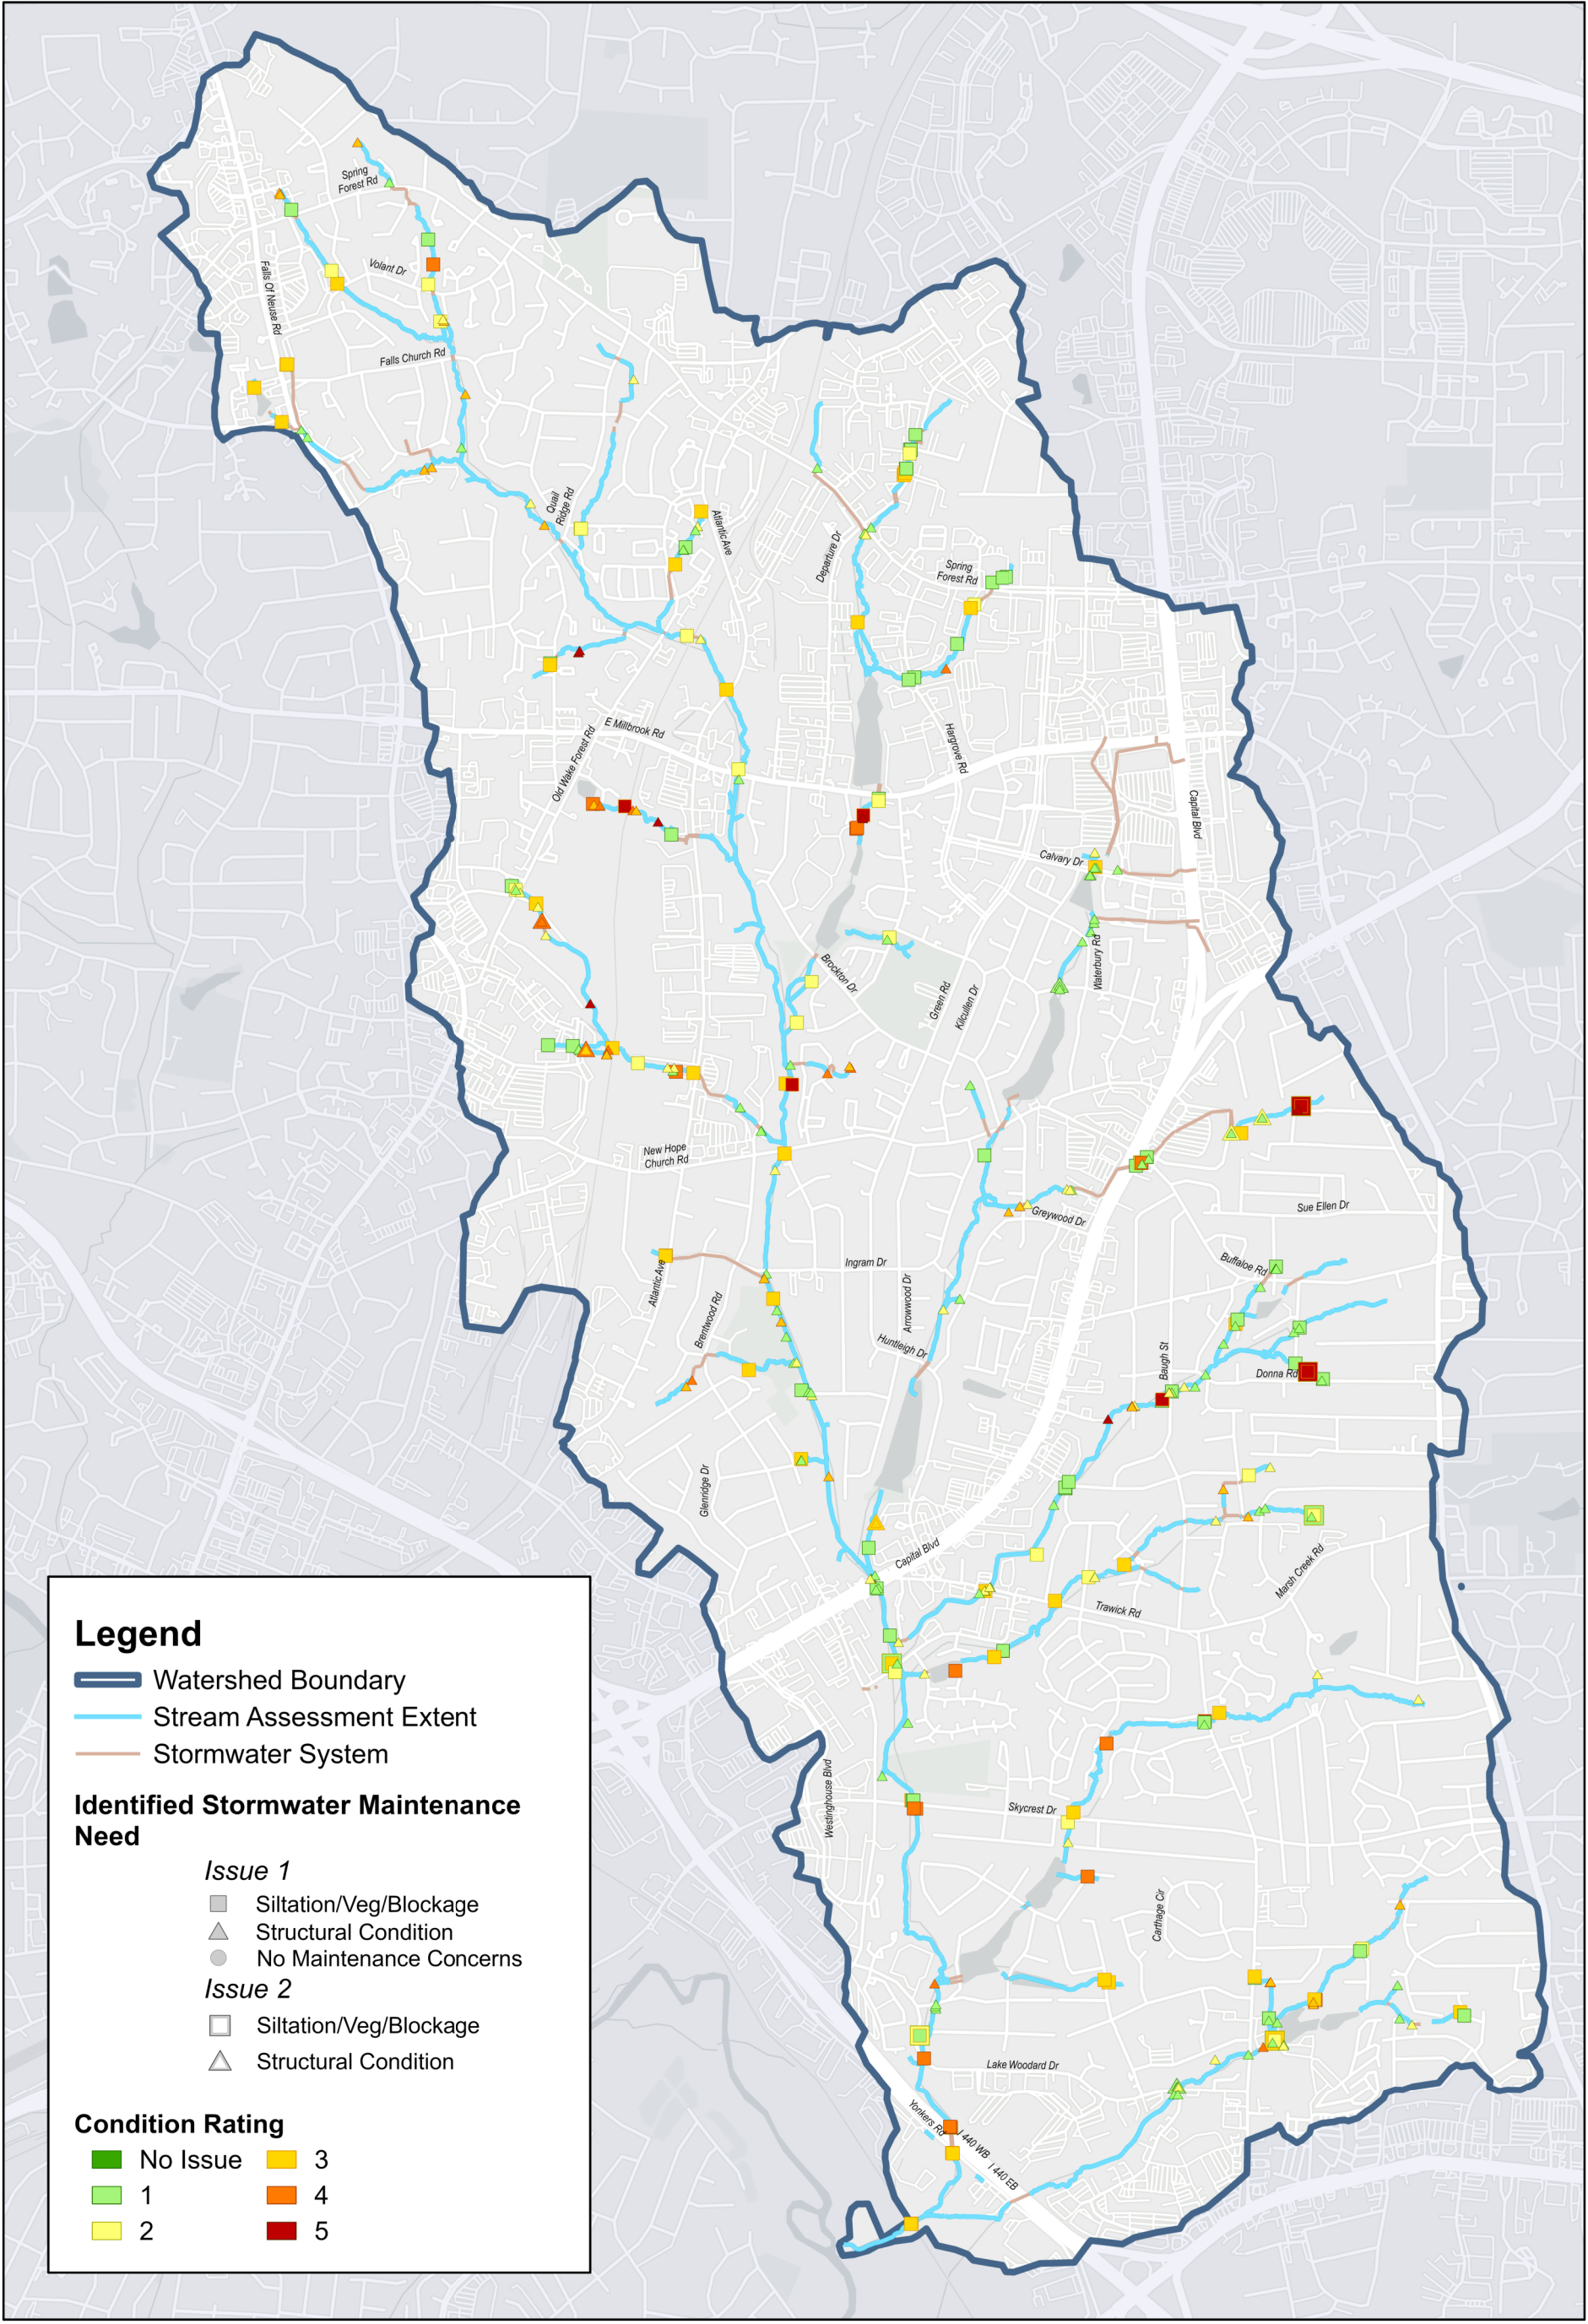
Figure 1-15 Stormwater Infrastructure Condition Assessment

Observations of stormwater maintenance issues or infrastructure concerns such as sediment blockages or structural issues were recorded as part of the stream assessment. The observations were divided into two categories: structural condition assessment (**Table 1-16**) and blockage condition assessment (**Table 1-17**). Each category was rated according to severity with zero being no issues observed and five being the most severe. Where both structural and blockage issues are occurring for the same feature, a second maintenance concern is recorded. For example, a single stormwater outfall may have both structural damage and a debris blockage. In these situations, **Figure 1-15** uses stacked symbols (Issue 1 and Issue 2) to show both maintenance issues. Refer to the Watershed Study Methodology Report for more details on how the ratings were assigned.
