MOORE SQUARE COMPREHENSIVE TREE STRATEGY

Raleigh Parks and Recreation Department
April 2013

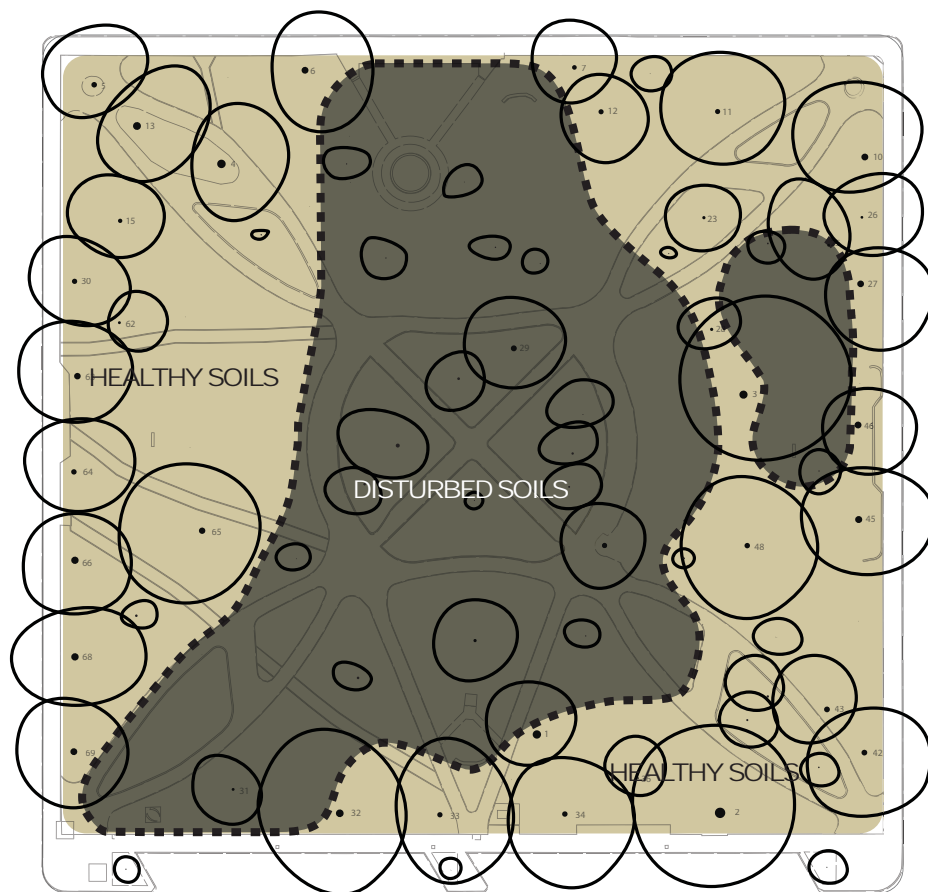
EXISTING SOILS ANALYSIS

Soil lying outside the area in the above plan diagram not recommended for soil modification (represented in light tan) are found to be healthier soils, while soil within the disturbed area (represented in dark brown) is found to be disturbed and not as healthy for planting growth. By overlaying existing tree canopies with this information, it becomes evident that the older trees, most of which are oaks, are located within the healthier soil zones that are not disturbed while younger trees with less canopy are located in disturbed soils. We can use this information for preserving healthy soils and making suggestions for where soil modifications should be made for future design and to help ensure healthy and long-term canopy for the site.

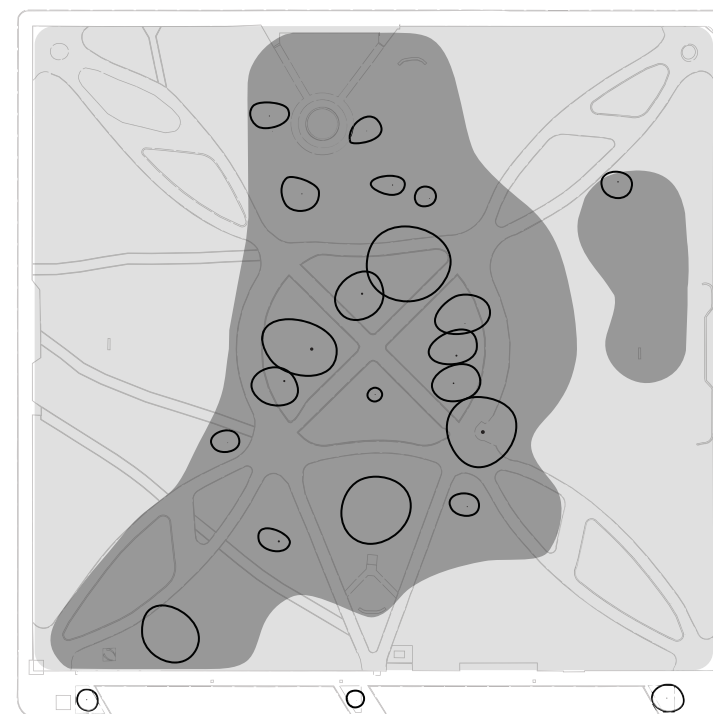
TREES WITHIN THE DISTURBED SOIL CONDITIONS

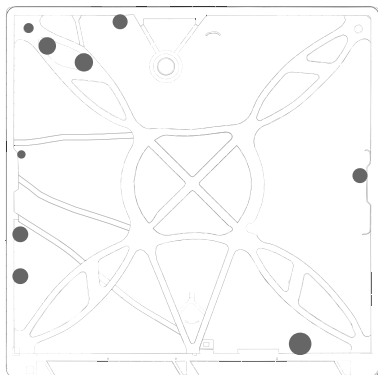
TRUNK PROTECTION CONFLICTS

There are six areas that currently exist in which new paths were aggressively cut into the trunk protection areas.

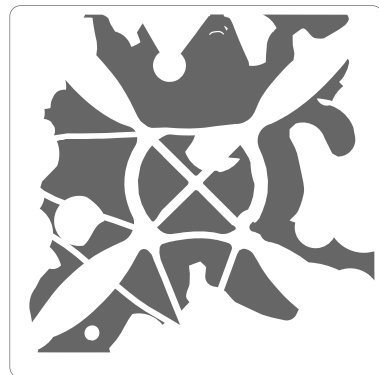
DISCONNECTED LAWN

The current small lawn panels have neither the size nor the soil structure to accommodate the intensity of current or anticipated urban use.

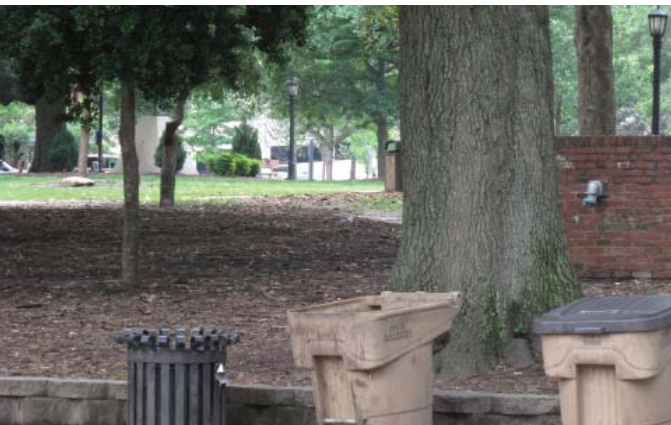
PATH AND WALL CONFLICTS WITHIN THE TRUNK PROTECTION AREA SHOULD BE IMPROVED

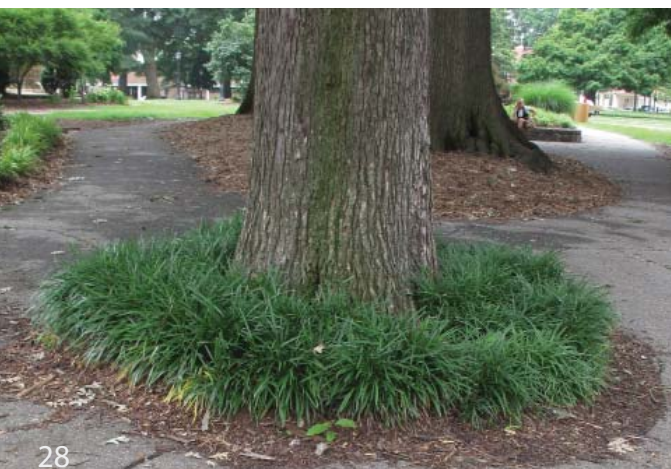
PATH CONFLICTS WITHIN THE TRUNK PROTECTION AREA SHOULD BE IMPROVED

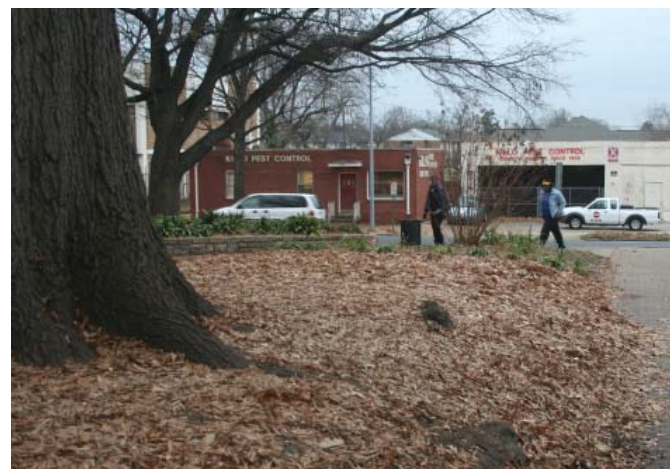
PATH CONFLICTS WITHIN THE TRUNK PROTECTION AREA SHOULD BE IMPROVED

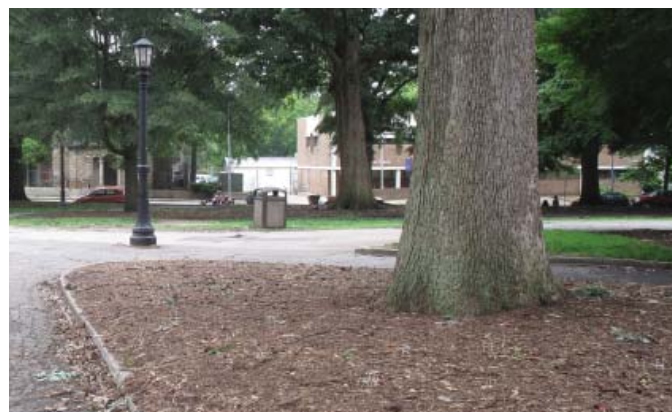
EXISTING PATHS AND UTILITY LINES VIOLATE TREE AND TRUNK PROTECTION AREAS

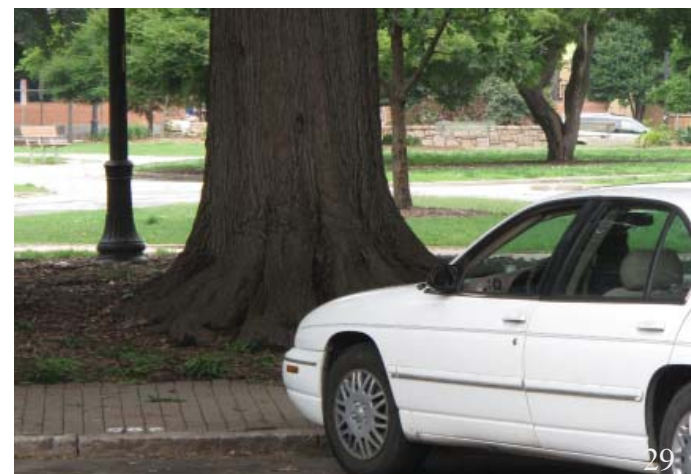
PATH CONFLICTS WITHIN THE TRUNK PROTECTION AREA SHOULD BE IMPROVED

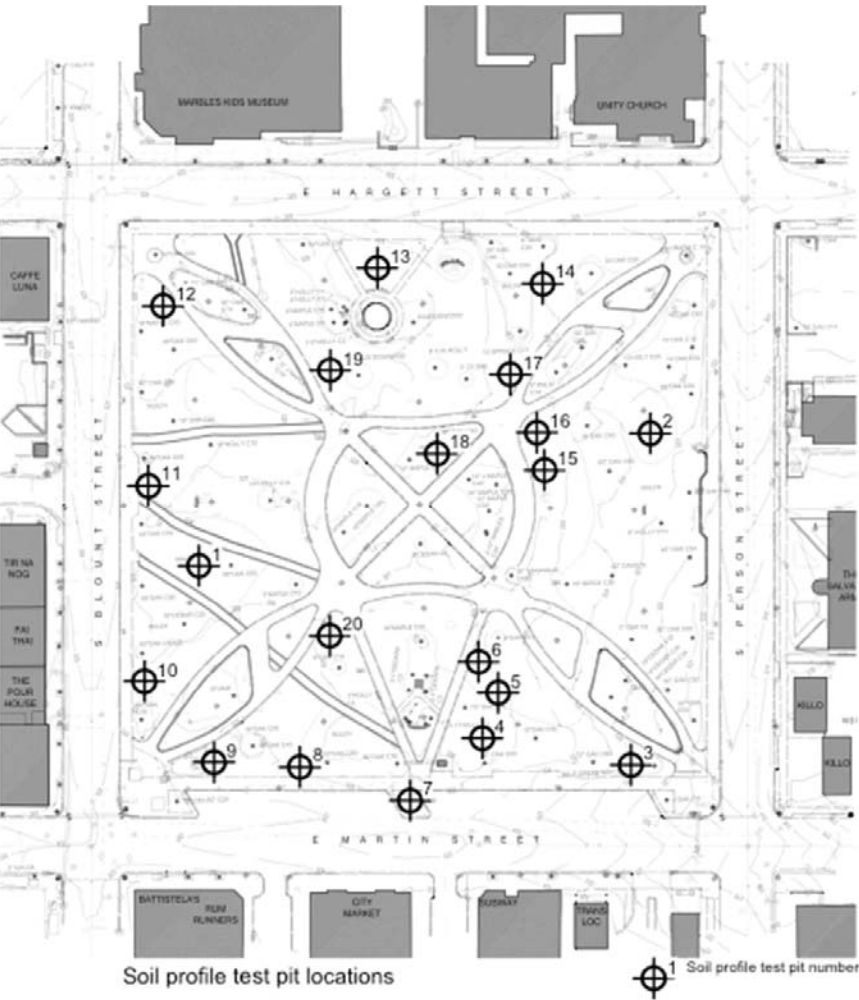
Location 1:

Soil profile	Depth	Description
		Surface cover: Wood chip mulch
	0-0.2'	Decomposing wood chip mulch; dark brown/black; moist; soft; roots observed
	0.2'-0.5'	High organic fine sandy loam; dark brown; damp/dry; firm; roots observed
	0.5'-1.0'	Fine sandy loam; light brown, dry; firm; roots observed
	1.0'-1.4'	Fine sandy clay loam; light brown/orange; dry; hard; roots observed
	1.4'-1.8'	Fine sandy clay loam; orange/brown; dry; very hard; roots observed
	1.8'-2.1'	Fine sandy clay loam; orange; dry; very hard; roots observed
	2.1'	Auger refusal

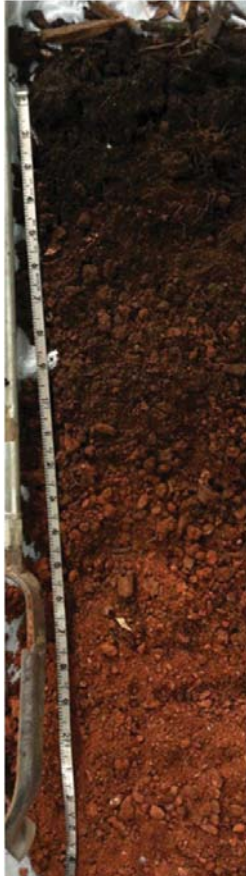
Location 3:

Surface cover: Wood chip mulch
	0-0.3'	Wood chips; dark brown/black; moist; soft; roots observed
	0.3'-0.5'	Decomposed organic material; dark brown/black; moist; soft; roots observed
	0.5'-0.8'	Fine sandy loam/ sandy clay loam; brown; moist; soft; roots observed
	0.8'-1.4'	Fine sandy clay loam/gravel; orange brown; moist; soft; roots observed;
		Cloth strip found at approximately 1.0', roots observed and large root struck
	1.4'-1.7'	Fine sandy clay loam, orange/ brown; moist; soft; minor roots
	1.7'-2.6'	Gritty, gravel sandy clay loam; orange; dry; firm to very hard w/depth
	2.6'	Same as above; very dry; auger refusal

Remarks: Profile below 1.4 feet likely an undisturbed sub soil. Profile adjacent to largest (DBH) tree on site

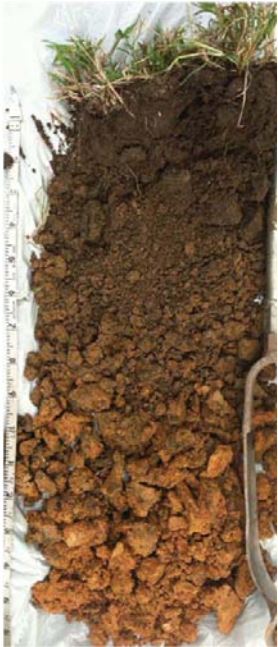
Location 13:

Surface cover: Turf grass
	0-0.3'	Loam; dark brown/black; moist; soft; roots observed
	0.3'-0.5'	Sandy loam; dark brown; moist; soft; roots observed
	0.5'-0.8'	Sandy loam; brown; moist; soft; roots observed
	0.8'-1.2'	Sandy clay loam; light brown/orange; moist; firm; roots observed
	1.2'-1.6'	Clay loam; orange; damp to moist; hard
	1.6'	Very hard; Stopped digging

Remarks: Disturbed profile

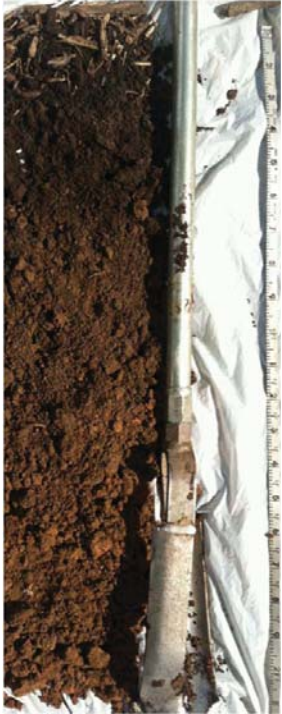
Location 18:

0-0.6'	Surface cover: Wood chip mulch Decomposing mulch; dark brown/black; moist; soft; roots observed
	0.6'-1.1'	Fine sandy loam; dark brown; moist; soft; roots observed
	1.1'-1.5'	Fine sandy loam; brown; moist; soft; roots observed
	1.5'-2.1'	Fine sandy clay loam; brown/ orange; moist; soft; roots observed
	2.1'	Auger refusal on large root

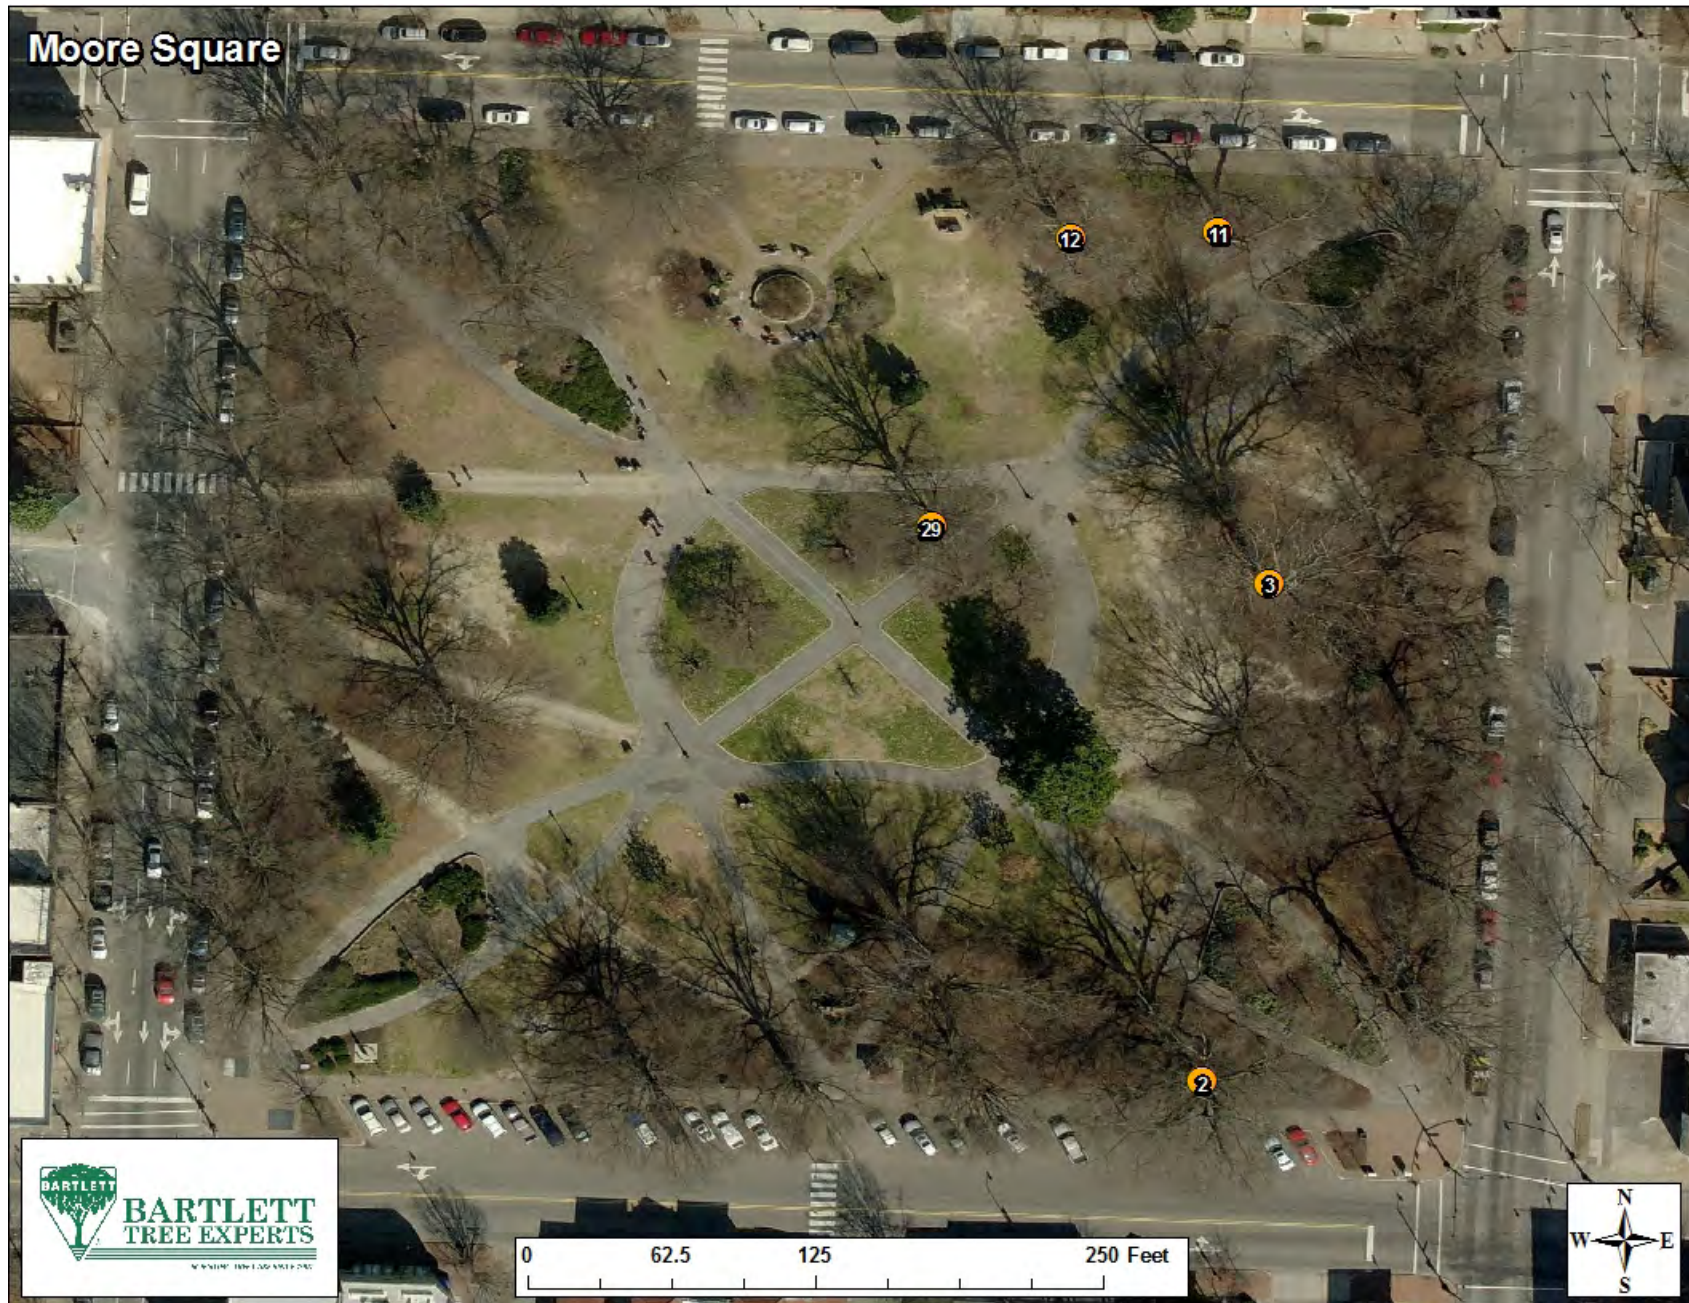
Map 5: TREES RECOMMENDED FOR ADVANCED ASSESSMENTS (LEVEL 3)

Tree ID #	Common Name	DBH	Roots	Stem	Crown	Condition or Defect	Condition or Defect	Condition or Defect
2	willow oak	65	yes	wound-branch	storm damage	lightning damage
3	swamp white oak	51	yes	wound-stem	deadwood >2	...
11	pecan	32	yes
12	sugar maple	32	yes	yes	...	fungi/conks
29	white oak	37	yes	yes	...	fungi/conks

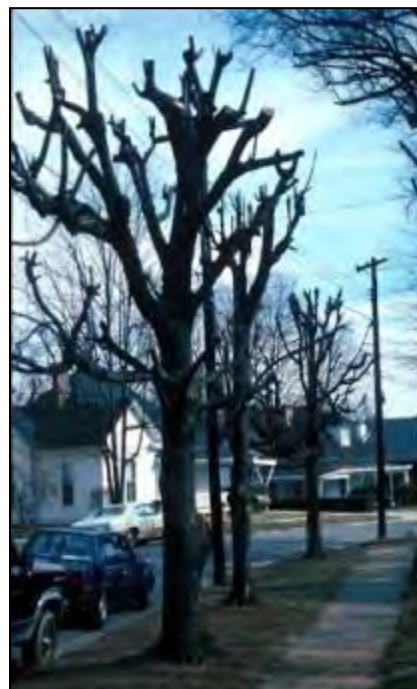
Figure 4: Examples of topping

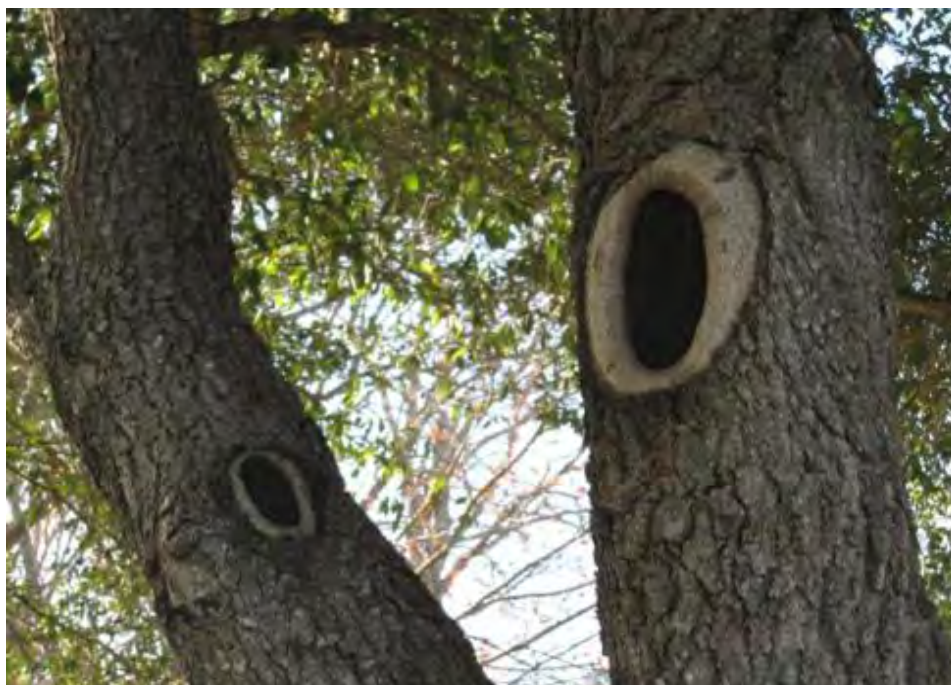
Figure 5: Examples of flush cuts

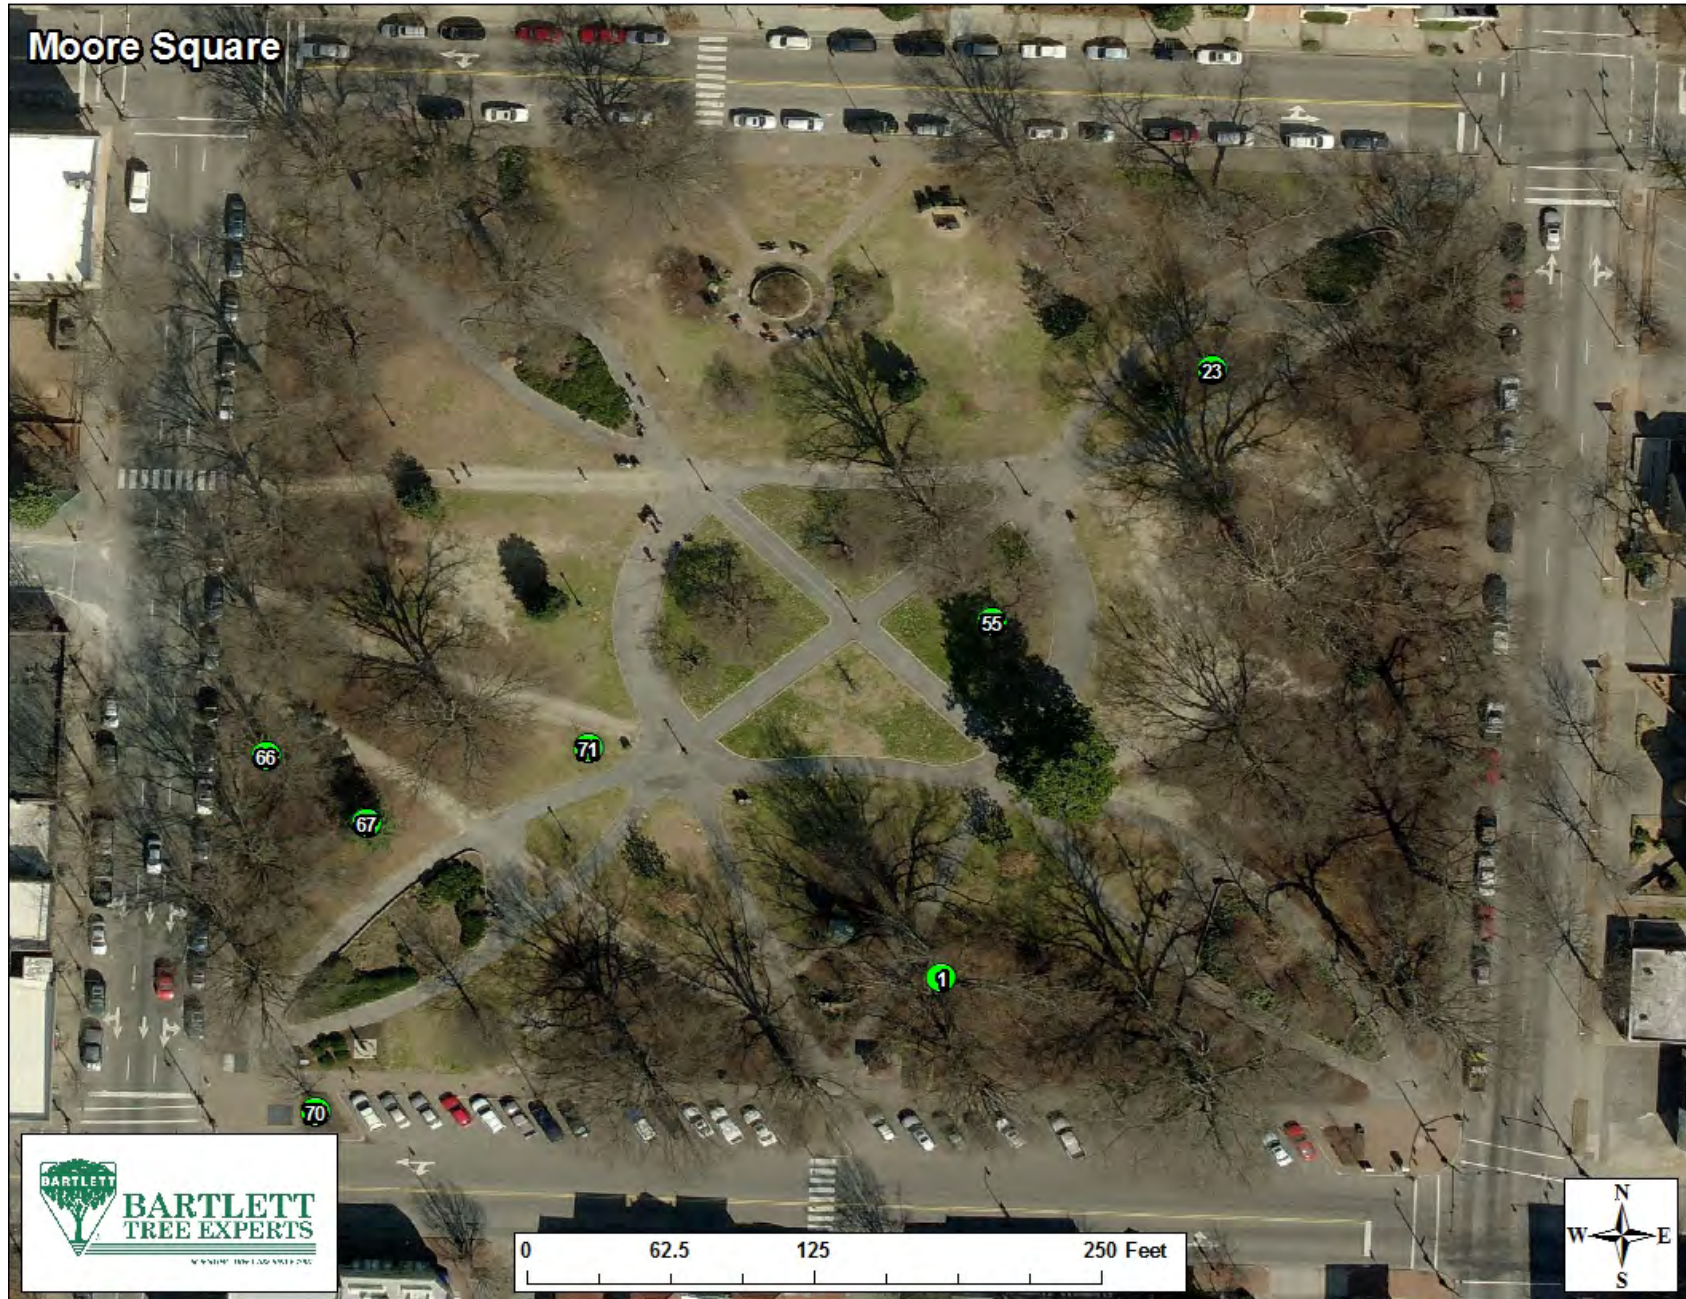
Map 9: TREES RECOMMENDED FOR PHC PROGRAM

Tree ID #	Common Name	DBH	Pest or Disease
1	swamp white oak	52	cankers
23	pin oak	20	cankers
55	Japanese maple	15	scale
66	willow oak	46	borers
67	Deodar cedar	16	borers
70	Nuttall oak	4	mites
71	red maple	5	cankers
