210 N. State Street – Major COA Scope of Work / Description of Work

The purpose of this project is to restore the house to as close as is feasibly possible to the original condition. The house was added on in many different ways over the years. In the few cases where the scope of work does not necessarily restore the house to its exact original condition we believe the work does not make its current condition worse.

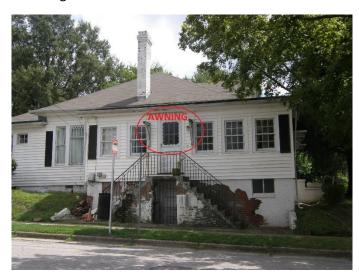
- **Rebuild north elevation awning** The LD report does not mention or have a picture of this awning. We will submit to staff a picture of an awning from a similar styled house. Shingle is expected to match existing roof.

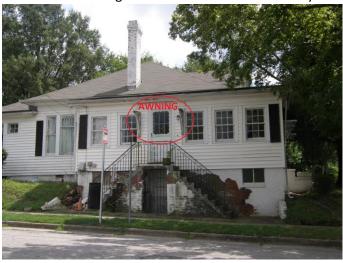
- #8 Rebuild awning on side sun room exterior entry door.
