#### APPLICATION FOR A CERTIFICATE OF APPROPRIATENESS – STAFF REPORT

COA-0032-2019 1016 W CABARRUS STREET

<u>Nature of Project</u>: Remove shed; remove rear addition, front porch, vinyl siding; construct rear addition, front porch, railing and stairs; remove and replace front walkway and driveway; install gutters, downspouts; replace roofing; changes to windows and doors; repair and paint existing siding

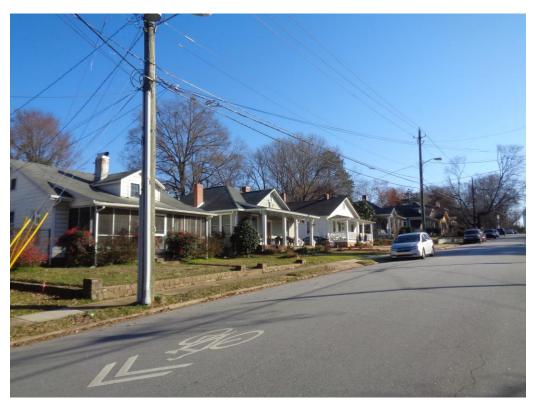
Photo 2: Streetscape Looking East

one story. (See Photo 2 for streetscape). The proposed addition keeps the front elevation as-is while restoring the front porch to what it may have looked like originally. The rear gabled is a typical roof form seen throughout the historic neighborhood.

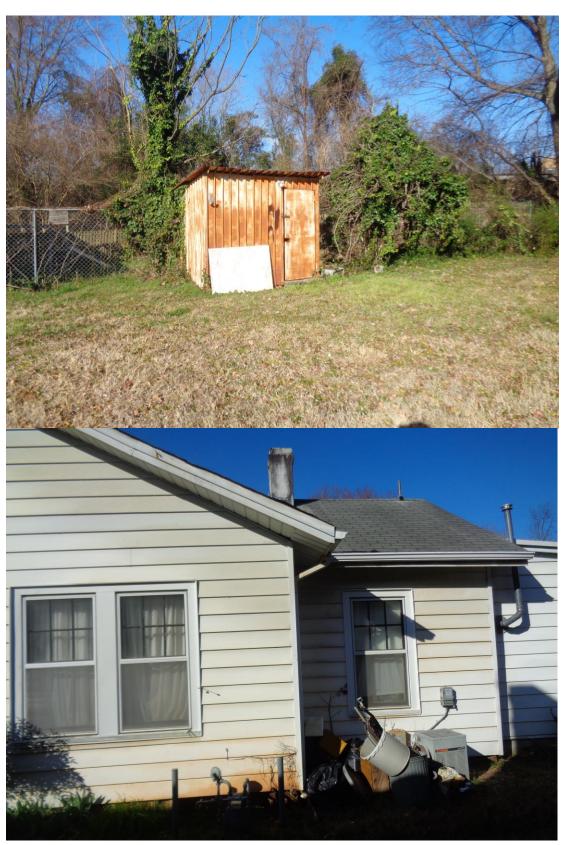
Photo 5: Existing Shed to be demolished, 7" dia. Tree to left of shed to be removed and not required to have a COA.

- 2\* The application includes the removal of a shed in the back yard which was described in the application as being in "poor condition".
- 3\* One photograph of the shed was provided which appears to show a small metal structure with a single door.

Landscaping features & Trees: There are no trees on the property with more than a 7" dia. therefore no COA is required. A 7" dia. Tree measured 4.5' off of the ground adjacent to shed is to be removed (see Photo 5). A Tree Protection Plan is not needed because there are no tree roots in the area of construction, however a tree protection fence shall be installed to protect neighboring trees from any site disturbance (see Site Plan). A large amount of underbrush will be removed and new grass will be planted. The shrubs in the front elevation will be removed due to the demolition of the front porch and new native plantings will take their place to match in scale.

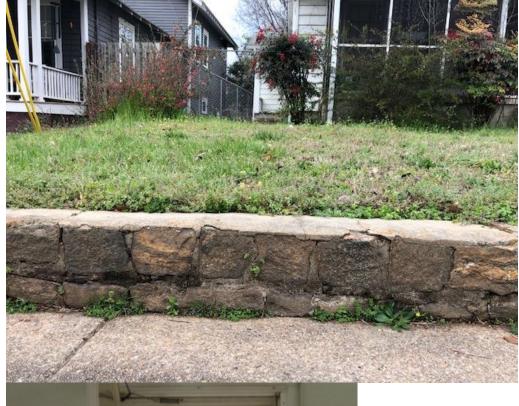
Photo 9: Existing Stone retaining wall-Use similar stone for new front steps and front porch foundation.

Front Porch: The new front covered porch shall have a new stone masonry foundation and stone cap protruding from foundation wall with an infilled concrete floor. The stonework shall match the existing stone retaining wall shown in Photo 9. Columns to be 8" wood with a 1x4 capital and 1x6 base painted. Structural members to be painted wood. The porch shall have a 36" high metal railing painted. The railing will contain a double-hinged gate at top of step (see Photo 13A for precedent). New shed roof to match the existing form and new shingles to match main roof will be installed. All eave, fascia and rake details to match main house and are to be confirmed after removal of vinyl. New stone steps to be installed similar to others in the district (see Photos 20 and 21).

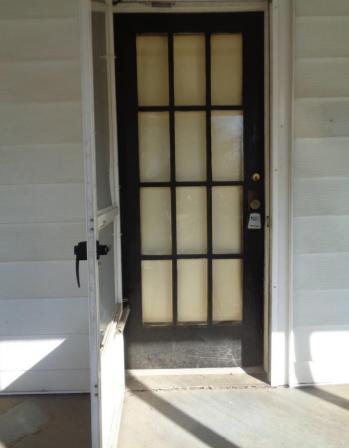
Photo 9B: Existing Front Door

Doors: The existing 12-lite front door is a full-lite glass door and is more typical for that of a side or rear entry. (see Photo 9B) It shall be relocated to the mudroom rear door. A new custom wood stained front door with ¾ glass shall be installed at the front porch. (See Photo 19) Three new full-lite wood doors shall be installed at the rear covered porch and will match the original full lite doors with 12 lites. All new doors shall be Lincoln with true divided lites and loweglass. See pages 21-26 for window and door details.

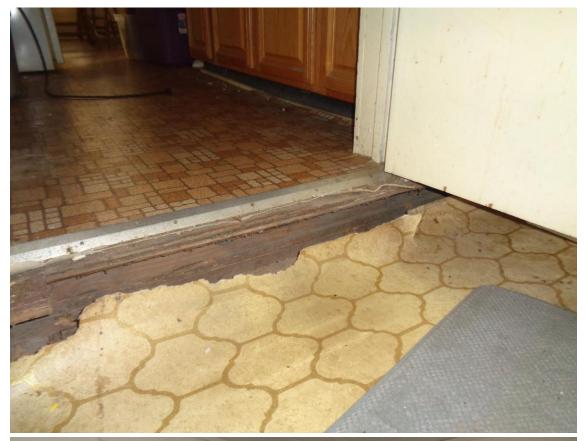
Photo 12A: Existing sunken floor at existing kitchen

Project consists of restoring a single story bungalow and removal of a rear addition to the main building mass that is in deteriorated condition beyond repair (due to a failing foundation and floor system- see photo 12A and 12B) and construction of a new rear and side addition. The existing front porch contains a non-original cmu foundation and the framing is in disrepair (see photo 7). This front porch will also be demolished and rebuilt to match existing footprint and roofline. The existing sidewalk and front porch stairs are in poor condition and will be replaced with new. The driveway has broken remnants of a ribbon concrete drive and will be replaced with new to match existing and extend to new mudroom entrance. The new addition does not diminish or overpower the existing house keeping the front elevation massing the same.

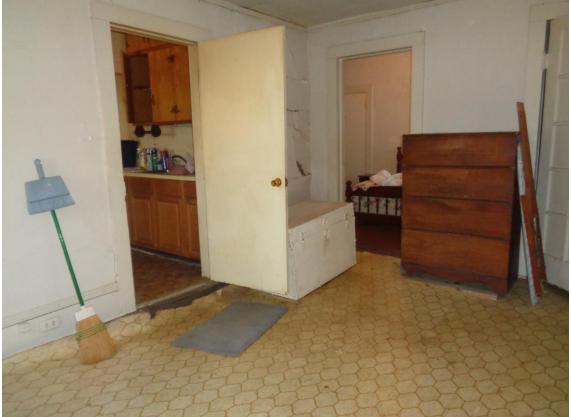
Photo 12B: Existing sunken floor of rear of house to be demolished

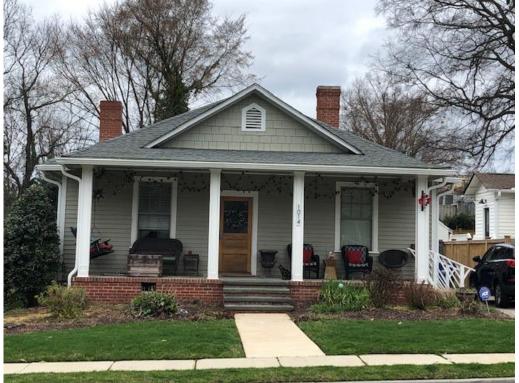
Photo 13:
Front concrete porch
with masonry
foundation1014 W. Cabarrus St.

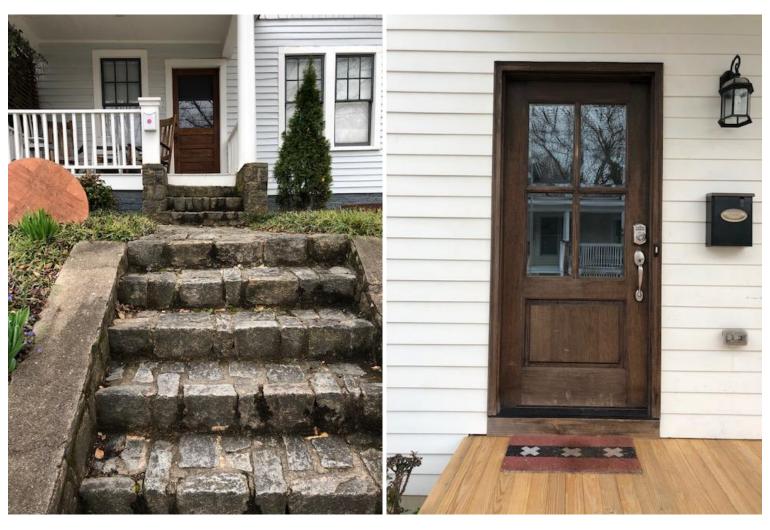
Photo 18: Stone Steps – 1110 Lenoir St.

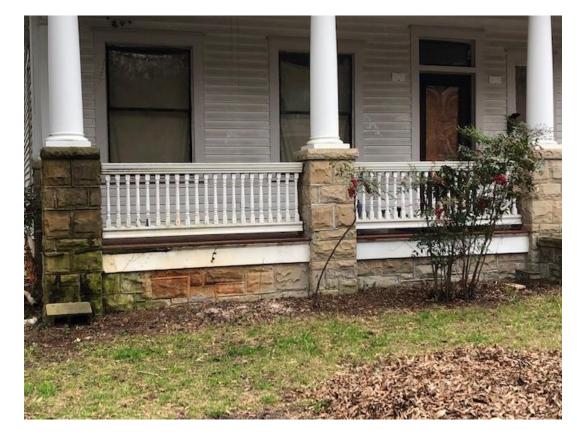
Photo 20: Stone Foundation-418 Cutler Street

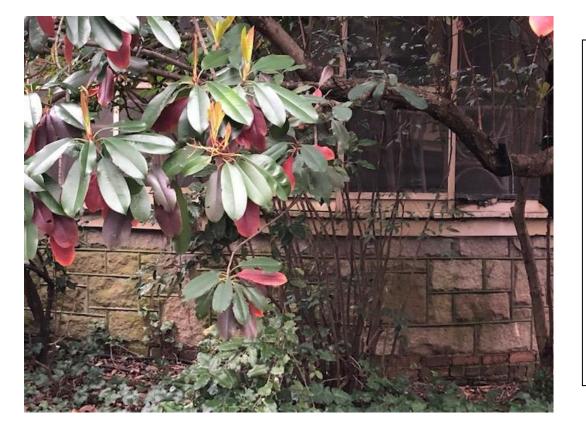
Photo 21: Stone Foundation-507 Cutler Street

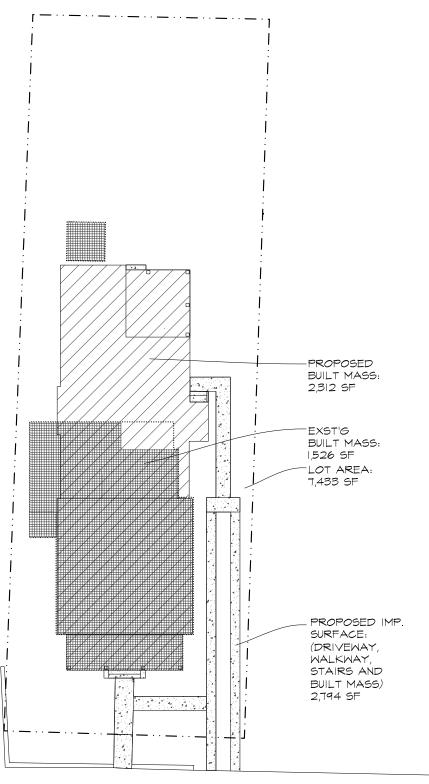
#### LOT COVERAGE COMPARISONS

Summary: 1016 W Cabarrus including proposed addition has 38%: 1012 W Cabarrus has

1016 W. Cabarrus Lot size: 7433 sf 1012 W. Cabarrus Lot size: 7500 sf 1016 W. Cabarrus: Original built area is 24%; proposed built area is 38% 1012 W Cabarrus: Existing built area on property 3,255 sf, or 43% 1016 W. Cabarrus: Original built mass is 21.4%; proposed built mass is 31.3% 1012 W Cabarrus: Existing built mass of house and addition is 3,063, or 41% Proposed Built Area and Built Mass for 1016 W Cabarrus St. is less than the Built Area and Built Mass at 1012 W. Cabarrus St.

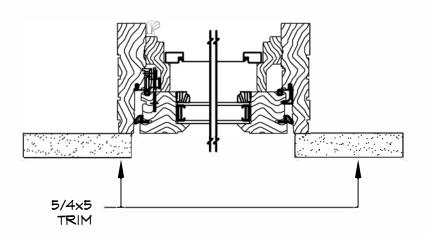
TYPICAL JAMB DETAIL - WINDOW

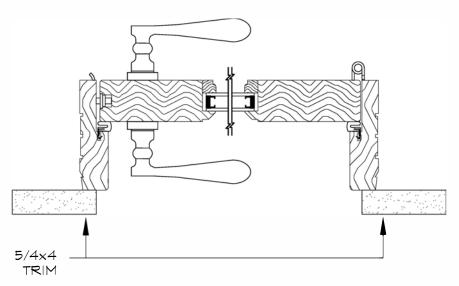
TYPICAL JAMB DETAIL - DOOR

1016 W CABARRUS STREET PROPOSED DOOR DETAILS SCALE: 3" = |'-0"

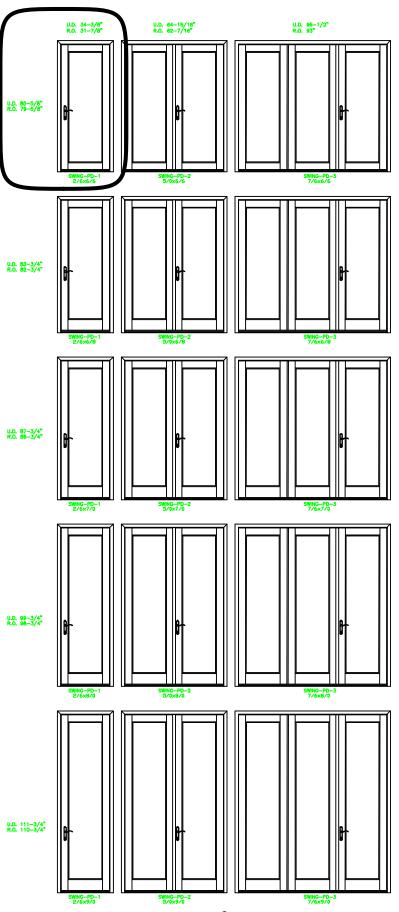
WOOD 1-3" PATIO DOOR OUT-SWING ELEVATION SCALE: NONE

MUTTINS NOT SHOWN- SEE ELEVATIONS

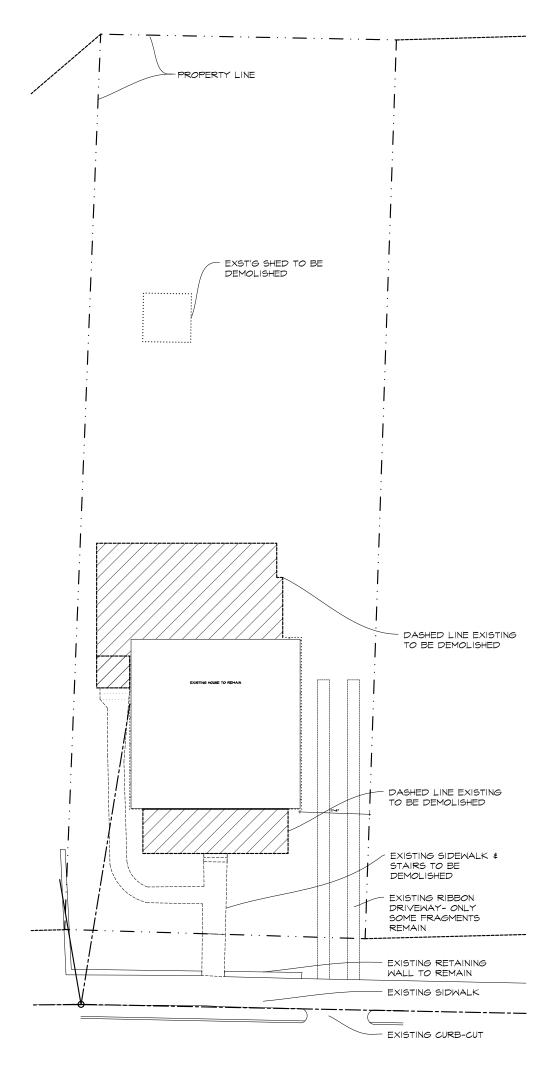
EXISTING PLOT PLAN

SEARS RE	SIDENCE		
1016 W. CABARRUS ST.			
PLOT PLAN	/ 6"=  '-0"	DATE:	3-28-19

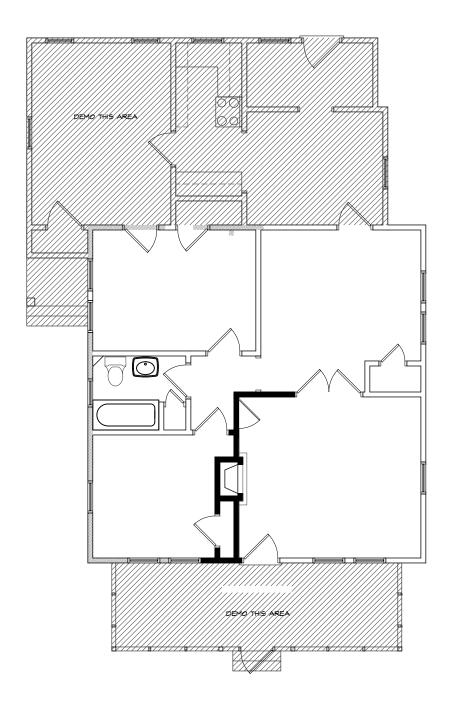
EXISTING FLOOR PLAN

SEARS RESIDENCE				
1016 W. CABARRUS ST.				
PLANS	1/8"= 1'-0"	DATE:	3-6-19

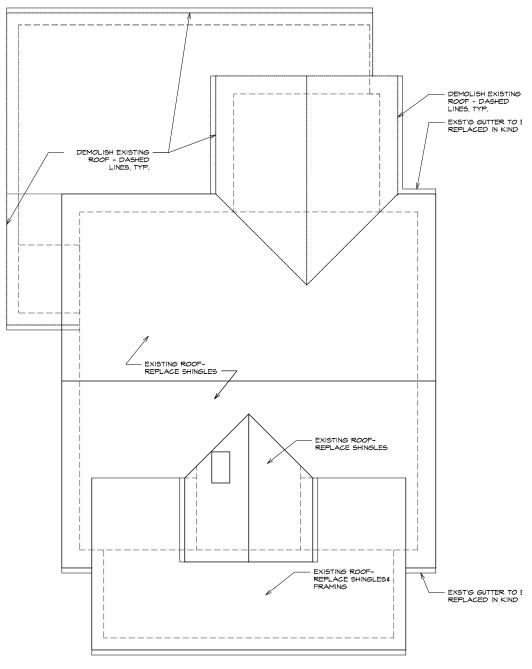
EXISTING ROOF PLAN

SEARS RESIDENCE			
1016 W. CABARRUS ST.			
PLANS	/8"=  '-0"	DATE:	3-12-19

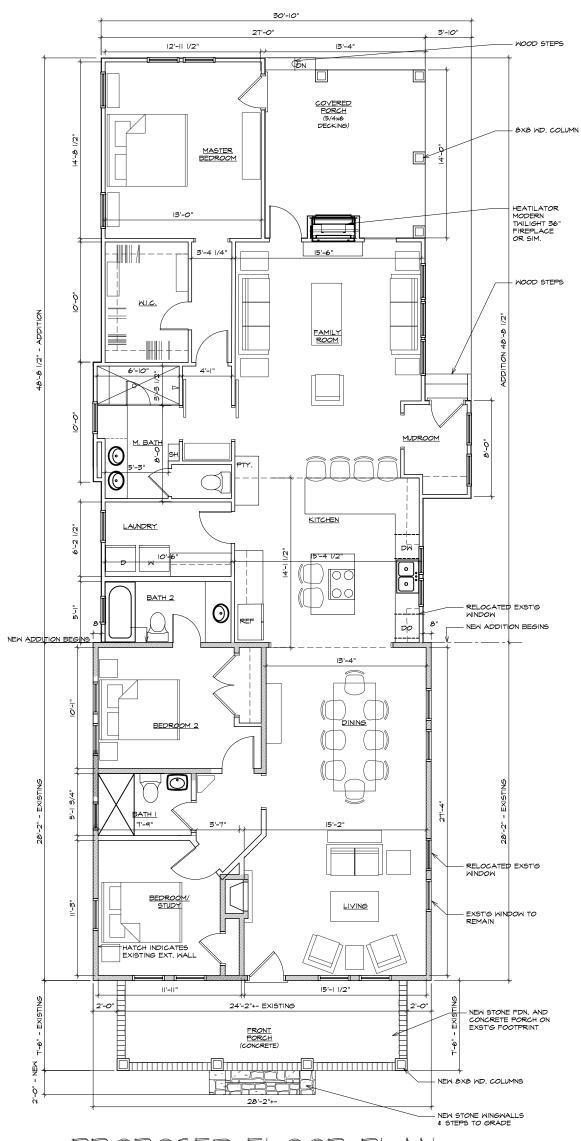
PROPOSED FLOOR PLAN

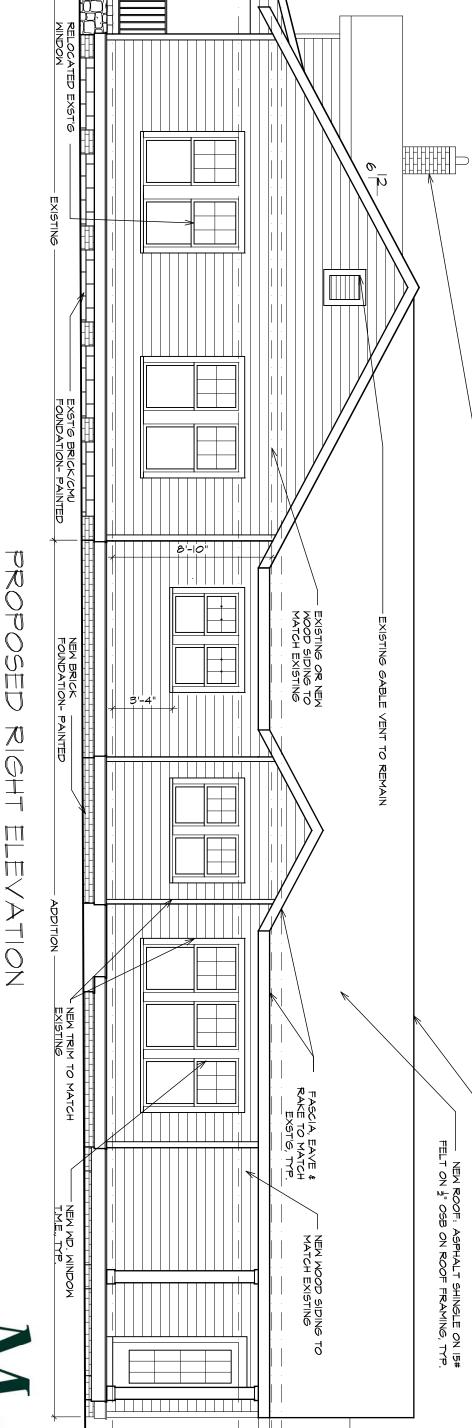
ELEVATIONS 3/16"= 1'-0" | DATE: 3-28-19

EXISTING CHIMNEY TO REMAIN

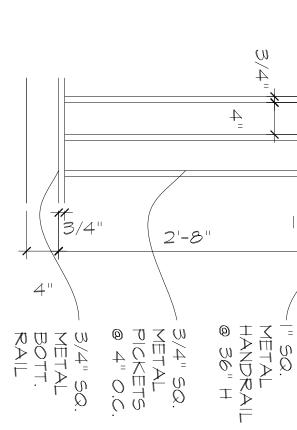
# SEARS RESIDENCE 1016 M. CABARRUS ST. DETAILS | 1"= 1'-0" | DATE: 3-28-19

## OUTSIDE FACE OF STONE STONE/CMU FDN. WALL POST/COL. STRUCTURE NAMA -BEAM ABOVE STONE CAP 2 \_ \_ \_ \_ #<u>4</u>/8 3/4 2 \_ \_ \_ \_ $\hat{\wp}$ $\bar{\wp}$ <u>-</u>4/8 \_4/B\_ Δ <del>1</del>3 Ď 1/2" 2 1/2" TO FACE OF FOUND.

METAL RAILING
