500 Polk Street

CERTIFICATE OF APPROPRIATENESS PLACARD

Raleigh Historic Development Commission COA Application - tree removal 500 Polk Street, Raleigh 27604

Tree Evaluation Report

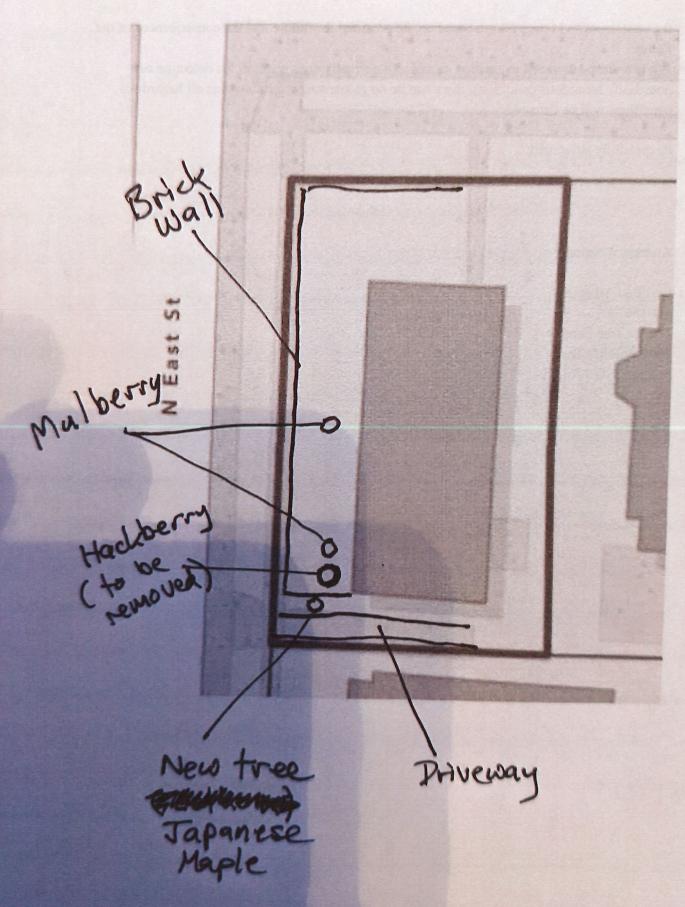
Polk St.

11/15/2021: Applicant amended application to locate replacement tree on subject property - site plan provided. Proposed replacement tree species is a Japanese maple sized to fit new location.
