ISSUES

SOLUTIONS

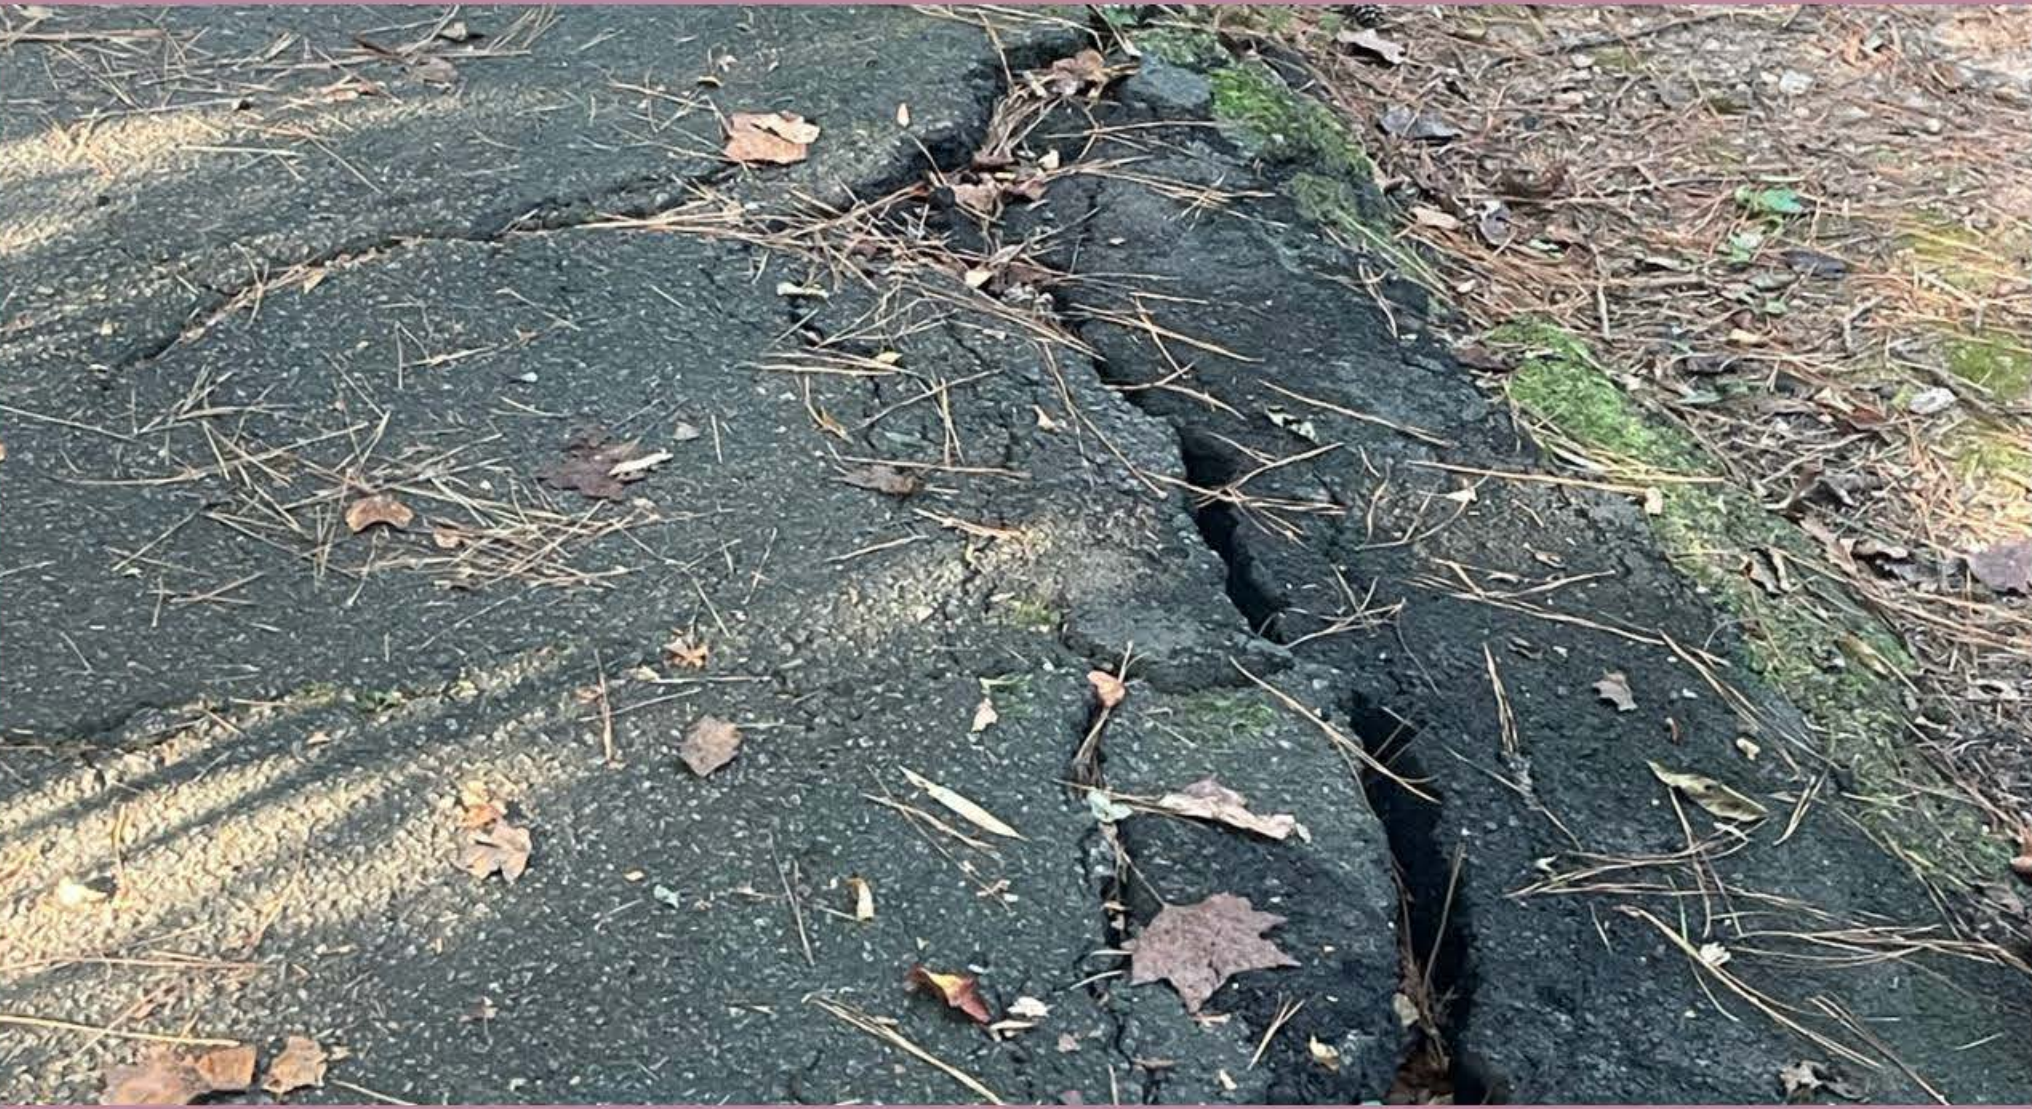
CRACKING

Asphalt cracking is caused by aging, root intrusion, and erosion

Replace the trail surface to create a smooth, even surface

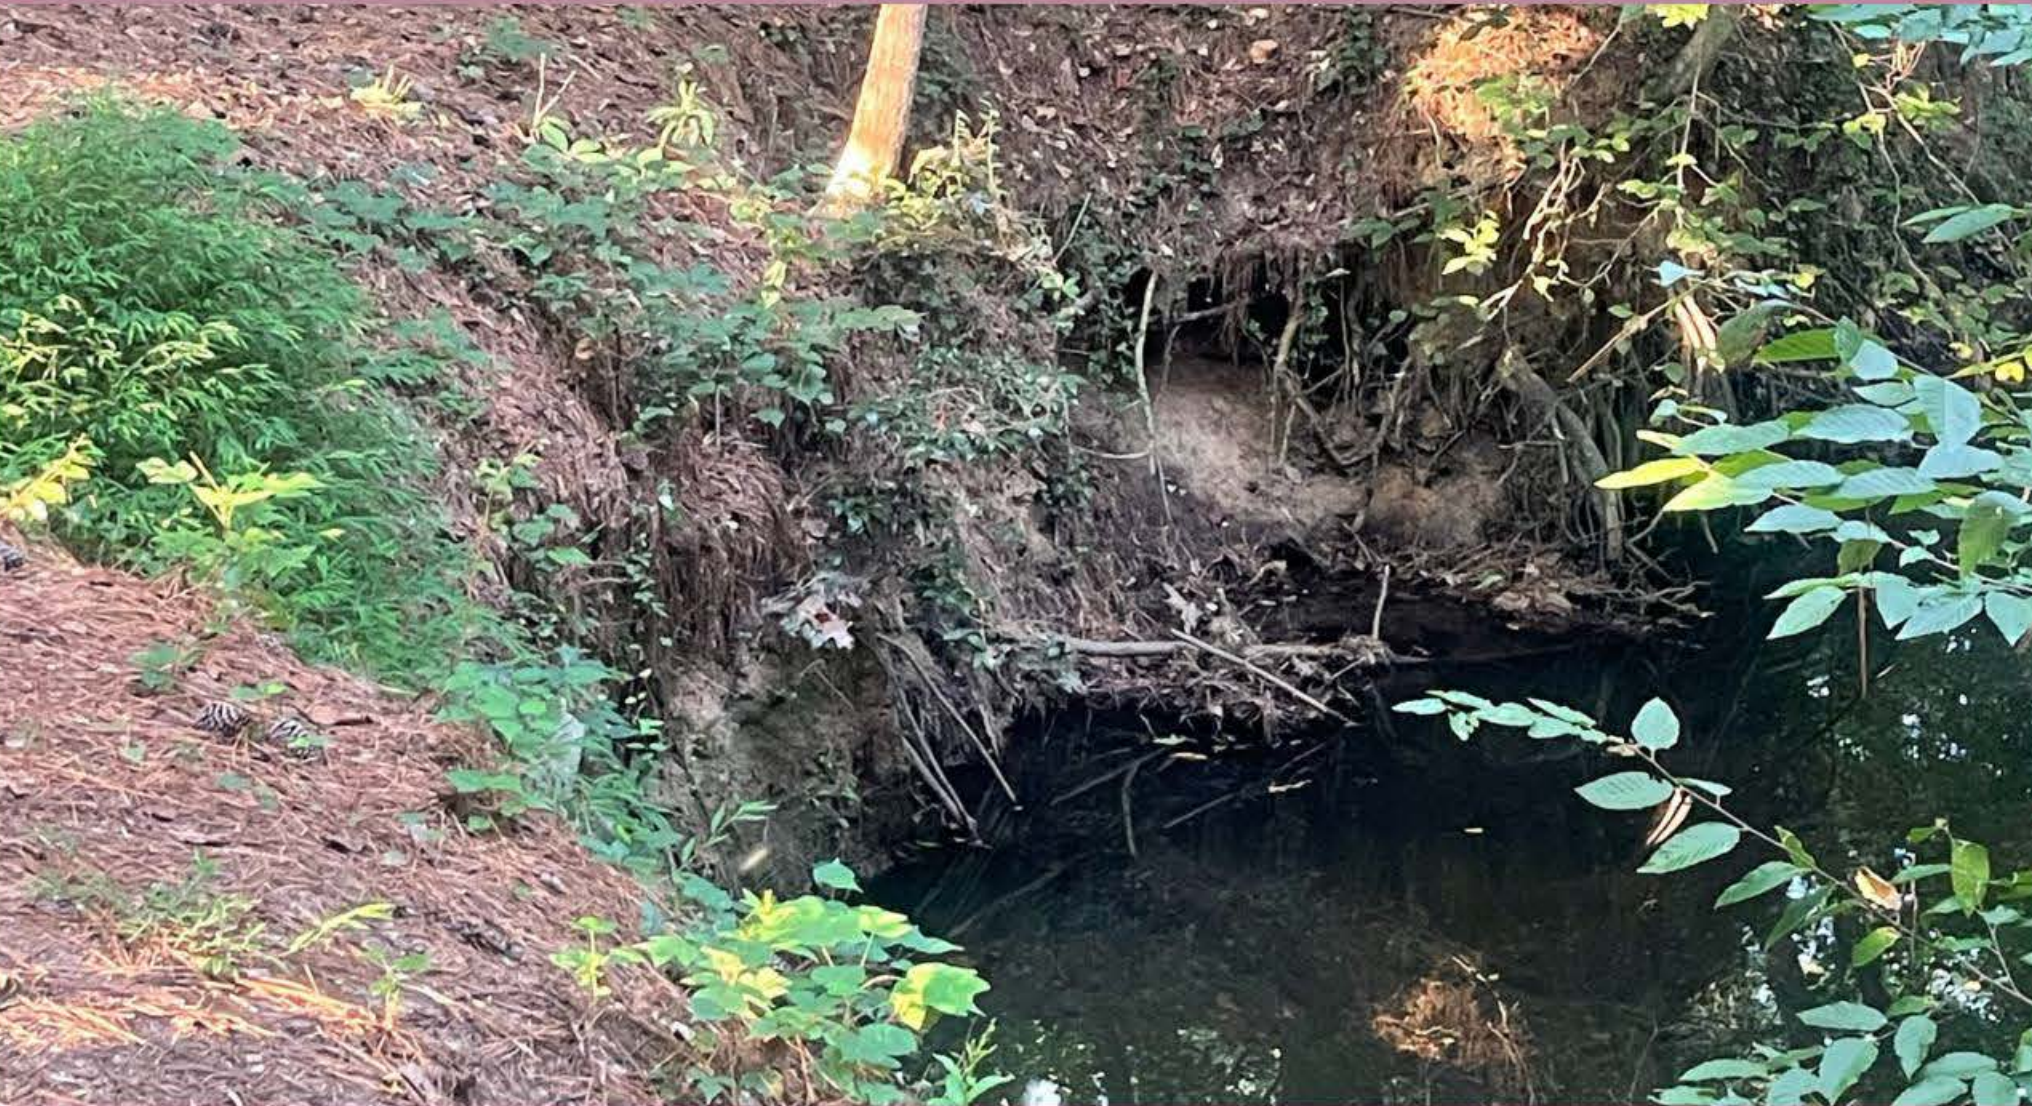
STREAM BANK EROSION

Large storm events have caused stream bank erosion, compromising the trail

Reinforcing the stream bank with materials and native plants to prevent erosion

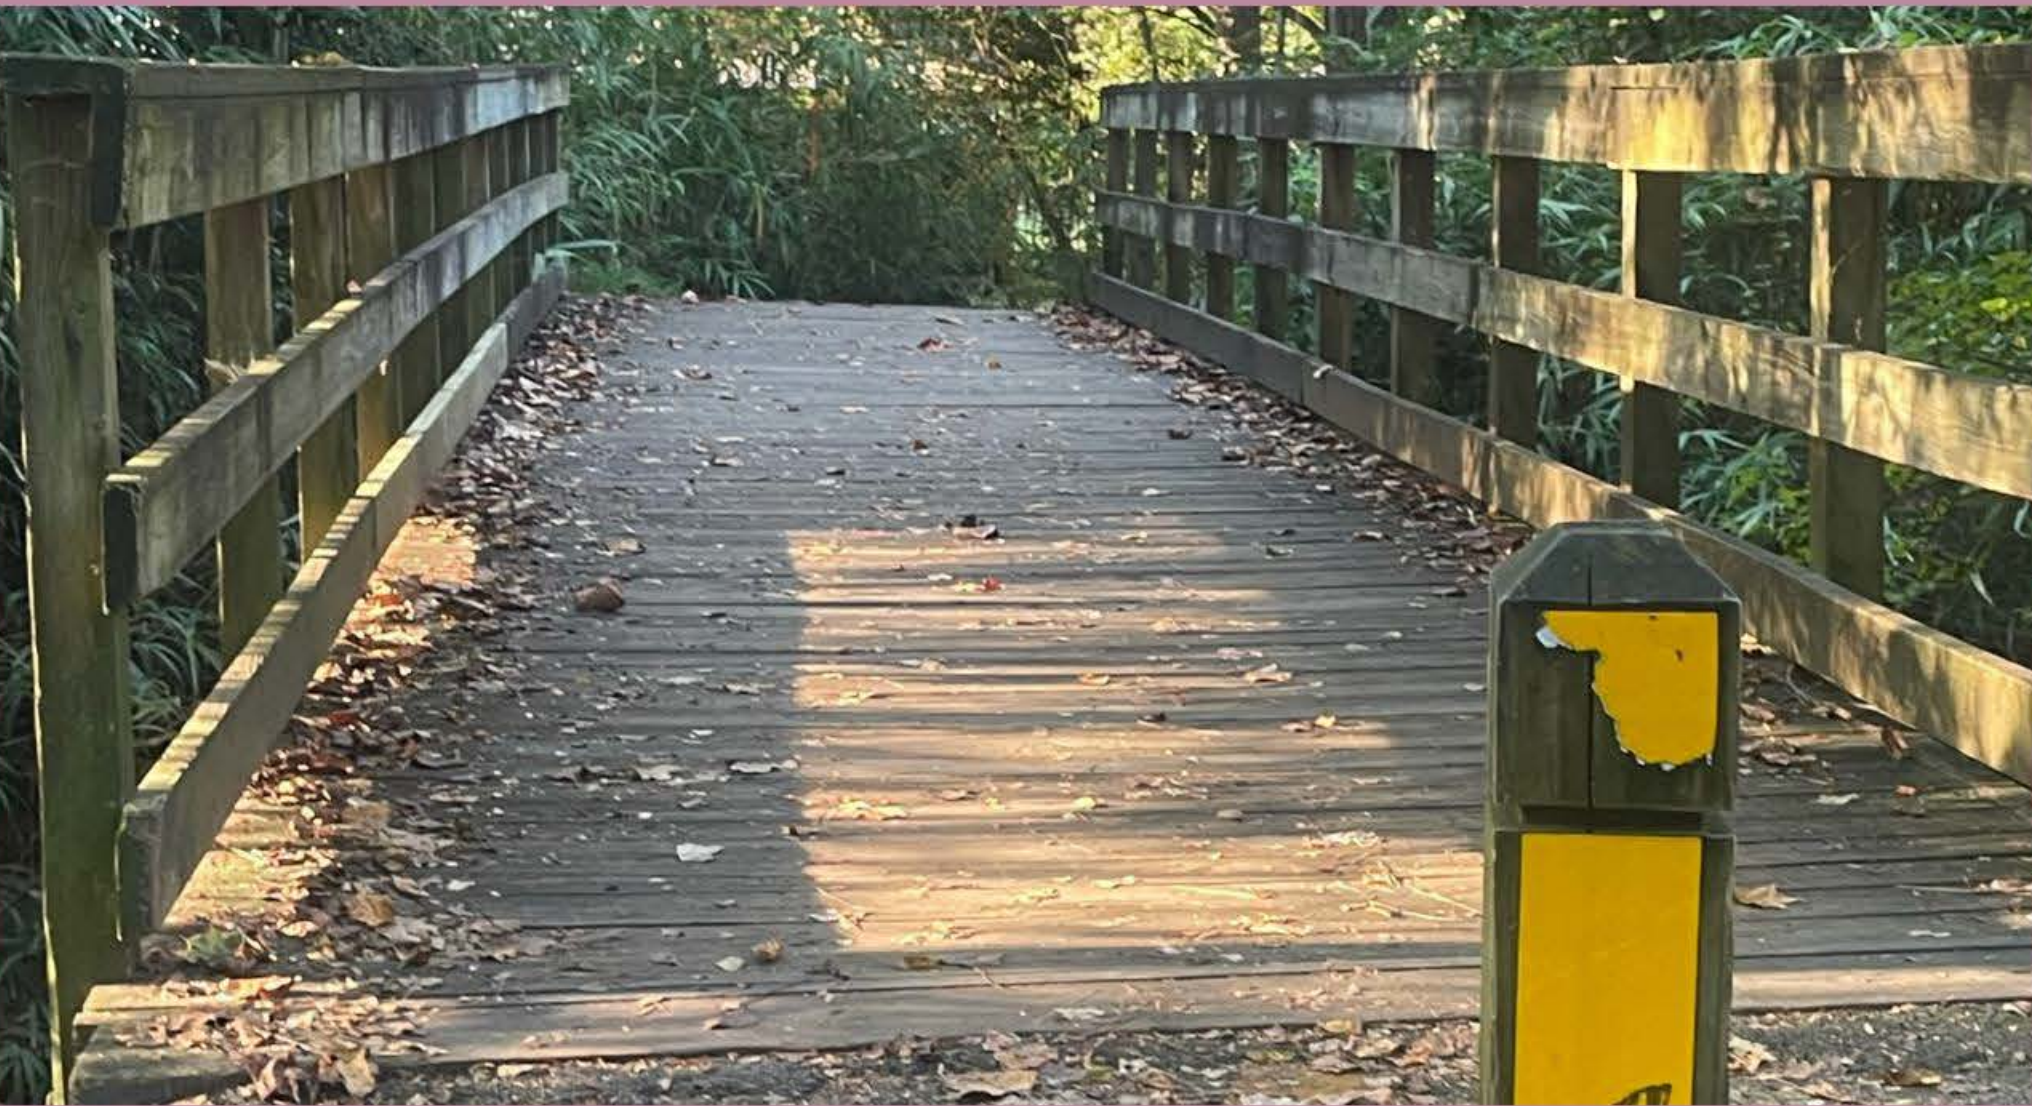
AGING INFRASTRUCTURE

Bridges that cross Mine Creek have deteriorated

Bridge replacement to improve pedestrian safety and aesthetics
